**SYSTEM ANNUAL
INSPECTION REPORT**
Fiscal Year 2022

NORTH TEXAS TOLLWAY AUTHORITY

Subject: FY 2022 GEC System Annual Inspection

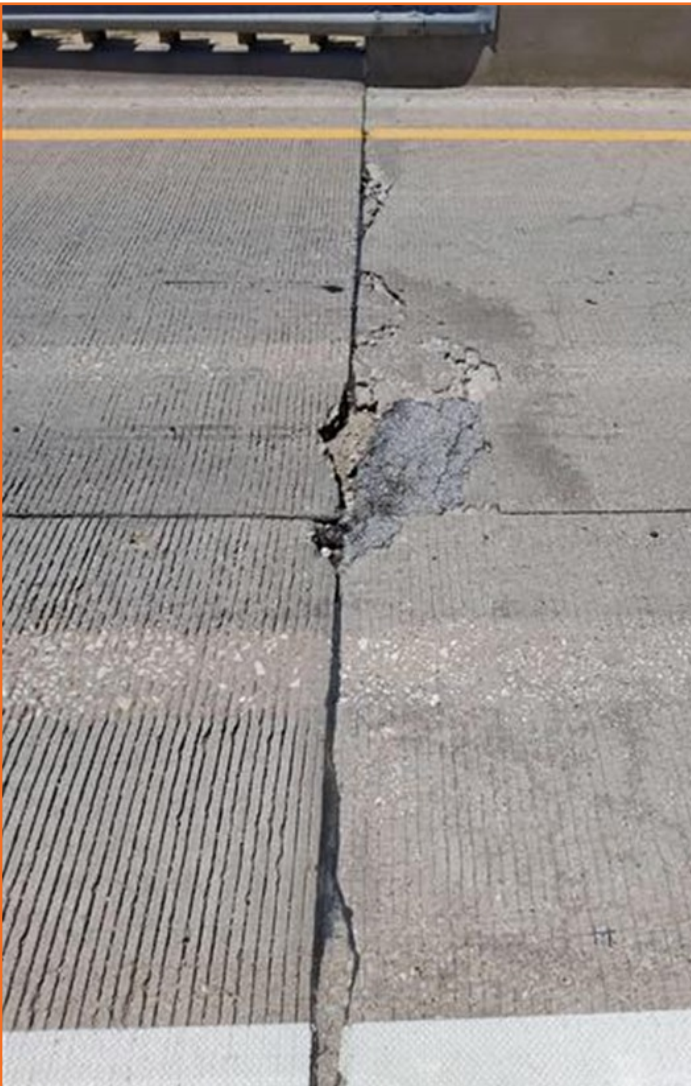
Minor barrier spalling was observed at various locations throughout the corridor as illustrated in Figure 2. There were multiple areas of erosion under bridges and landscape areas as illustrated in Figure 3. Also noted were areas of pavement cracking and spalling as well as joint deterioration noted in Figures 4 and 5.

Figure 5: DNT pavement joint deterioration NBML N. of Eldorado Pkwy.

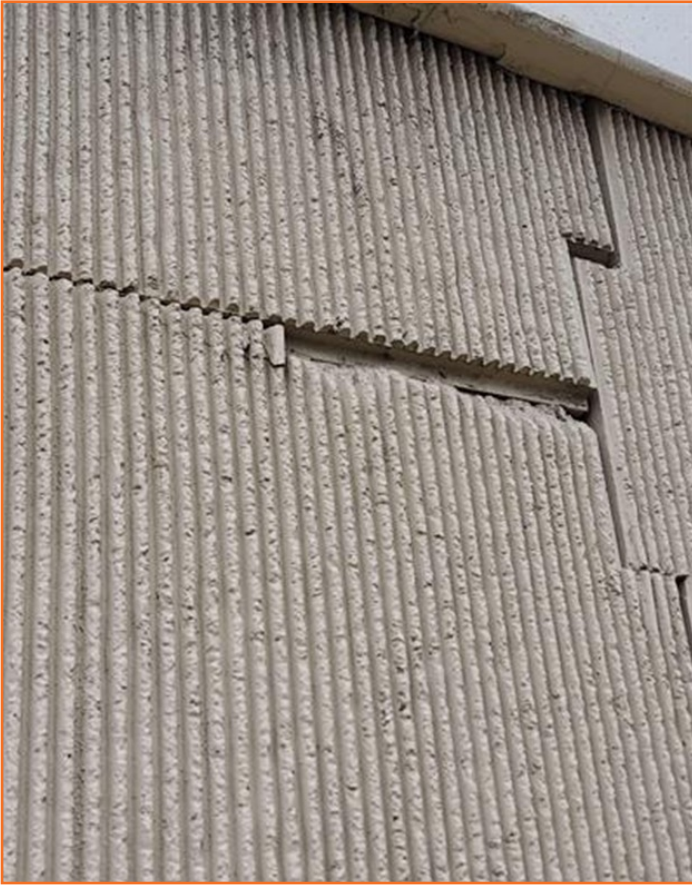
Wall panels and copings were observed with minor spalling and cracking at various locations (Figure 9).

Figure 9: DNT retaining wall panel crack NBML S. of IH-635

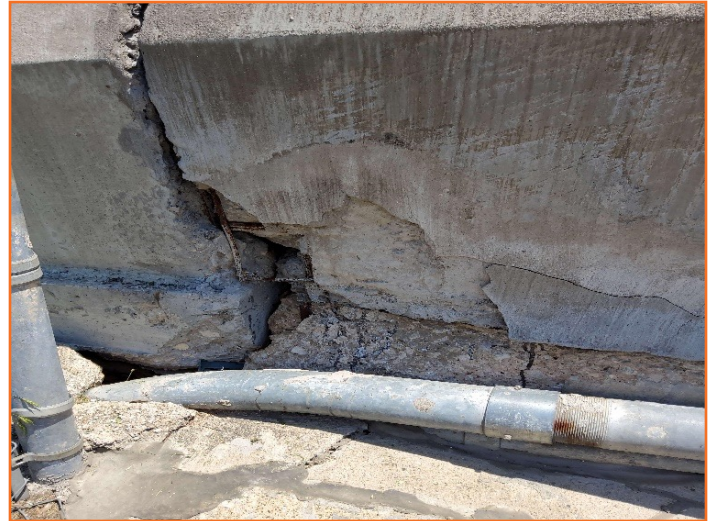
- One observation noted was areas where the concrete rail is damaged (Figure 10).
- Cracking in the abutment backwall was also observed at various locations as illustrated in Figure 11.

Figure 10: DNT concrete rail damage SB at Maple Ave.

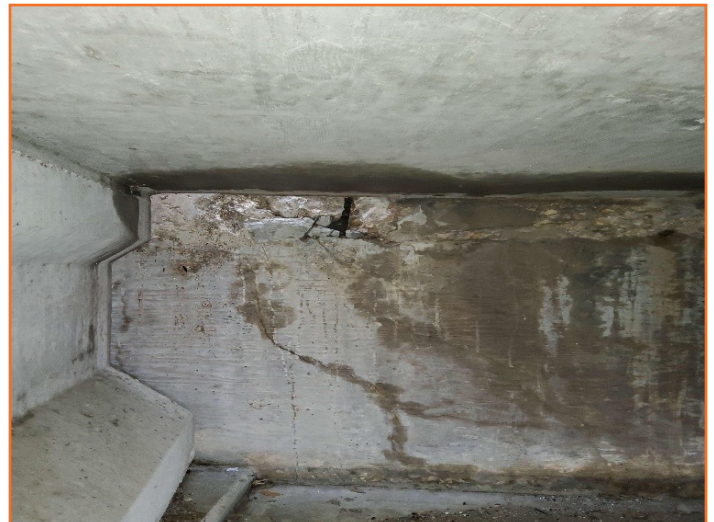
Figure 11: DNT bridge abutment cracking NB at Harvest Hill Rd.

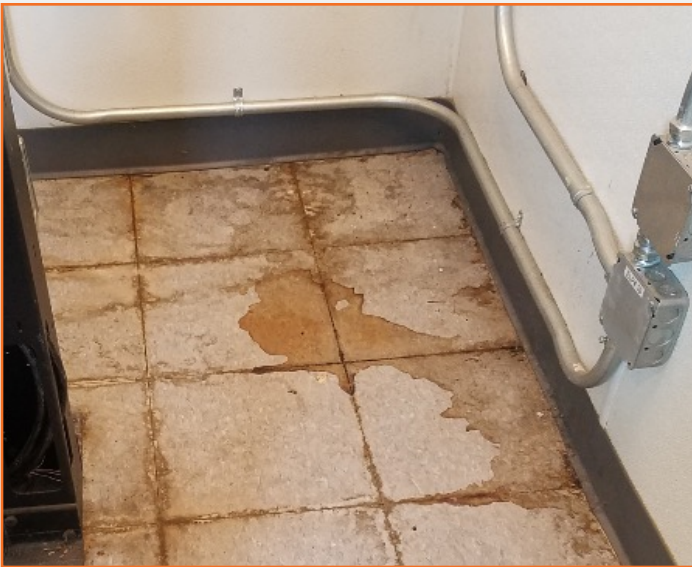
- At MLP 2, observations included sealant missing from the building perimeter concrete.
- At MLG 3, located near Parker Road there was floor damage from water intrusion as illustrated in Figure 12, and a general deterioration of the site improvements such as parking areas, curbs, and walks.
- At MLP4, significant deterioration of the existing roof (Figure 13) was observed; it has been reported to the GEC that a roof replacement project is in design. The gantry structure at MLP4 continues to experience coatings failure which is not yet affecting its function.

Figure 12: DNT MLP3 – floor damage from water intrusion

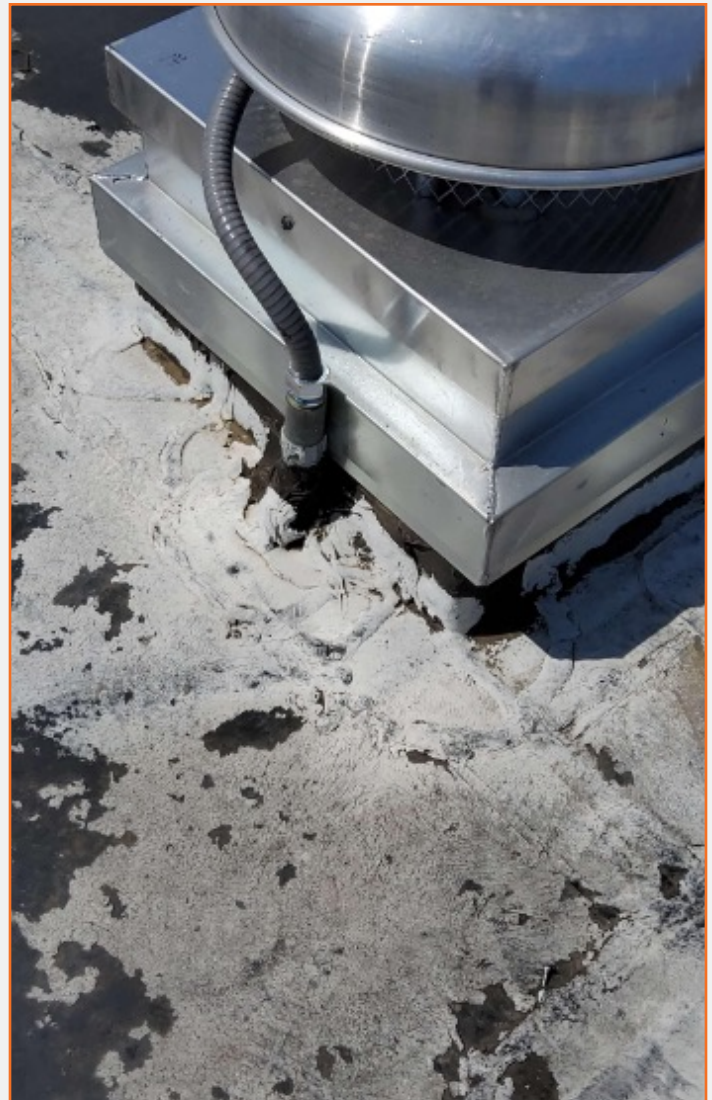
Figure 13: DNT MLP4 – deteriorated roof

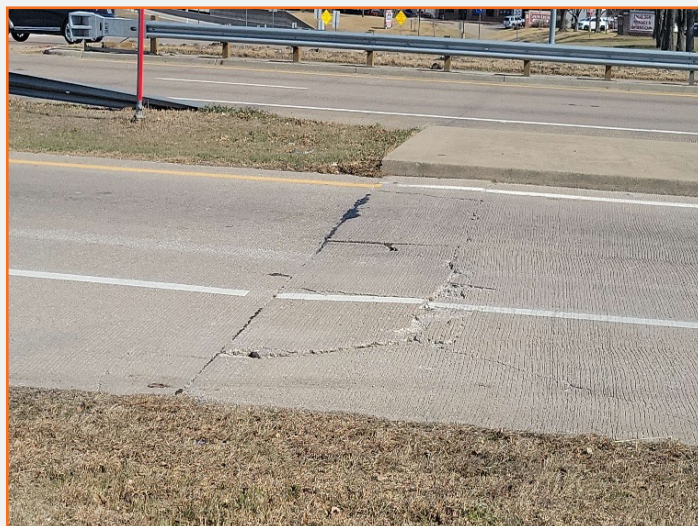
Figure 17: PGBT pavement cracking SB exit ramp to Hwy. 78

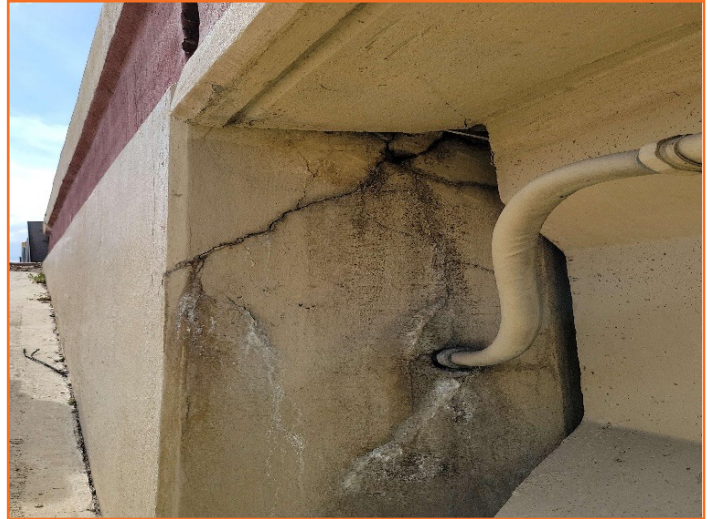
Bridge observations include abutment backwall cracking and spalling (Figure 19). Also noted were areas where the bridge beam is pushing against the backwall causing spalls on beam ends. Erosion was noted around bridge riprap and under bridges (Figure 20).

Figure 19: PGBT backwall cracking/spalling on SB structure at E. Rosemeade Pkwy.

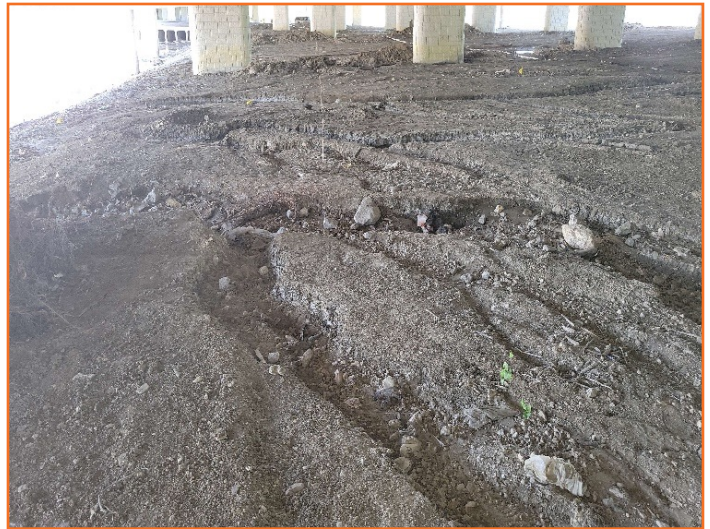
Figure 20: PGBT erosion under bridge SBFR South of N. Carrier Pkwy.

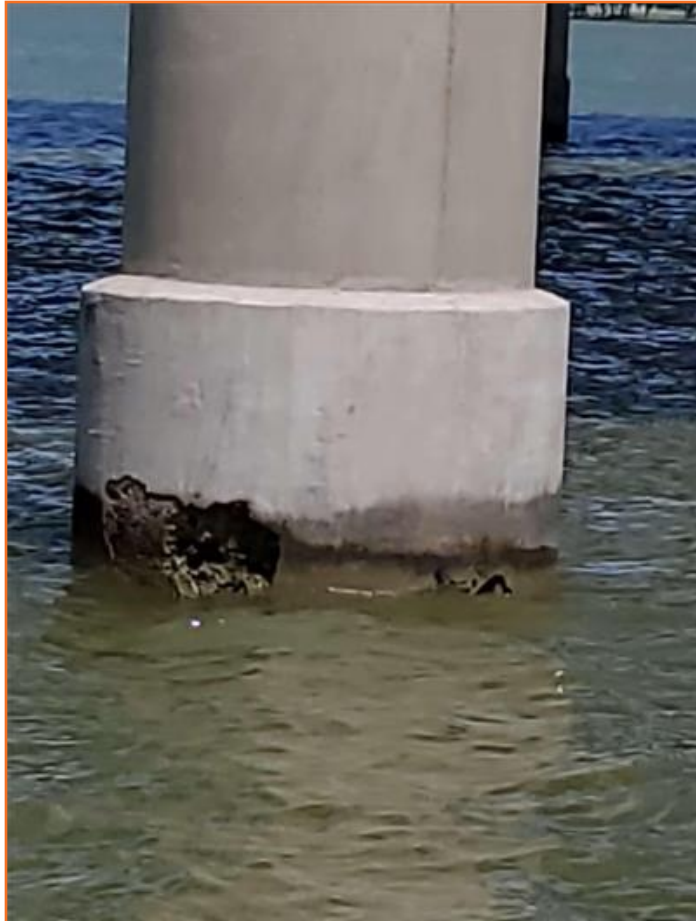
The substructure of the mainlane bridge over Lake Ray Hubbard is in good condition with only minor spalling in the sacrificial column protection (Figure 21). There were a few areas where the water collection system piping was disconnected and leaking (Figure 22).

Figure 21: PGBT at Lake Ray Hubbard column spall NB bent No. 48

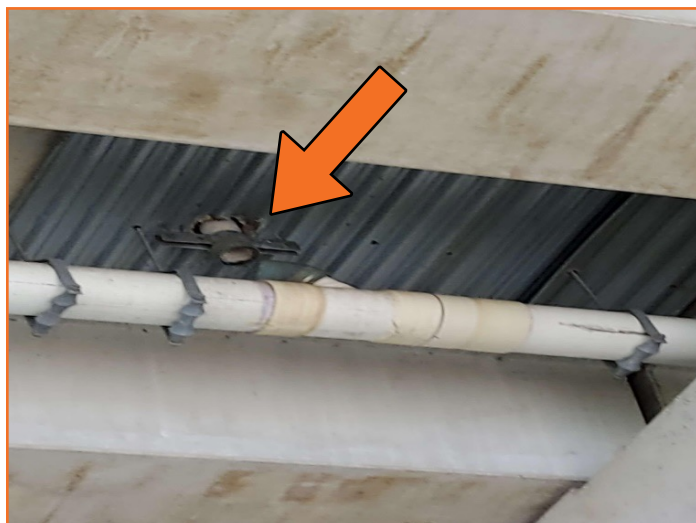
Figure 22: PGBT at Lake Ray Hubbard Deck drain pipe disconnected NB bent No. 21

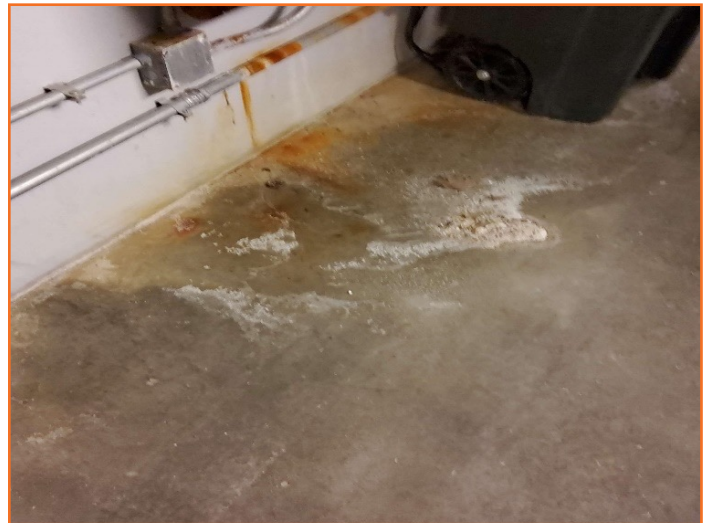
Observations identified throughout the facilities included stains on the ceiling indicating a roof or mechanical leak, missing lens on light fixtures, paint failing and rust developing on steel as noted on Figures 23 and 24. Recent HVAC replacement and roofing projects at MLPs 7, 8 and 10 have provided for high functionality of those facilities.

Figure 23: PGBT MLP 7 – rust staining on floor

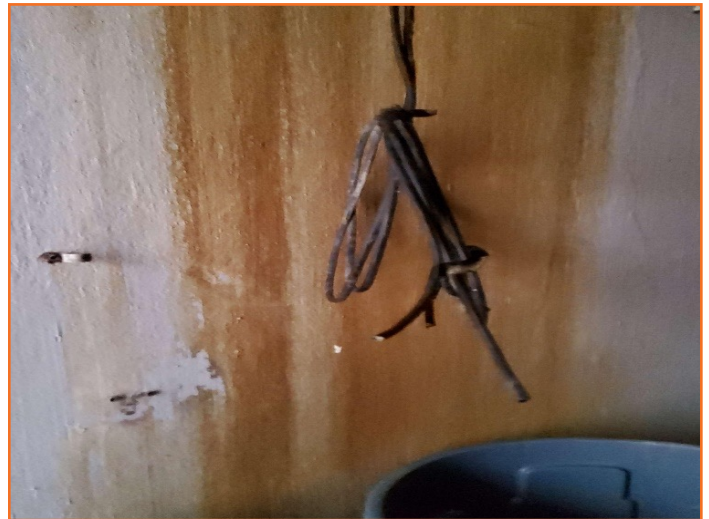
Figure 24: PGBT MLP 8 – rust developing on wall

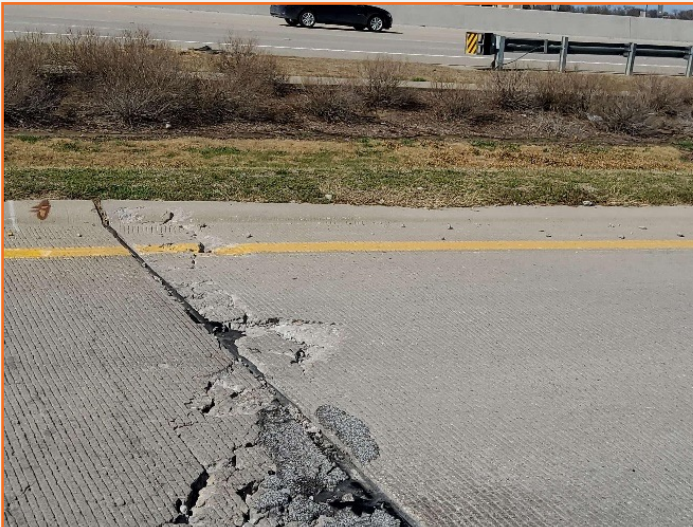
- There were multiple areas with pavement cracking, spalling and joint deterioration as noted in Figure 25. Pavement edge drop offs, as illustrated in Figure 26, were noted in various areas along the corridor.
- There were locations with erosion under bridges and around appurtenances as noted in Figure 27.
- Curb damage, as illustrated in Figure 28, was observed at multiple locations at intersections and on frontage roads.

Figure 25: SRT pavement cracking/spalling NB exit ramp to N. Josey Ln.

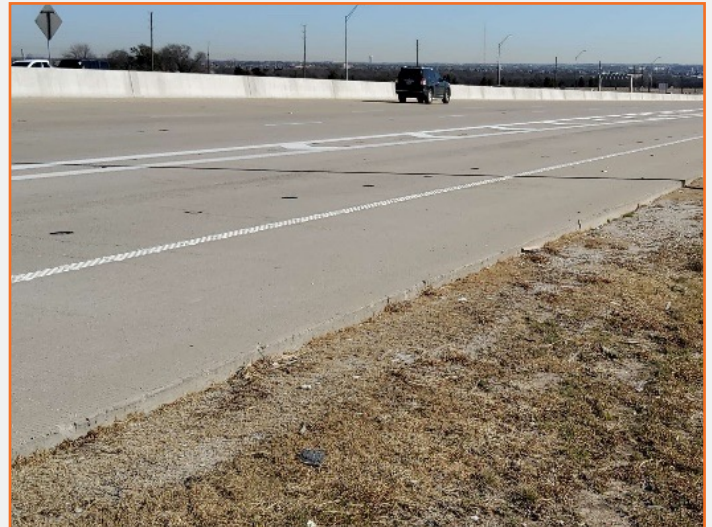
Figure 26: SRT pavement edge drop-off NB exit ramp to Independence Pkwy.

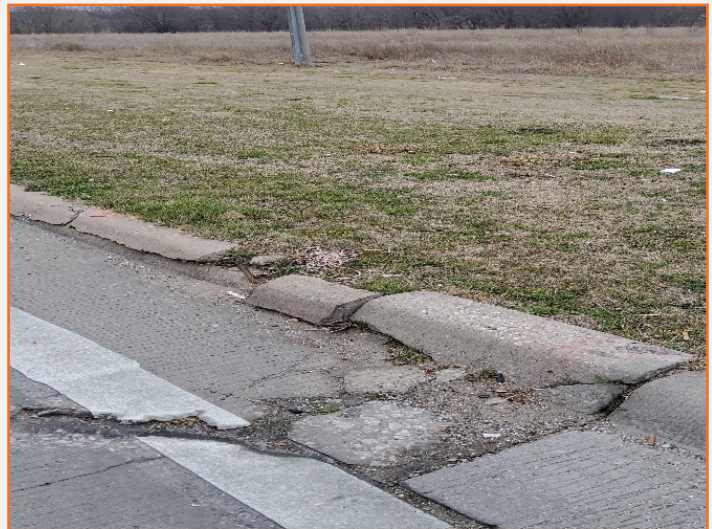
Figure 28: SRT curb damage NBR at Razor Blvd.

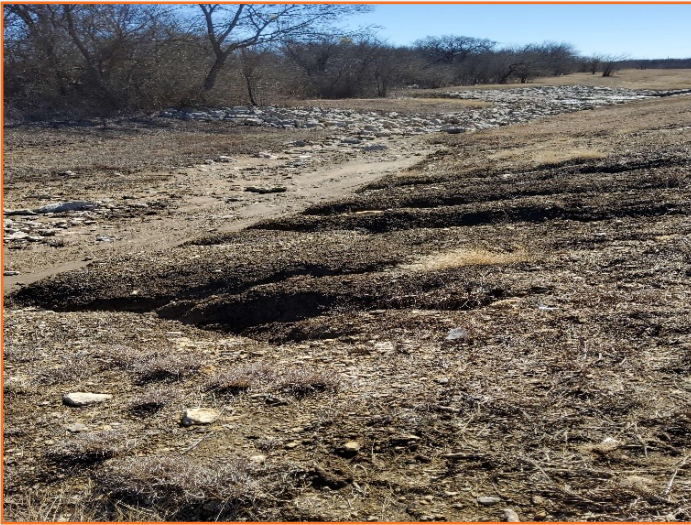
Areas of erosion were noted at various locations as illustrated in Figure 33. There are areas with pavement edge drop offs as shown in Figure 34. Multiple areas were observed where the pavement joint seal was missing/damaged (Figure 35) or where concrete barrier spalling (Figure 36) occurred.

Figure 33: CTP embankment erosion – NB North of CR 1015

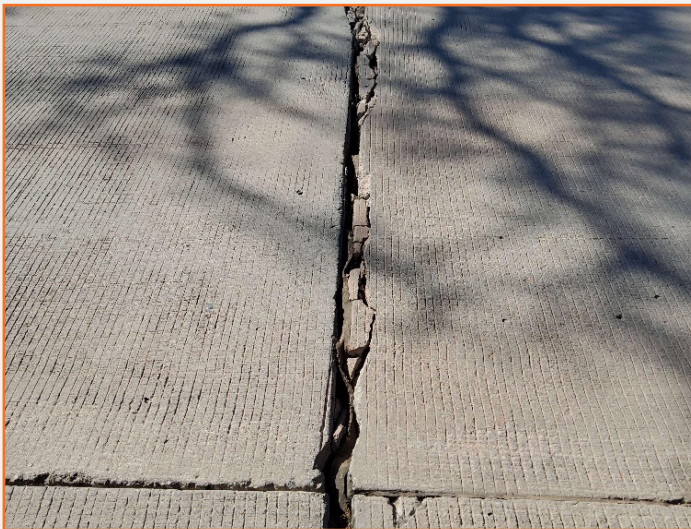
Figure 35: CTP pavement joint deterioration at SB exit ramp to Arborlawn Dr.

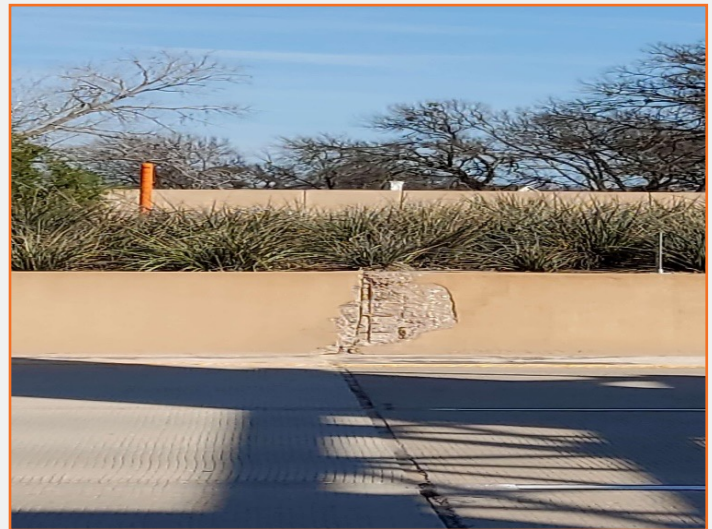
Figure 36: CTP barrier spalling NB just South of Arborlawn Dr.

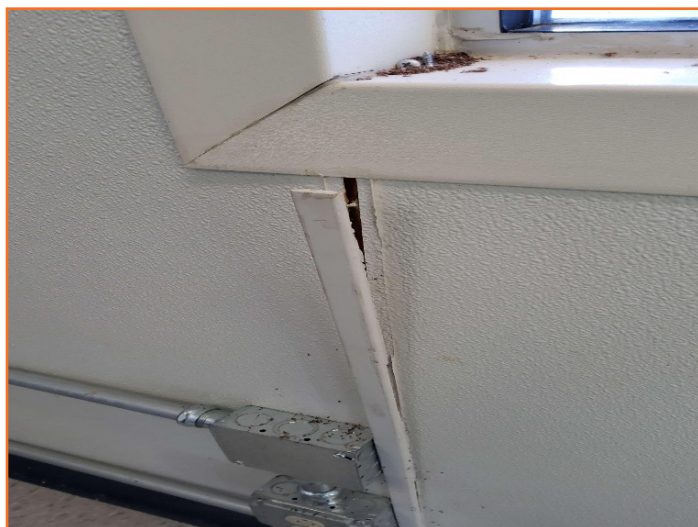
Facilities along the CTP corridor are in good condition with only a few minor findings. Rust developing on door where paint is missing at MLG1 and water damage to floor due to water intrusion at MLG2 as noted in Figures 38 and 39. Insect infestation is a continuing issue at these facilities.

Figure 38: CTP MLG 1 – wall trim peeling away

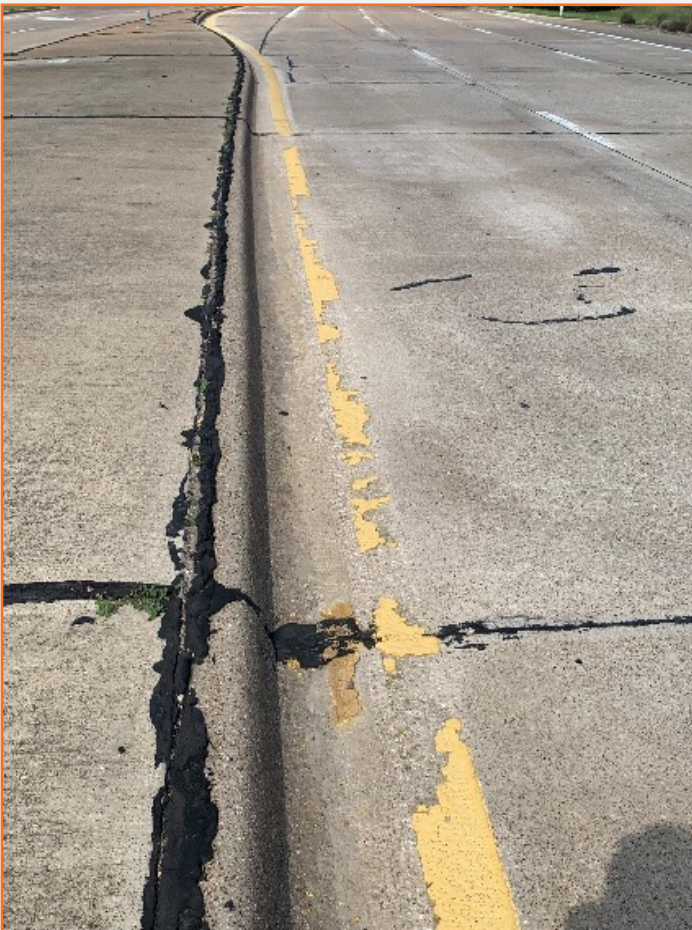
Observations noted on this year's inspection included faded and missing pavement markings as noted in Figure 40 and unsealed flume as noted in Figure 41.

Figure 40: MCLB faded or missing pavement markings

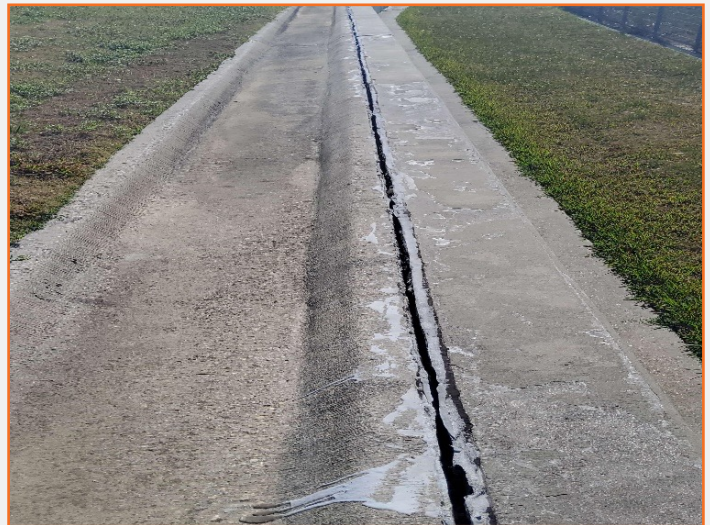
Figure 41: MCLB flume unsealed at wall East end of bridge

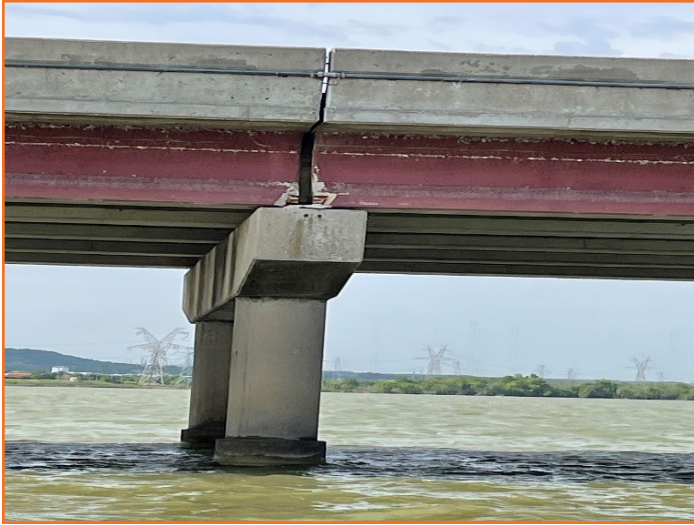
Figure 42: MCLB typical beam end spall

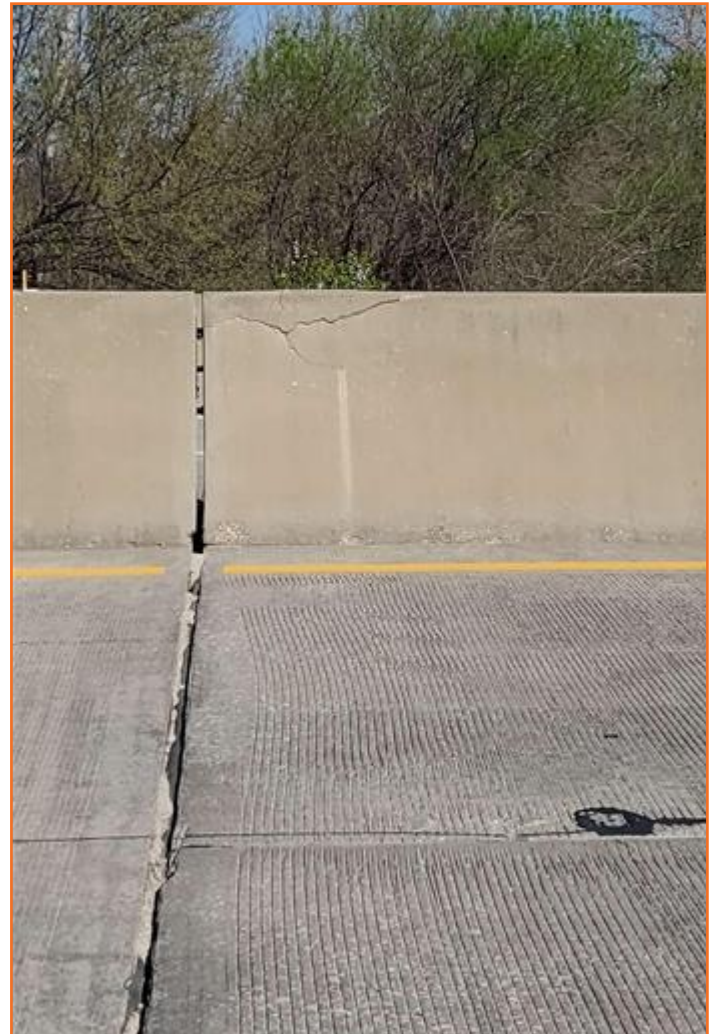
Observations on the roadway include minor cracking and spalling on the concrete rail in addition to pavement joint seal missing/damaged as shown in Figure 44.

Figure 44: LLTB pavement seal missing/damaged

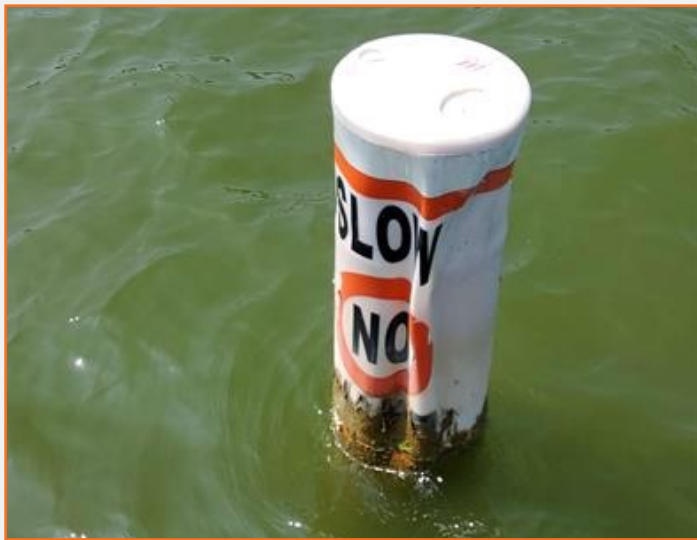
Observations on or related to the bridge include damaged buoys (Figure 45), and column and abutment spalling (Figure 46 and 47). In addition, it was noted that the AquaShield bridge drainage system has a broken weld (Figure 48).

Figure 45: LLTB damaged buoy

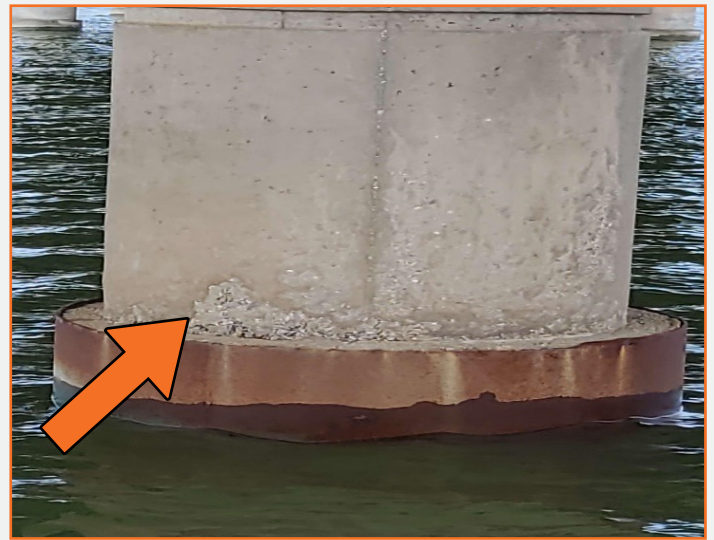
Figure 46: LTTB column spalling near bent No. 53 from West

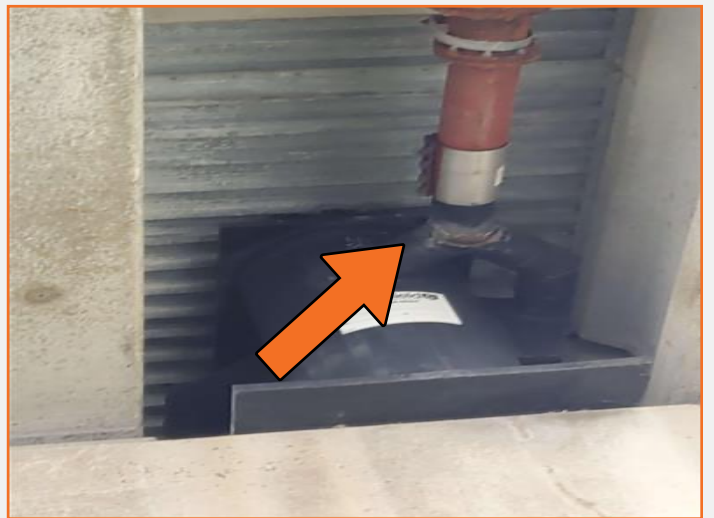
Figure 48: LLTB AquaShield pipe welding broken

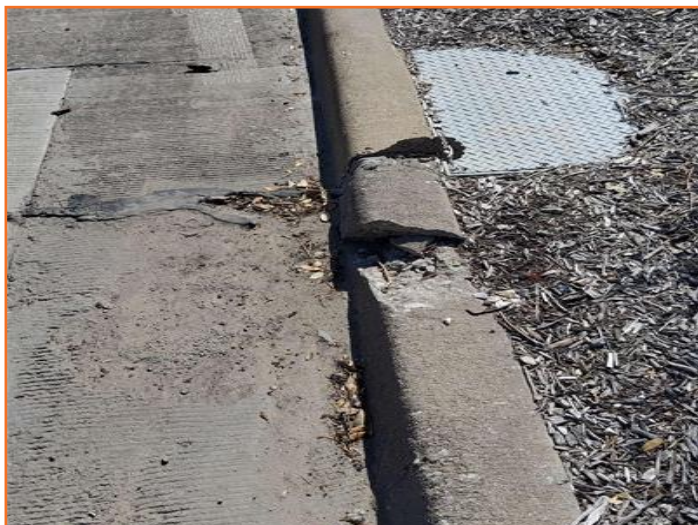
Observations on the roadway include curb damage on both ends of the tunnel (Figure 49).

Figure 49: AATT curb damage

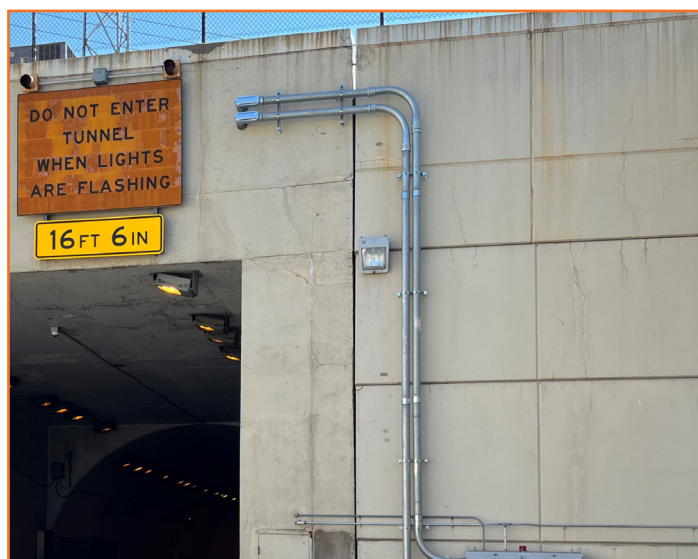
Observations concerning the tunnel include cracking and spalled wall panels along with faded signs (Figure 50). These signs will be replaced as part of the AATT Improvements project which will start construction in late 2022. There were a few locations with wall spalling along the tunnel.

Figure 50: AATT cracked and spalled wall panels on West end tunnel entrance

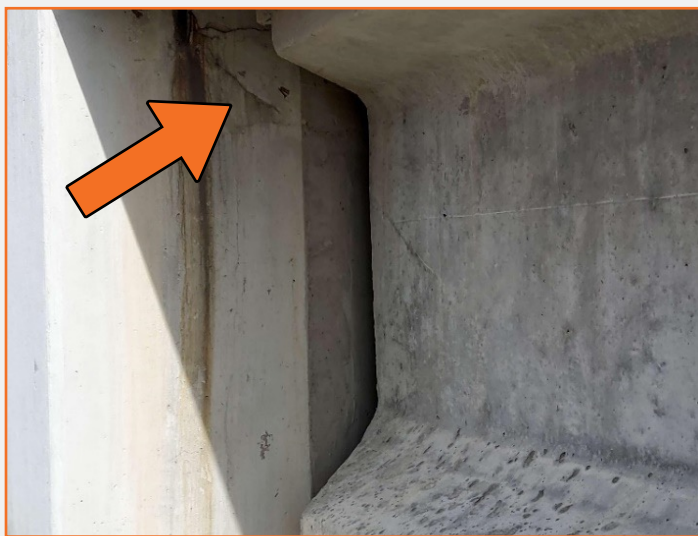
Figure 54: 360T backwall cracking at Bowman Branch bridge

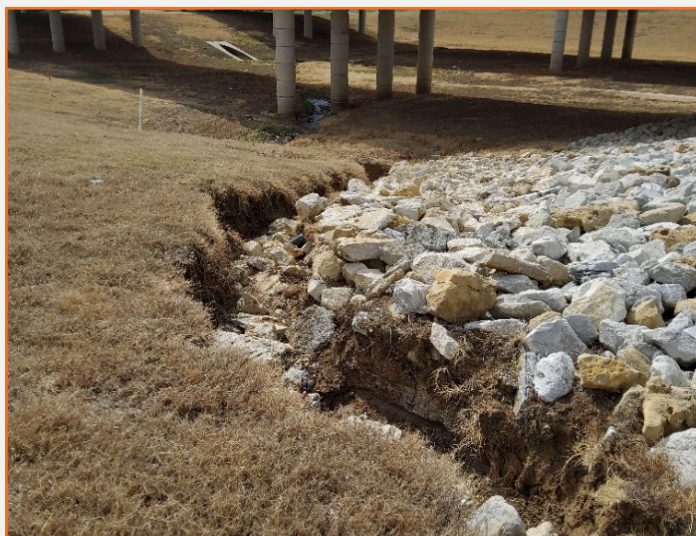
Figure 55: 360T erosion around riprap at Walnut Creek bridge

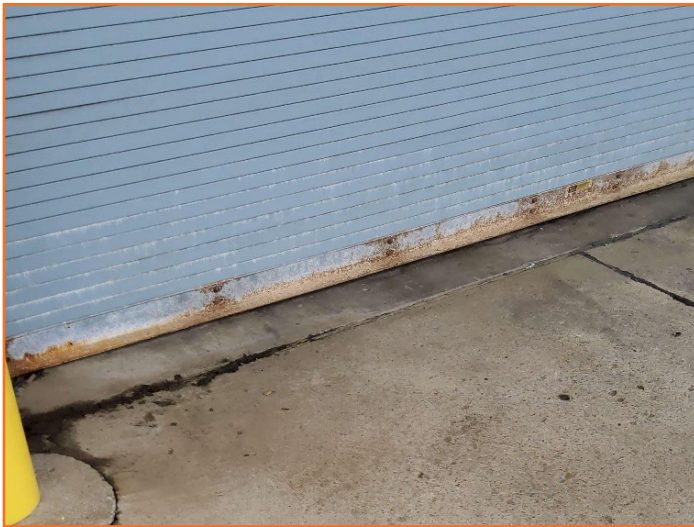
Observations at the Ohio Drive Maintenance Service Center include gutter damage, rust on overhead door seals (Figure 56) and structural frames, stains on ceiling indicating roof or mechanical leak and gate closure damage.

Figure 56: Ohio – rust on overhead door seals

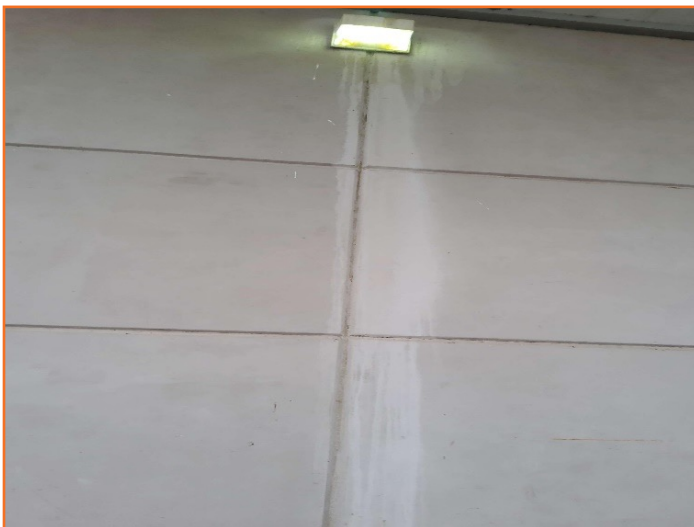
Observations at the Frisco Maintenance Service Center include cover missing from pole base and near manhole cover, staining at light fixture (Figure 57) and areas of rain intrusion.

Figure 57: Frisco – staining at light fixture

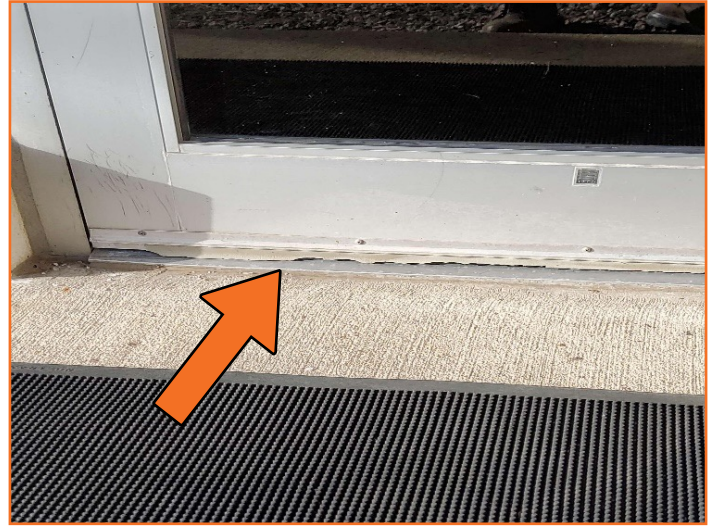
Observations at the Gleneagles Office Center at 5900 West Plano Parkway include water staining on ceiling and lamps burnt out at multiple locations, deteriorated door sweeps (Figure 58), sprinkler escutcheon missing and handrail rusting at base (Figure 59).

Figure 58: Gleneagles 5900 – door sweeps deteriorated

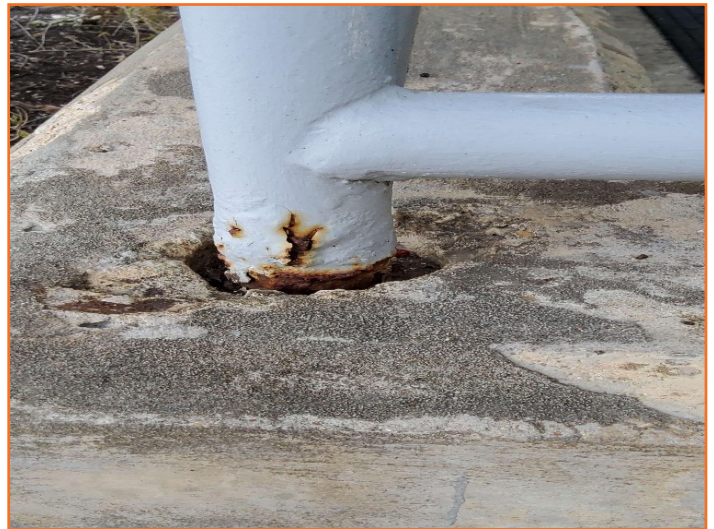
Figure 59: Gleneagles 5900 – handrail rusting at base
