ANNUAL INSPECTION REPORT SYSTEM

Fiscal Year 2021

Subject: FY 2021 GEC System Annual Inspection

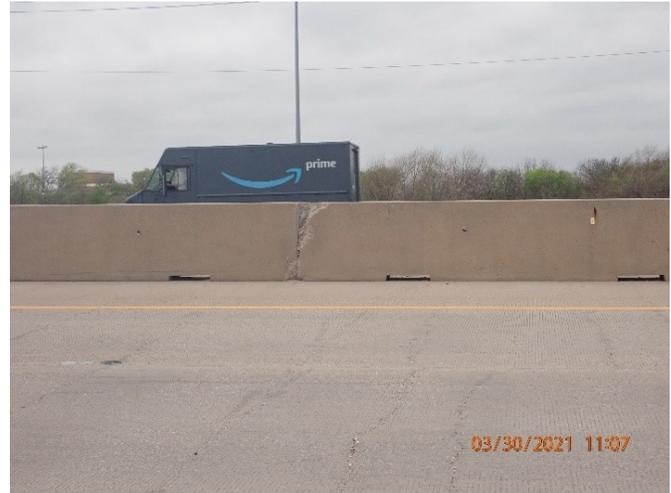
Minor barrier spalling was observed at various locations throughout the corridor as illustrated in Figure 2. There were multiple areas of erosion under bridges and landscape areas as illustrated in Figure 3. Also noted were areas of pavement cracking and spalling as noted in Figures 4 and 5.

Figure 2: DNT barrier wall spall NBML S of Eldorado Pkwy

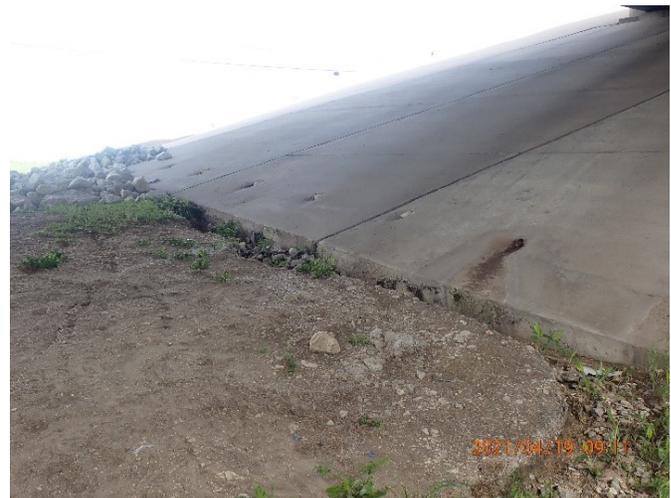
Figure 3: DNT Erosion at Stewart Creek bridge

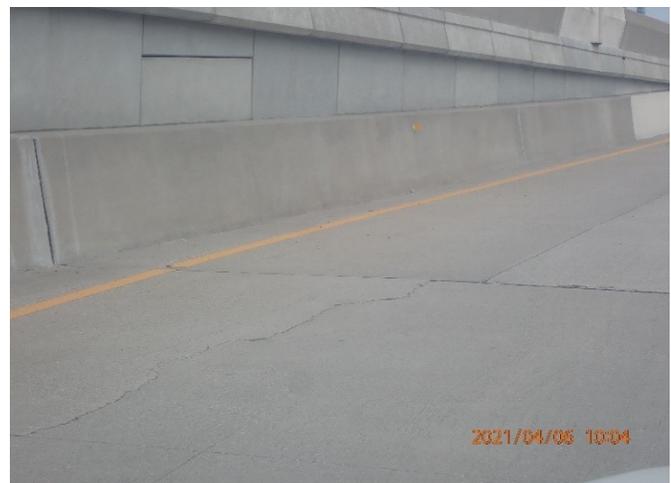
Figure 4: DNT pavement crack on ramp from Main St.

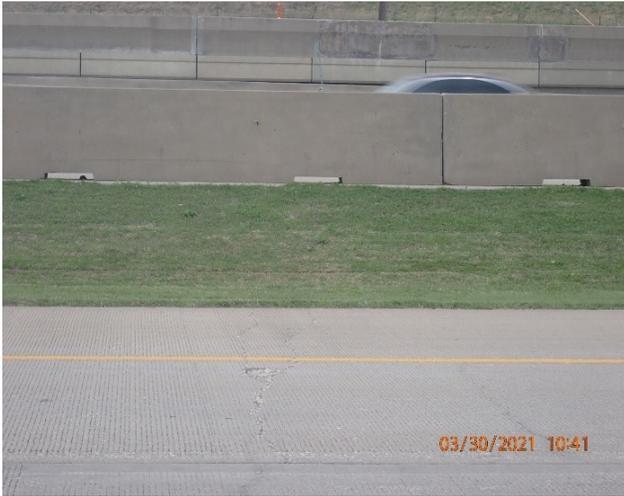
Figure 5: DNT pavement spall NBML N. of Stonebrook Pkwy.

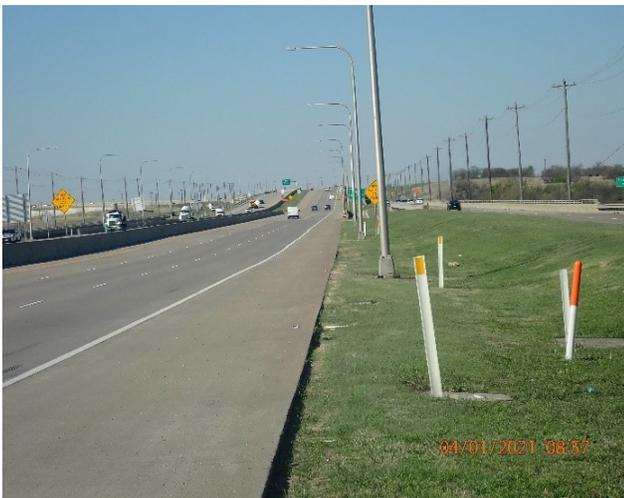
There are multiple isolated locations of pavement edge drop offs as illustrated in Figure 6. Also noted were areas of curb damage. Delineation was missing on the concrete traffic barrier (CTB) and on the metal beam guard fence in various locations as illustrated in Figure 7. Several clearance signs were faded as noted in Figure 8.

Figure 6: DNT pavement edge drop-off SBML N of Panther Creek.

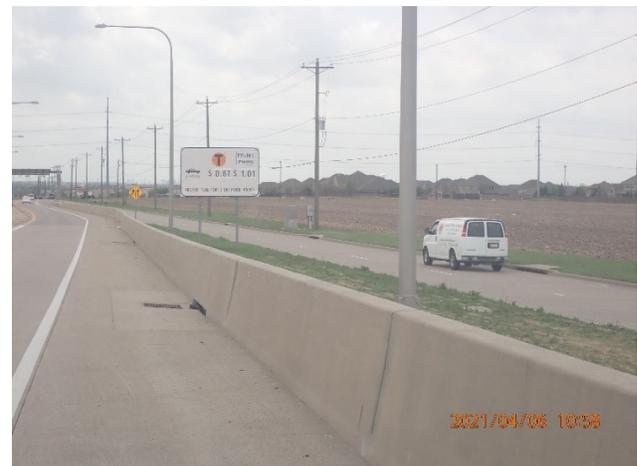
Figure 7: DNT delineation missing on CTB SB ramp at Panther Creek

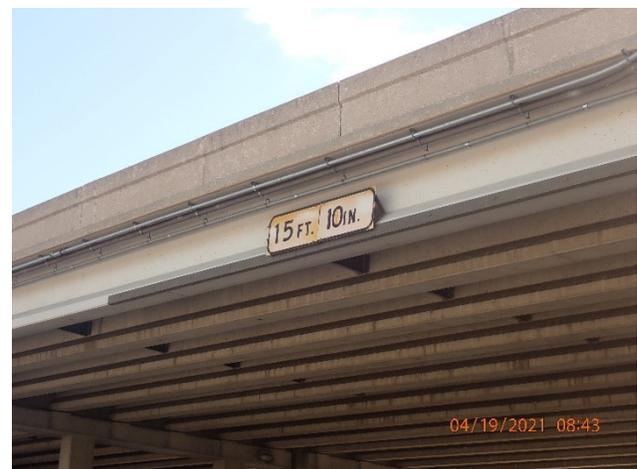
Figure 8: DNT clearance sign faded SB at Trinity Mills Rd.

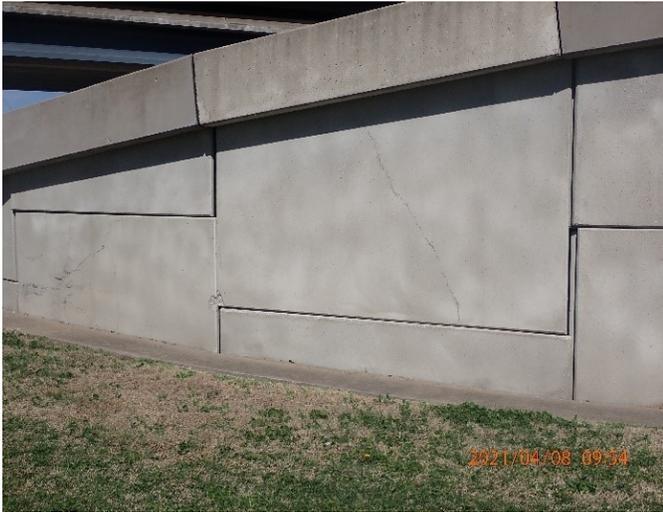
Wall panels and copings were observed with minor spalling and cracking at various locations (Figure 9).

Figure 9: DNT retaining wall panel crack at Panther Creek

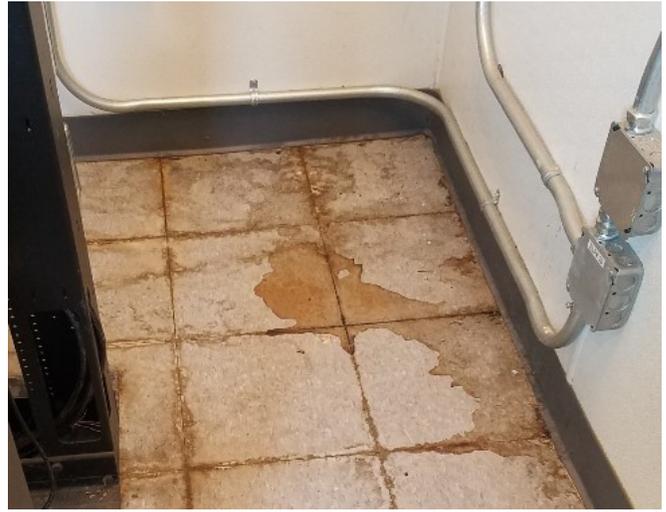
At MLG 3, located near Parker Road there was floor damage from water intrusion as illustrated in Figure 12.

Figure 12: DNT MLP3 – floor damage from water intrusion

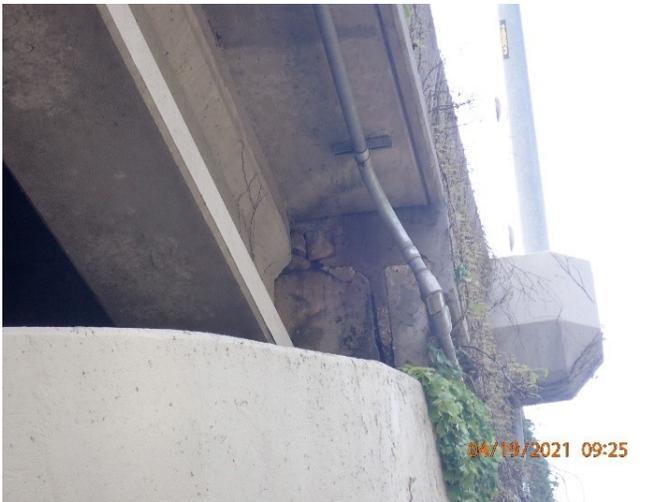
One observation noted was areas where the abutment backwall was spalling (Figure 10). There was no further progression of the spalling in this year’s inspection.

Figure 10: DNT backwall spall SB at Spring Valley Rd.

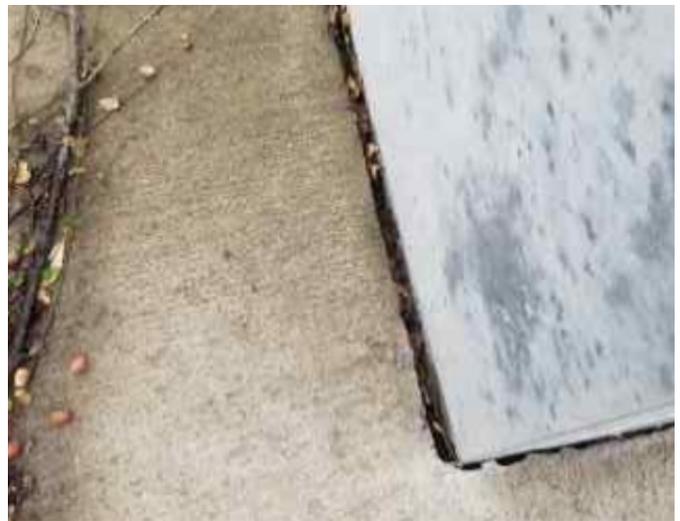
At MLP 2, observations included sealant missing from the building perimeter concrete as noted in Figure 13.

Figure 13: DNT MLP2 – sealant missing at concrete joint

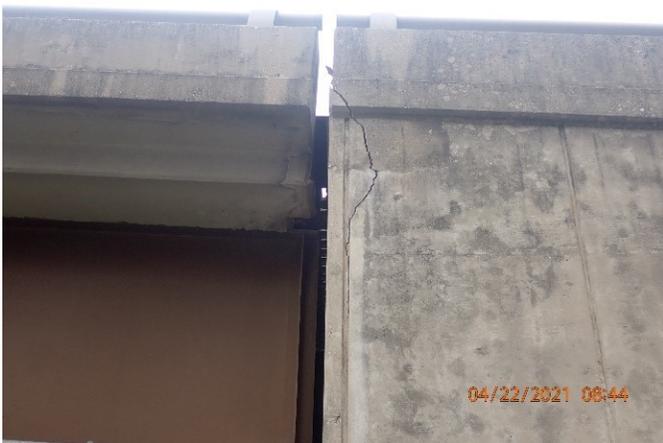
Cracking in the abutment backwall was also observed at various locations as illustrated in Figure 11.

Figure 11: DNT bridge abutment cracking at Harry Hines

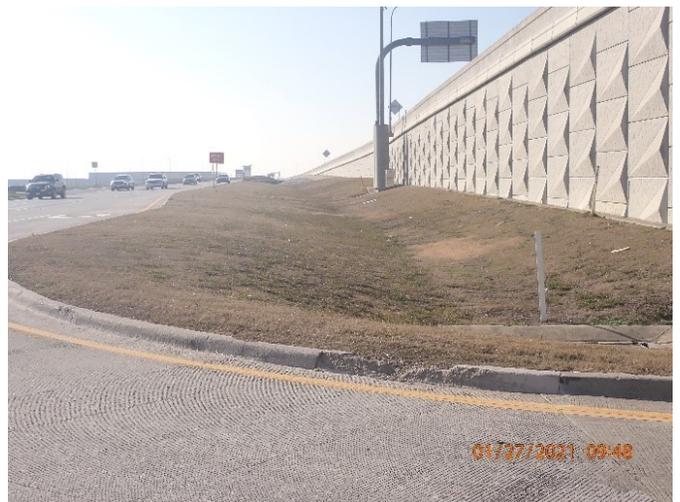
Figure 14: PGBT curb damage SB frontage N of Mayfield Rd.

There were multiple areas of damaged curb as illustrated in Figure 14. There were also areas of erosion on the roadside, around concrete appurtenances (Figure 15) and under bridges.

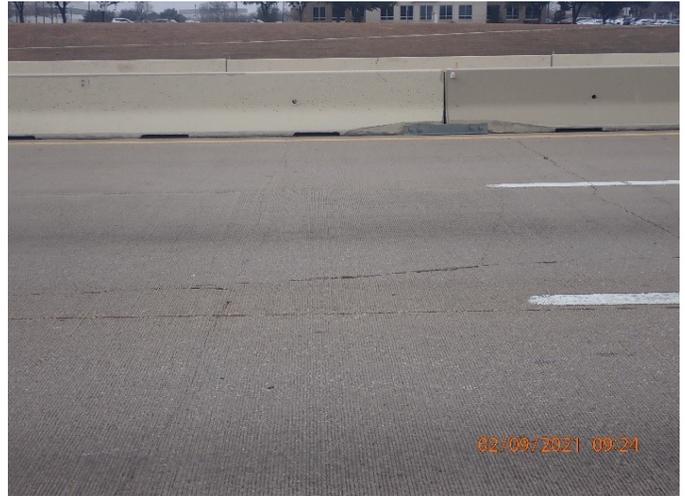
Pavement edge drop-offs (Figure 16) and pavement cracking and spalling (Figure 17) were observed at various locations throughout the corridor.

Figure 17: PGBT pavement cracking NB S. of SH 114

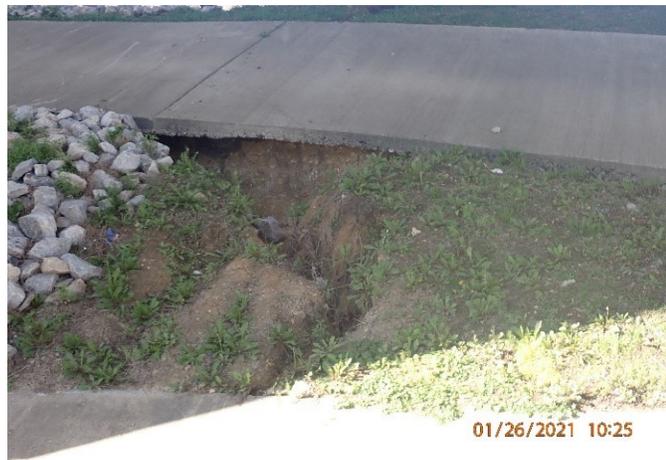
Figure 15: PGBT erosion under sidewalk SB ramp to IH-20

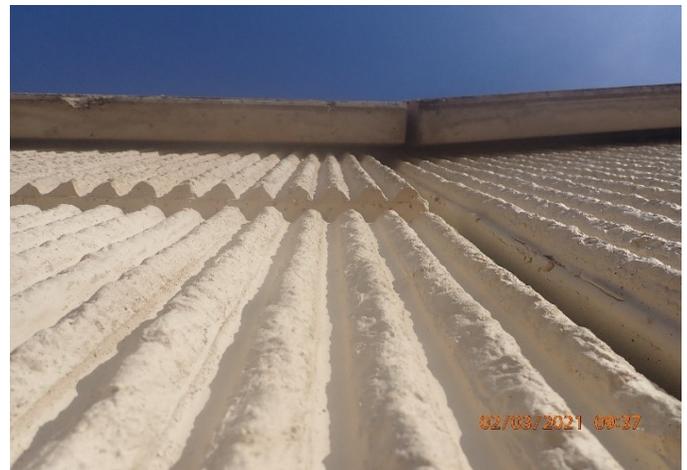
Retaining wall elements are generally in good condition. There were some observations of panel cracks and spalls on the retaining walls. One location noted movement in the retaining wall panel as shown in Figure 18.

Figure 18: PGBT retaining wall panel movement EB at Egyptian Way

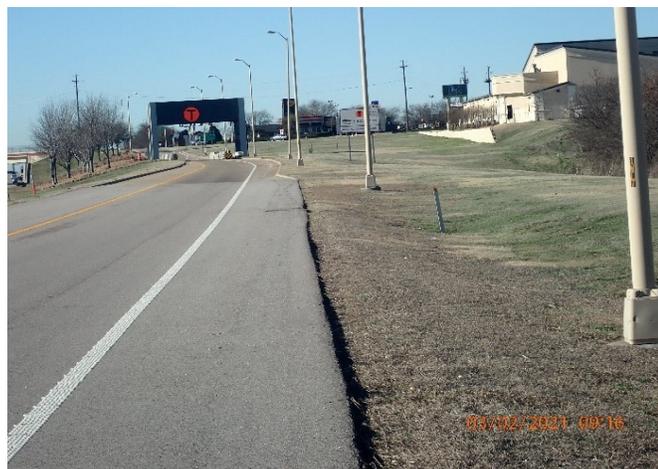
Figure 16: PGBT pavement edge drop-off WB exit to Marsh Ln.

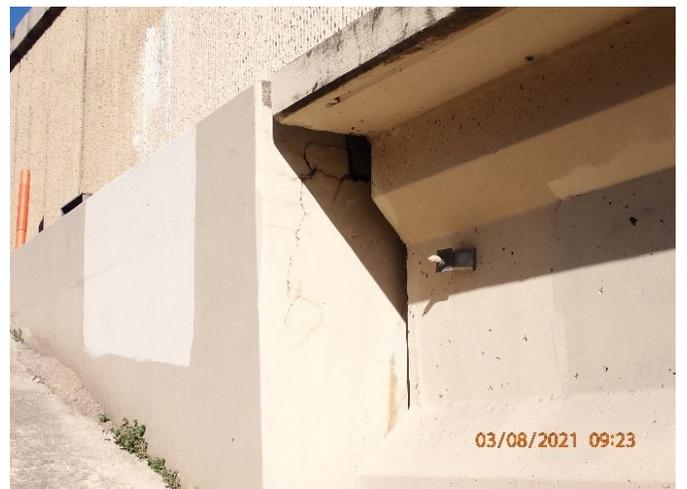
Bridge observations include abutment backwall cracking and spalling (Figure 19). Also noted were areas where the bridge beam is pushing against the backwall causing spalls on beam ends. Erosion was noted around bridge riprap and under bridges (Figure 20).

Figure 19: PGBT backwall cracking/spalling at Creek Bridge W. of Preston Rd.

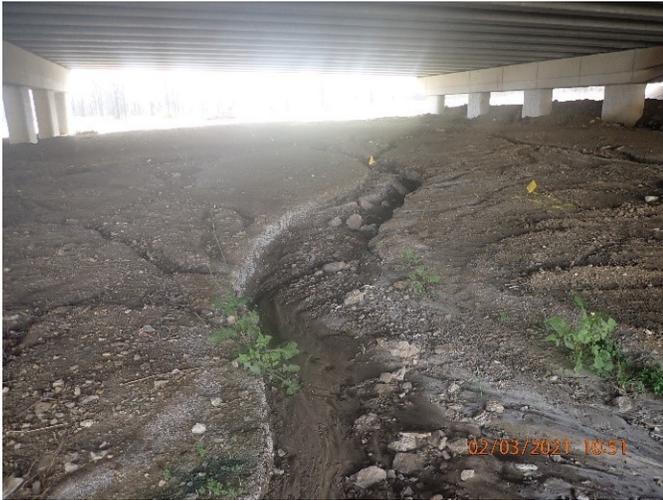
Figure 20: PGBT erosion under bridge S. of Carrier Way

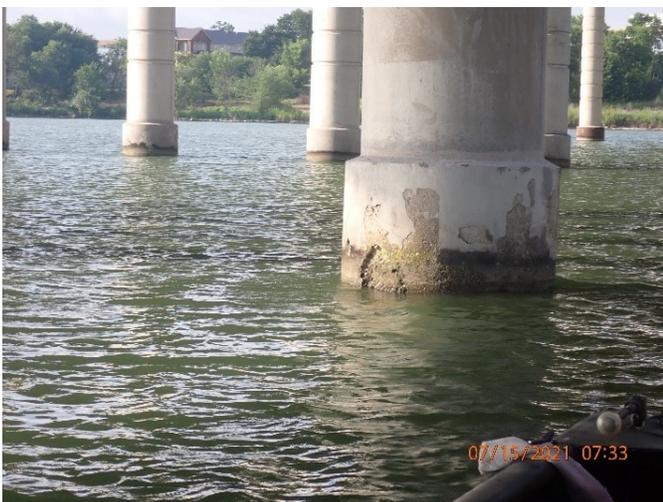
The substructure of the main lane bridge over Lake Ray Hubbard is in good condition with only minor spalling in the sacrificial column protection (Figure 21). There were a few areas where the water collection system piping was pulled apart and leaking (Figure 22).

Figure 21: PGBT column spall SB bent No. 41

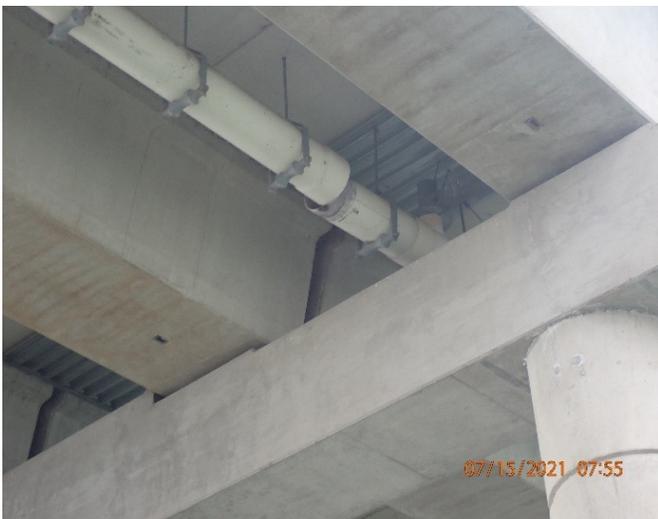
Figure 22: PGBT drainage pipe separation NB bent No. 14

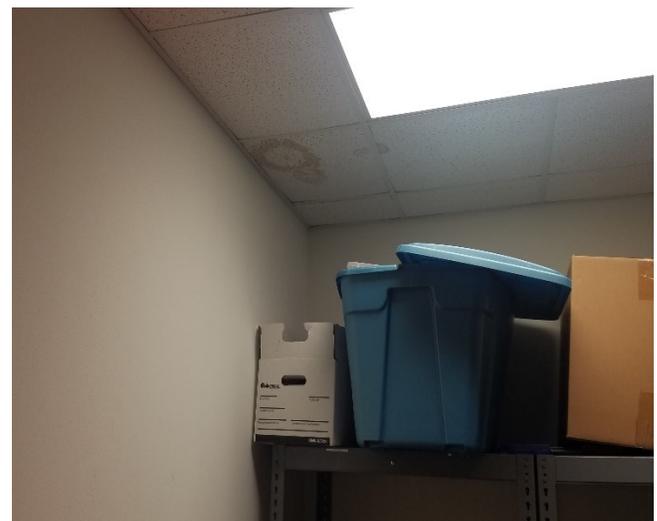
Observations identified throughout the facilities included stains on the ceiling indicating a roof or mechanical leak, missing lens on light fixtures, paint failing and rust developing on steel as noted on Figures 23 and 24.

Figure 23: PGBT MLP07 water stain on ceiling

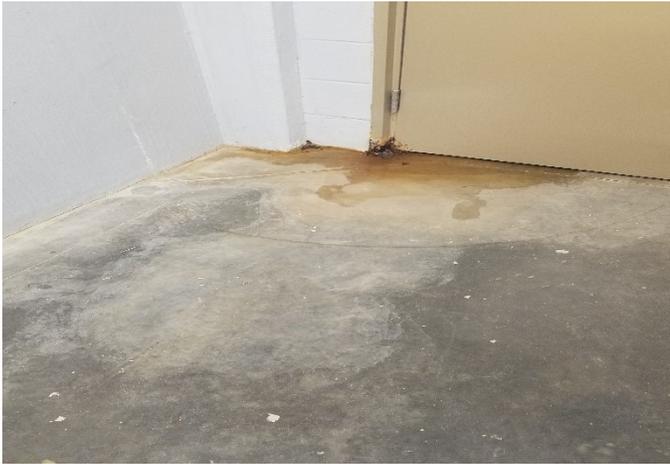
Figure 24: PGBT MLP08 rust developing at door frame

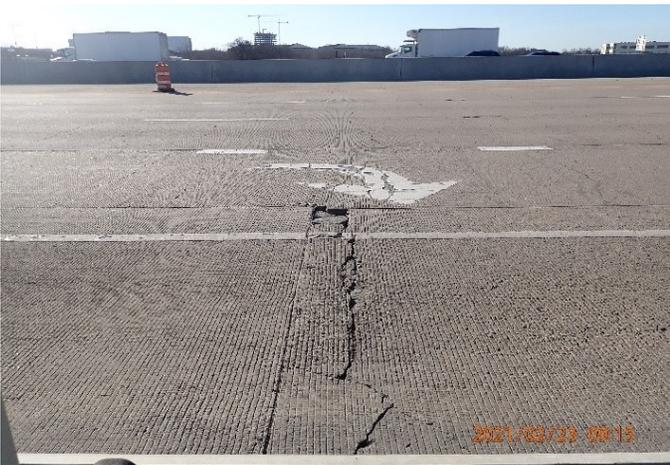
Figure 25: SRT pavement cracking/spalling SB N of Legacy Dr.

There were multiple areas with pavement cracking and spalling as noted in Figure 25. Pavement edge drop offs, as illustrated in Figure 26, were noted in various areas along the corridor.

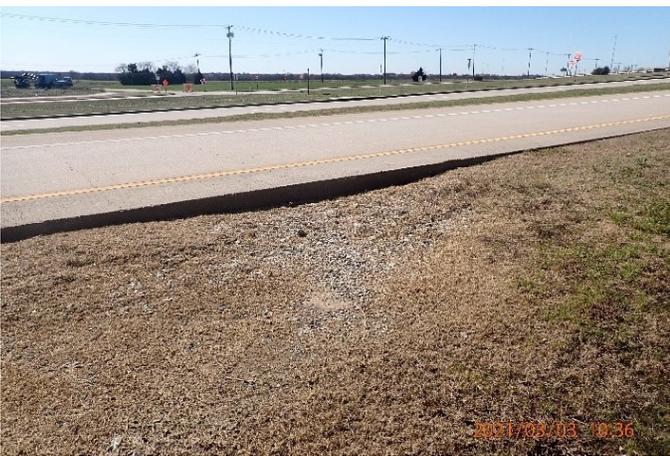
Figure 26: SRT pavement edge drop-off NB exit ramp to Medical Center Dr.

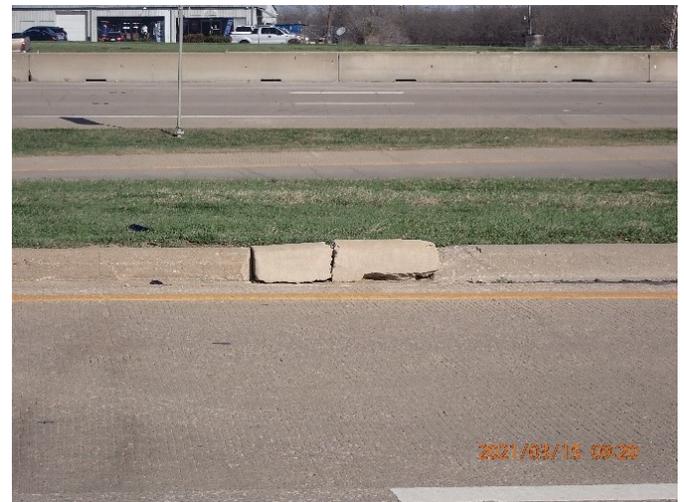
Curb damage, as illustrated in Figure 27, was observed at multiple locations at intersections and on frontage roads. Delineation was missing on guardrail and concrete traffic barrier in various locations as noted in Figure 28.

Figure 27: SRT curb damage NB frontage of FM 544

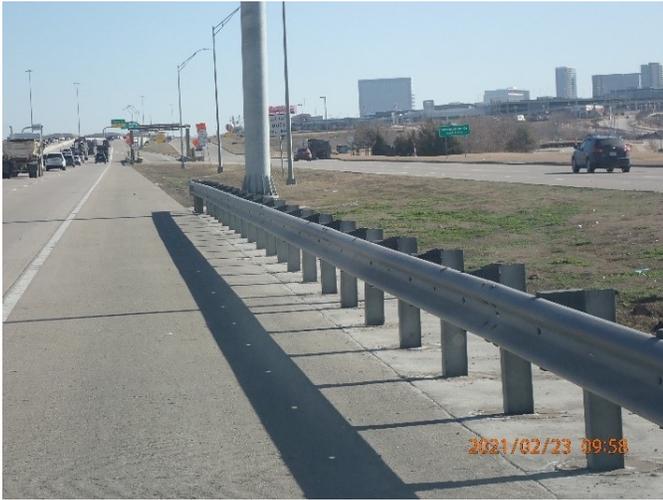
Figure 28: SRT delineation missing S. of Morning Star Dr.

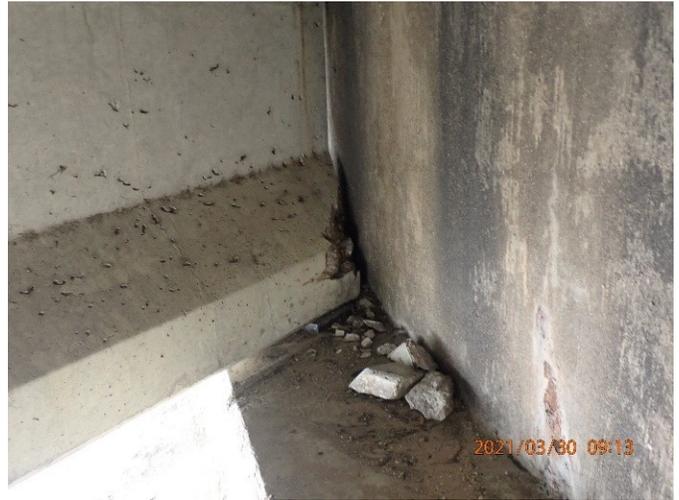
Bridges are in good condition with one recurring observation where the beams are pushing against the backwall causing minor spalling at the beam end and backwall as noted in Figure 31. This condition is being monitored by NTTA staff.

Figure 31: SRT beam end spall SB S. of Standridge Dr.

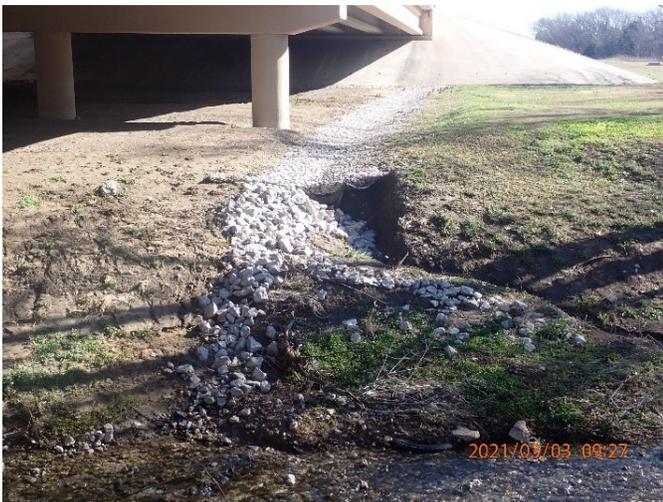
There were locations with erosion under bridges and around appurtenances as noted in Figure 29.

Figure 29: SRT erosion NB at Cotton Wood Creek

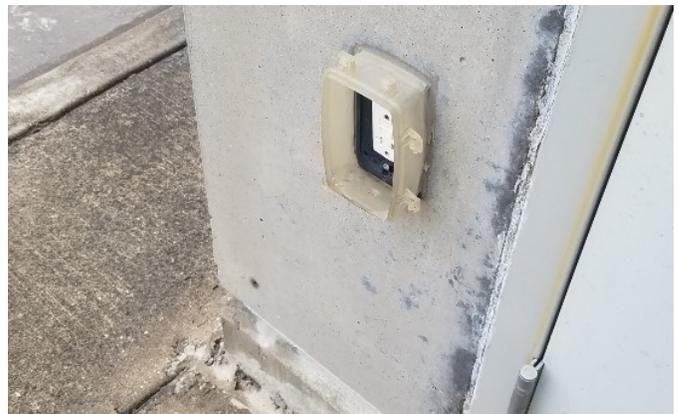
There were several observations noted on mainlane gantries including an electrical outlet box missing the protective cover at MLG02 and sealant missing at building perimeter at MLG03 (Figures 32 and 33).

Figure 32: SRT MLG2 – electrical box cover missing

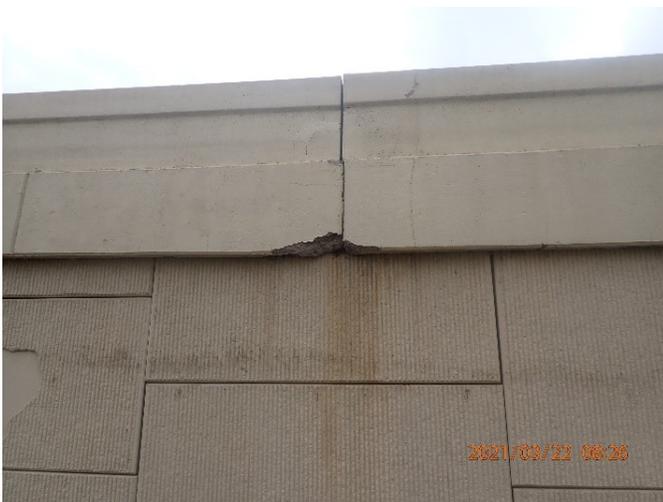
The retaining wall elements were in overall good condition. There was noted some spalling on the coping in a few areas as illustrated in Figure 30.

Figure 30: SRT coping spall SB frontage of BNSF Railroad

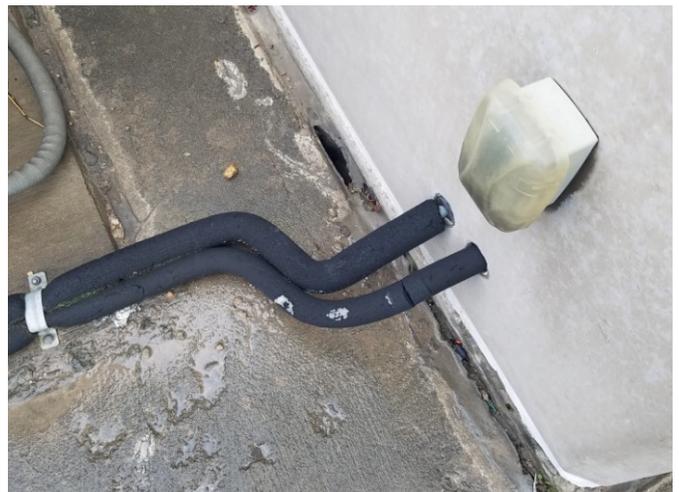
Figure 33: SRT MLG3 – sealant failing at building perimeter

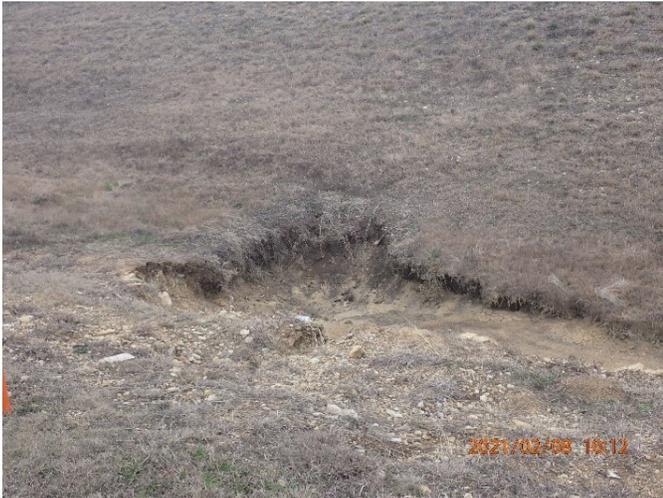
Figure 34: CTP erosion in ditch-line S. of Old Granbury Rd.

Areas of erosion were noted at various locations as illustrated in Figure 34. There are areas with pavement edge drop offs as shown in Figure 35. Multiple areas where the pavement joint seal was missing or damaged (Figure 36) and pavement cracking and spalls (Figure 37) were observed.

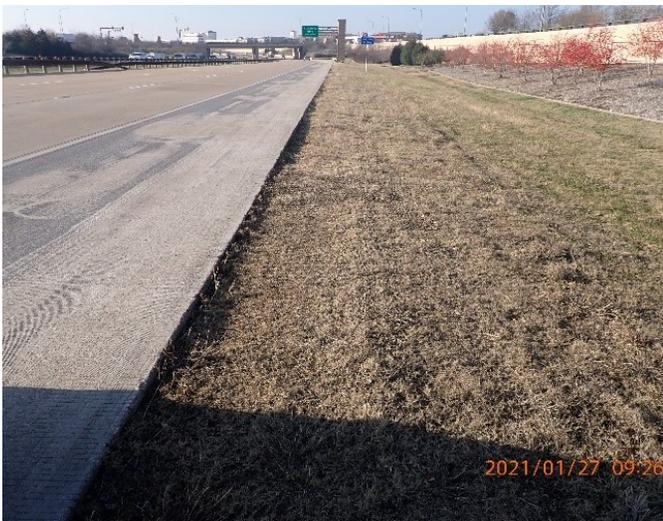
Figure 35: CTP pavement edge drop-off SB at N Oakmont Blvd.

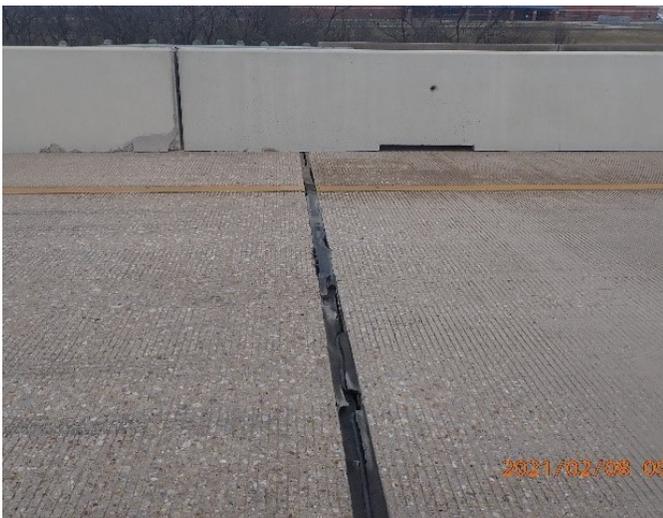
Figure 36: CTP pavement joint seal missing SB at Riparian Woodland

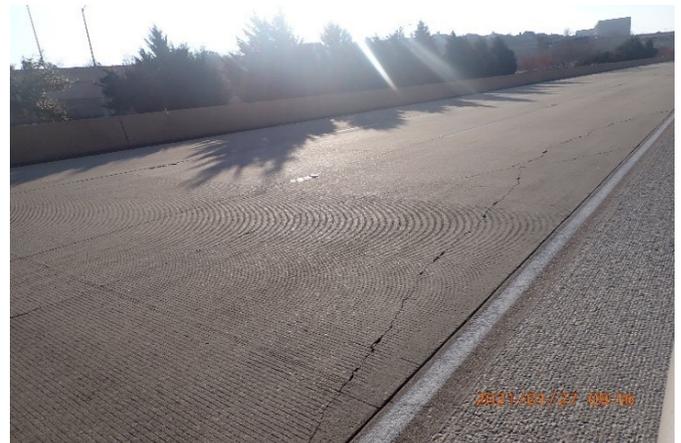
Figure 37: CTP pavement crack S of Arborlawn Dr.

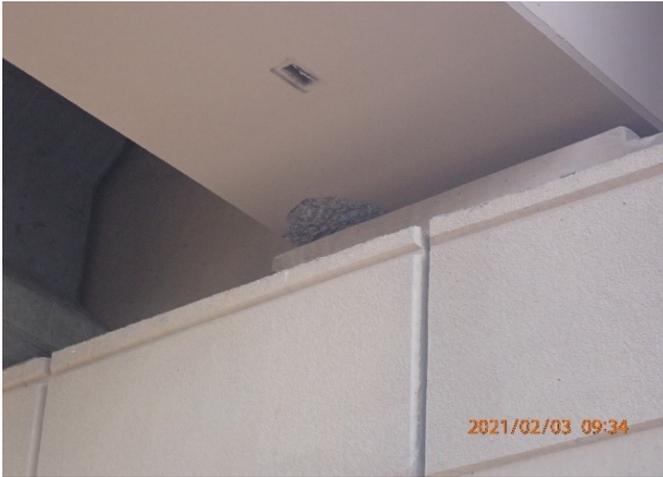
The majority of the bridge elements are in good condition with few issues observed. One observation noted this year was minor bearing pad movement and minor beam spalls as illustrated in Figure 38.

Figure 38: CTP bridge beam spall at Edwards Ranch Rd.

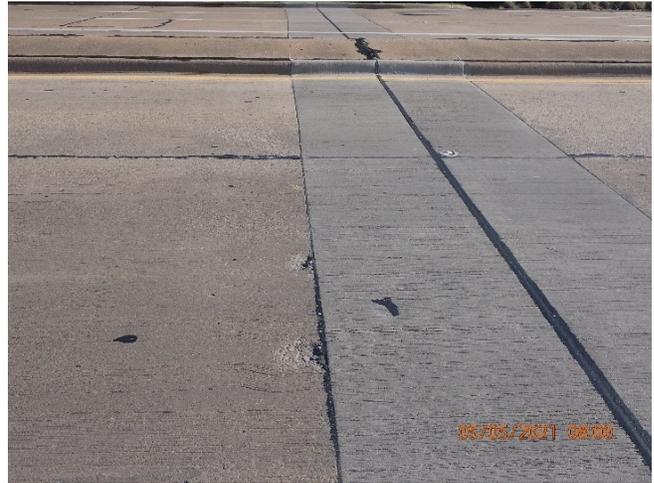
Figure 41: MCLB pavement spall EB West end of bridge

Observations noted on this year’s inspection included pavement spalls as noted in Figure 41, curb damage and an inlet spall as noted in Figure 42.

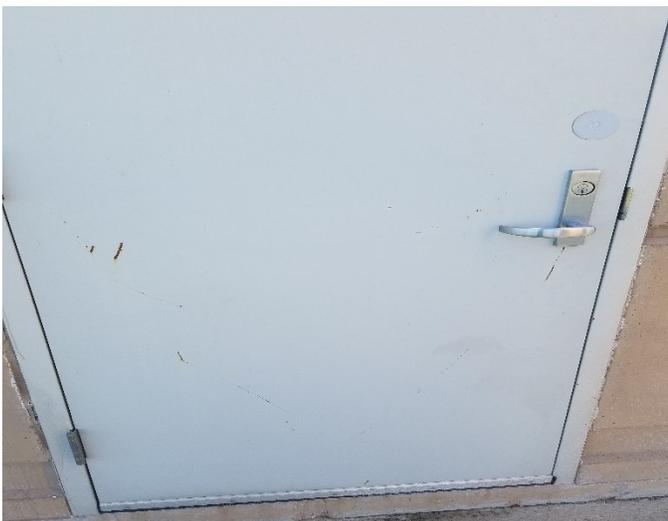
Figure 39: CTP MLG1 rust developing on door

Facilities along the CTP corridor are in good condition with only a few minor findings. Rust developing on door where paint is missing at MLG1 and water damage to floor due to water intrusion at MLG2 as noted in Figures 39 and 40.

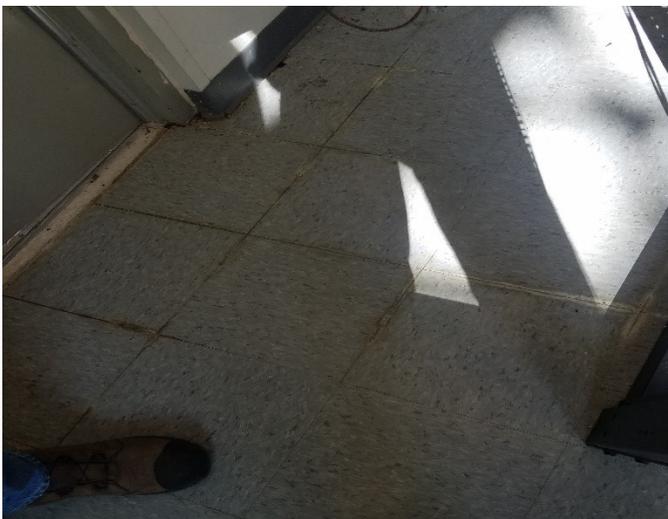
Figure 40: CTP MLG2 SB floor damage due to water intrusion

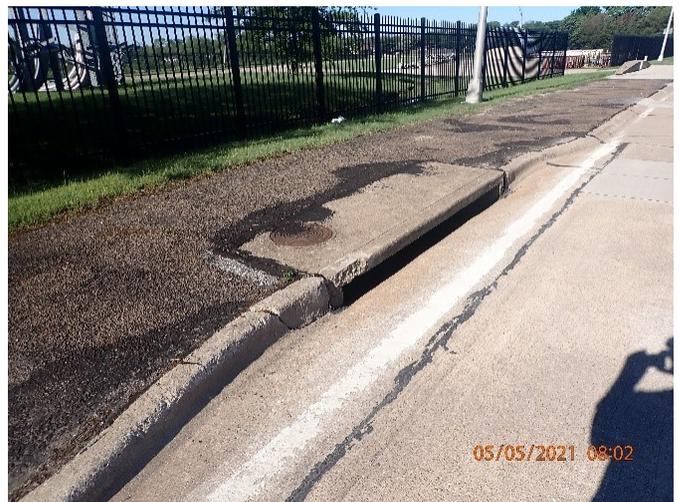
Figure 42: MCLB curb damage at inlet EB West end of bridge

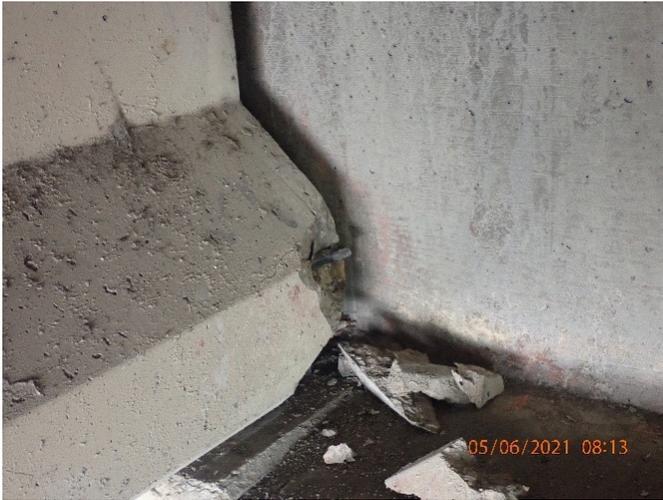
Figure 43: MCLB beam end spall at West abutment

Bridge observations include interior and exterior bridge beam end spalling, as illustrated in Figure 43. There are hairline vertical and diagonal cracks with efflorescence on some of the bent caps. Also noted is moderate to heavy scaling on the concrete encasements on the columns. There was also noted backwall spalling as noted in Figure 44 and erosion under the west abutment riprap as noted in Figure 45.

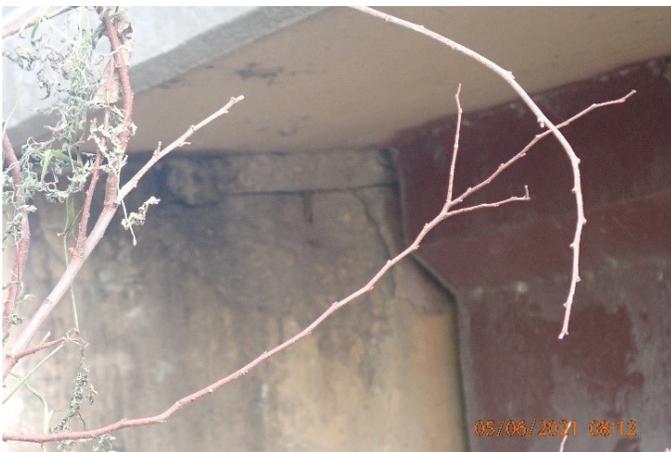
Figure 44: MCLB backwall spalling at West abutment

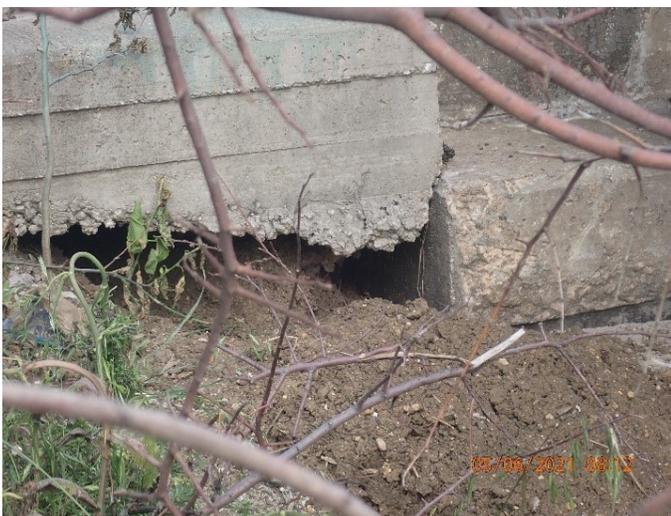
Figure 45: MCLB erosion under abutment riprap West end

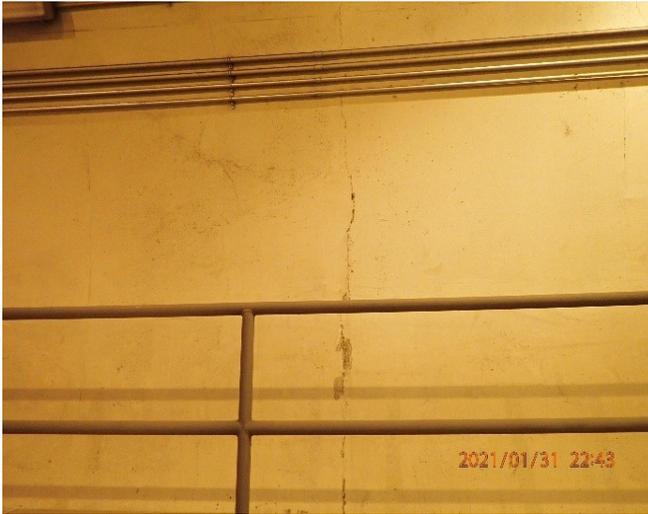
Wall observations include cracking on retaining walls at multiple locations.

Figure 46: AATT cracking on walls (various locations)

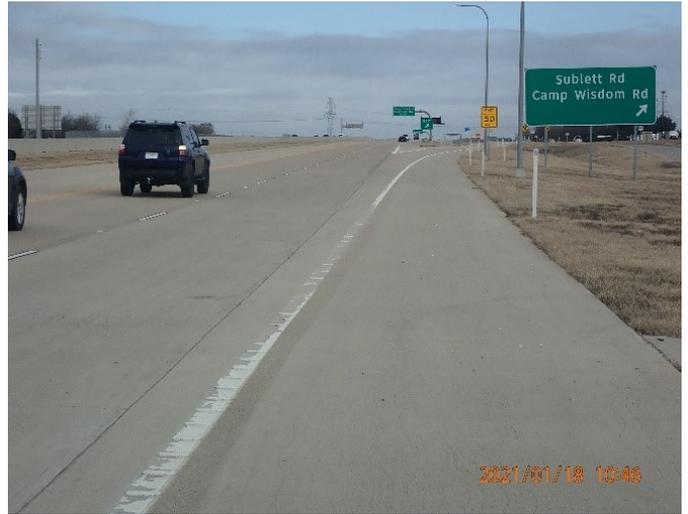
Figure 49: 360T faded striping N of Lynn Creek

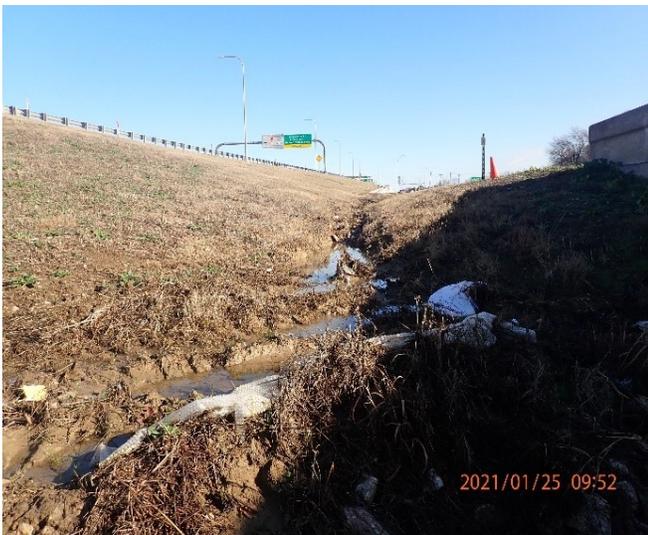
Figure 47: 360T ditch-line erosion at Bowman Branch

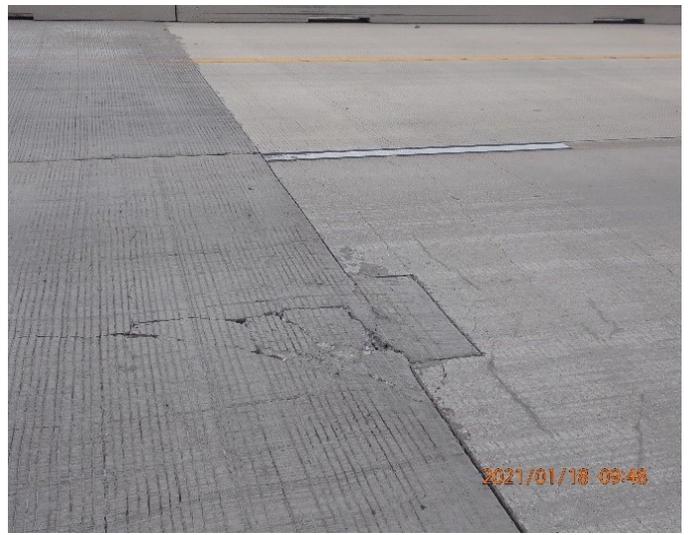
Figure 50: 360T pavement spall N of East Sublett Rd.

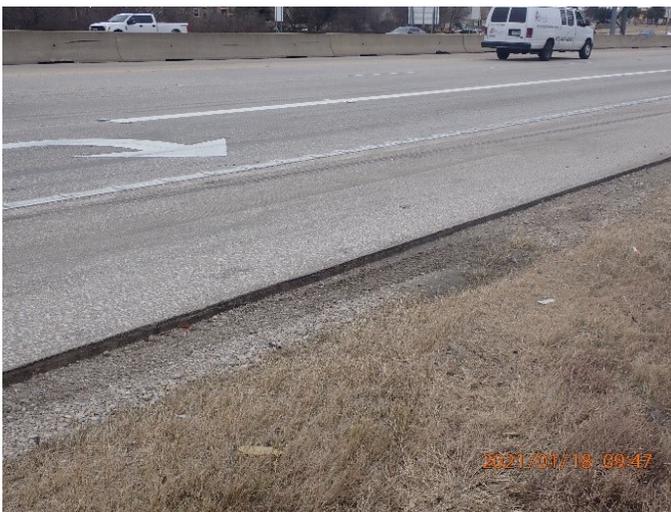
Figure 48: 360T pavement edge drop-off S of Green Oaks Blvd.

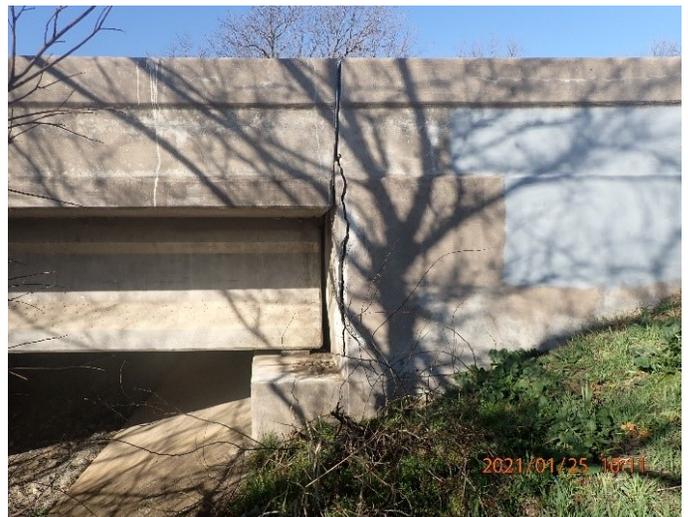
Figure 51: 360T backwall cracking at Walnut Creek bridge

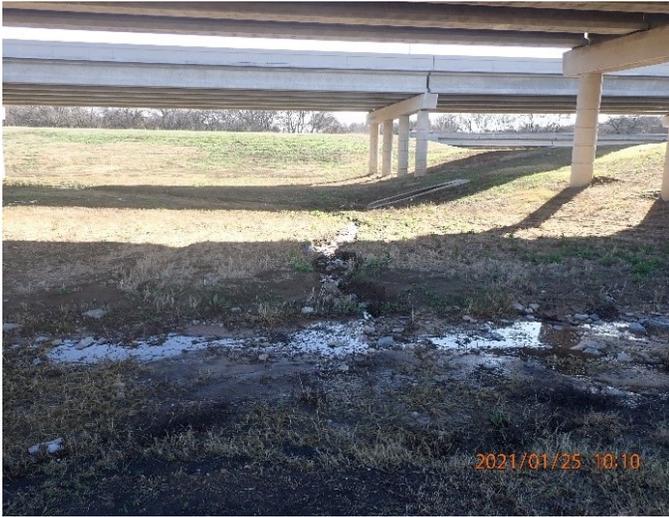
Figure 52: 360T minor erosion under bridge at Walnut Creek

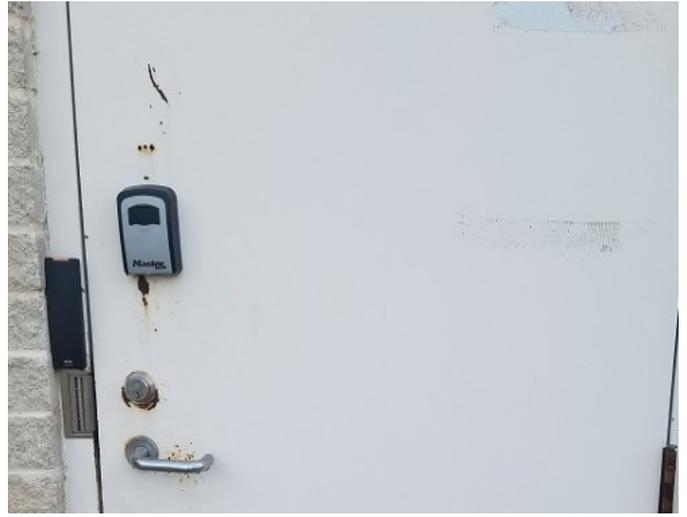
Figure 55: Gleneagles 5900 – rust developing on door

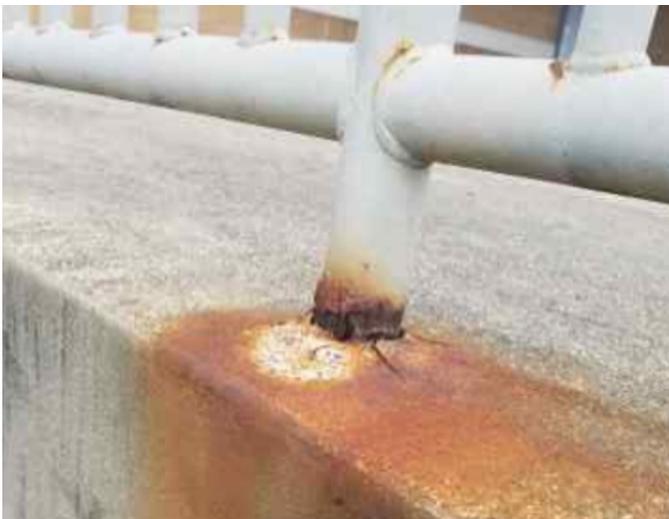
Figure 53: Ohio – rust on railing

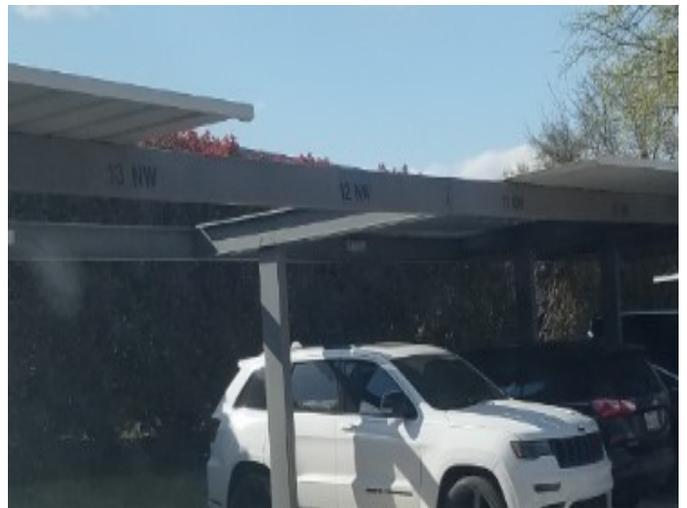
Figure 56: Gleneagles 5900 – canopy roof section missing

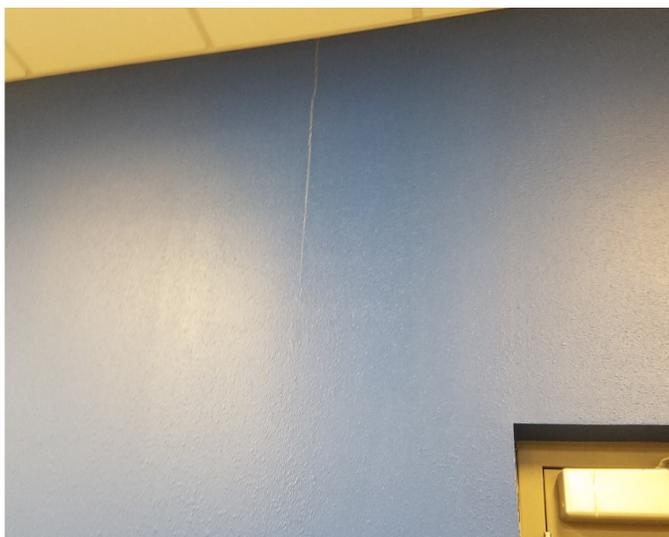
Figure 54: Frisco – crack in drywall

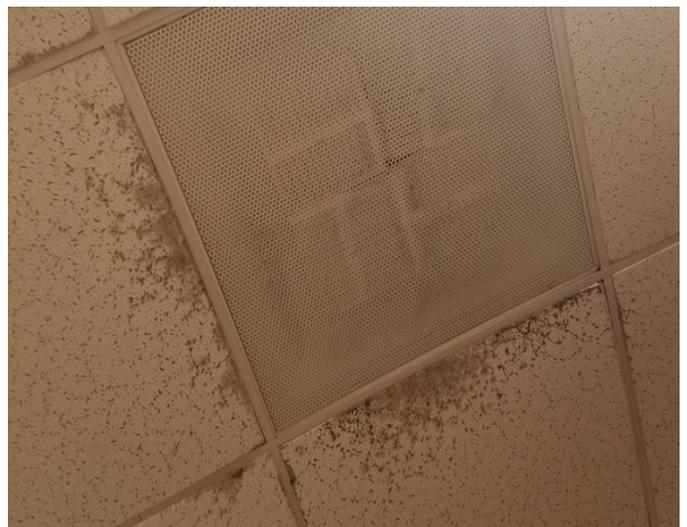
Figure 57: Gleneagles 5910 – water stains on ceiling tiles
