SYSTEM ANNUAL INSPECTION REPORT

Fiscal Year 2024

Subject: FY 2024 GEC System Annual Inspection

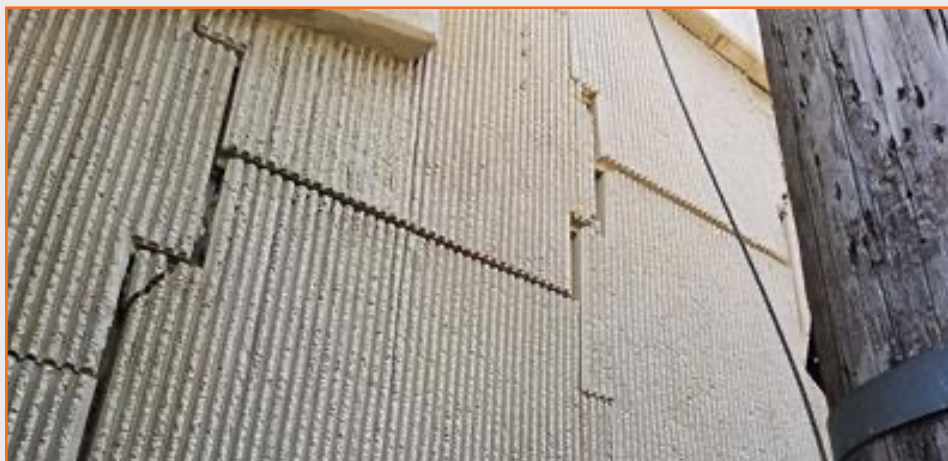
Figure 8: DNT MSE wall with racked panels exhibiting cracking and spalling SBML south of IH-635.

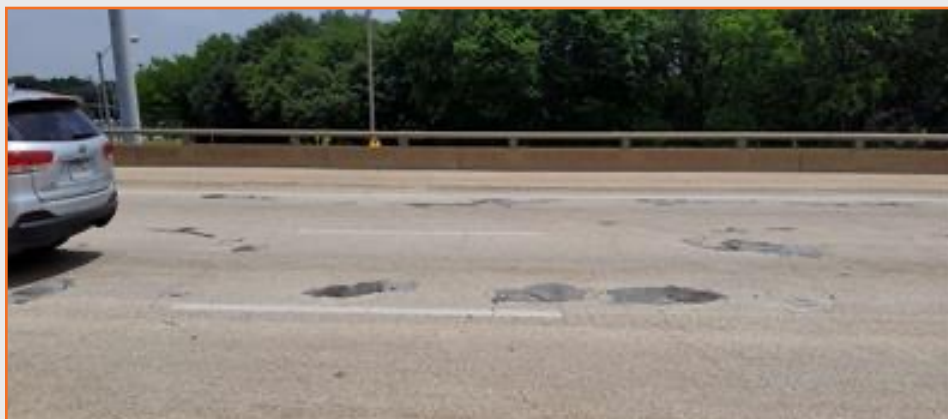
Common observations along the DNT corridor included deterioration of various bridge decks which occurred primarily within the southern-most segment (Figure 9). Cracking and spalling at abutments were observed at multiple locations throughout the corridor (Figure 10). Also noted were locations of concrete beam spalling, some with exposed reinforcement (Figure 11).

Figure 9: DNT bridge deck deterioration at Lomo Alto Dr.

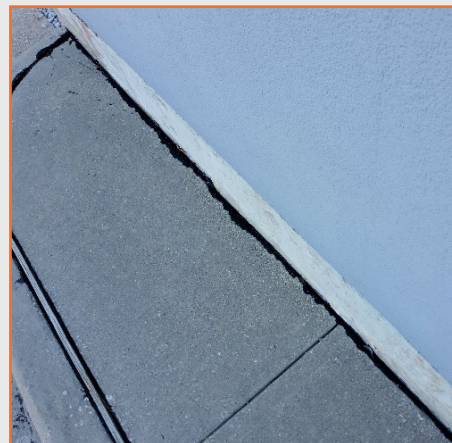
Figure 13: DNT MLP3 joint sealant failure.

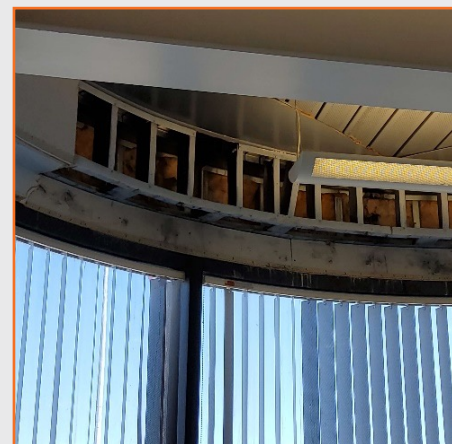
Figure 15: DNT MLP4 missing gypsum board.

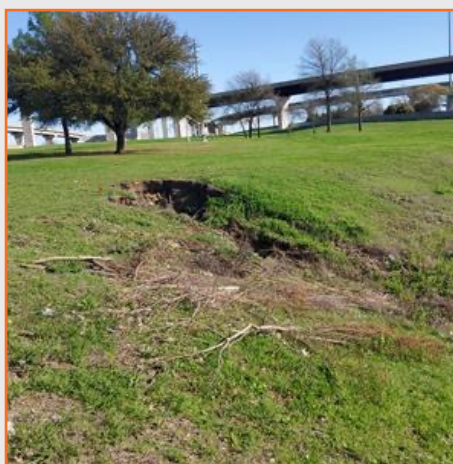
Several locations of ditch and embankment erosion (Figure 18) were observed. Also noted were locations of concrete pavement distresses (Figure 19). Asphalt pavement shoulder deterioration was identified at numerous locations (Figure 20). There was a location that was exhibiting concrete pavement and MBGF separation at Merritt Rd. (Figure 21). There were several locations of concrete barrier cracking and spalling (Figure 22). Multiple locations of damage or faded pavement markings (Figure 23) were identified.

Figure 18: PGBT erosion SBML at IH-30 in Garland, TX.

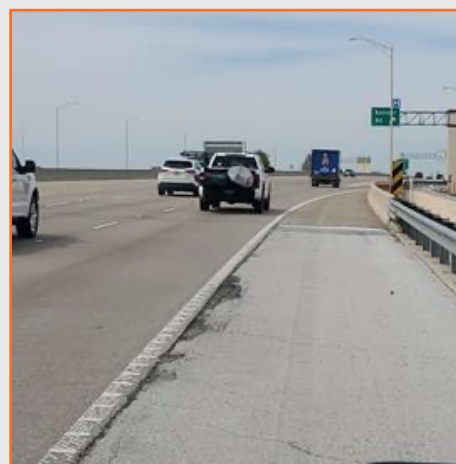
Figure 20: PGBT asphalt shoulder deterioration NBML at Lookout Dr.

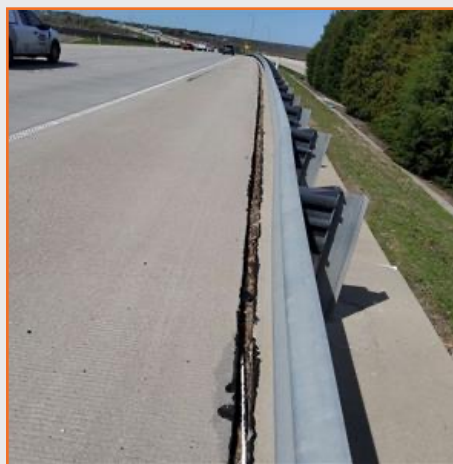
Figure 21: PGBT pavement and mow strip separation NBML at Merritt Rd.

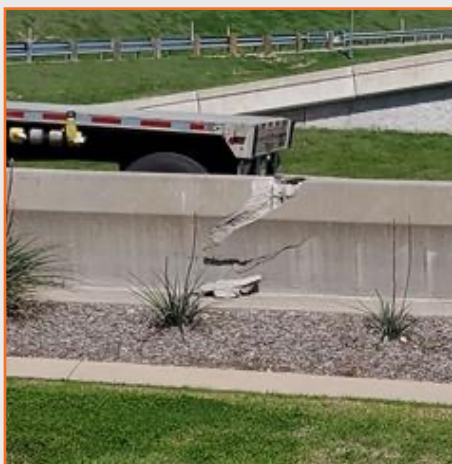
Figure 22: PGBT concrete rail damage WBML at Lavon Dr.

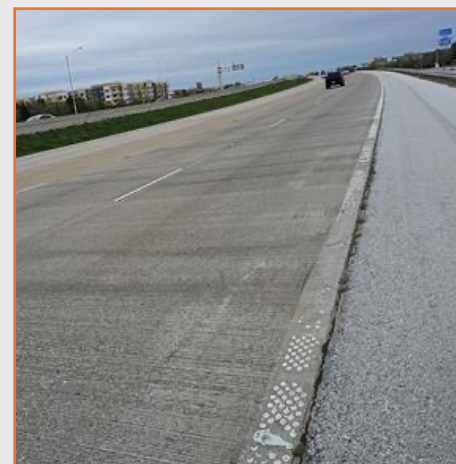
Figure 23: PGBT pavement marking deterioration SBML south of N. Shiloh Rd.

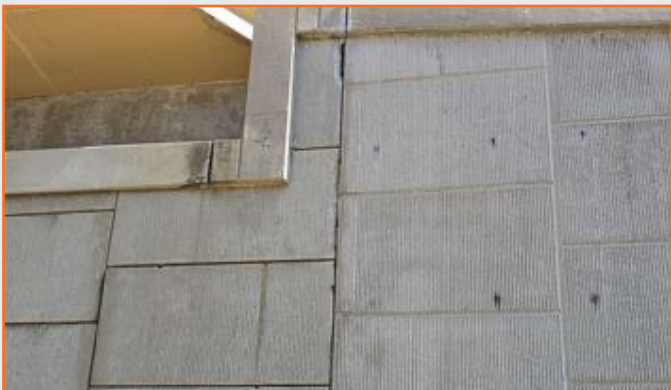
General visual observations included instances of panels that were racked or experiencing some level of spalling or cracking at various locations (Figure 24). The soundwall adjacent to the NB exit to Frankford Rd is leaning (Figure 25). These observations alone can not confirm nor negate current wall movement. NTTA, the MMC and the GEC hold regular coordination meetings, and NTTA has confirmed that further evaluation of these walls is being conducted.

Figure 24: PGBT retaining wall spalls NBML at Las Colinas Blvd.

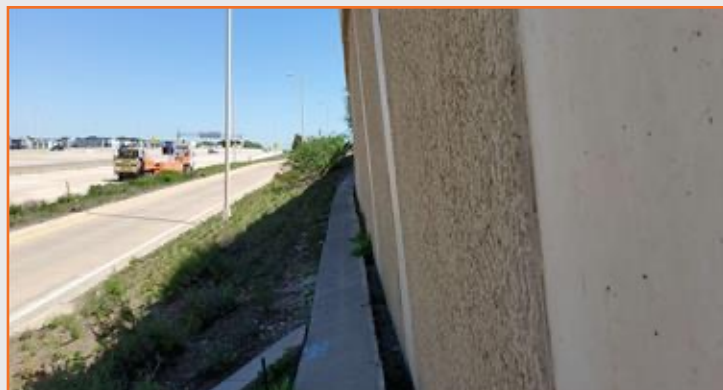
Figure 25: PGBT soundwall movement adjacent to NB exit ramp to Frankford Rd.

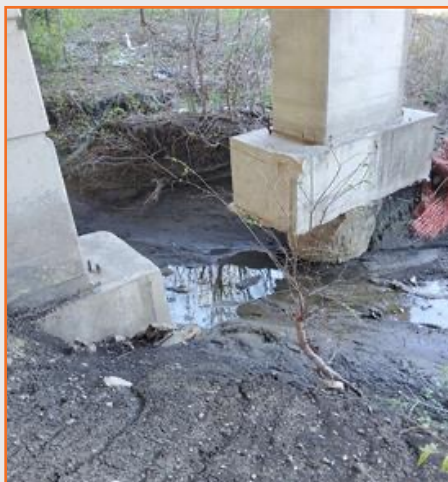
Typical noted bridge observations along the PGBT included erosion near or around bridge columns (Figure 26), some of which exceed the level of routine maintenance. These locations have been budgeted for construction level projects to occur within the 5-year budget window. Other typical observations included spalling at concrete beam ends due to their contact with abutment backwalls (Figure 27), as well as spalls and cracking of abutment backwalls which were noted at several locations (Figure 28).

Figure 26: PGBT bridge erosion at Rowlett Creek.

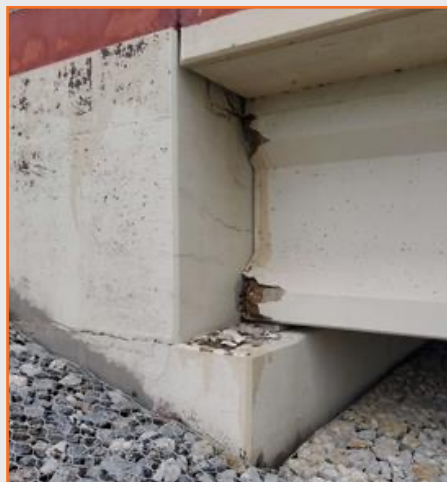
Figure 27: PGBT concrete beam spalling near future Valwood Pkwy.

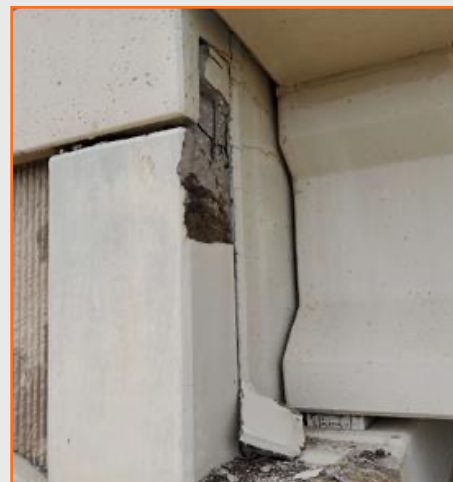
Figure 28: PGBT abutment spalling north of Sandy Lake Rd.

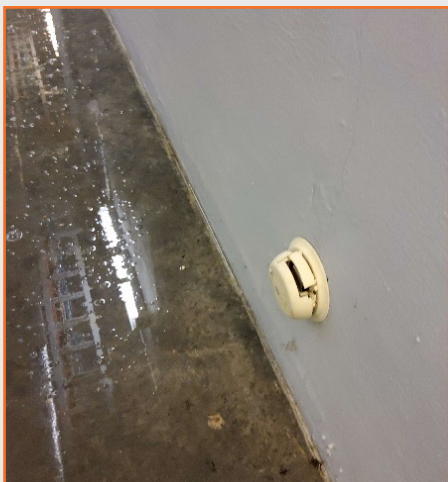
Figure 29: PGBT MLP7 tunnel damaged CO sensor.

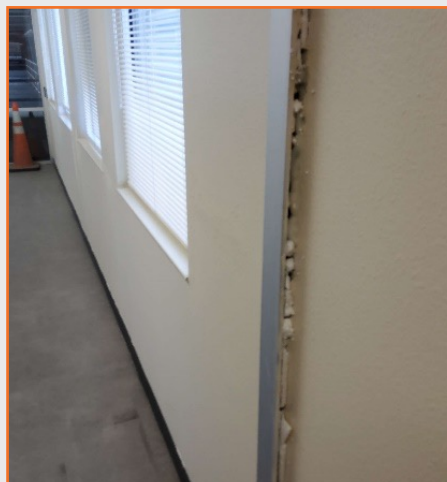
Figure 30: PGBT MLP9 wall separation/shifting.

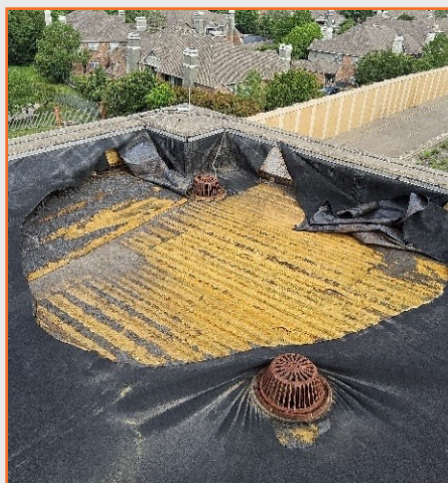
Figure 32: PGBT Renner Road On-Ramp Gantry roof deterioration.

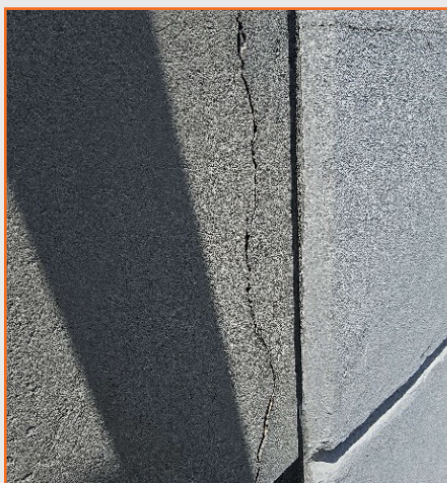
Figure 33: PGBT Midway Road On-Ramp Gantry panel crack.

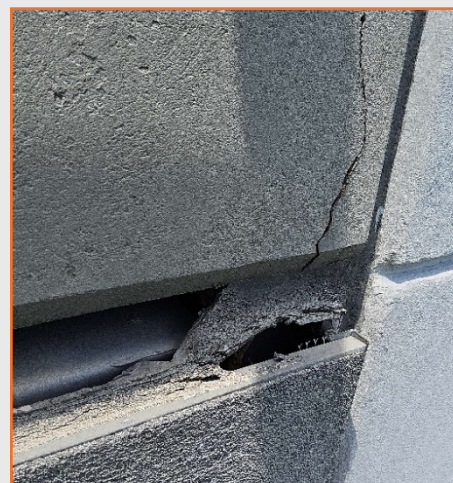
Figure 34: PGBT Midway Road On-Ramp Gantry panel separation.

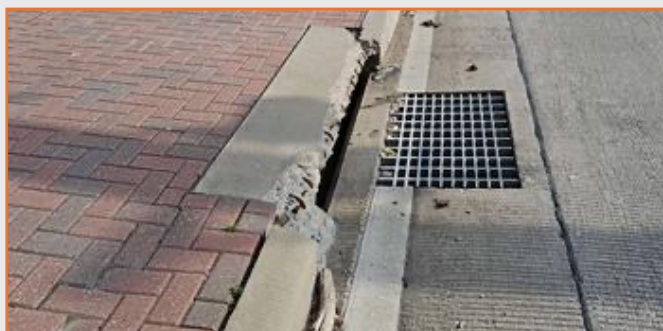
Figure 41: SRT curb inlet damage at W. Exchange Pkwy.

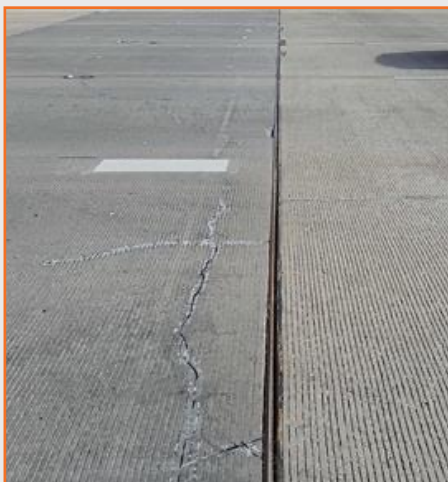
Observations on the SRT for 2024 included multiple closed joints which could contribute to cracking or spalling of the bridge deck or adjacent approach slab pavement (Figure 45). Other noted conditions were related to abutment backwall spalling similar to what has been observed on other corridors (Figure 46). Spalling at concrete beam ends due to their contact with the abutment backwall were observed at multiple locations (Figure 47).

Figure 45: SRT closed bridge joint with cracked approach slab pavement at Paige/Plano Pkwy.

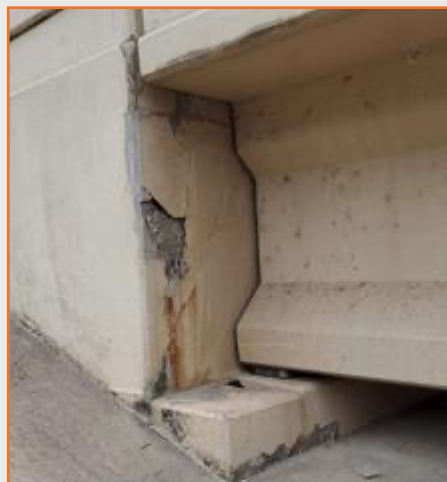
Figure 46: SRT abutment backwall spalling at W. Rowlett Creek.

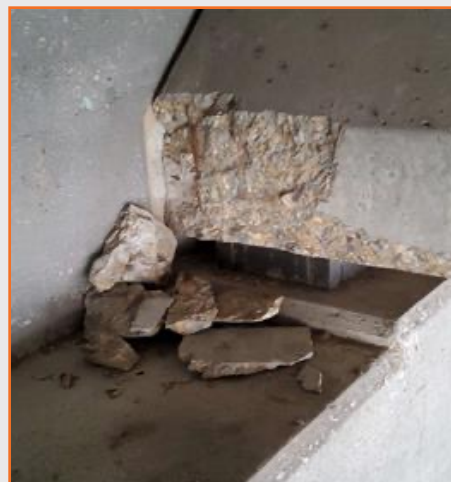
Figure 47: SRT bridge beam spalling with exposed reinforcement at W. Rowlett Creek.

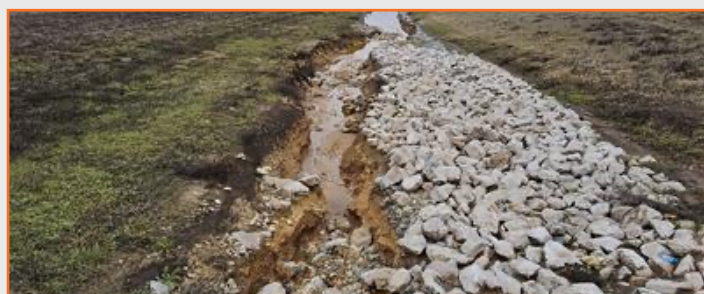
Erosion was noted in ditch lines (Figure 51), landscape beds exposing irrigation lines (Figure 52) and included the undermining of drainage flumes (Figure 53). Observations also included multiple locations with concrete pavement joint deterioration (Figure 54).

Figure 51: CTP ditch erosion SBML embankment erosion NBML north of W. FM 917.

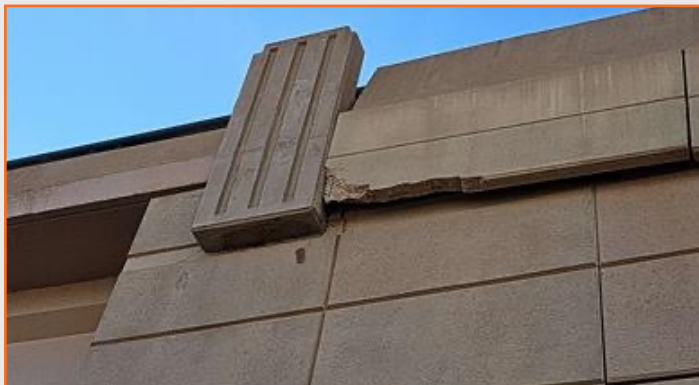
General visual observations included instances of panels that were racked or exhibited some level of spalling or cracking at various locations (Figure 55). These observations do not confirm nor negate current wall movement. Unsealed wall joints were noted at a few locations (Figure 56).

Figure 55: CTP retaining wall coping spall on SBML at damage NBML at SH-183.

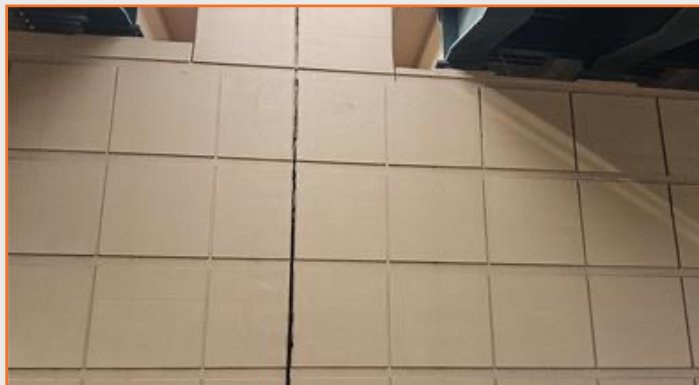
Figure 56: CTP retaining wall panels unsealed NBML at Old University Dr.

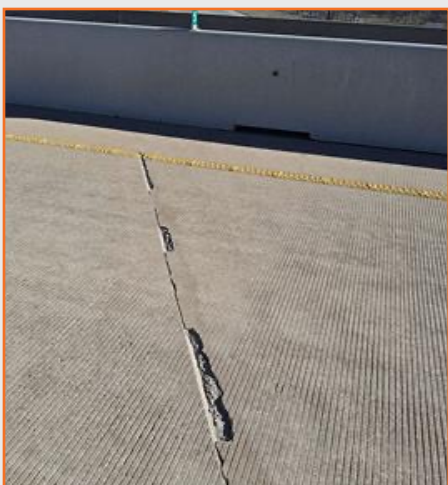
Noted observations for bridges on CTP included surface spalling of bridge decks, typically near construction joints (Figure 57). Backwall spalling was seen at several abutments, primarily occurring at the interface of the backwall to the wingwall (Figure 58). Erosion adjacent to bridge approach slabs was also noted at multiple locations along the corridor (Figure 59).

Figure 57: CTP approach slab construction joint spalling at FM 1902.

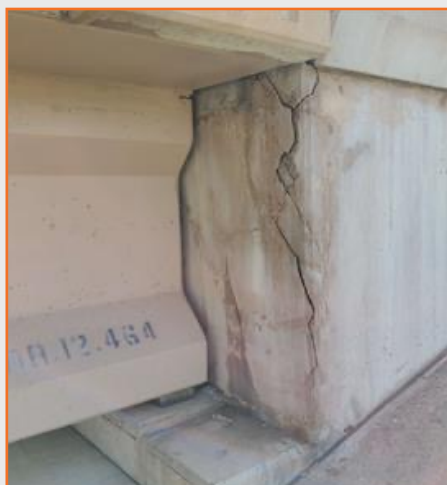
Figure 58: CTP abutment backwall cracking at IH-20.

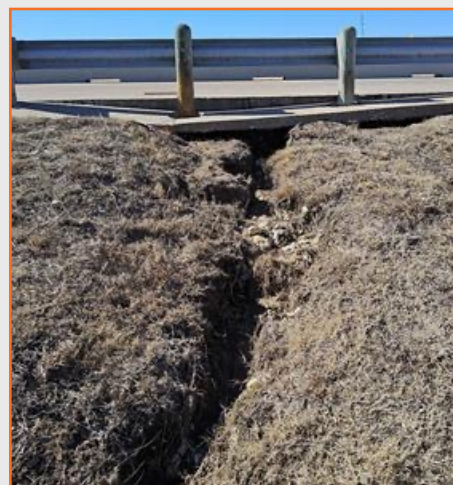
Figure 59: CTP erosion at Sparks Dr.

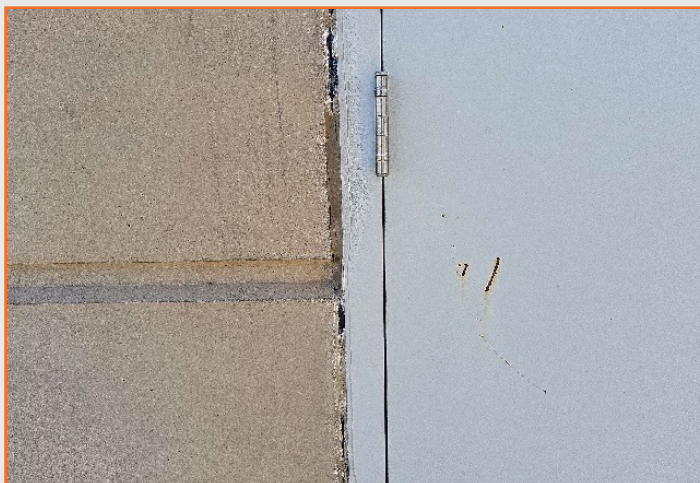
Facilities along the CTP corridor were in good condition, with only minor sealant and paint deterioration (Figure 60), water infiltration (Figure 61), landing deterioration (Figure 62), and seam strip peeling (Figure 63) observed at the southbound side Fiber Huts. At restrooms, door lock and water heater issues were observed.

Figure 60: CTP MLG1 Fiber Hut deteriorated door sealant.

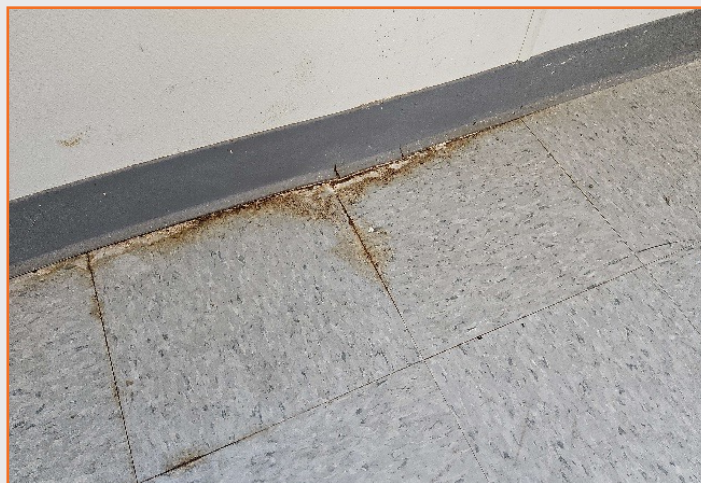
Figure 61: CTP MLG2 Fiber Hut water infiltration.

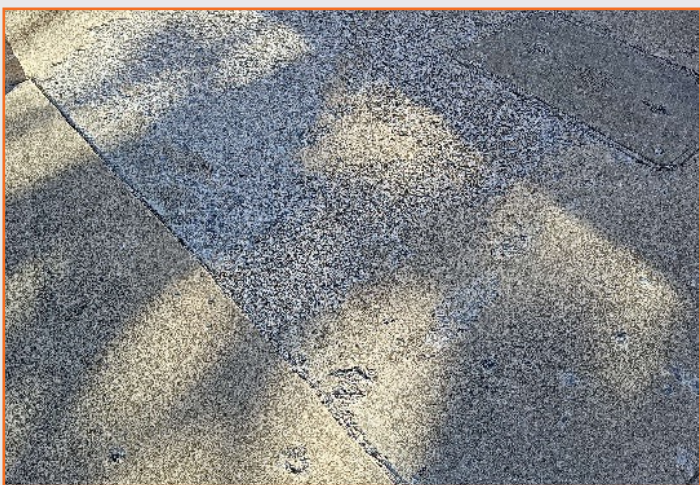
Figure 62: CTP MLG1 Fiber Hut deteriorated landing.

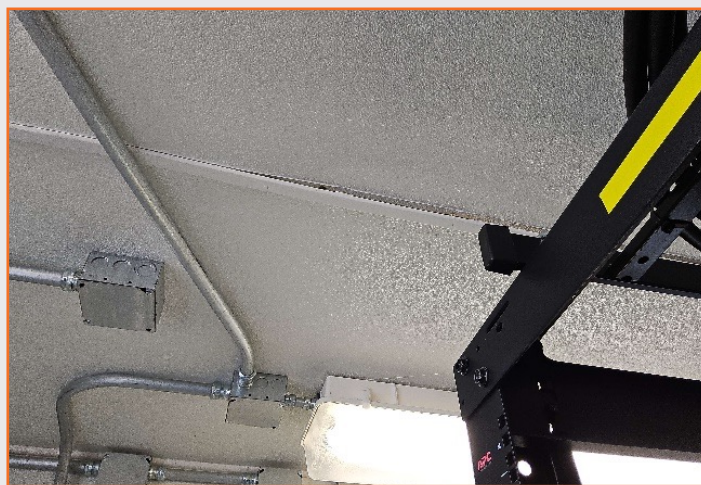
Figure 63: CTP MLG1 peeling ceiling seam strip.

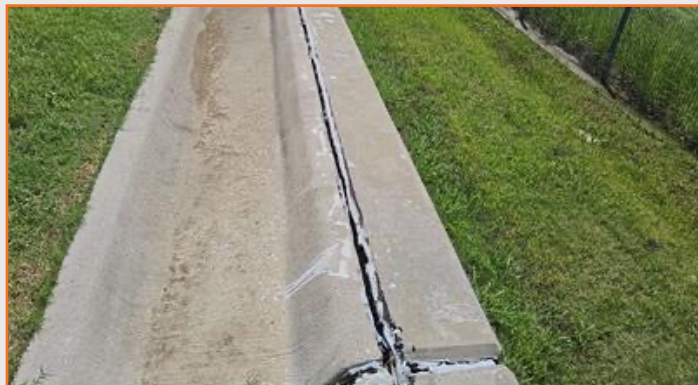
Figure 64: MCLB drainage flume unsealed EBML near Mountain Creek Pkwy.

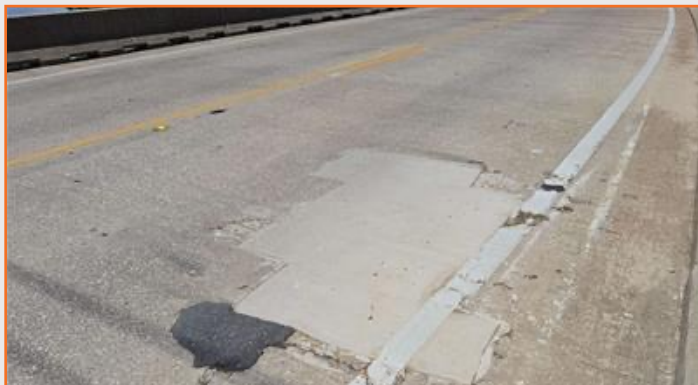
Figure 65: MCLB east abutment approach slab surface spalling.

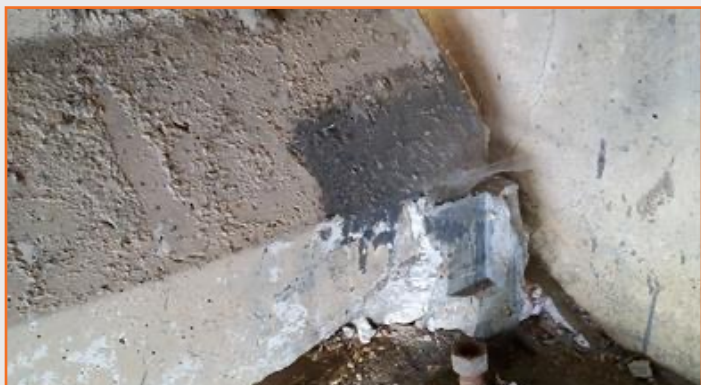
Figure 66: MCLB west abutment concrete beam spalling.

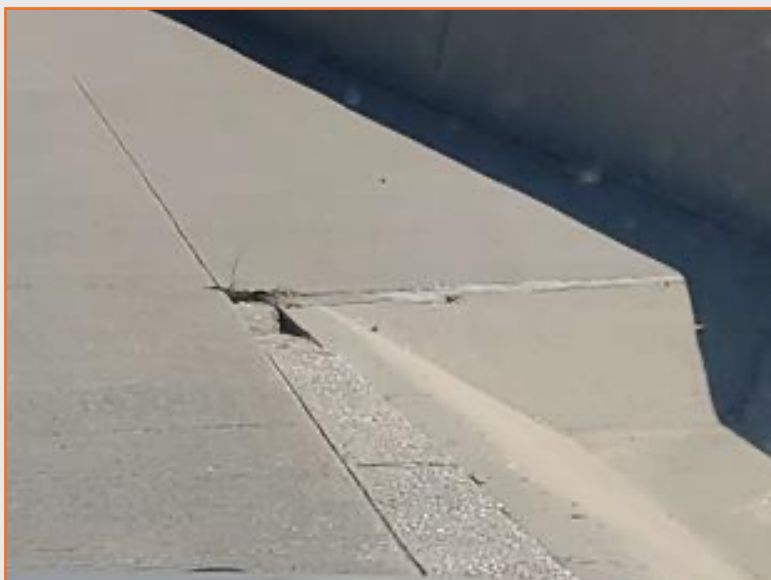
Figure 67: LLTB concrete flume spalling EBML on east approach to bridge.

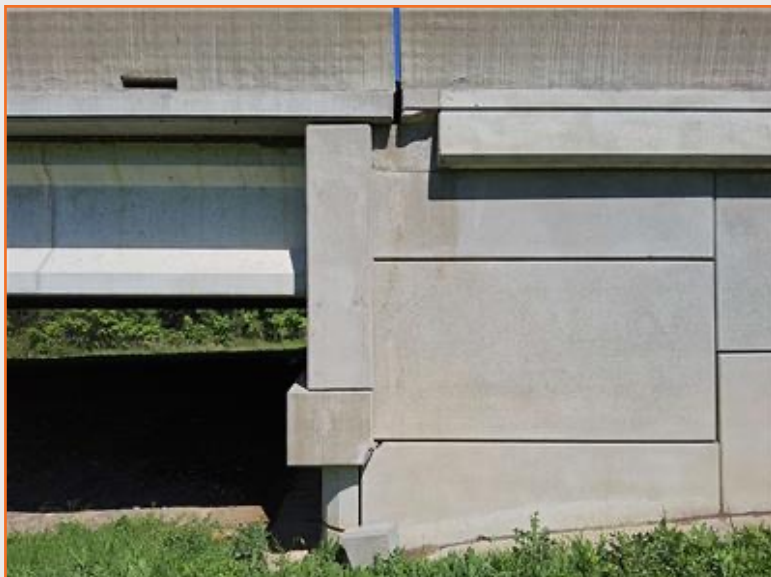
Wall observations include a damaged wall coping (Figure 68).

Figure 68: LLTB retaining wall coping damage.

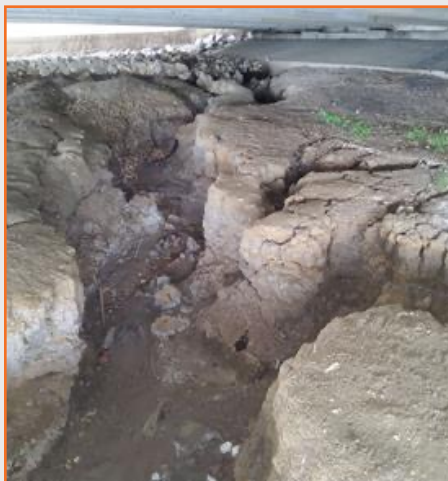
Significant erosion at the East abutment was noted with the 2024 annual inspection for LLTB (Figure 69). Construction efforts to address the deficiency is to begin 3rd Quarter of 2024. Numerous damaged buoys (Figure 70) were observed that will be repaired as part of the East abutment erosion project. Additionally, spalling with exposed reinforcement at the East abutment (Figure 71) was noted and is to be addressed with the currently scheduled project.

Figure 69: LLTB east abutment erosion.

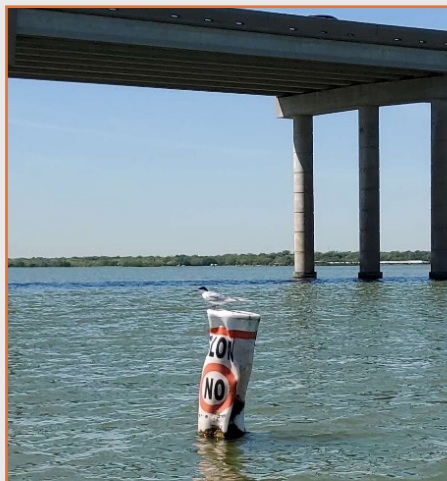
Figure 70: LLTB buoy damage.

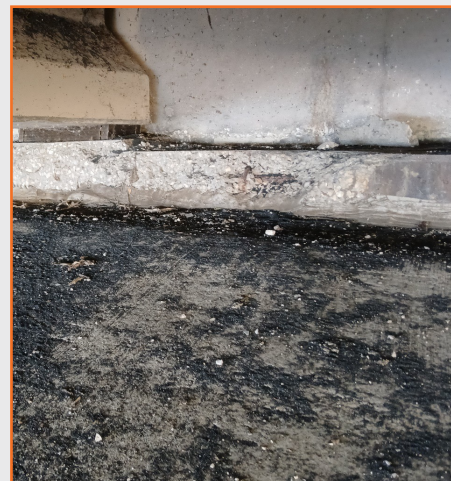
Figure 71: LLTB east abutment spalling with exposed reinforcement.

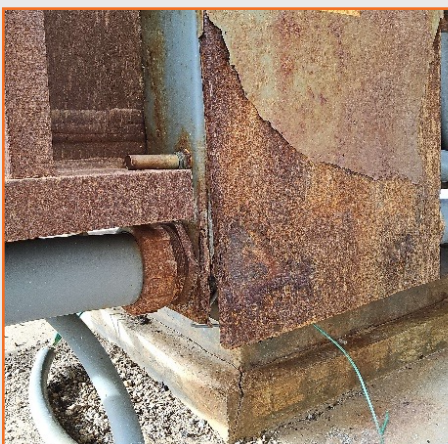
Corrosion was observed on electrical conduit/enclosures (most severe at one box — Figure 72), a separated drain pipe (Figure 73), and insect infestation was noted (Figure 74).

Figure 72: LLTB corroded electrical box.

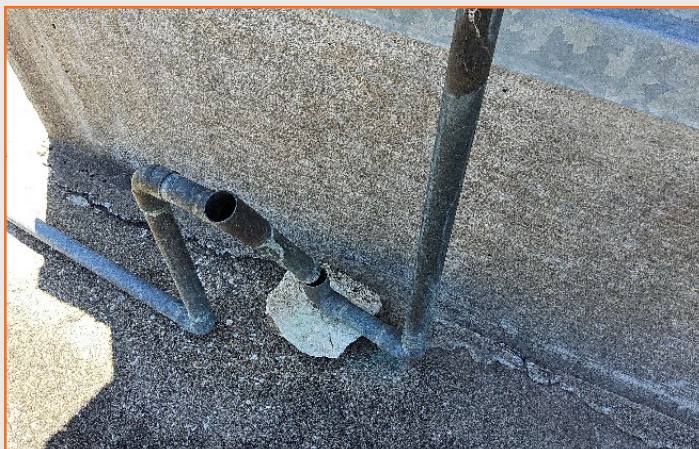
A tunnel fan replacement project, and a recoating and relighting project were in progress at the time of inspection. HVAC RTU condensate pipes were broken (Figure 81) or clogged. The gantry roof condition worsened since the previous inspection (Figure 82), while the toll plaza electrical room roofing has failed (Figure 83). The electrical rooms are functioning as required, though one main electrical room surge protection device has failed (Figure 84).

Figure 81: AATT broken RTU condensate drain pipe.

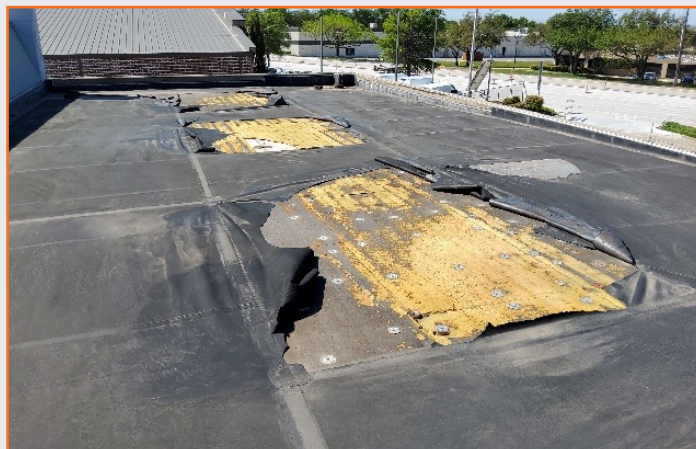
Figure 82: AATT Gantry roof damage.

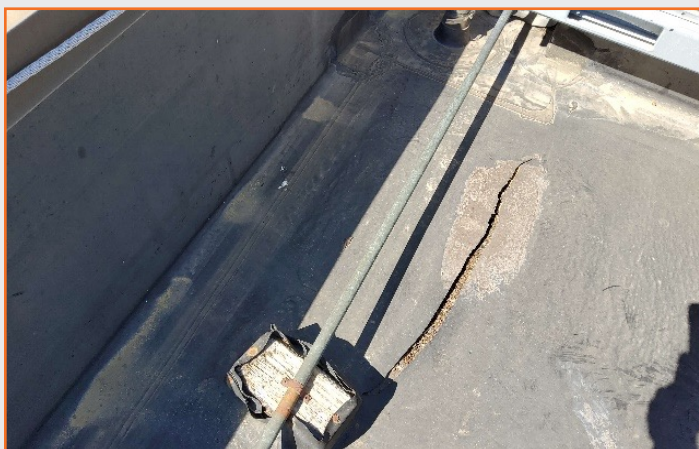
Figure 83: AATT Toll Plaza Electrical Room failed roof.

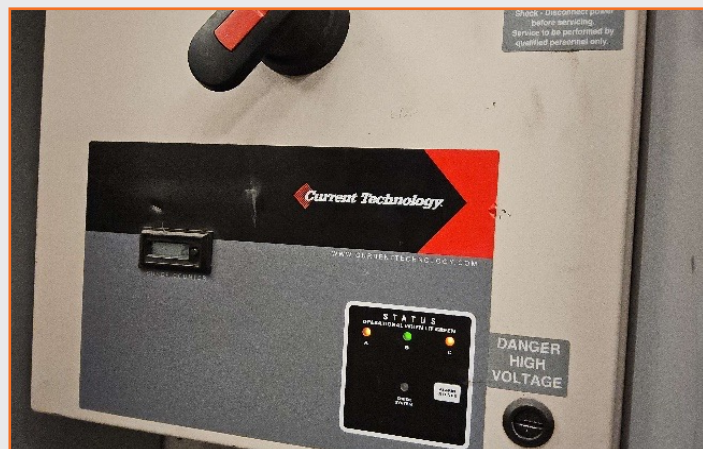
Figure 84: AATT Main Electrical Room failed surge protection device.

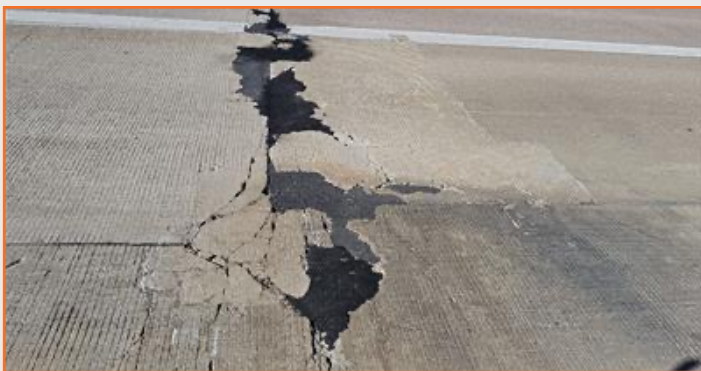
Observations on the roadway include locations concrete pavement deterioration (Figures 85 and 86) and asphalt overlay delamination (Figure 87). Also noted were locations of ditch line and outfall erosion (Figures 88 and 89). There were locations of damaged concrete curb inlets (Figure 90).

Figure 85: 360T concrete pavement deterioration NBML north of Lone Star Rd.

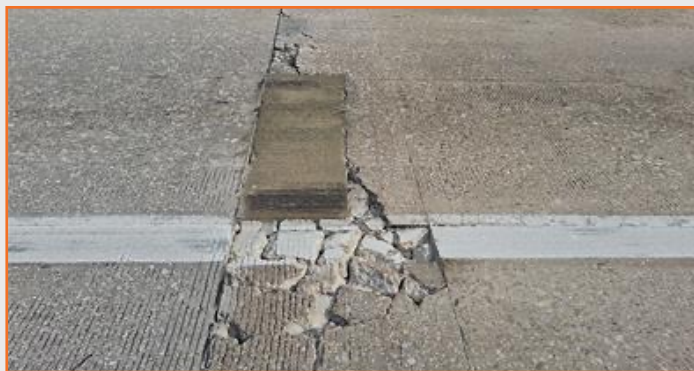
Figure 86: 360T concrete pavement deterioration SBFR north of E. Sublett Rd./W. Camp Wisdom Rd.

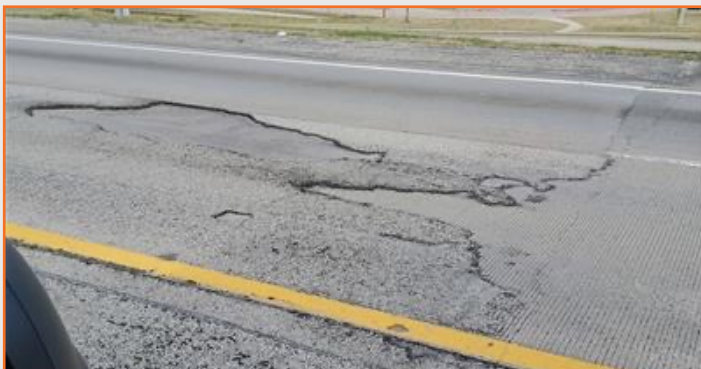
Figure 87: 360T asphalt overlay pavement deterioration NBML south of SE Green Oaks Blvd./Kingwood Blvd.

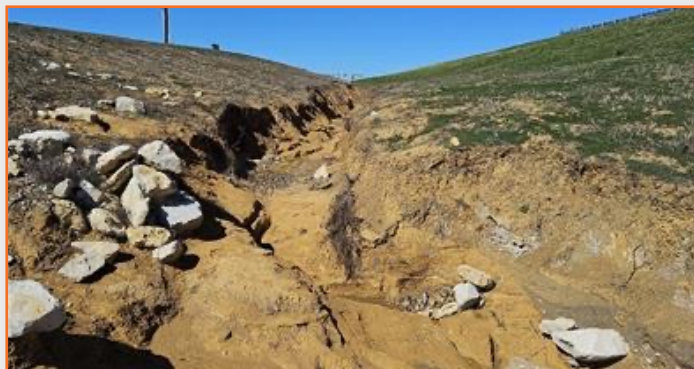
Figure 88: 360T ditch line erosion at Heritage Pkwy.

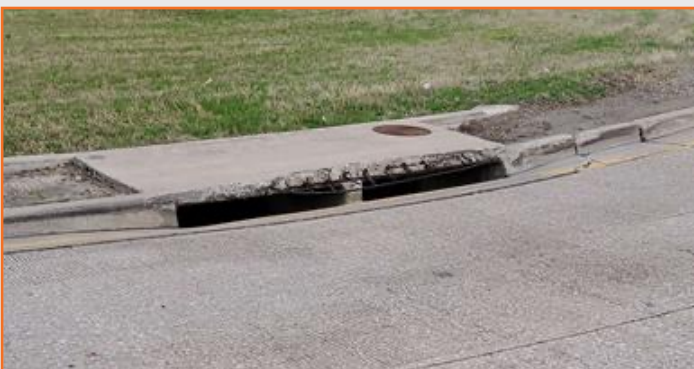
Figure 90: 360T concrete curb inlet damage at Kingswood Blvd. SB U-Turn.

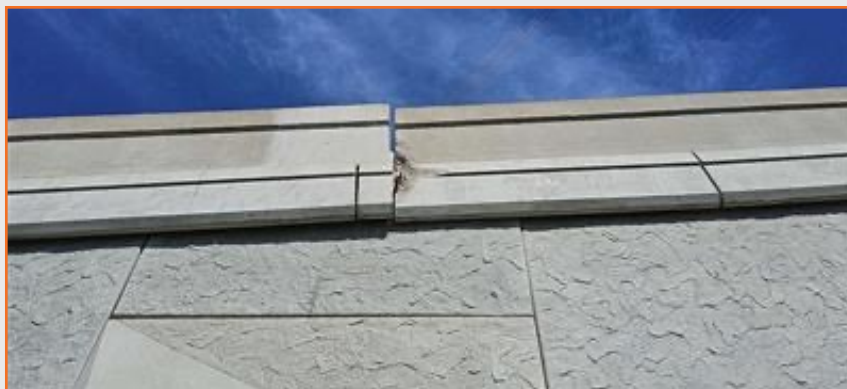
Wall observations include isolated cracked and spalled wall panels and copings (Figure 91).

Figure 91: 360T MSE wall coping and rail cracking and spalling at N. Holland Rd.

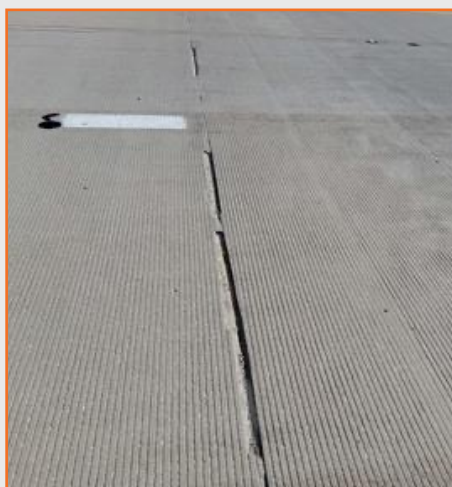
Random cracking was observed on several of the bridge decks, some of which also exhibited spalling near construction joints (Figure 92). Other notable observations included erosion around approach slabs and abutment rip rap (Figure 93). Some of the erosion noted occurs around guardrail posts, adjacent to approach slabs. Similar to other corridors, spalling and cracking was noted on the abutment backwalls at their interface with the wingwalls (Figure 94).

Figure 92: 360T spalling deck at Walnut Creek.

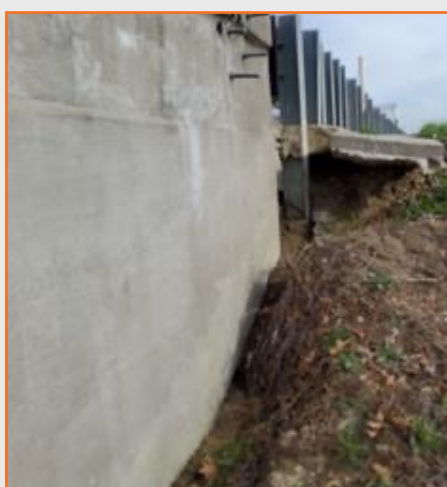
Figure 93: 360T erosion adjacent to approach slab guardrail at Bowman Branch.

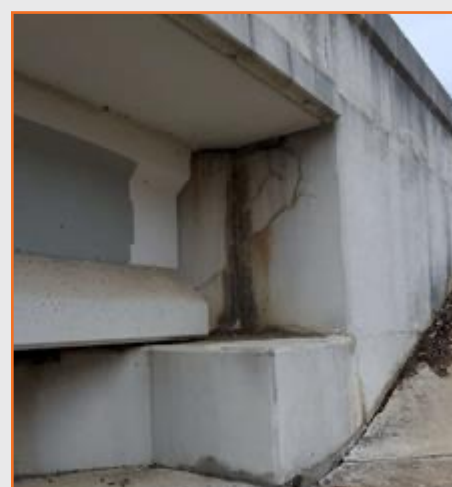
Figure 94: 360T abutment backwall cracking at Fish Creek.

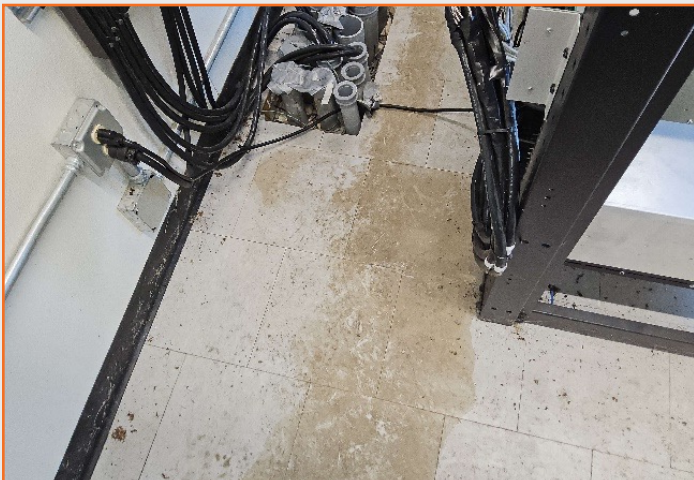
Figure 95: 360T MLG15 water infiltration.

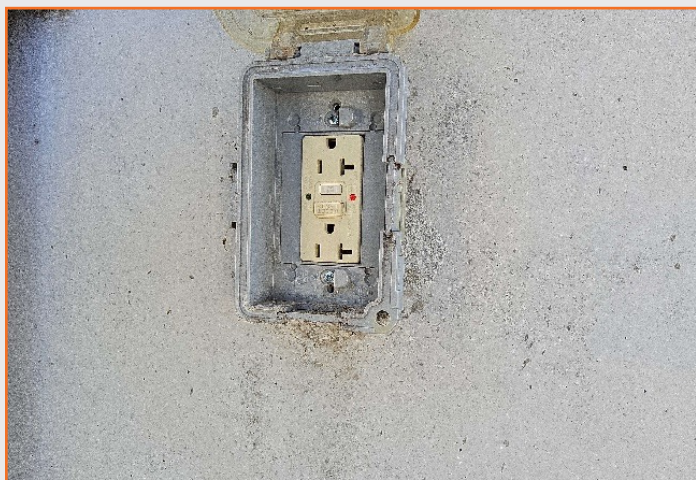
Figure 96: 360T MLG14 faulted GFCI receptacle.

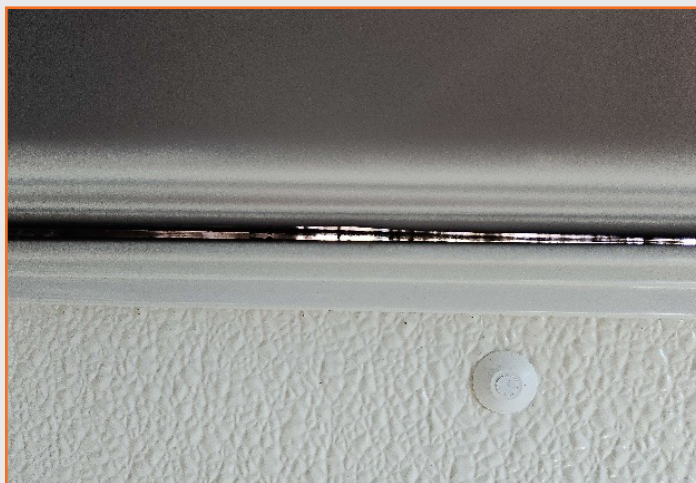
Figure 98: 360T MLG14 failed HVAC unit seal.

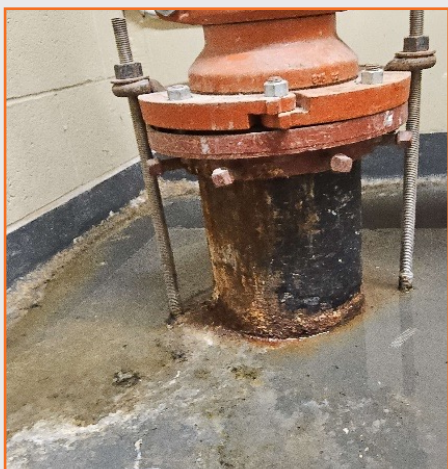
Figure 99: Plano Operations Center corroded fire riser pipe.

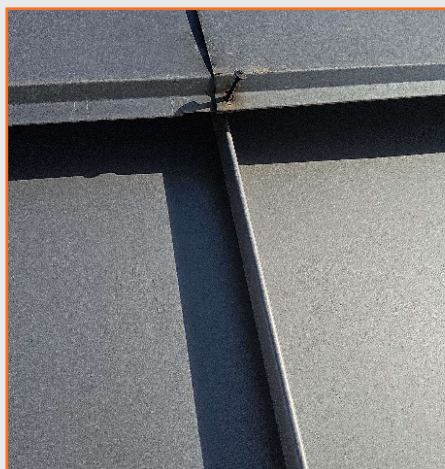
Figure 100: Plano Operations Center loose roof fastener.

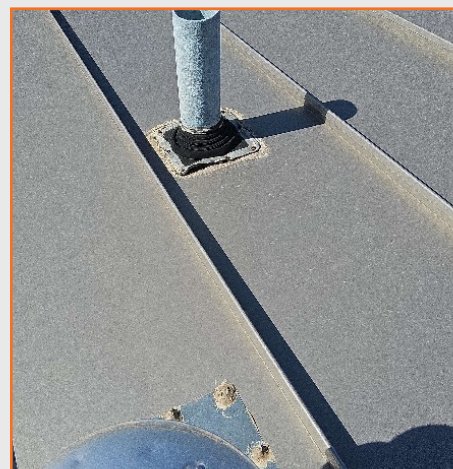
Figure 101: Plano Operations Center damaged roof pipe boot.

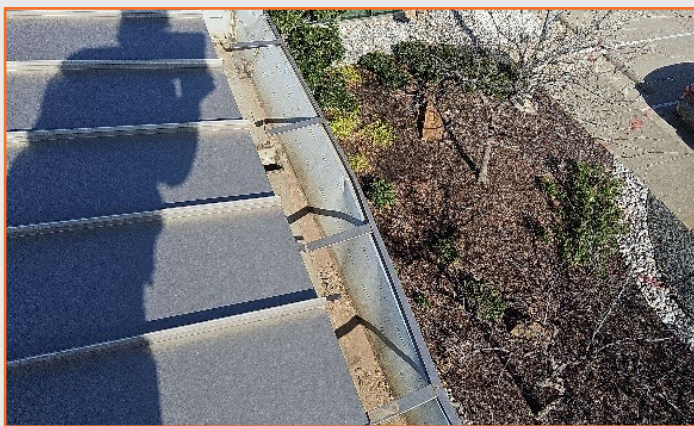
Figure 102: Plano Operations Center damaged gutter.

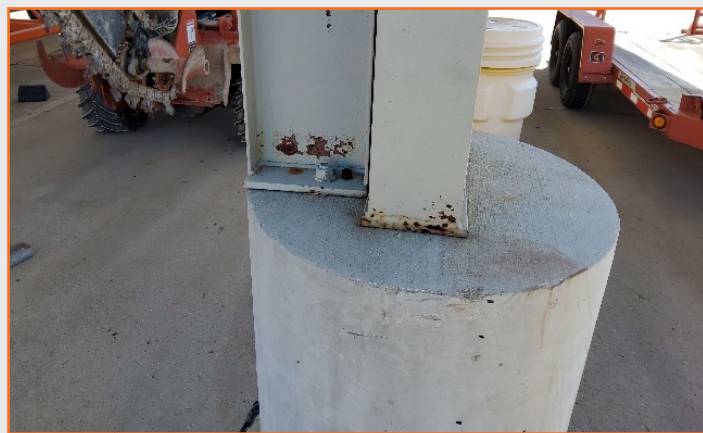
Figure 103: Plano Operations Center outbuilding rust.

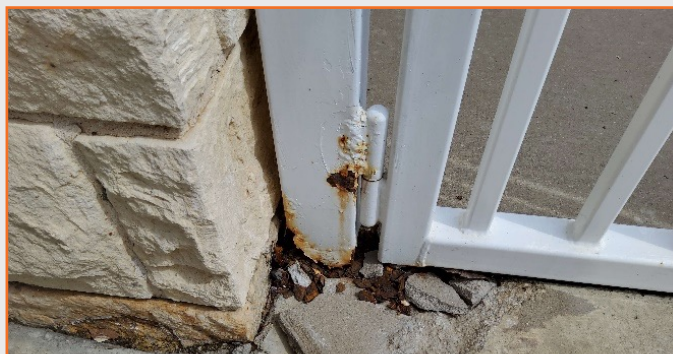
Observations at the Frisco Operations Center included: a deteriorated personnel gate (Figure 104), minor safety violations, exterior areas of rust formation, and joint sealant failures. NTTA has reported that there is a project in design to replace the deteriorated personnel gate.

Figure 104: Frisko Operations Center deteriorated personnel gate.
