SYSTEM ANNUAL INSPECTION REPORT

Fiscal Year 2025

Subject: FY 2025 GEC System Annual Inspection

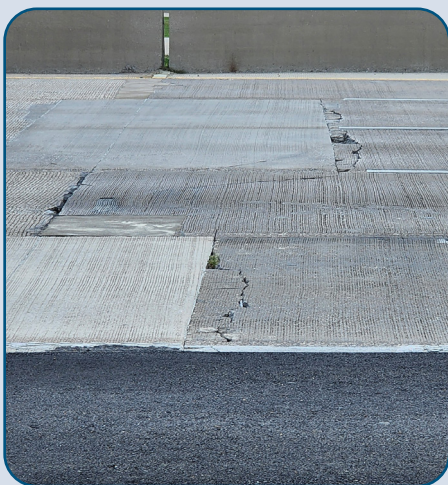
Common roadway deficiencies included cracking and spalling at joints and deterioration of previous pavement repairs (Figures 21,22). There were several locations that included concrete spalling, cracking, and damage to concrete barriers (Figure 23). General erosion observations included erosion of roadway slopes, areas under bridges, and erosion/rutting of landscape beds exposing irrigation lines (Figures 24,25).

Figure 21: PGBT WB Pavement Cracking and Spalling West of Alma Rd.

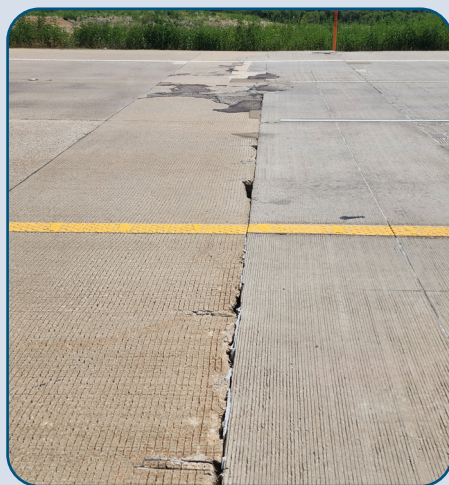
Figure 22: PGBT NB Pavement Joint Deterioration and Spalling North of Merritt Rd.

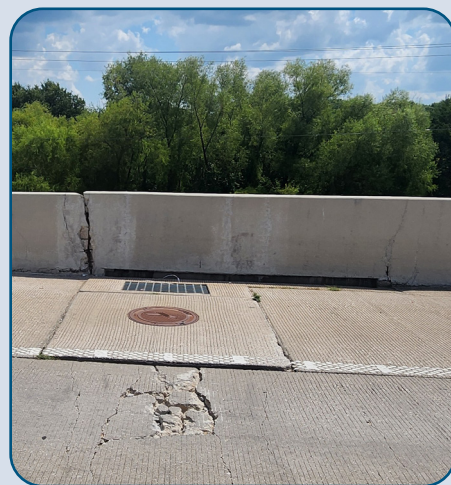
Figure 23: PGBT NB Concrete Rail Cracking and Spalling North of Miller Rd.

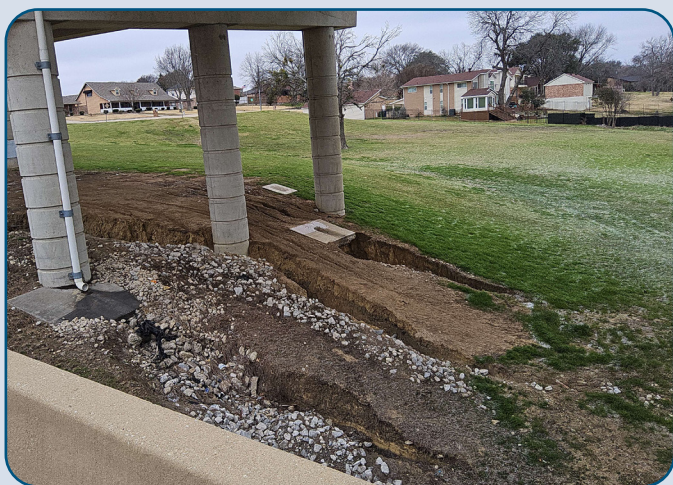
Figure 24: PGBT SB Slope Erosion North of IH 30 in Garland.

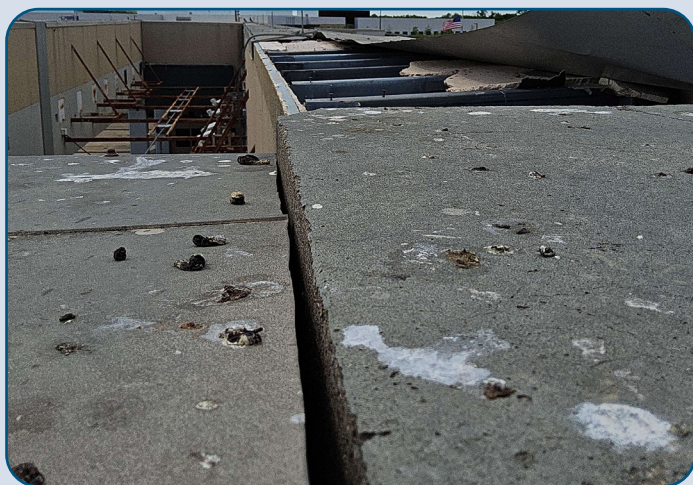
Observations at these facilities included: continued exterior and sealant deterioration, continued tunnel water infiltration, and continued gantry roof/structure deterioration. At MLP6, there was an HVAC upgrade project in progress. In MLP8, multiple rooms had inadequate HVAC cooling. Main lane and ramp gantry roofs continued deteriorating (Figure 31), and lightning protection failures were again observed. At the Midway Road Eastbound On-Ramp gantry, one side panel still has a large crack (Figure 32), while another side panel has continued separating from the structure (Figure 33). MLP6 building's new roof had an issue (Figure 34).

Figure 31: MLP10 Gantry Roof Deterioration.

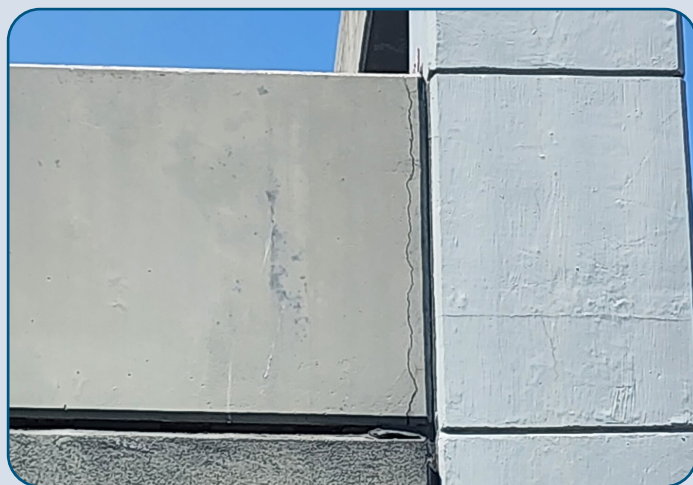
Figure 32: PGBT Midway Road On-Ramp Gantry Panel Crack.

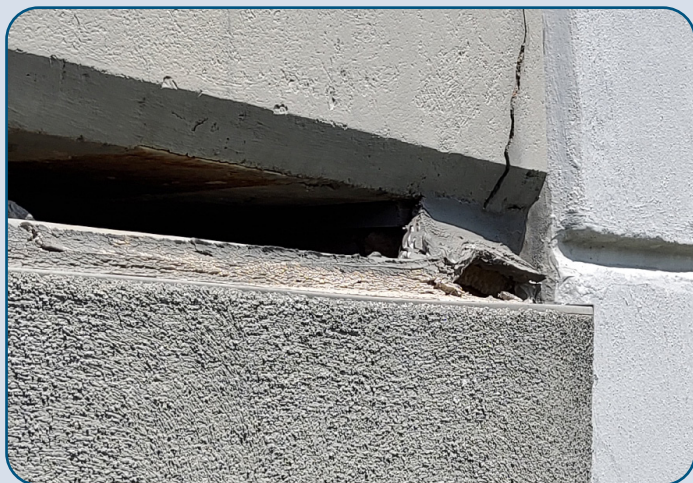
Figure 33: PGBT Midway Road On-Ramp Gantry Panel Separation.

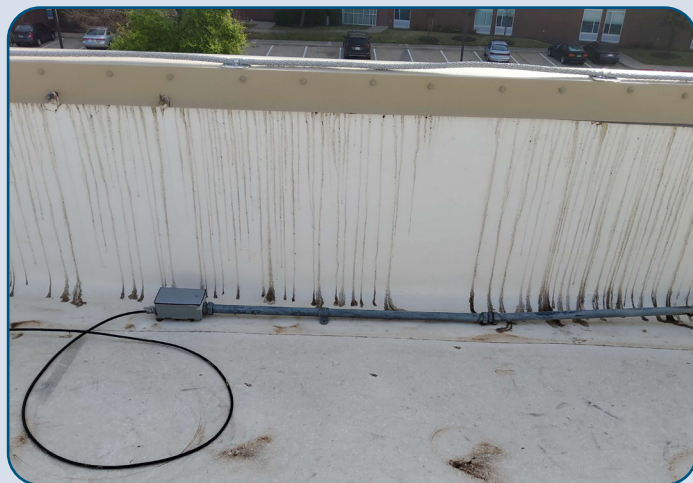
Figure 34: MLP6 Roof Coping Degradation.

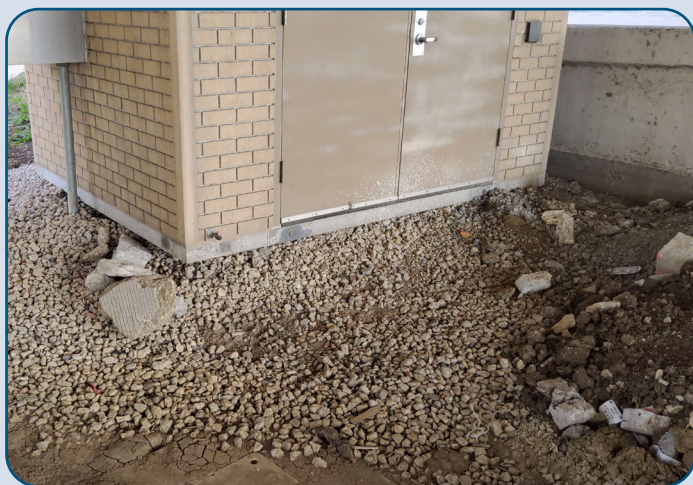
At the Fiber Huts, water infiltration, seal failure, minor ceiling issues, erosion (Figure 35), insect infestation, and GFCI receptacles issues were again observed. At the Winter Weather Operation Facilities, there was corrosion (Figure 36), damage to walls (Figure 37) and damaged fences/gates (Figure 38). GEC understands there are upcoming projects to replace the MLP7 roof, and the MLP8 HVAC system.

Figure 35: PGBT Fiber Hut 5 Erosion.

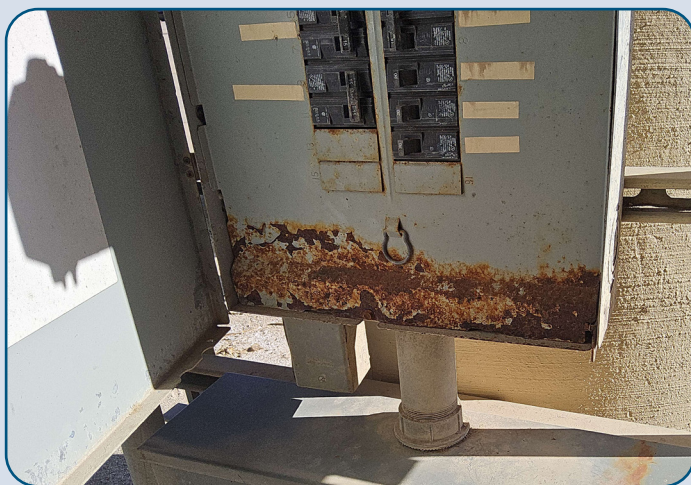
Figure 36: PGBT Brand Road Winter Weather Operation Facility Corrosion.

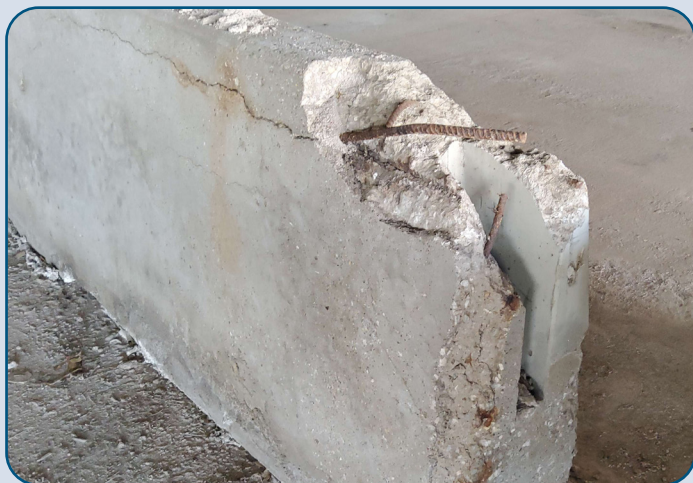
Figure 37: PGBT Oakdale Road Winter Weather Operation Facility Damaged Wall.

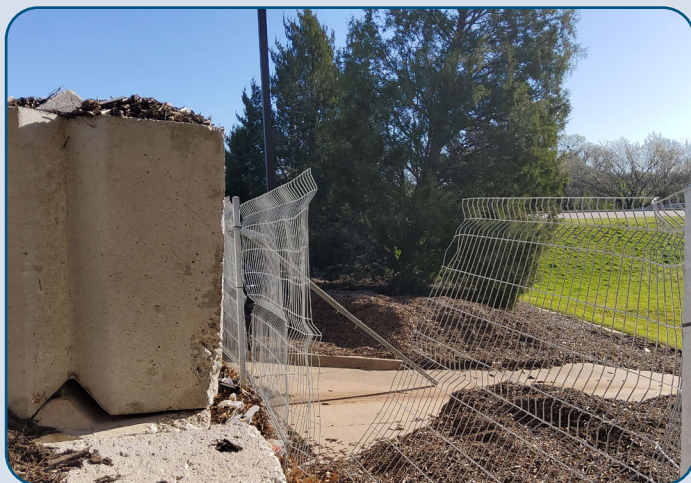
Figure 38: PGBT Brand Road Winter Weather Operation Facility Damaged Fence.

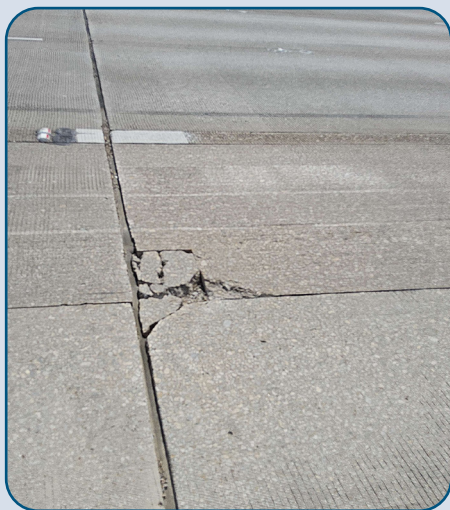
Our observations included several locations of concrete spalls at joints (Figure 39), and joint deterioration and spalls at previous repairs (Figure 40). There were several locations where the longitudinal joint between the pavement and the concrete mow strip for the Metal Beam Guard Fence (MBGF) is unsealed which has led to undermining of the mow strip due to erosion (Figure 41). Additionally, there were several instances of missing, damaged, or faded pavement markings (Figure 42). General erosion issues included erosion at landscape beds resulting in exposed irrigation lines and in some instances undermined landscaping mow strips (Figure 43) and turf erosion (Figure 44).

Figure 39: SRT WBML Pavement Spalling West of Hillcrest Rd.

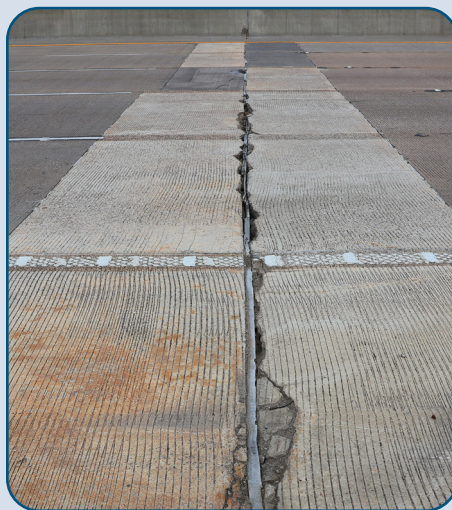
Figure 40: SRT EBML Pavement Joint Deterioration West of Standridge Dr.

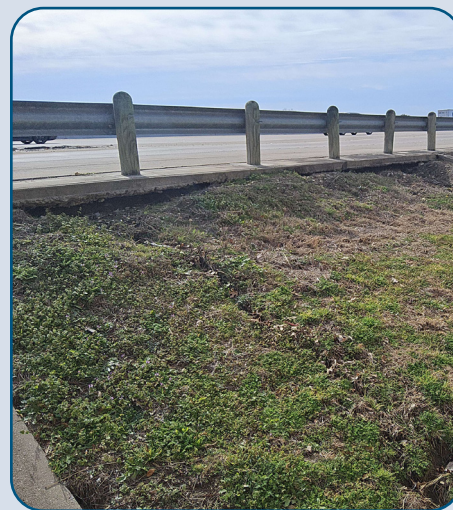
Figure 41: SRT WBML Mow Strip Undermining and Turf Erosion West of Hebron Pkwy.

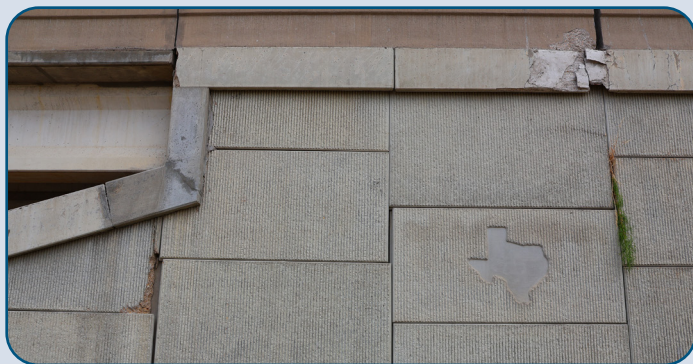
General visual observations included instances of spalling and racked panels in addition to coping that exhibited cracking and/or spalling (Figures 45,46). These observations alone can not confirm nor negate current wall movement. NTTA, the MMC and the GEC conduct regular coordination meetings where NTTA has confirmed that further evaluation of these walls is being conducted.

Figure 45: SRT NB MSE Wall Panel and Coping Cracking and Spalling at Spring Creek Pkwy.

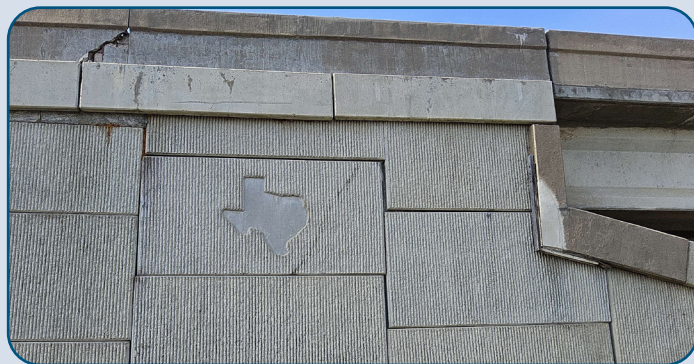
Figure 46: SRT NB MSE Wall Panel Racking at Paige/Plano Pkwy.

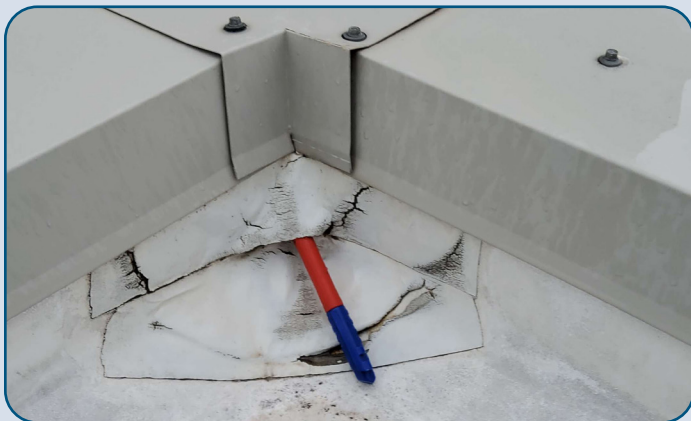
SRT Facilities were generally in good condition. Sealant failure, insect infiltration and roof deterioration/damage were observed at the main lane gantry buildings (Figure 51) and restrooms (Figure 52). At MLG1, window degradation was also noted (Figure 53).

Figure 51: SRT MLG1 Damaged Roof.

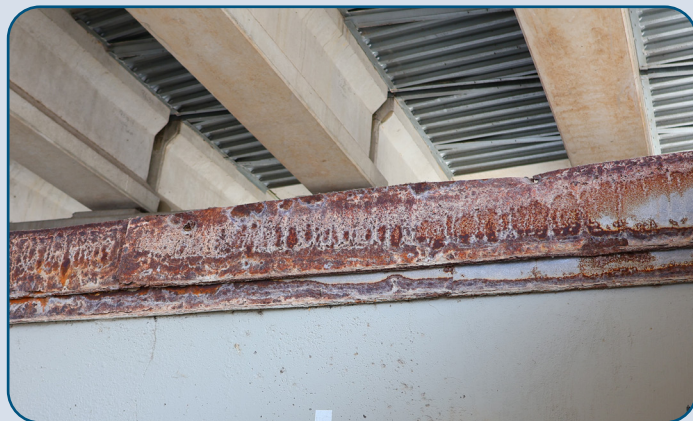
Figure 52: SRT Restroom Corroded Roof.

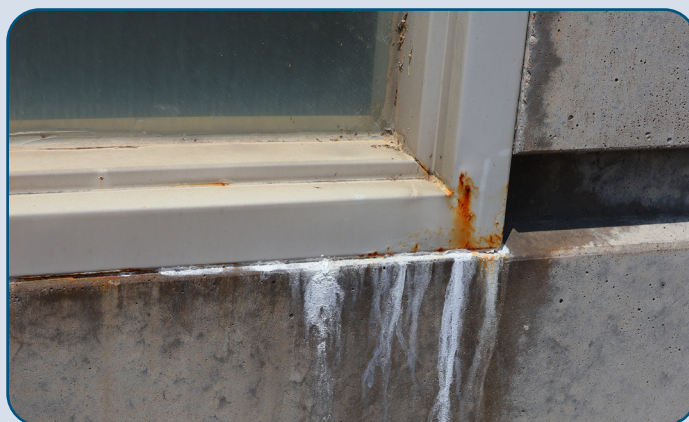
Figure 53: SRT MLG1 Window Degradation.

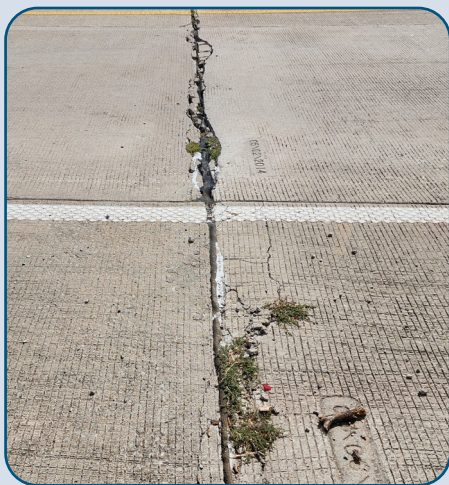
Common roadway deficiencies included concrete cracking and spalling of concrete pavement joints (Figure 54) and minor concrete spalling (Figure 55). There are several locations exhibiting separation between the concrete shoulder and the concrete mow strip for the MBGF (Figure 56). There are also areas where erosion is undermining the concrete mow strip for the MBGF (Figure 57). Other common erosion issues included erosion and rutting at landscape beds resulting in exposed irrigation lines and turf erosion and rutting at backslopes (Figures 58,59).

Figure 54: CTP SB Pavement Joint Deterioration North of Arborlawn Dr.

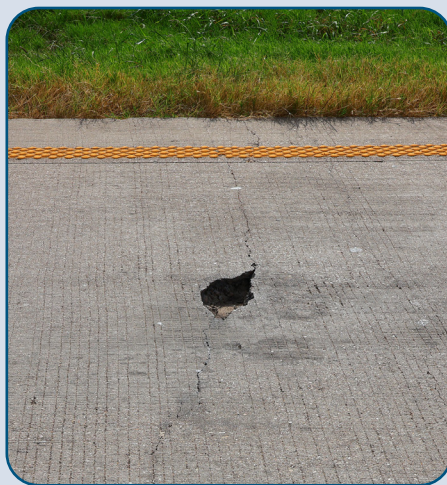
Figure 55: CTP SB Pavement Spalling North of FM 1187.

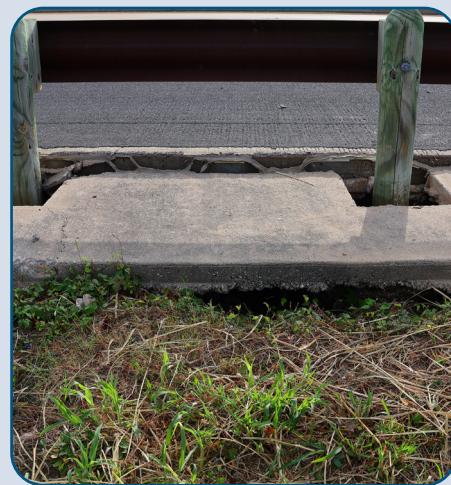
Figure 56: CTP SB Unsealed Joint Undermining Mow Strip South of Dutch Branch Rd.

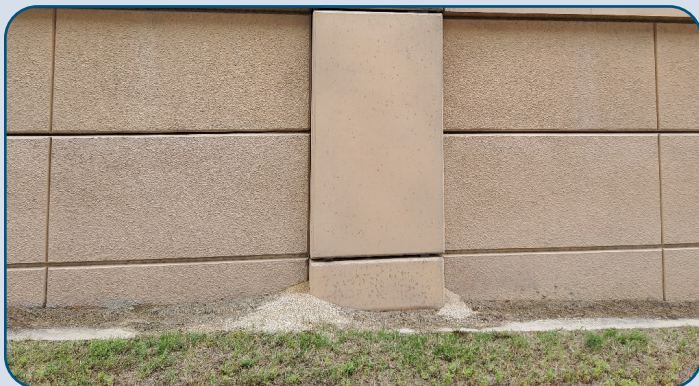
General visual retaining wall observations included instances where panels were racked and exhibited backfill material migration at several locations (Figure 60). Observations also included cracked and spalled retaining wall copings and barriers (Figure 61). These observations alone can not confirm nor negate current wall movement. NTTA, the MMC and the GEC conduct regular coordination meetings where NTTA has confirmed that further evaluation of these walls is being conducted.

Figure 60: CTP MSE Wall Backfill Migration North of Overton Ridge Blvd.

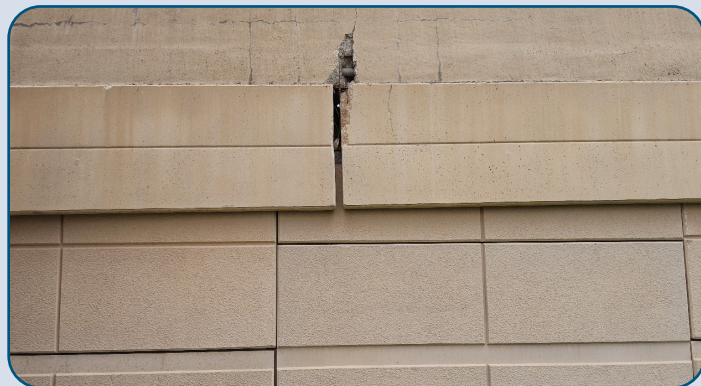
Figure 61: CTP MSE Wall Coping and Concrete Rail Spalling South of Overton Ridge Blvd.

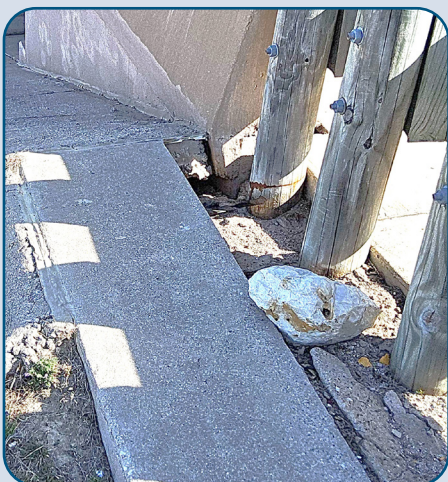
Figure 62: CTP SB Erosion and Undermining of MBGF Mow Strip and Adjacent Concrete Riprap South of McPherson Blvd.

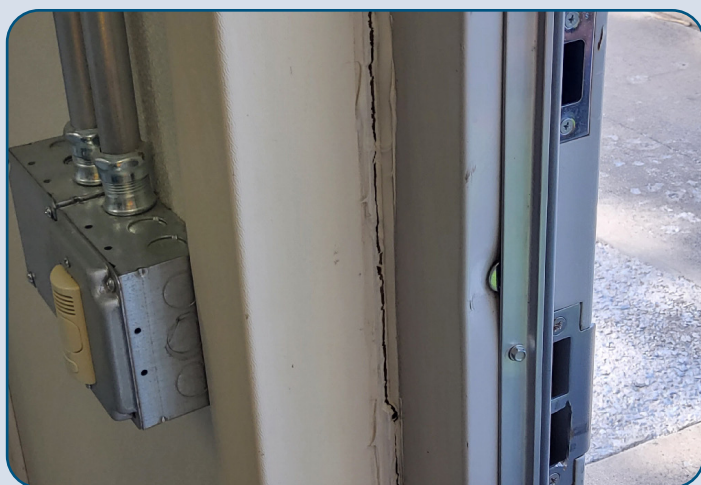
Facilities along the CTP corridor were in good condition, with only minor sealant deterioration (Figure 65) water infiltration (Figure 66), landing deterioration (Figure 67) all again noted. Light fixtures' insect infestation was also noted (Figure 68). At restrooms, door lock and water heater issues were again observed.

Figure 65: CTP MLG1 Deteriorated Seal.

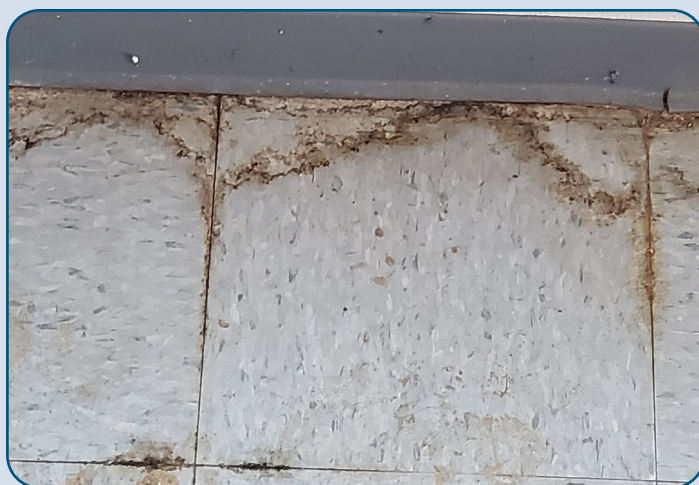
Figure 66: CTP MLG2 Water Infiltration.

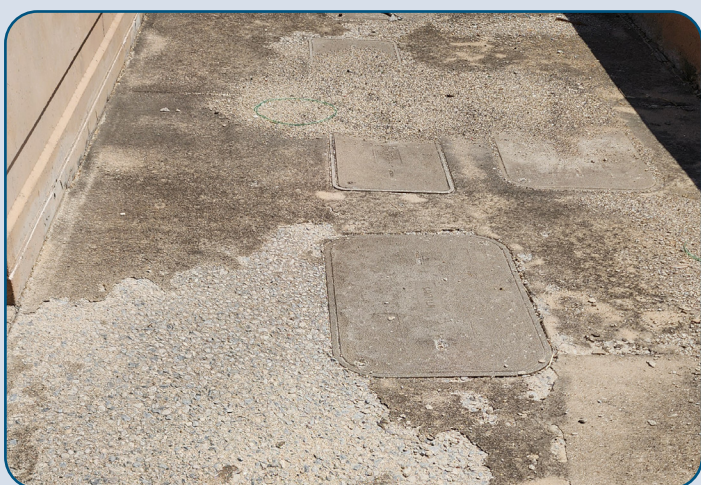
Figure 67: CTP MLG1 Deteriorated Landing.

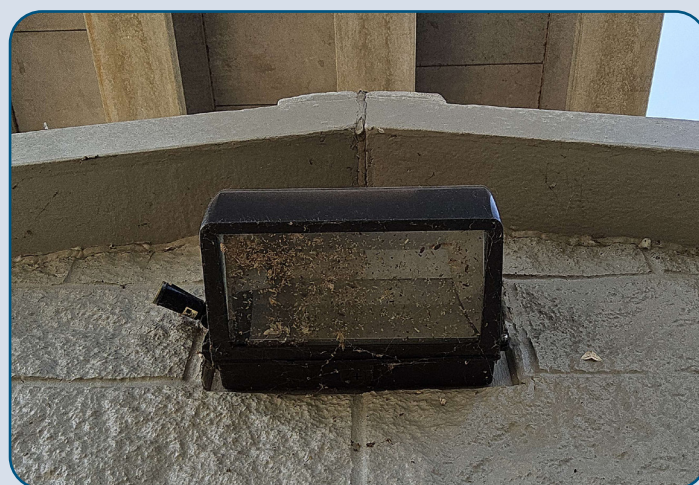
Figure 68: CTP Restroom Light Fixture Insect Infestation.

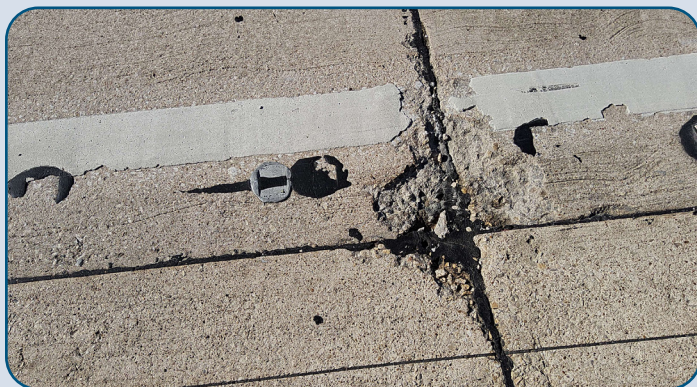
Common roadway deficiencies included concrete spalling at joints (Figure 69). Other observations included erosion and undermining of concrete riprap at a drainage outfall structure (Figure 70).

Figure 69: MCLB Pavement Spalling on the East End.

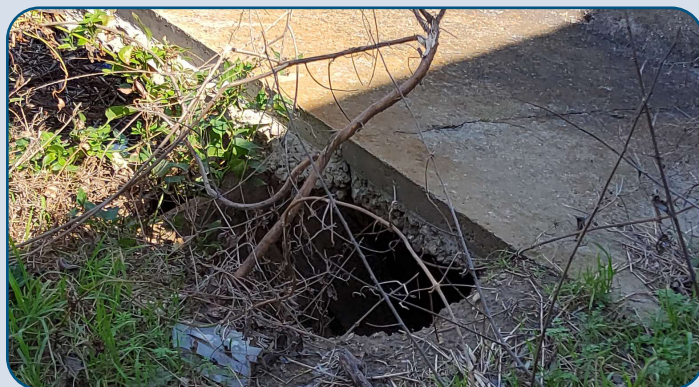
Figure 70: MCLB Storm Sewer Outfall Structure Erosion West End.

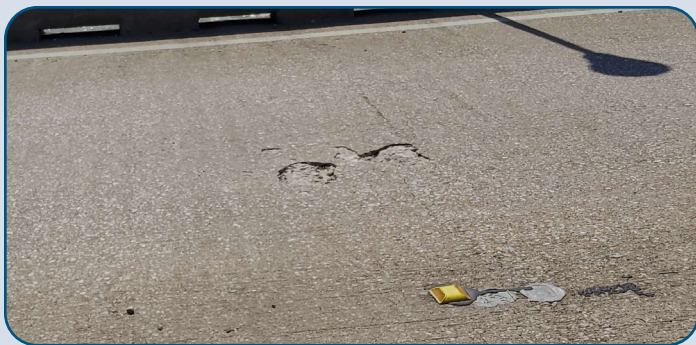
Common observations along the MCLB corridor included concrete spalling on the bridge deck (Figure 71), concrete spalling on the column collars (Figure 72), concrete spalling with exposed reinforcement on the bent caps (Figures 73, 74), and concrete spalling with exposed reinforcement on backwalls (Figure 75).

Figure 71: MCLB Deck Spalling.

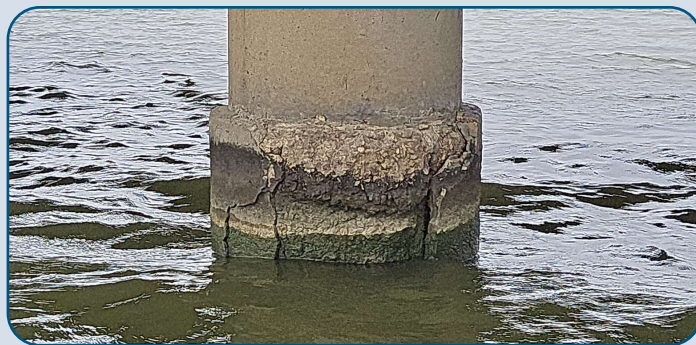
Figure 72: MCLB Column Collars Spalling.

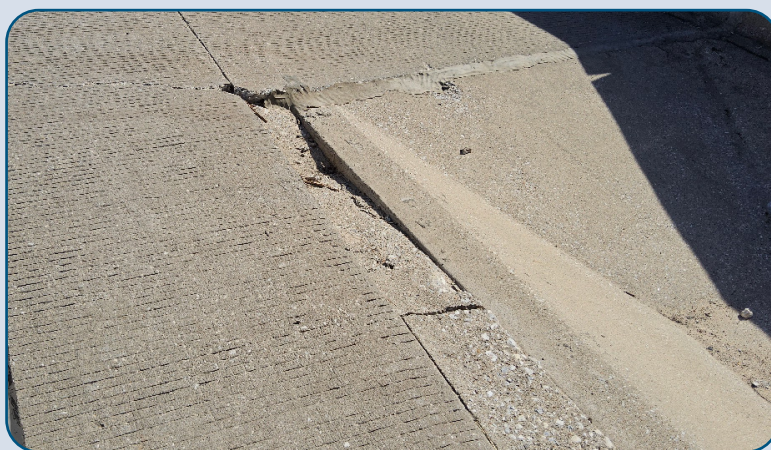
Our observations included a pavement spall adjacent to a concrete flume (Figure 78).

Figure 78: LLTB Concrete Pavement Spalling.

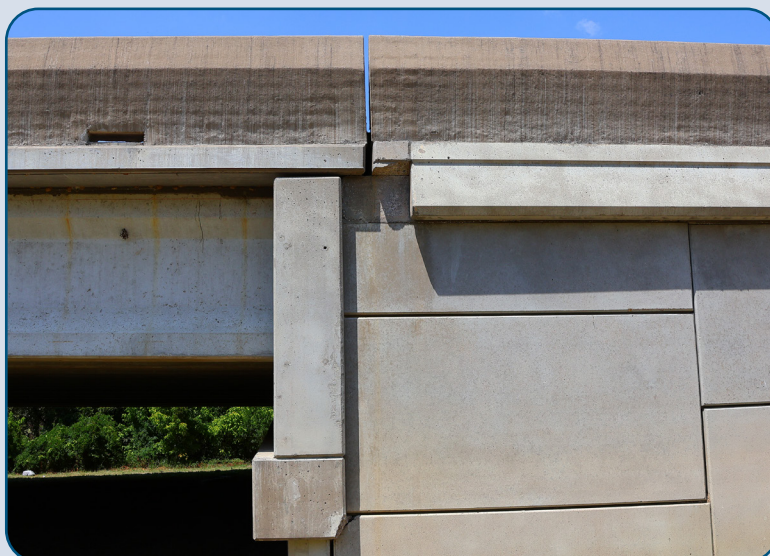
General visual retaining wall observations included instances where panels were racked with some damage to the coping (Figure 79). These observations alone can not confirm nor negate current wall movement. NTTA, the MMC and the GEC conduct regular coordination meetings where NTTA has confirmed that further evaluation of these walls is being conducted.

Figure 79: LLTB MSE Wall Coping Damage.

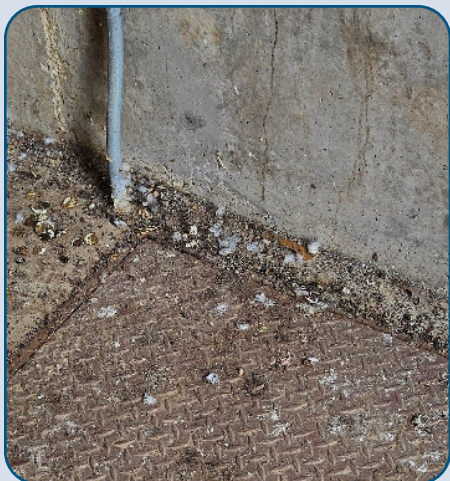
In the electrical rooms, corroded electrical conduit/enclosures, a separated drain pipe, and insect infestation (Figure 83) were all again noted. At the Fiber Hut, roof degradation (Figure 84), water infiltration, and insect infestation (Figure 85) were noted.

Figure 83: LLTB Insect Infestation.

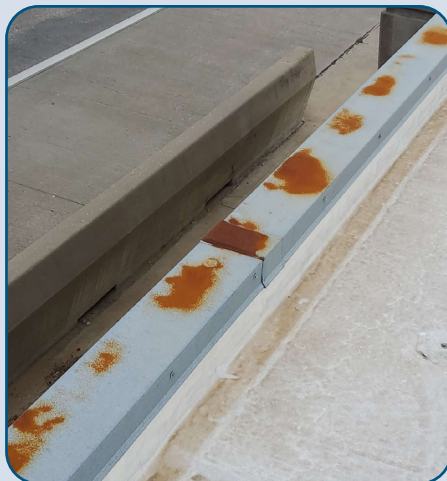
Figure 84: LLTB Fiber Hut Roof Degradation.

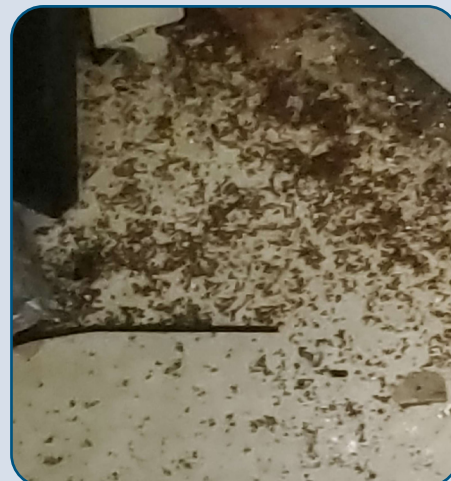
Figure 85: LLTB Fiber Hut Insect Infestation.

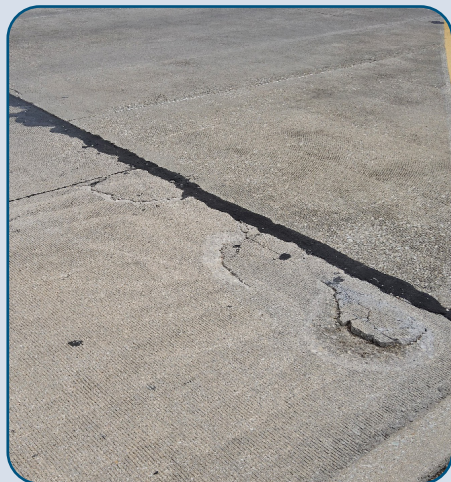
Common roadway deficiencies included concrete cracking and spalling at joints (Figure 86). Common erosion issues included erosion and rutting at landscape beds (Figure 87). Other observations included a chain link fence that was damaged and misaligned (Figure 88).

Figure 86: AATT Pavement Spalling.

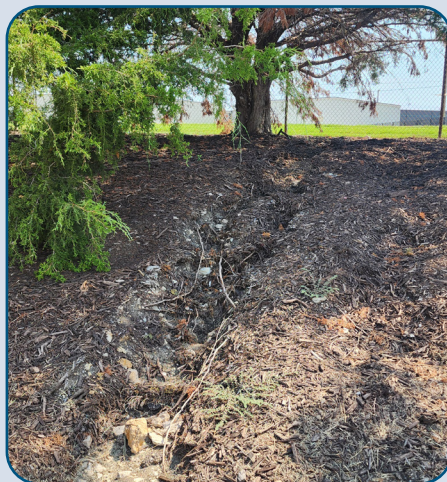
Figure 87: AATT Landscape Bed Erosion.

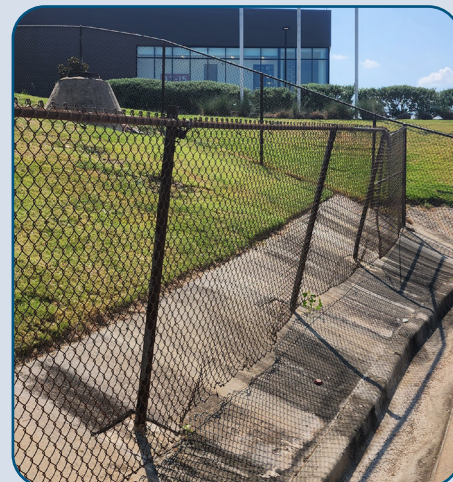
Figure 88: AATT Fence Damage.

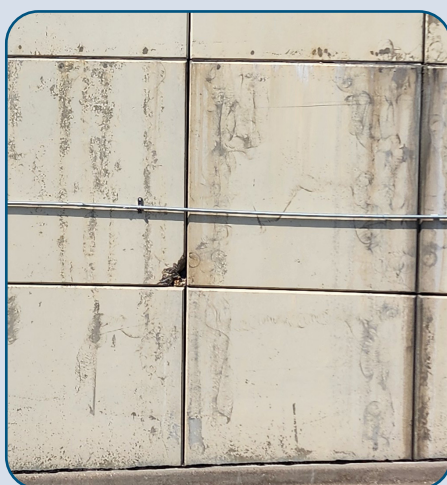
Figure 89: AATT Panel Wall Spalling.

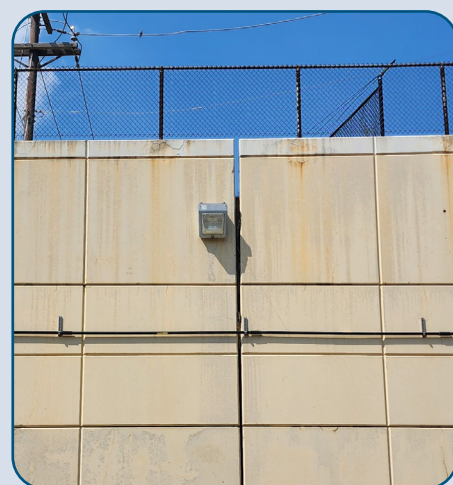
Figure 90: AATT Panel Wall Cracking and Missing Joint Seal.

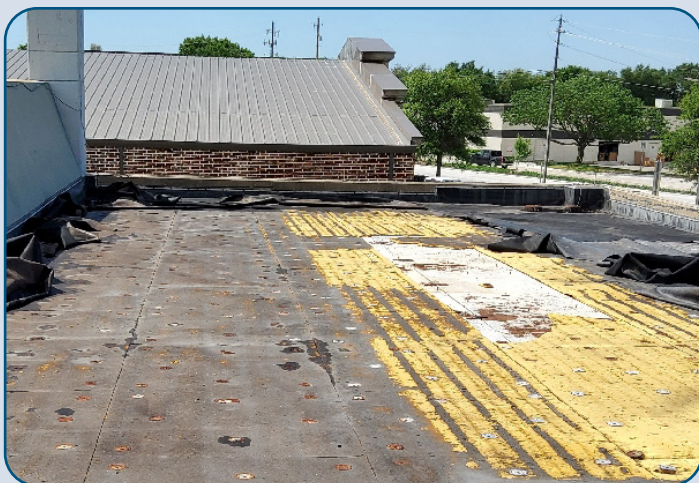
Figure 91: AATT Gantry Roof Damage.

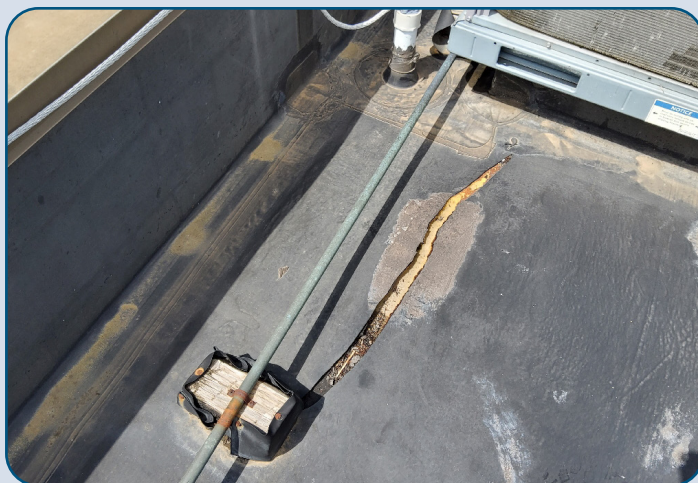
Figure 92: AATT Toll Plaza Electrical Room Roof Damage.

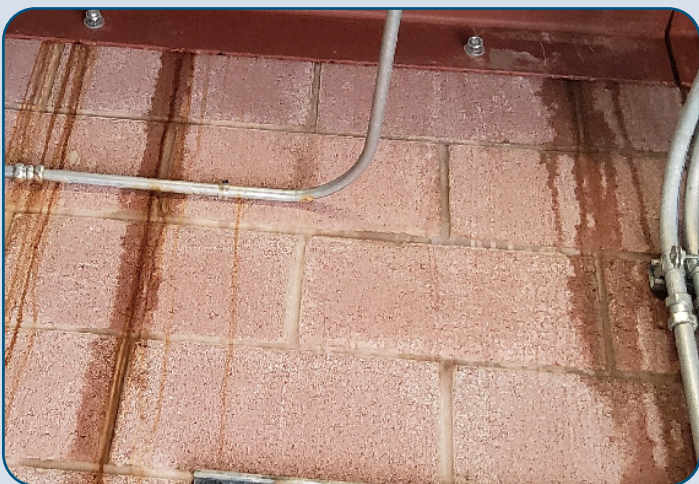
Figure 93: AATT Toll Plaza Electrical Room Water Leak.

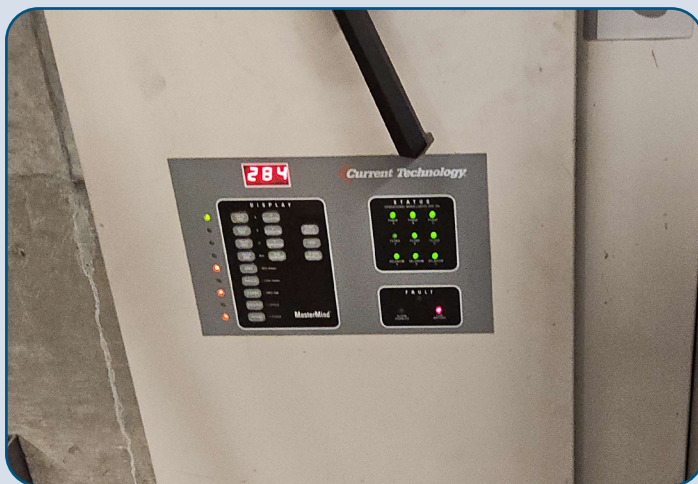
The tunnel fan replacement project was still in progress at the time of inspection. One toll plaza HVAC RTU condensate pipe was still clogged. The gantry roof condition worsened since the previous inspection (Figure 91), while the toll plaza electrical room roof has failed (Figure 92), allowing water to enter the Electrical Room (Figure 93). In the main electrical room, a surge suppression device failure was noted (Figure 94).

Figure 94: AATT Main Electrical Room Failed Surge Suppressor.

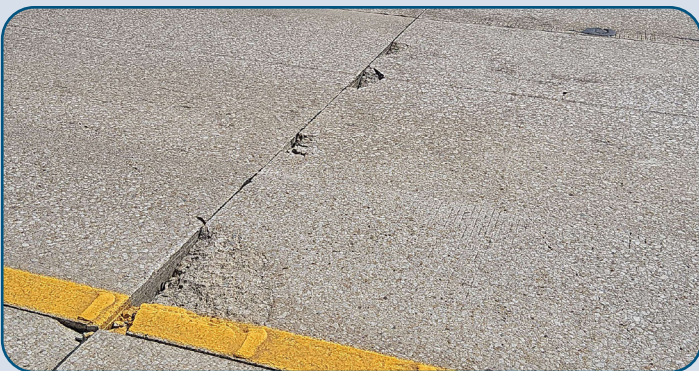
Common roadway deficiencies included cracking and spalling at joints (Figure 95). Other observations included damaged curb inlet tops with exposed reinforcement (Figure 96). Common erosion issues included outfall drainage structures being undermined (Figure 97) and eroded backslopes contributing to silted end treatments (Figure 98). There were several locations that included concrete spalls, cracking, and damage to concrete barriers (Figure 99).

Figure 95: 360T NB Concrete Pavement Cracking and Spalling North of Doryn Dr.

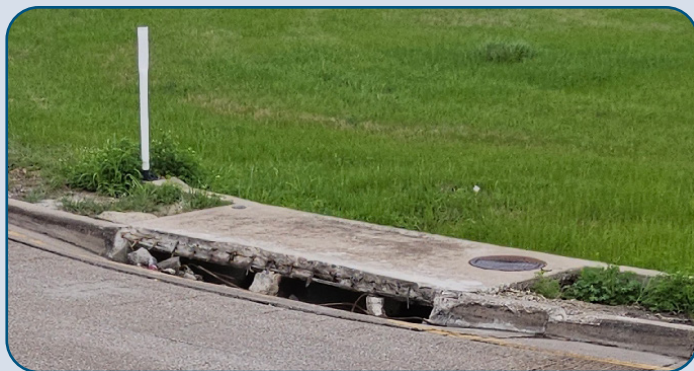
Figure 96: 360T NB Curb Inlet Damage at SE Green Oaks Blvd.

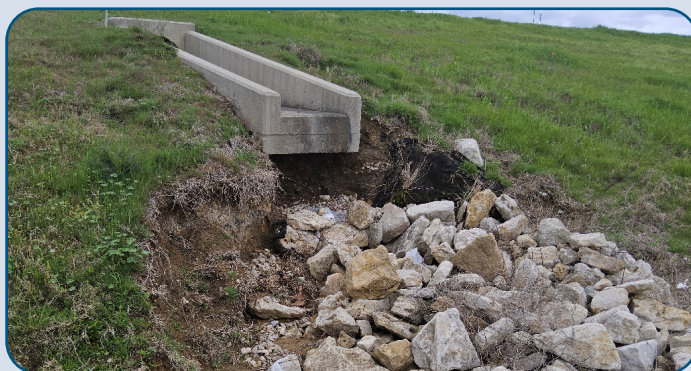
Figure 97: 360T SB Drainage Structure Undermined at N Holland Rd.

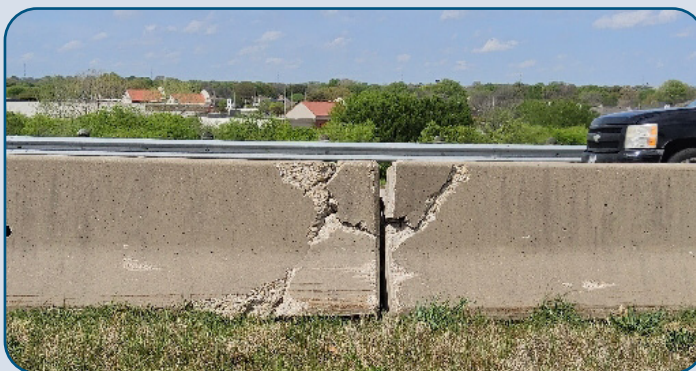
Figure 99: 360T SB Concrete Rail Cracking and Spalling South of SE Green Oaks Blvd.

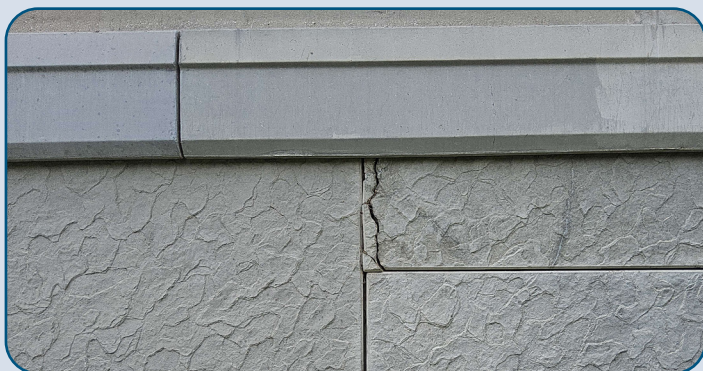
General visual retaining wall observations included instances where panels were racked or exhibited concrete cracking and/or spalling (Figures 100, 101). These observations alone can not confirm nor negate current wall movement. NTTA, the MMC and the GEC conduct regular coordination meetings where NTTA has confirmed that further evaluation of these walls is being conducted.

Figure 100: 360T NB MSE Wall Panel Cracking North of N. Holland Rd.

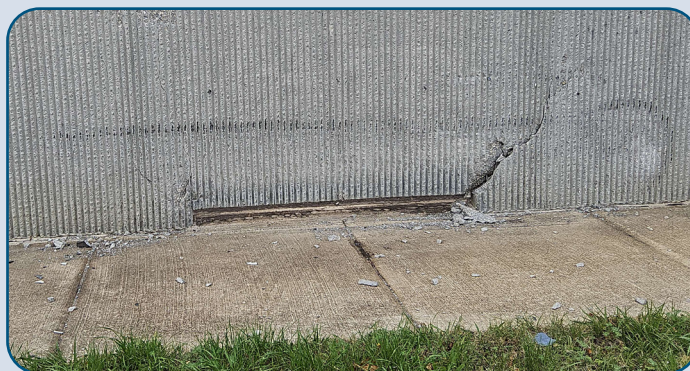
Figure 101: 360T SB MSE Wall Panel Damage North of Debbie Ln.

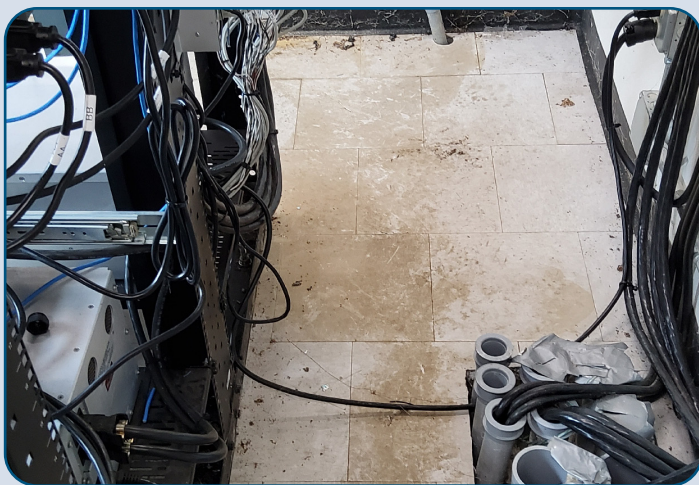
These facilities were in overall good condition, with water infiltration (Figure 106), electrical GFCI receptacle issues (Figure 107), minor code issues, insect infestation (Figure 108), and sealant failures at the HVAC units (Figure 109) all again noted.

Figure 106: 360T MLG15 Water Infiltration.

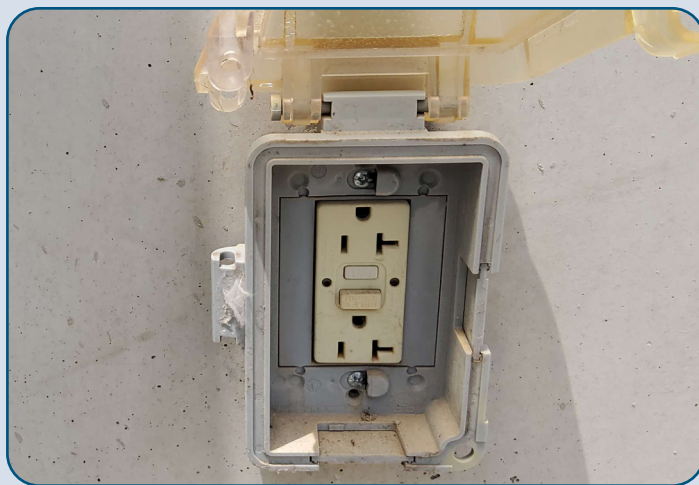
Figure 107: 360T MLG15 Electrical Receptacle Failure.

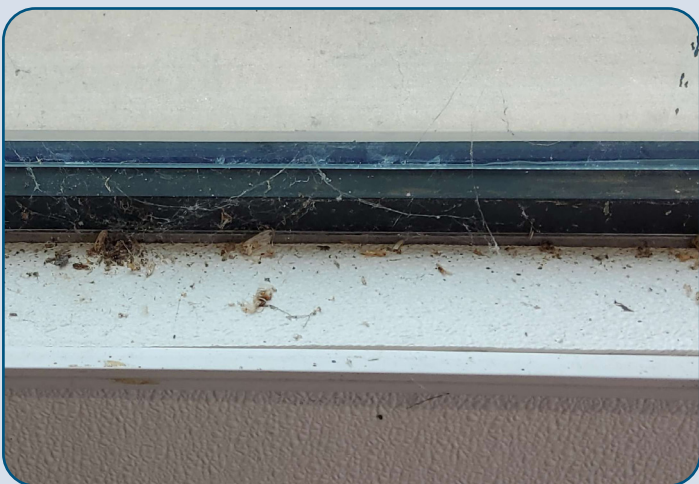
Figure 108: 360T MLG15 Insect Infestation.

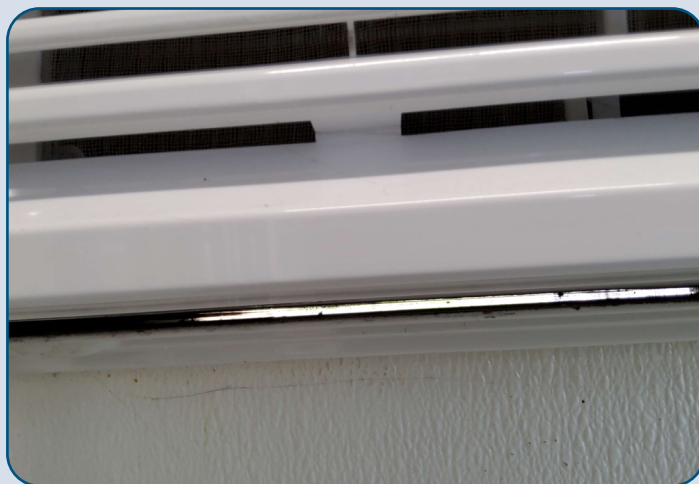
Figure 109: 360T MLG15 Failed Sealant.

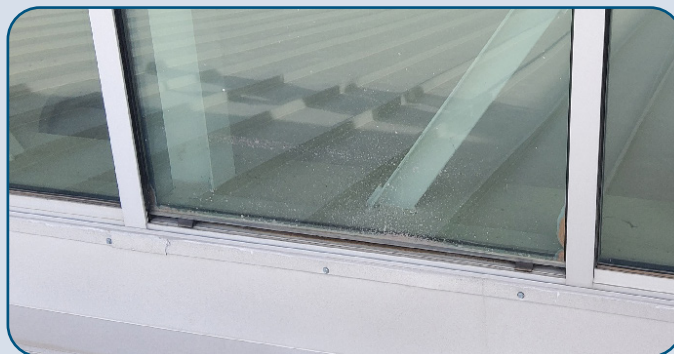
Figure 116: FOC Deteriorated Windows.
