NORTH TEXAS TOLLWAY AUTHORITY

# SYSTEM ANNUAL INSPECTION REPORT

## Fiscal Year 2026

Subject: FY 2026 GEC System Annual Inspection

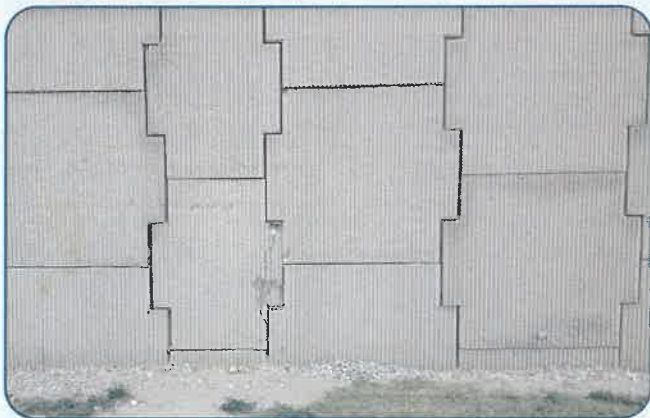
Our observations included instances where wall panels had racked and were exhibiting cracking and/or spalling (Figure 8), spalling with exposed reinforcement (Figure 9), and exhibited wall staining (Figure 10). These observations alone cannot confirm nor negate current wall movement. NTTA, the MMC and the GEC conduct regular coordination meetings where NTTA has confirmed that further evaluation of these walls is being conducted.

Figure 8: DNT SB MSE Wall Cracking and Spalling South of Alpha Rd.

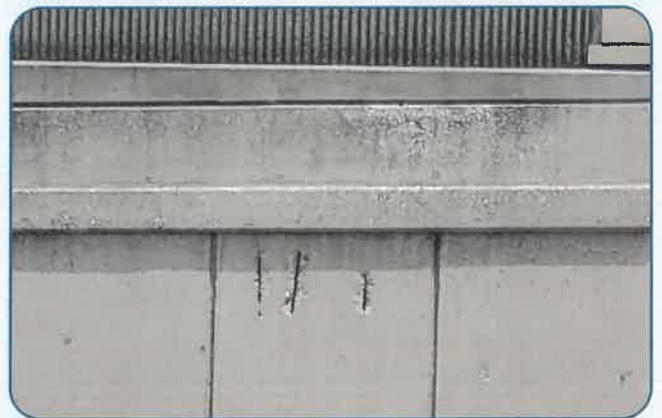
Figure 9: DNT NB MSE Wall Spalling with Exposed Reinforcement North of Cedar Springs Rd.

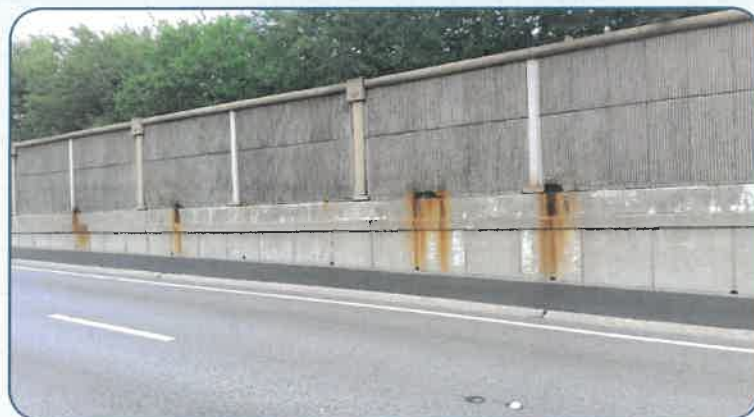
Figure 10: DNT SB Wall Staining South of Glenwick Ln.

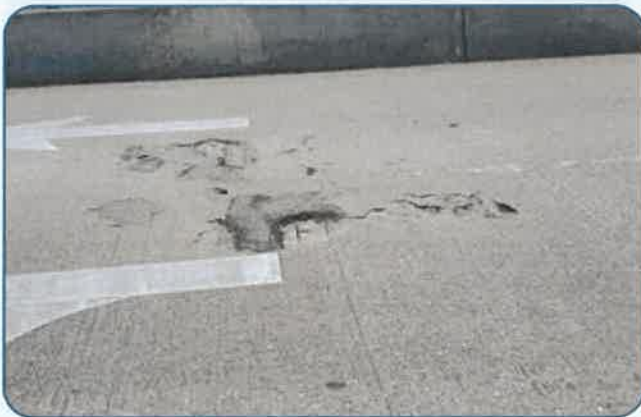
Observations along the DNT corridor included bridge decks which exhibit different types of maintenance needs including cracking and spalling on top and underneath the concrete decks (Figures 11 and 12). Spalling of concrete beams due to impact with the abutment backwall (Figure 13) and localized pavement movement including spalling, and cracking of the abutment backwall with exposed reinforcing steel (Figure 14).

Figure 11: DNT Deck Spalling at IH 635.

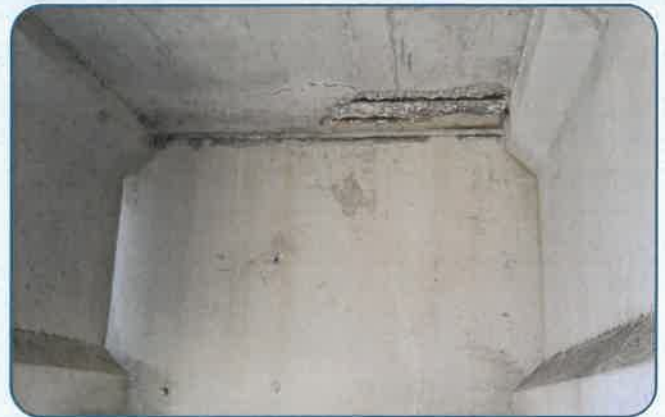
Figure 12: DNT Underdeck Spall with Exposed Reinforcement at IH 635.

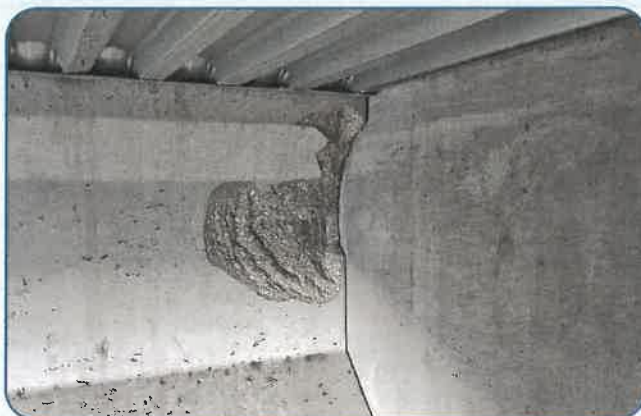
Figure 13: DNT Bridge Beam Spalling at Eldorado Pkwy.

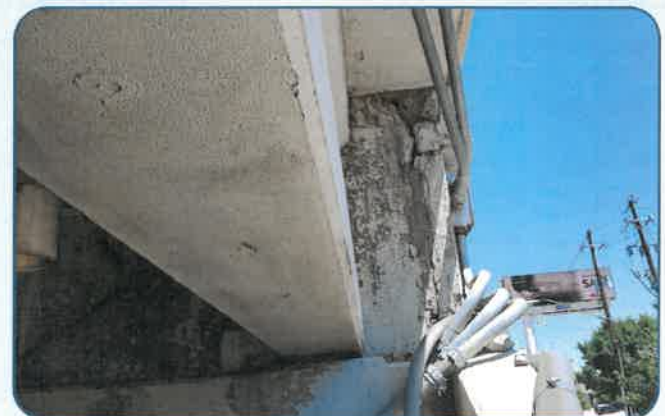
Figure 14: DNT Abutment Backwall Spall at Alpha Rd.

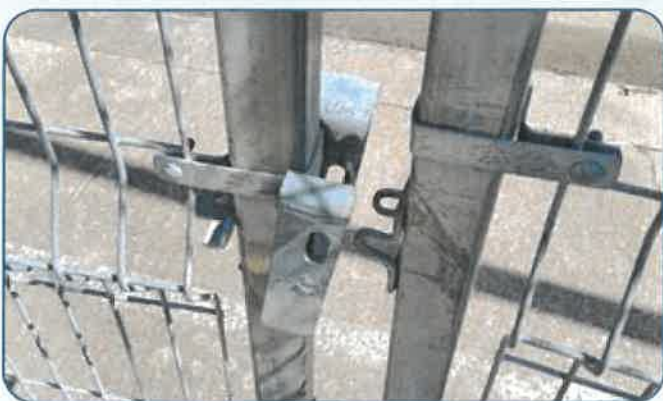
Figure 18: DNT Fiber Hut 1 Uncloseable Gate Lock.

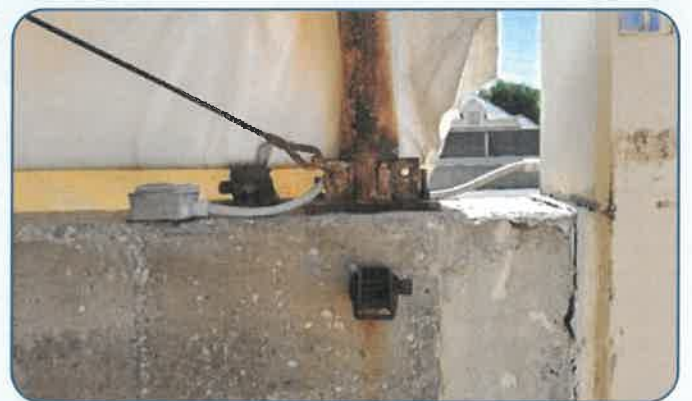
Figure 19: DNT Meaders Lane Winter Weather Operations Facility Corroded Member.

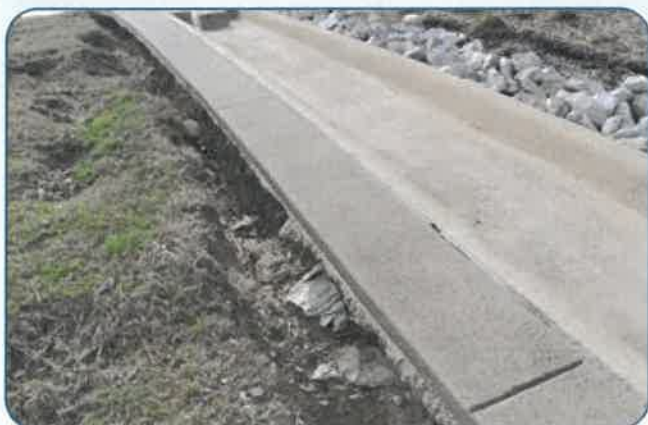
Figure 23: PGBT NB Turf Erosion and Flume Undermining South of Telecom Pkwy.

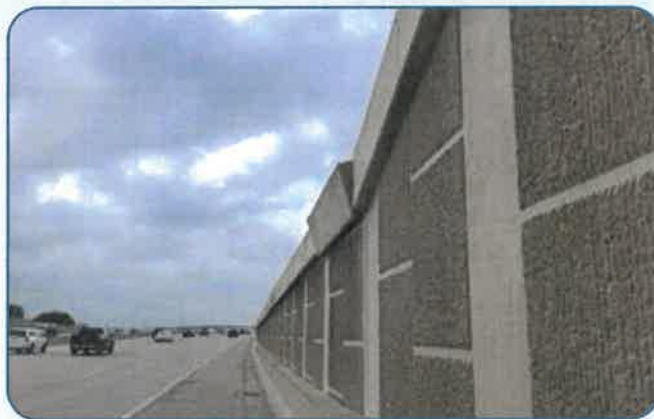
Our observations included instances of retaining wall coping displacement (Figure 25) and of wall panel cracking and spalling at other isolated locations (Figure 26). These observations alone cannot confirm nor negate current wall movement. NTTA, the MMC and the GEC conduct regular coordination meetings where NTTA has confirmed that further evaluation of these walls is being conducted.

*Figure 25: PGBT WB Wall Coping Displacement at Old Denton Rd.*

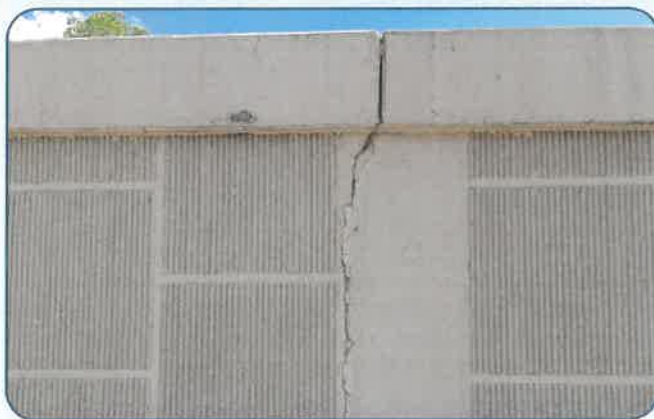
*Figure 26: PGBT EB Wall Cracking West of Independence Pkwy.*

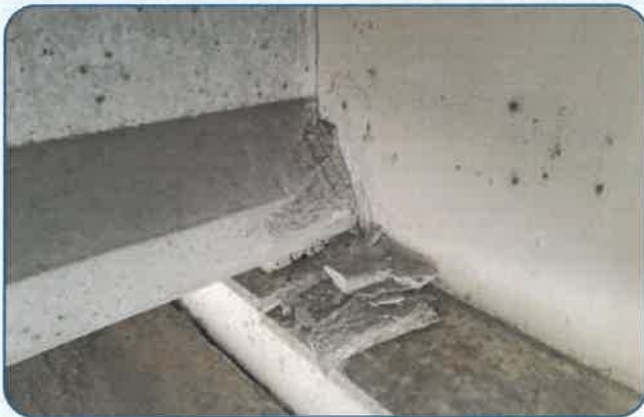
Our observations along the PGBT corridor included concrete beams with multiple concrete beam spalls with some exhibiting exposed reinforcing steel from contact with the abutment backwall (Figure 27). Substructure observations include cracking and spalling of the backwalls (Figure 28) and exposed column footings from channel scour and erosion (Figure 29).

Figure 27: PGBT Concrete Beam Spall at Royal Ln.

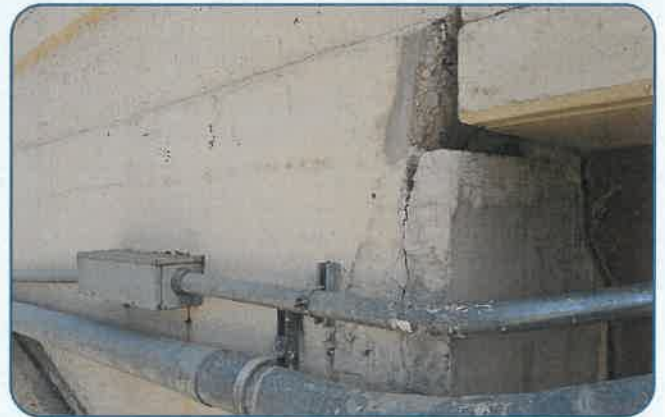
Figure 28: PGBT Backwall Cracking and Spalling at Gateway Dr.

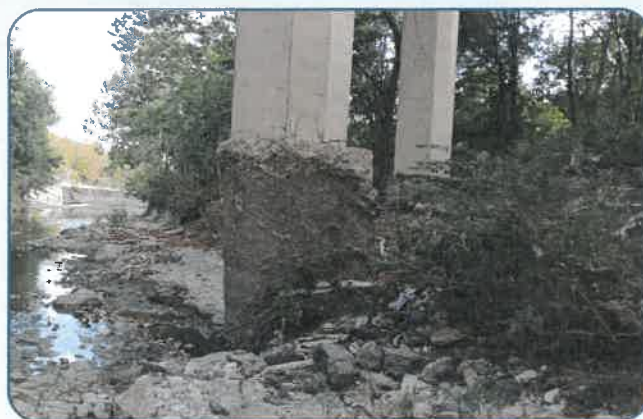
Figure 29: PGBT Exposed Column Footings at US 75.

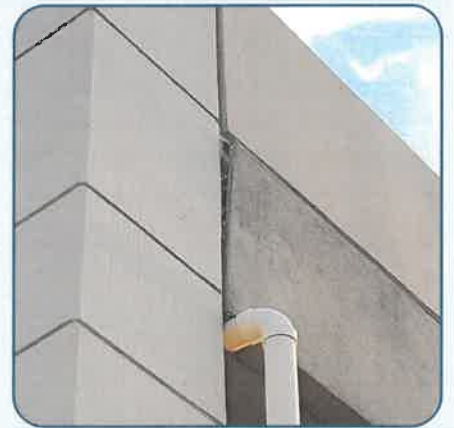
Figure 32: PGBT Midway On-Ramp Gantry Separated Wall Panel 1.

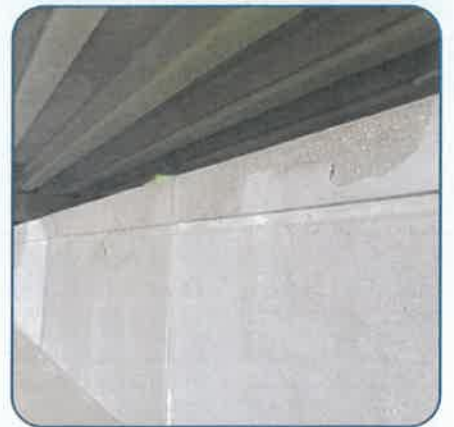
Figure 35: PGBT Oakdale Road Winter Weather Operations Facility Damaged Wall.

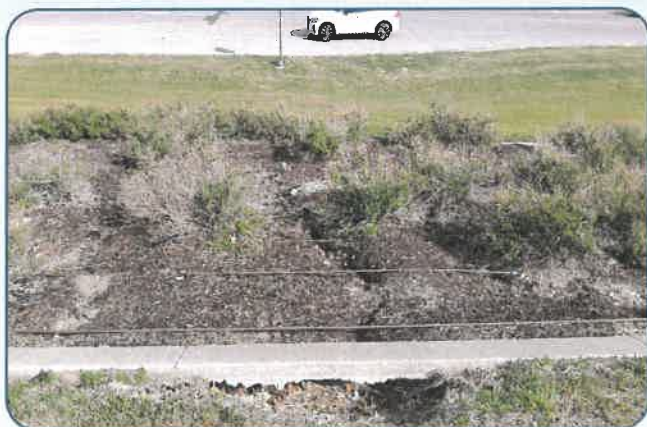
*Figure 39: SRT WB Landscape Bed Erosion East of Legacy Dr.*

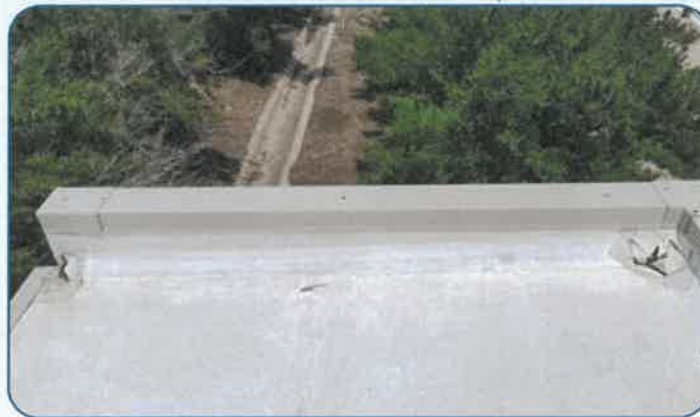
SRT Facilities were generally in good condition. Notable observations included: sealant failure, insect/water infiltration and roof deterioration/damage at the fiber huts (Figure 47), with roof corrosion at the restroom. The winter weather operations facilities had wall and fence degradation/damage issues (Figure 48).

*Figure 47: SRT MLG1 Fiber Hut Damaged Roof.*

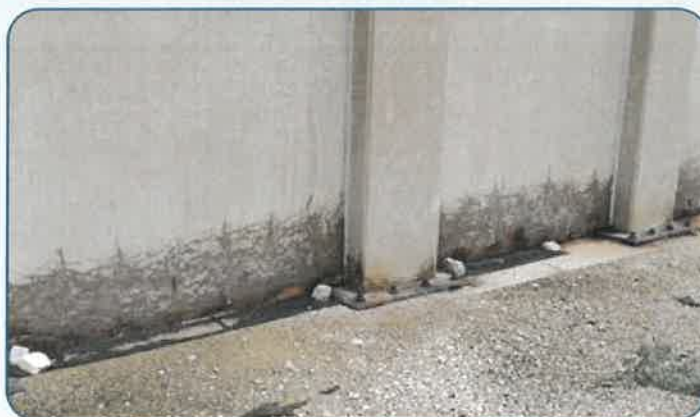
*Figure 48: SRT IH-35E Winter Weather Operations Facility Degraded Wall.*

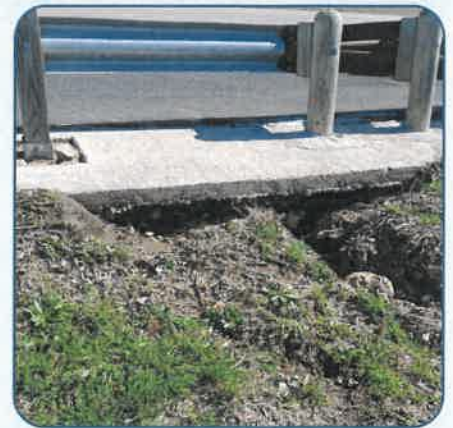
Figure 51: CTP SB MBGF Mow Strip Undermining North of Dutch Branch Rd.

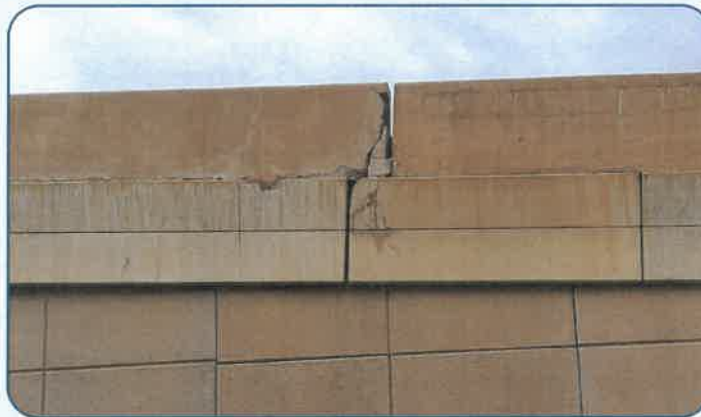
Two wall observations include cracking of the rail and wall coping (Figure 55) and vegetation overgrowth on the MSE wall (Figure 56).

Figure 55: CTP NB MSE Wall Rail and Coping Cracking North of SH 183.

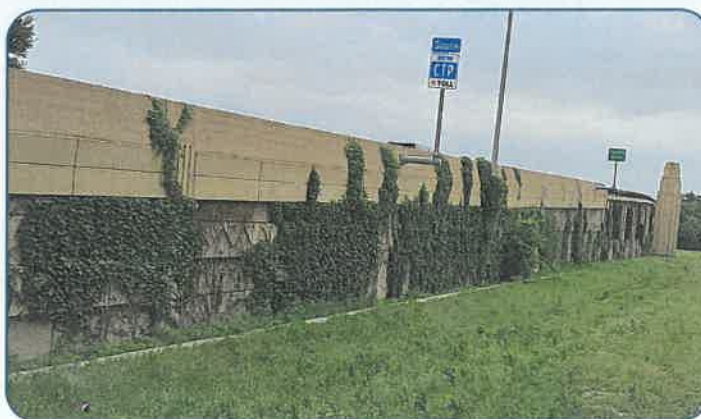
Figure 56: CTP SB MSE Wall Vegetation Overgrowth North of Clearfork Main St.

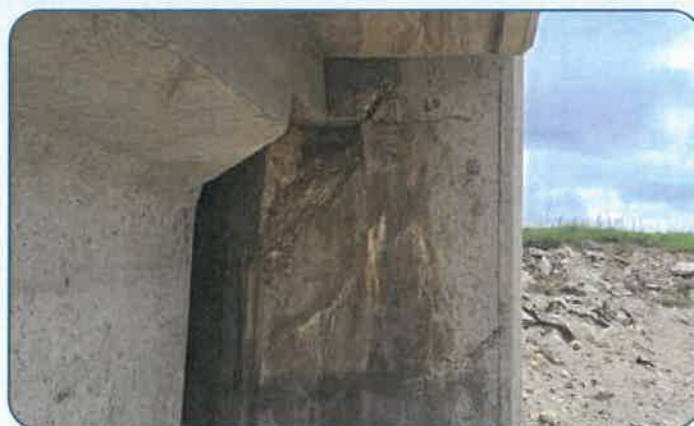
Figure 61: CTP SB Bridge Backwall Spalling North of CR 1016.

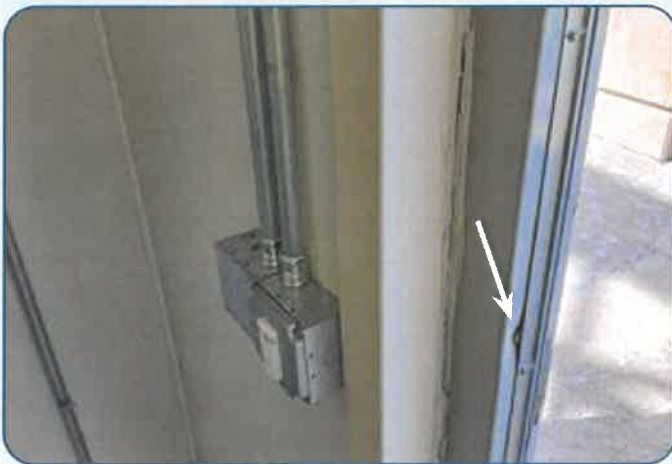
Minor observations include sealant deterioration (Figure 62), landing deterioration (Figure 63), insect infestation, and non-functioning GFCI test buttons again noted. More notable observations were an uninstalled smoke detector (Figure 64), and a failed surge suppressor at MLG2. At the restrooms, previous door lock and water heater issues were again observed. The winter weather operations facilities had wall and fence damage issues.

Figure 62: CTP MLG1 Fiber Hut Deteriorated Seal.

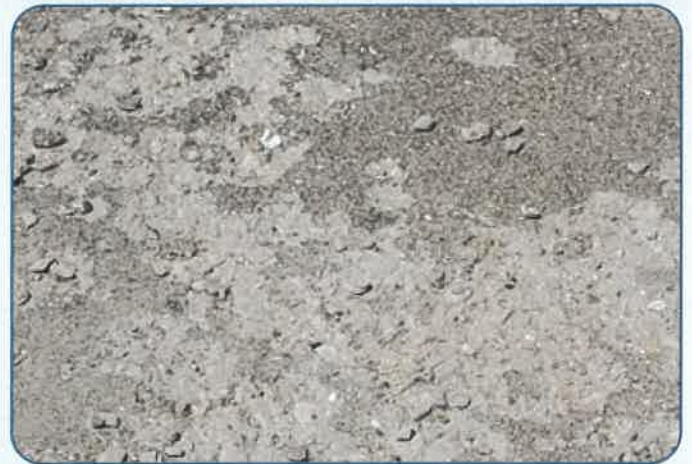
Figure 63: CTP MLG3 Deteriorated Landing.

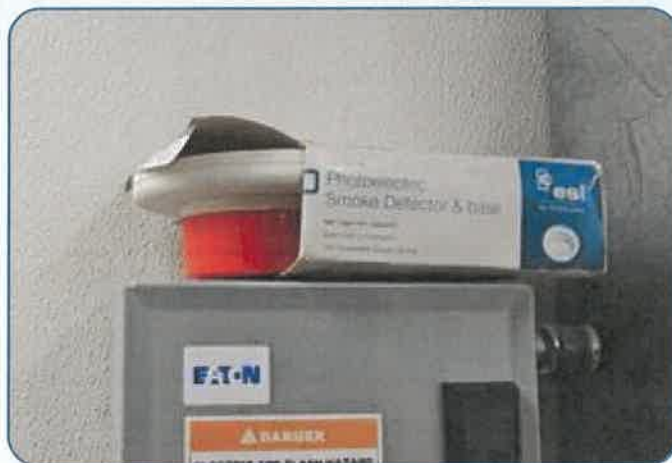
Figure 64: CTP MLG3 Non-Installed Smoke Detector.

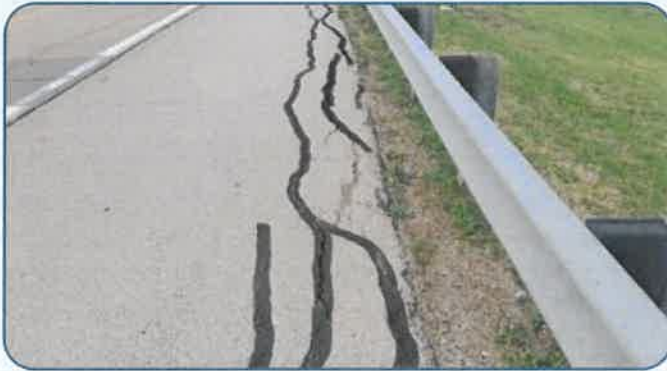
Minor observations included asphalt shoulder cracking (Figure 65) in addition to missing, damaged, and faded pavement markings (Figure 66).

Figure 65: MCLB WB Asphalt Shoulder Cracking.

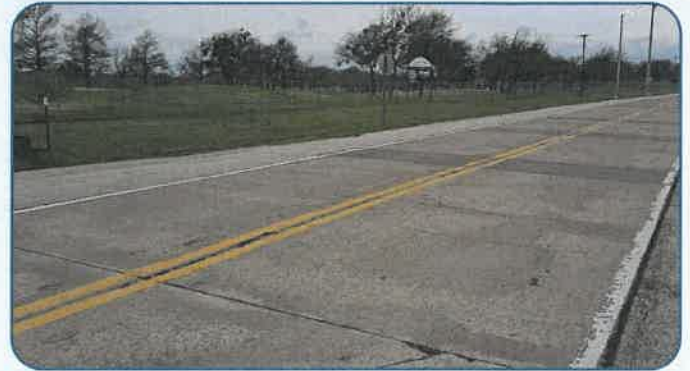
Figure 66: MCLB EB Damaged or Faded Pavement Markings at West Approach.

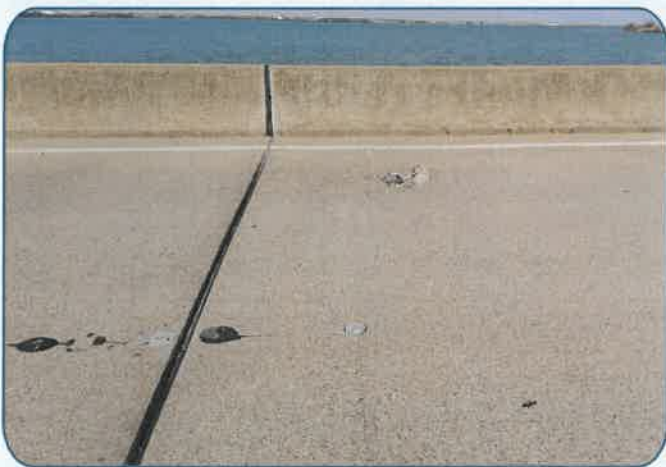
Our observations along the MCLB corridor included bridge deck spalling (Figure 67) and bridge rail spalling with localized areas of exposed reinforcement (Figure 68). Observations included spalling with exposed reinforcing steel on the bent cap (Figure 69) and at multiple locations on the concrete beams (Figure 70). Substructure observations included concrete cracking and spalling with exposed reinforcing steel on the abutment backwall (Figure 71).

Figure 67: MCLB Deck Spalling.

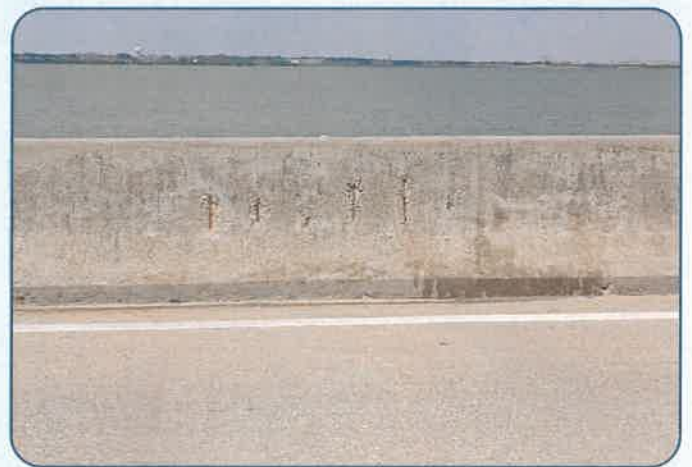
Figure 68: MCLB Concrete Rail Spalling with Exposed Reinforcement.

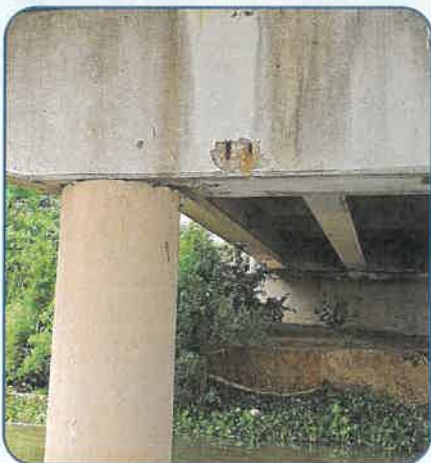
Figure 69: MCLB Bent Cap Spalling with Exposed Reinforcement.

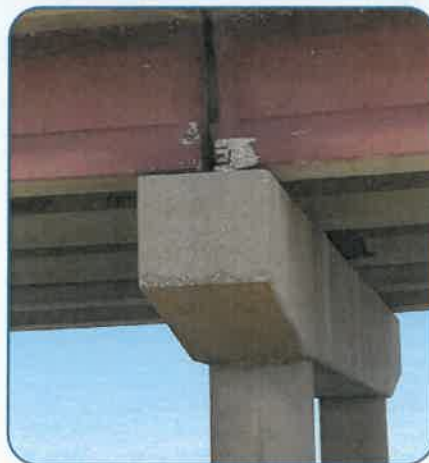
Figure 70: MCLB Concrete Bridge Beam Spalling with Exposed Reinforcement.

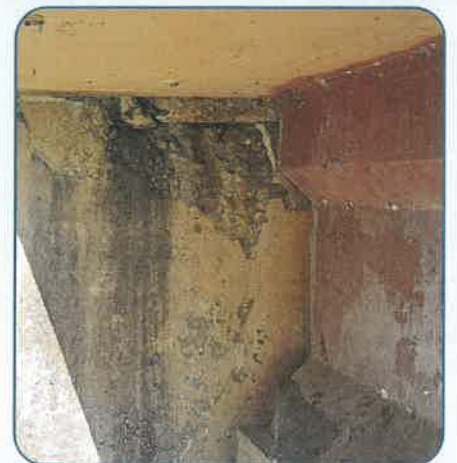
Figure 71: MCLB Abutment Backwall Cracking and Spalling.

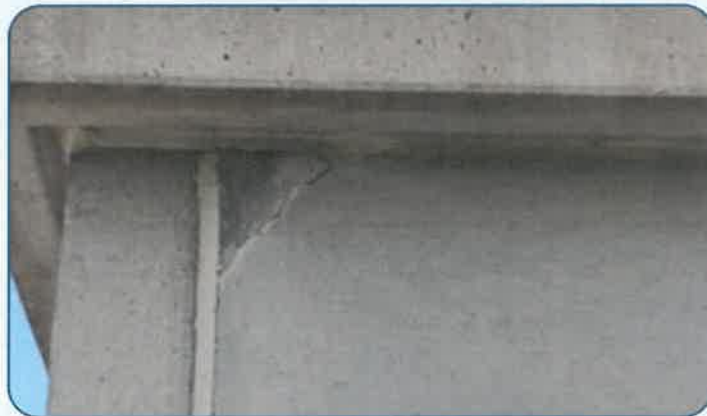
The MCLB facility is generally in good condition. Notable minor observations included: camera base plate not fully secured, exterior wear/cracking (Figure 72), exterior joint failures (Figure 73), and water infiltration.

*Figure 72: MCLB Fiber Hut Exterior Wear and Crack.*

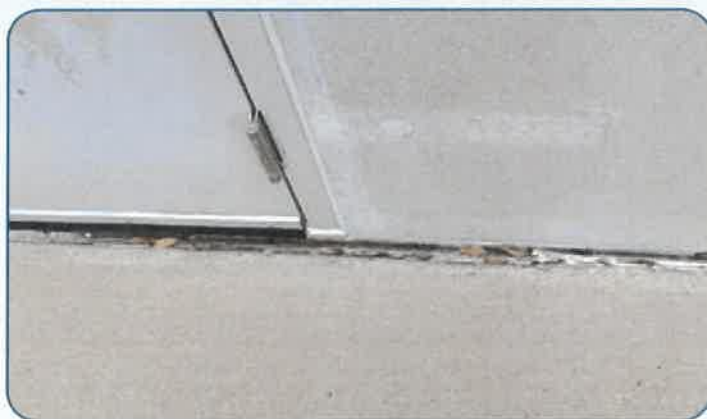
*Figure 73: MCLB Fiber Hut Exterior Joint Failure.*

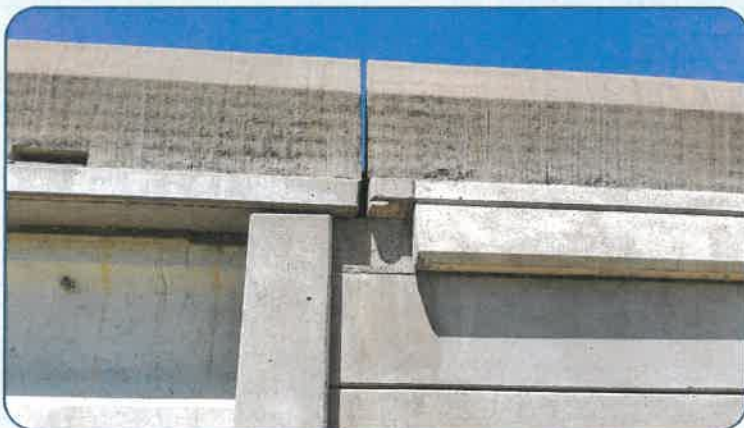
Figure 75: LLTB MSE Wall Coping Damage.

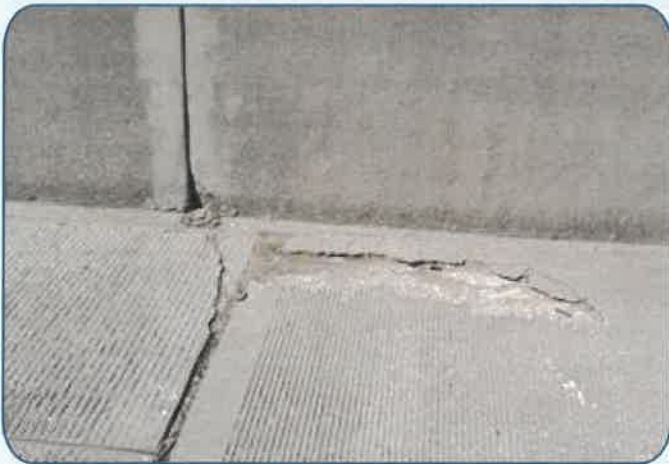
Our observations along the LLTB corridor included concrete spalling at the bridge approach slab (Figure 76) as well as on the deck overhang (Figure 77). A substructure observation included minor cracks on a bridge bent cap column (Figure 78). In addition, observations include disconnected or damaged pipes of the bridge collection runoff system (Figure 79).

Figure 76: LLTB Approach Slab Spalling.

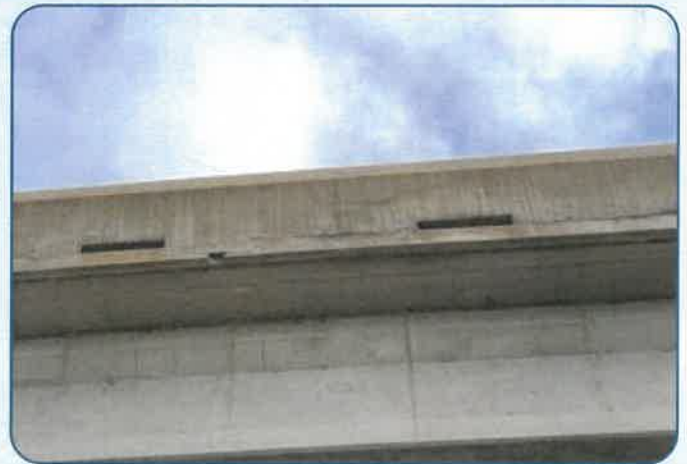
Figure 77: LLTB Deck Overhang Spalling.

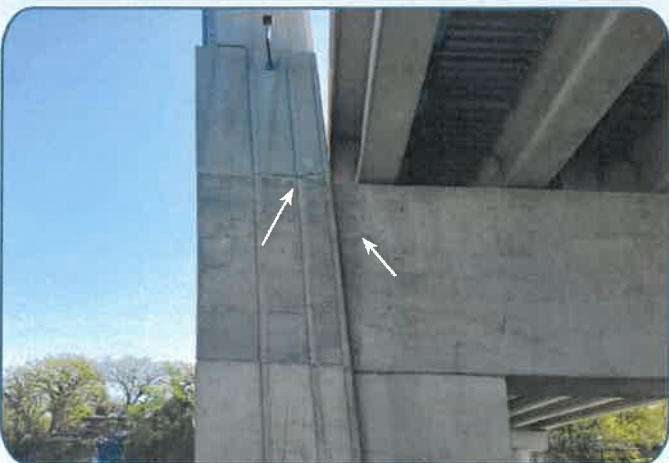
Figure 78: LLTB Minor Cap Column Cracking at the East End.

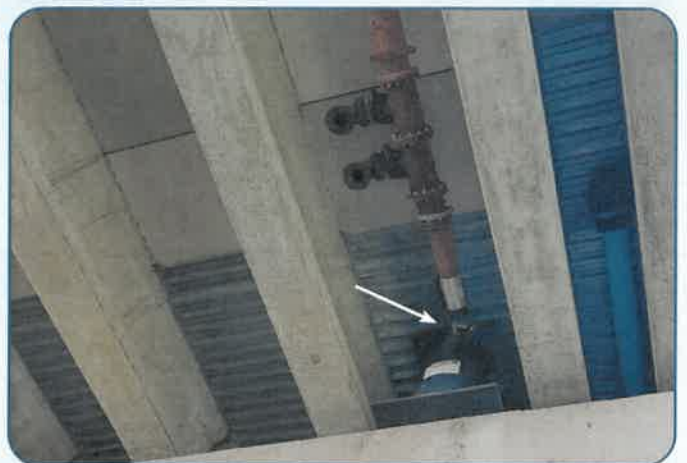
Figure 79: LLTB Damaged Pipe of Bridge Collection Runoff System.

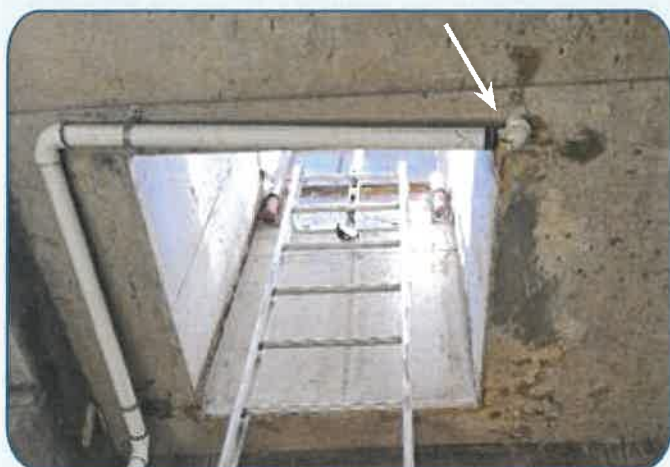
Electrical Room observations included: corroded electrical conduit/enclosures, a separated drain pipe (Figure 80), damaged concrete landing (Figure 81), and bird/insect infestation (Figure 82). At the fiber hut, roof degradation (Figure 83), water infiltration, and insect infestation (Figure 84) were observed.

Figure 80: LLTB Electrical Room Separated Drain Pipe.

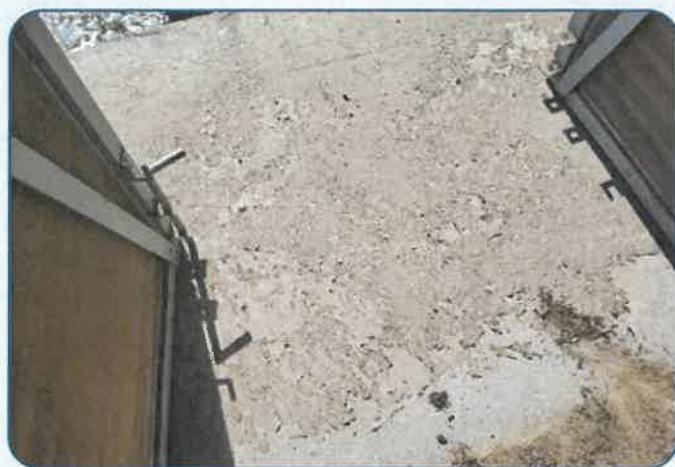
Figure 81: LLTB Damaged Concrete Landing.

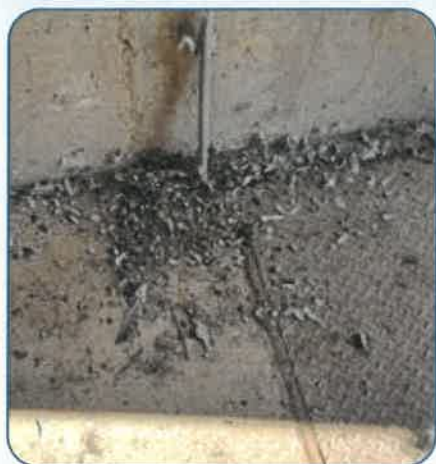
Figure 82: LLTB Electrical Room Bird-Insect Infestation.

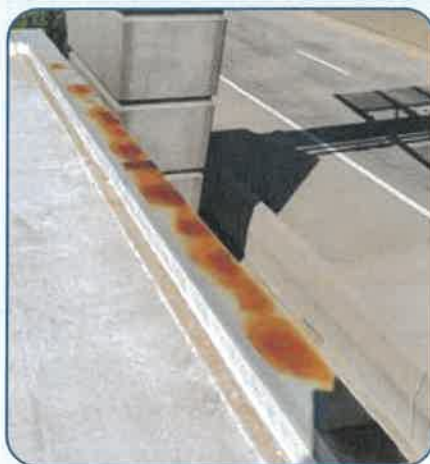
Figure 83: LLTB Fiber Hut Degraded Roof.

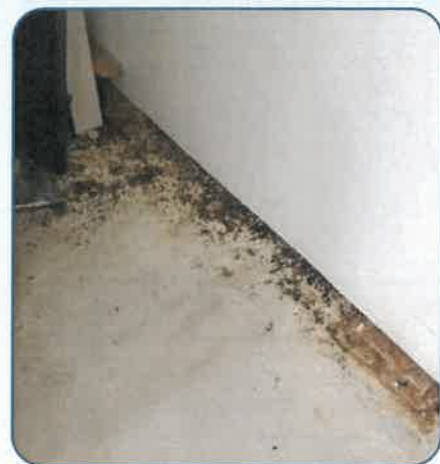
Figure 84: LLTB Fiber Hut Insect Infestation.

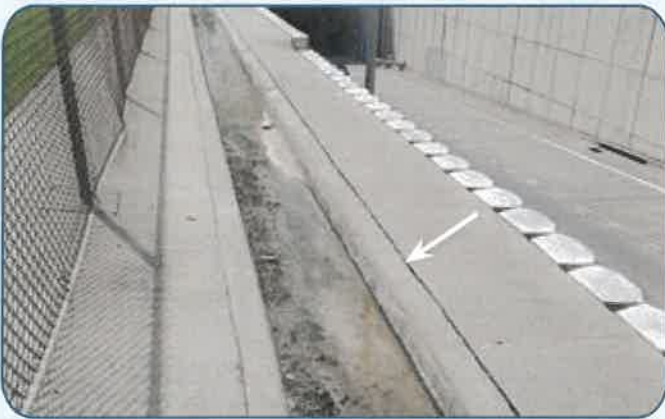
Our observations included an unsealed joint at a concrete flume adjacent to a retaining wall (Figure 85) and an isolated occurrence of a grate inlet obstructed by dirt and debris within the tunnel (Figure 86). Additional observations along the east side of the tunnel included localized erosion on the turf slope (Figure 87) and fence damage (Figure 88).

Figure 85: AATT Unsealed Concrete Flume at East End.

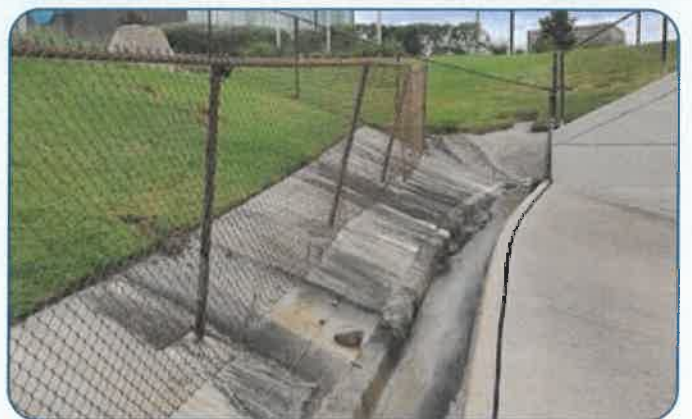
Figure 88: AATT Fence Damage.

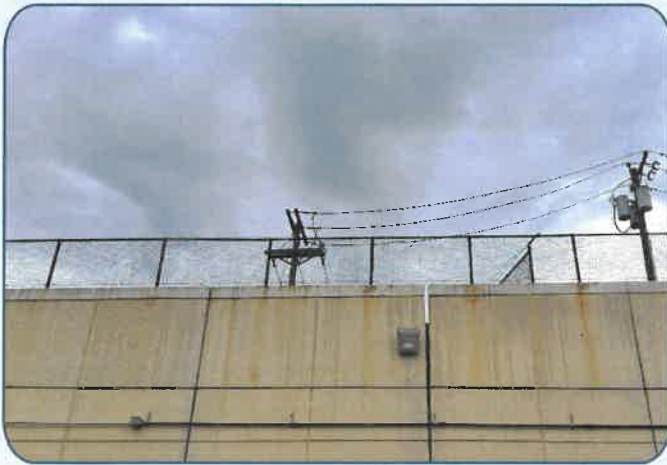
Our observations included instances where walls exhibited cracking, spalling as well as stained wall panels (Figures 89, 90). These observations alone cannot confirm nor negate current wall movement. NTTA, the MMC and the GEC conduct regular coordination meetings where NTTA has confirmed that further evaluation of these walls is being conducted.

Figure 89: AATT Cracking, Spalling and Stained Wall Panels at West Side.

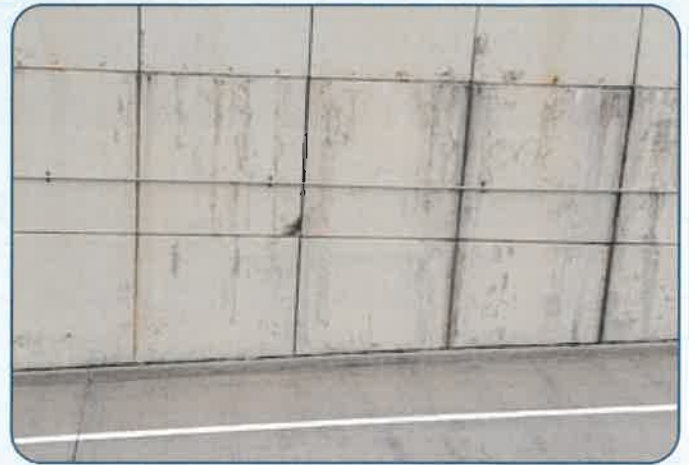
Figure 90: AATT Cracking, Spalling and Stained Wall Panels at East Side.

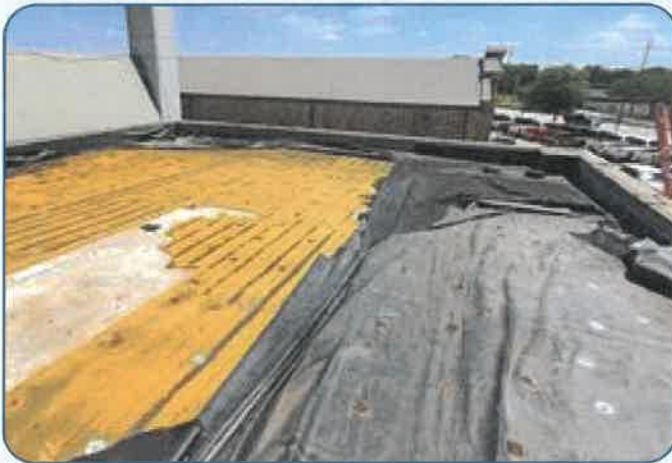
Figure 91: AATT Gantry Deteriorated Roof.

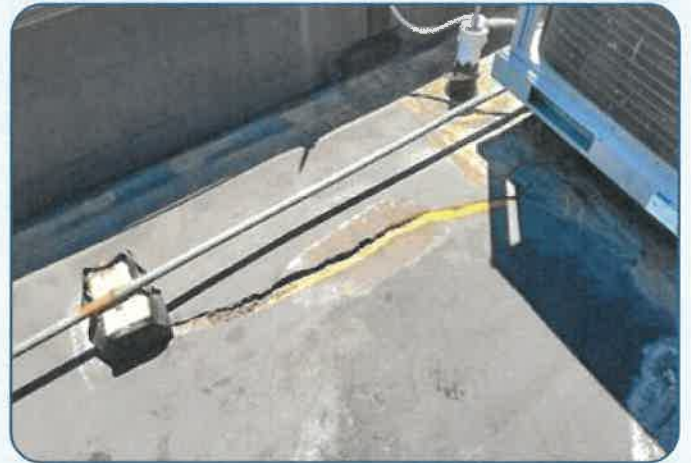
Figure 92: AATT Gantry Electrical Room Damaged Roof.

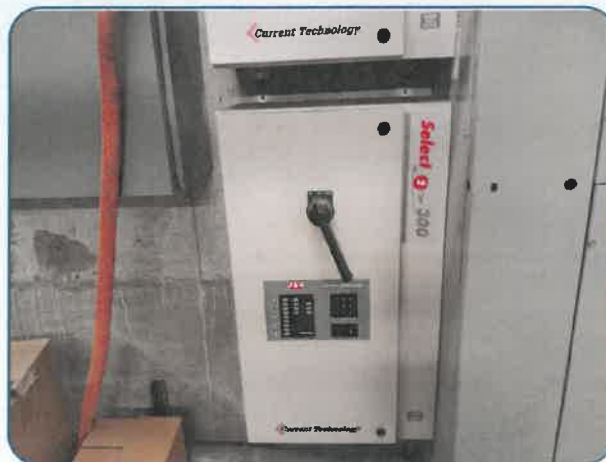
The tunnel fan replacement project was still in progress at the time of inspection, as well as a project to repair/replace the fire alarm system. The roofs for the toll gantry and associated electrical room have further deteriorated since the previous inspection (Figures 91, 92). In the main electrical room, a surge suppression device failure was again noted (Figure 93).

Figure 93: AATT Main Electrical Room Failed Surge Suppressor.

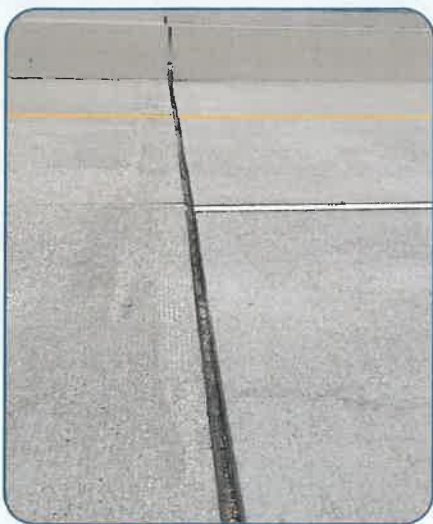
The GEC's inspection identified recurring observations of dirt and debris accumulation within bridge approach joints (Figure 101), deformed bearing pads (Figure 102), and debris and sediment accumulation within bridge-class box culverts (Figure 103). If left unaddressed, these conditions can reduce drainage efficiency, impede hydraulic performance, and contribute to the long-term deterioration of bridge components.

Figure 101: 360T Bridge Relief Joint with Debris North of N. Holland Rd.

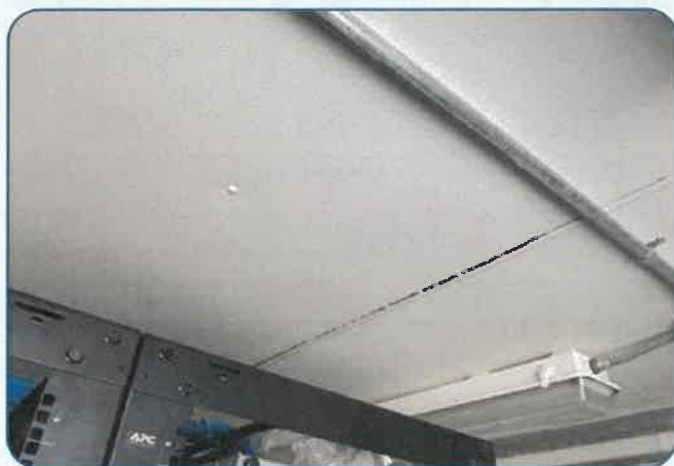
Our observations include minor ceiling damage (Figure 104), exterior wall/door issues (Figure 105), water infiltration, incomplete electrical panelboard schedules, electrical GFCI receptacle issues (Figure 106), insect infestation (Figure 107), and winter weather operations facility corrosion.

Figure 104: 360T MLG14 Fiber Hut Damaged Ceiling.

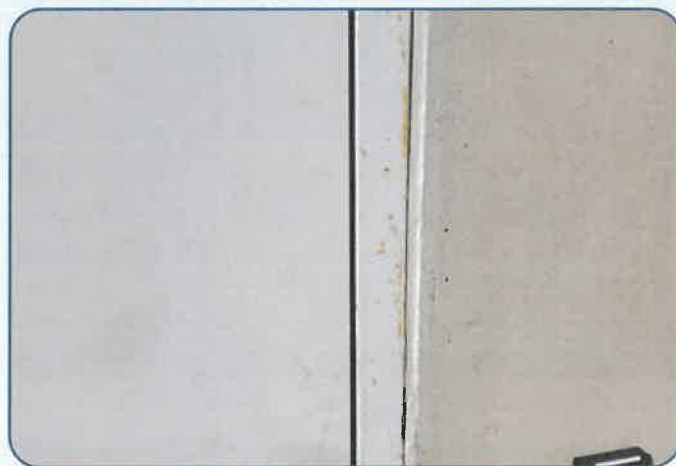
Figure 105: 360T MLG14 Fiber Hut Degraded Door Frame.

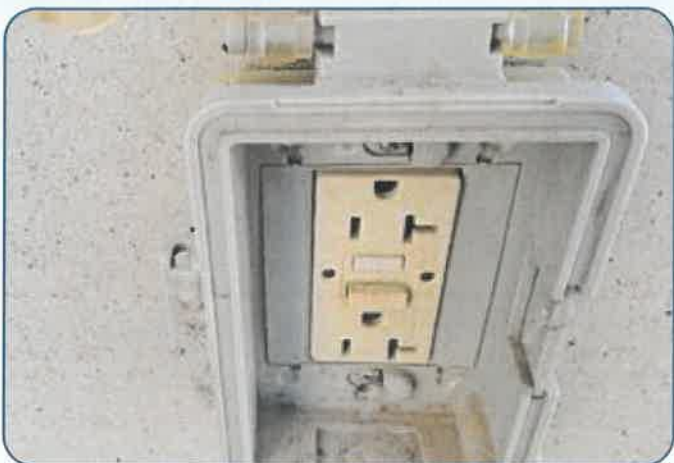
Figure 106: 360T MLG14 Failed Electrical Receptacle.

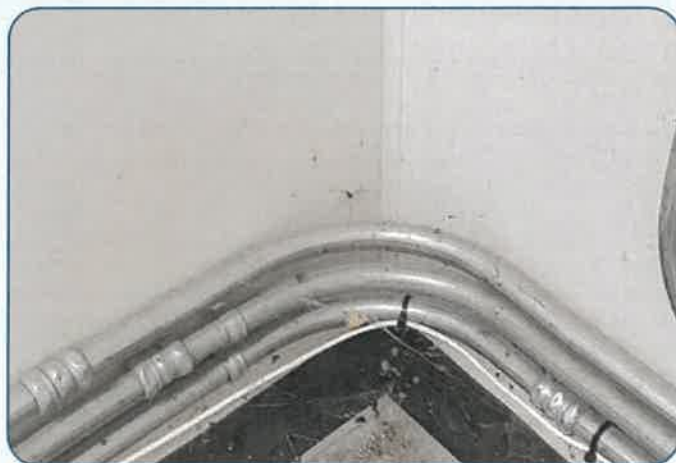
Figure 107: 360T Fiber Hut 1 Insect Infestation.

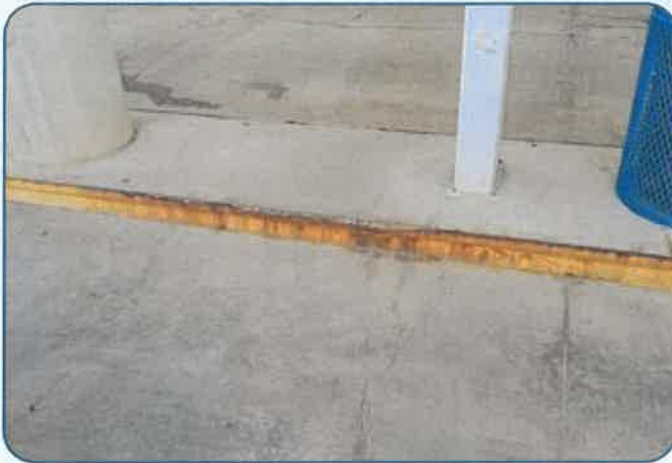
At the Frisco Operations Center, fuel island corrosion was observed (Figure 114), along with a damaged surge suppressor, an improperly functioning eye wash, roof damage (Figure 115), a HVAC unit leak (Figure 116), fire egress obstructions in the warehouse (Figure 117), and expired fire extinguishers.

Figure 114: FOC Fuel Island Corrosion.

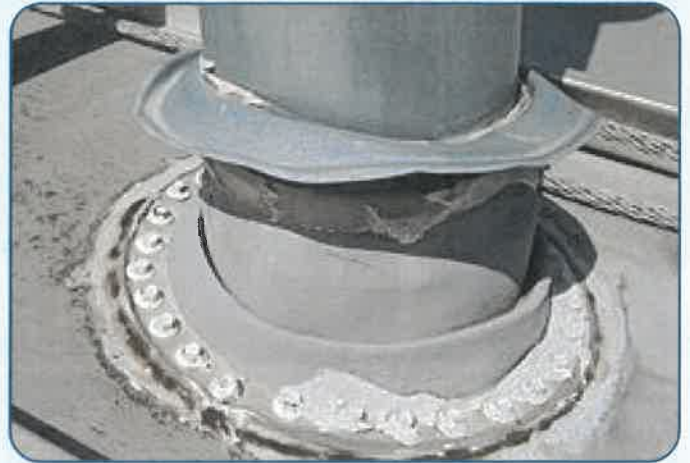
Figure 115: FOC Roof Failed Rain Hood.

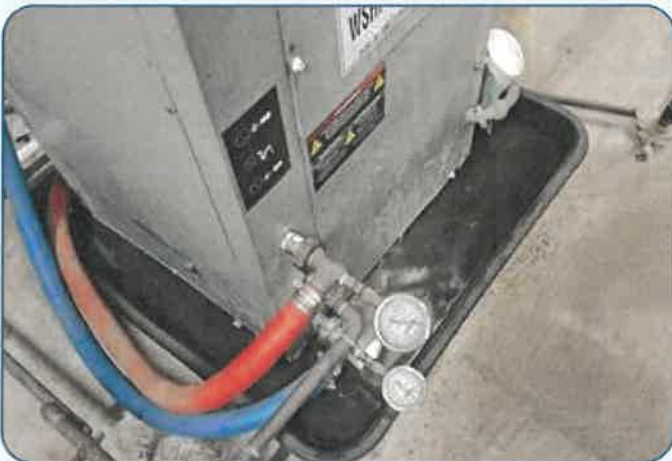
Figure 116: FOC HVAC Unit Leak.

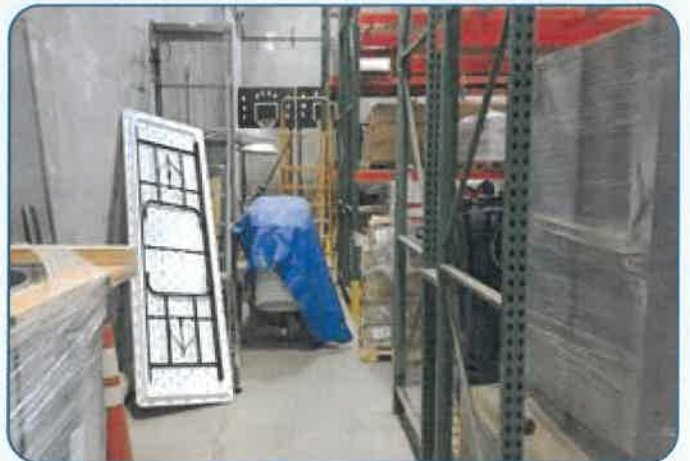
Figure 117: FOC Warehouse Blocked Egress Route.

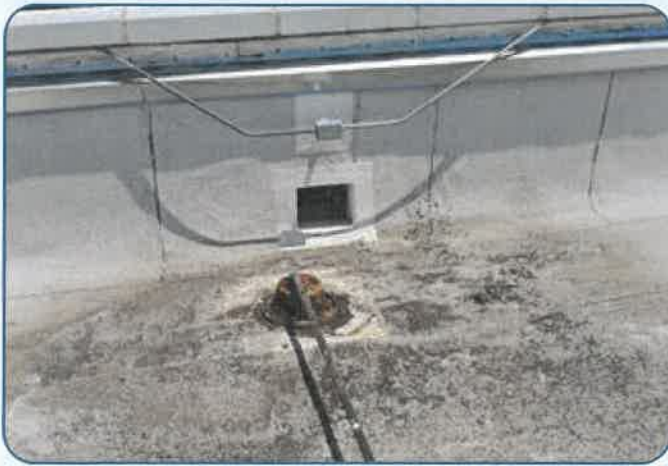
Figure 118: GE 5900 Deteriorated Roof.

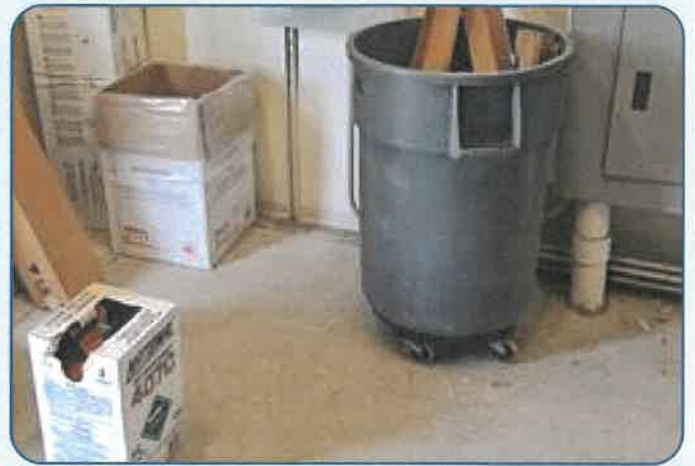
Notable observations at the Gleneagles 5910 Office Center included: ceiling issues, minor plumbing items and improper storage in electrical rooms (Figure 119). The GEC understands that the data center project will address ceiling issues in the data center.

Figure 119: GE 5910 Electrical Room Improper Storage.
