ANNUAL INSPECTION REPORT SYSTEM

FISCAL YEAR 2016

Prepared by Atkins North America, Inc.
General Engineering Consultant

September 2016

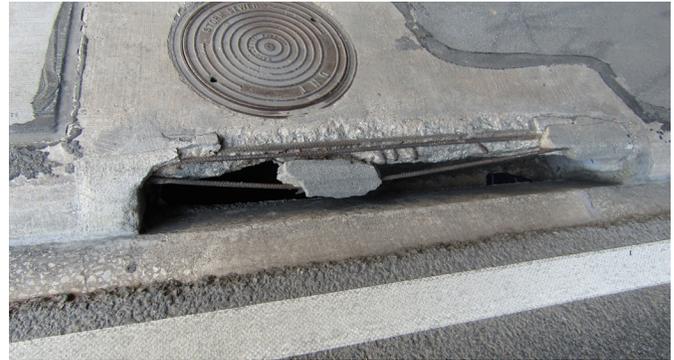
Figure 2: Spalling Main Lane Inlet (S. of Forest Lane)

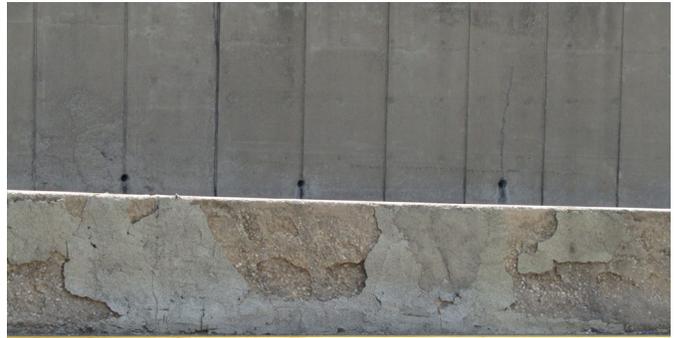
Figure 3: Spalling Center Concrete Barrier (S. of Meaders Lane)

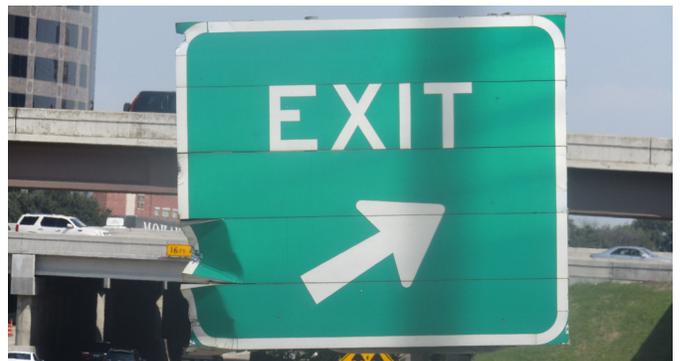
Figure 4: Damaged Exit Sign (S. of IH-635 in NB lanes)

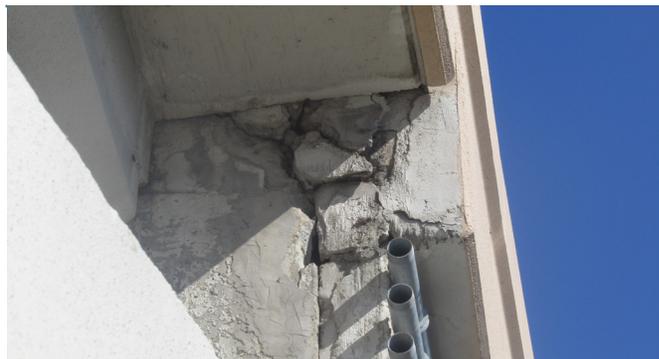
Cracking in abutment backwall was observed at various locations throughout the tollway.

Figure 5: Abutment Backwall Cracking at Alpha Road

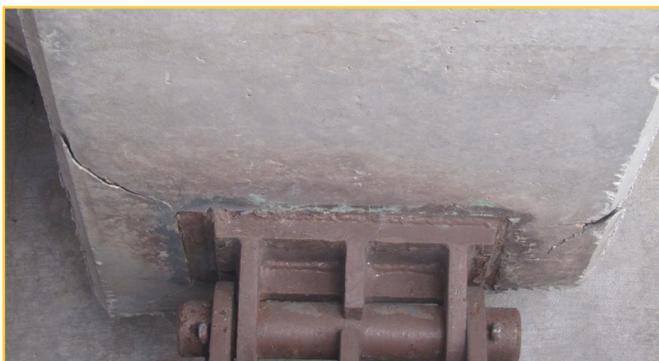
Figure 6: Beam End Cracking at Forest Lane

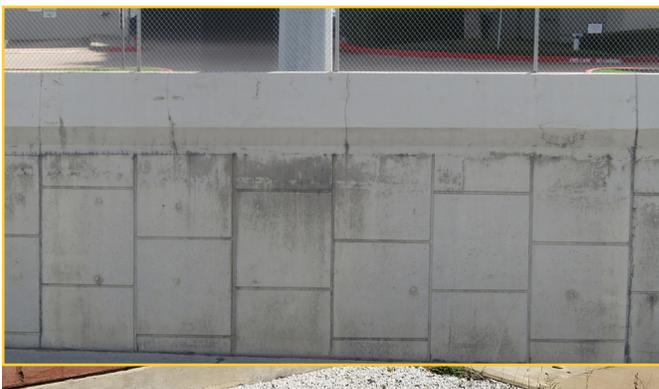
Retaining wall panels and coping were observed with minor cracking and spalling at various locations throughout the tollway.

Figure 7: Retaining Wall between Arapaho Road and Beltline Road

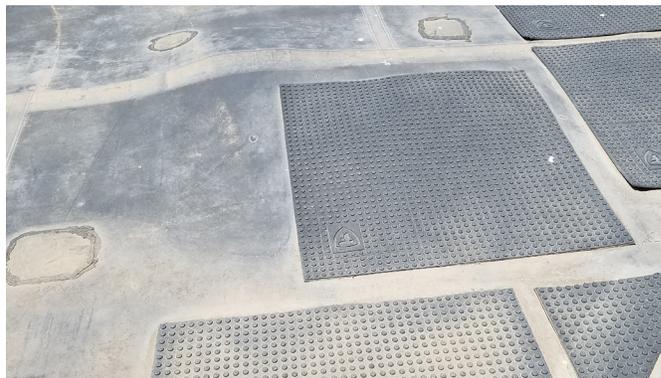
At MLP 4, located near Eldorado Parkway, observations include leaks causing water damage on ceilings and at windows, rust on exterior railings, and uneven sections of roof indicating possible water damage.

Figure 8: MLP4 Roof Bubbling

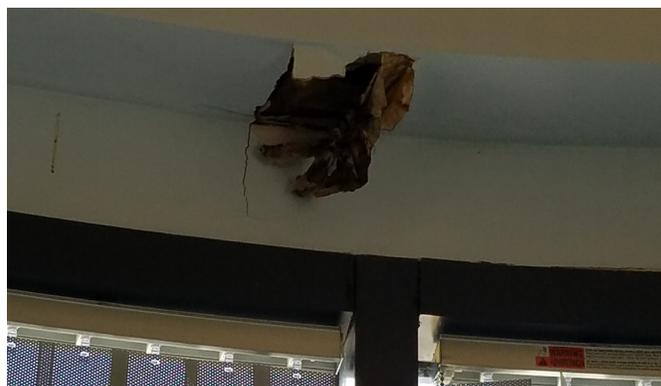
Figure 9: MLP4 Ceiling Damage

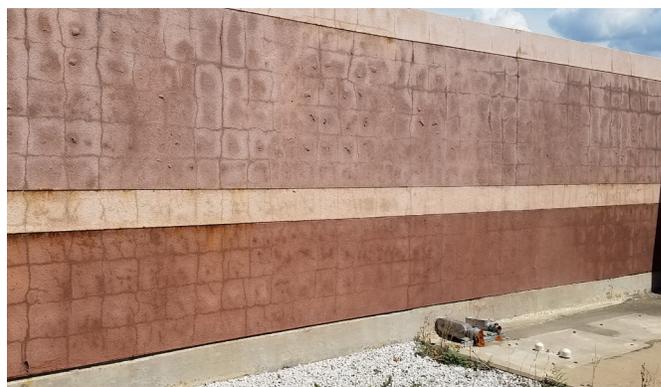
At MLP 3, located near Parker Road, several indications on ceiling of roof or mechanical leaks, several stains on ceilings of possible roof or mechanical leaks, moisture intrusion in the Concrete Masonry Unit (CMU) wall is causing cracking and deterioration of finishes.

Figure 10: MLP3 Cracking and Deterioration of Wall Finishes

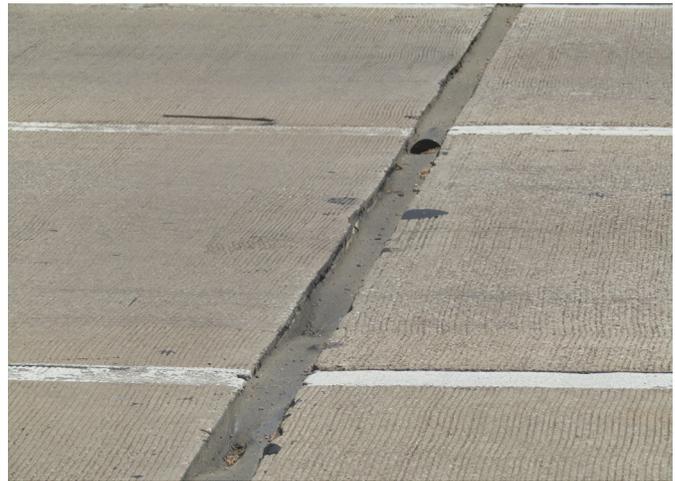
Figure 11: Faded Pavement Markings and Aging Expansion Joint (PGBT WB mainlanes at SH 114)

Aging sealed expansion joints noted at a few bridges including: SH 114, Royal Lane, Brand Road, and Spring Creek.

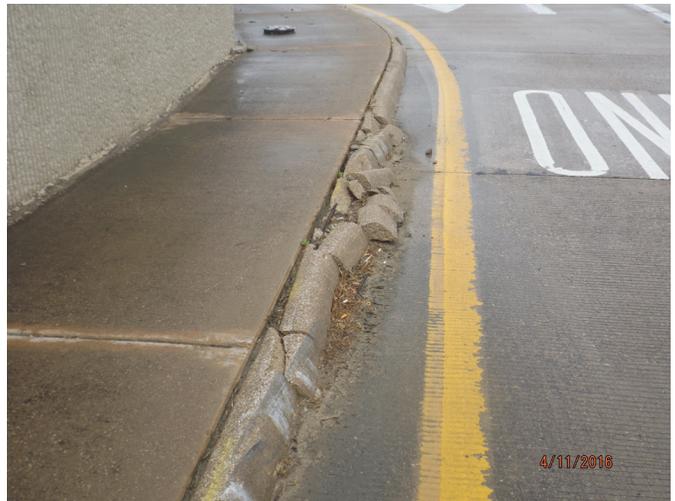
Figure 12: Curb Damage (Turnaround at Gateway Drive)

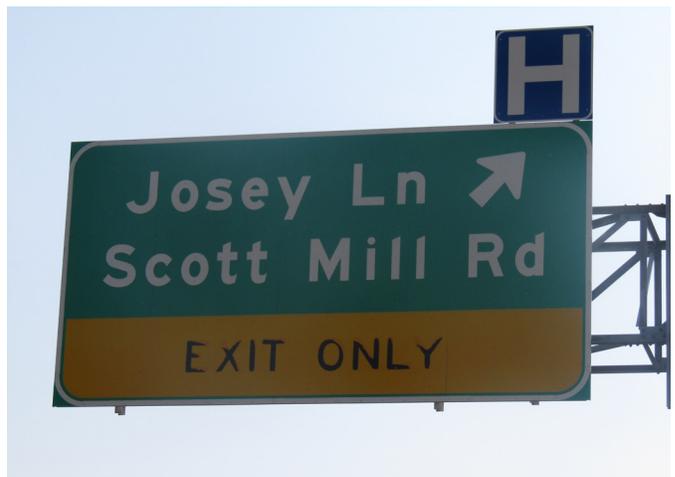
Figure 13: Overhead Sign Faded and Deterioration of Lettering (PGBT NB and Josey Lane exit)

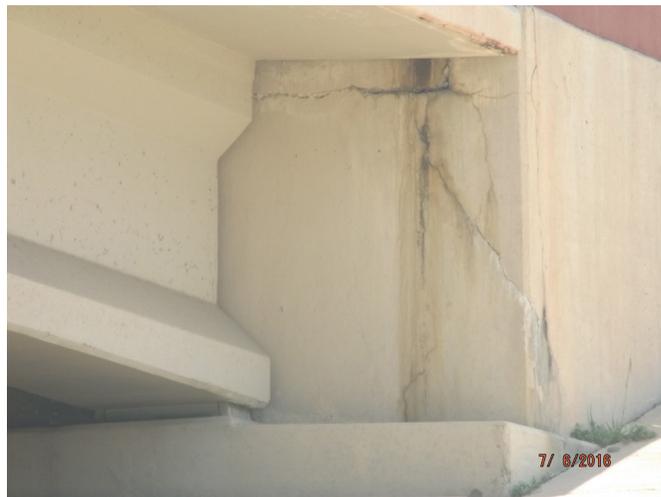
Cracking abutment backwalls were observed at several bridges throughout the tollway. The cracking appears to be aesthetic in nature, not affecting the structural integrity of the bridge.

Figure 14: Bridge Backwall Cracking (SB lanes at Jupiter Road bridge)

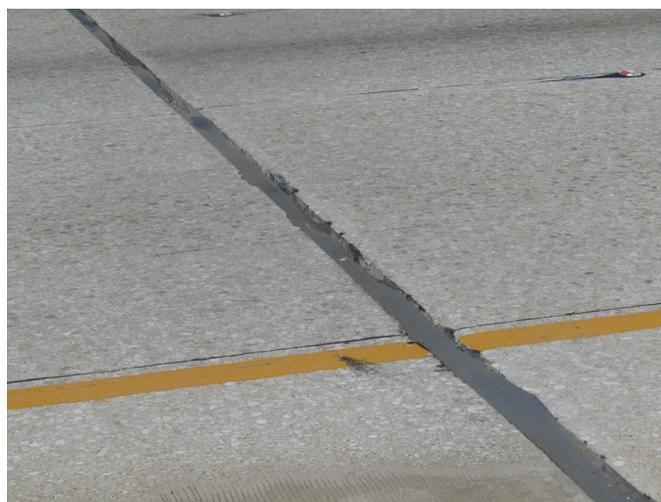
Figure 15: Expansion Joint (SB main lanes at SH114 bridge)

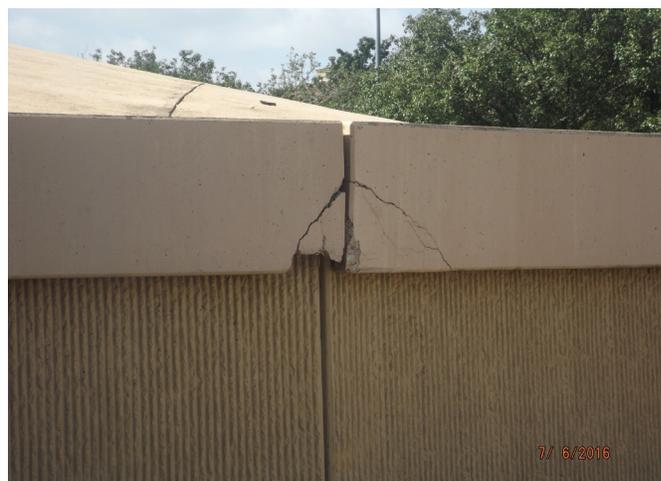
Figure 16: Cracked Coping (SW corner of Renner Road and PGBT bridge)

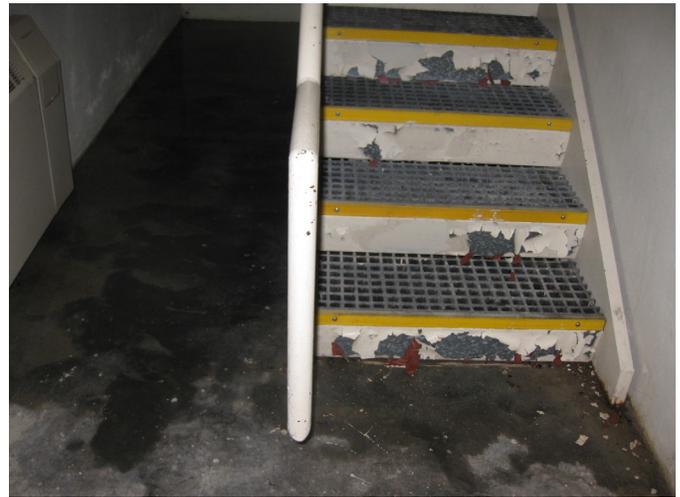
Figure 17: MLP 6 Stairs

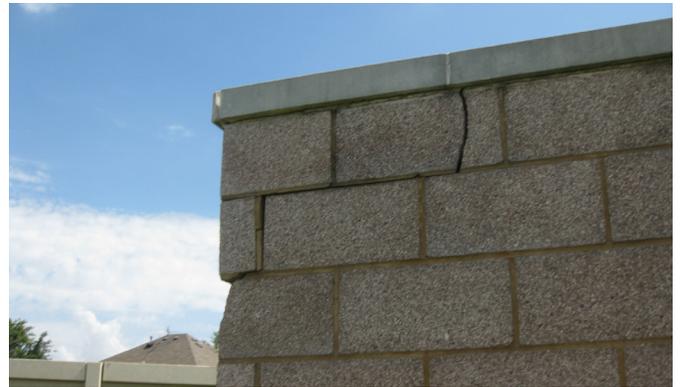
Figure 18: MLP 8 Corner Masonry

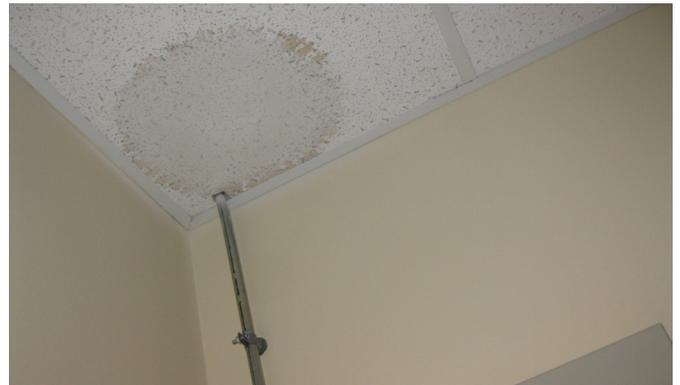
Figure 19: MLP 7 Ceiling Stain

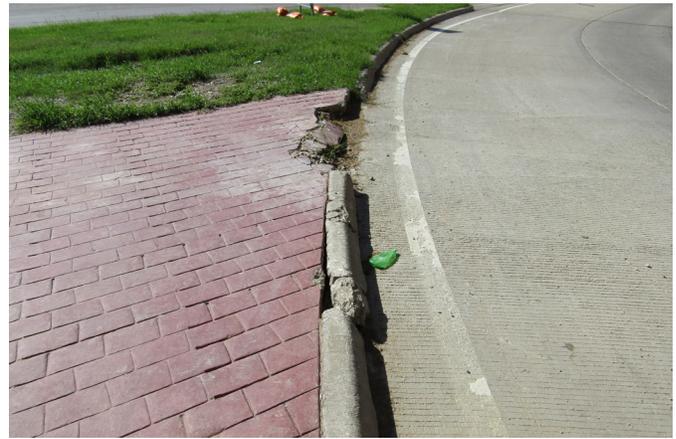
Curb damage was observed on the frontage roads and cross streets median islands.

Figure 21: Missing/Spalling Curb (EB Turnaround at Lake Vista Drive)

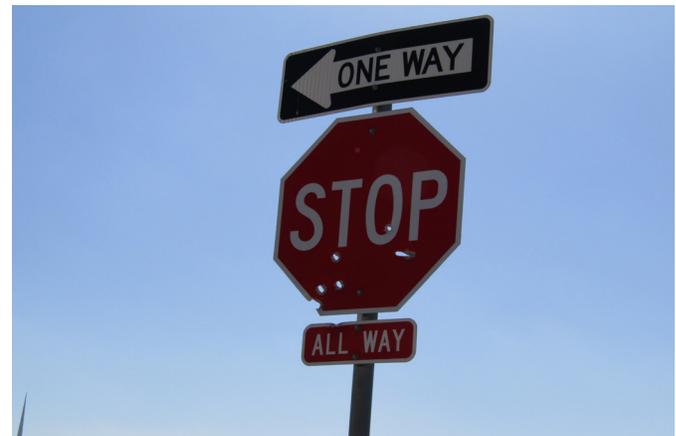
Figure 22: Damaged Sign at Huffines Boulevard

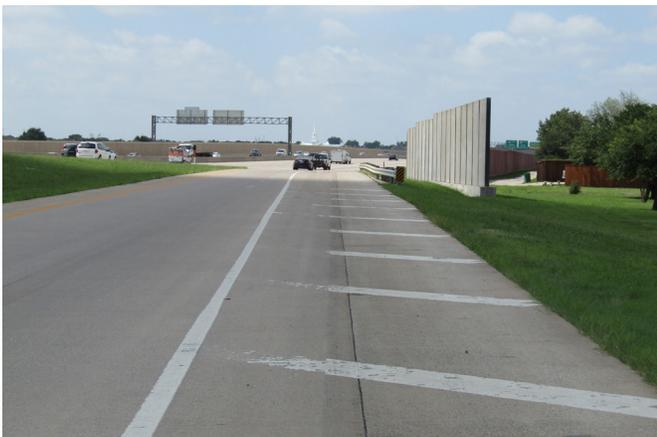
Figure 20: Faded Pavement Markings (Hebron Parkway entrance ramp)

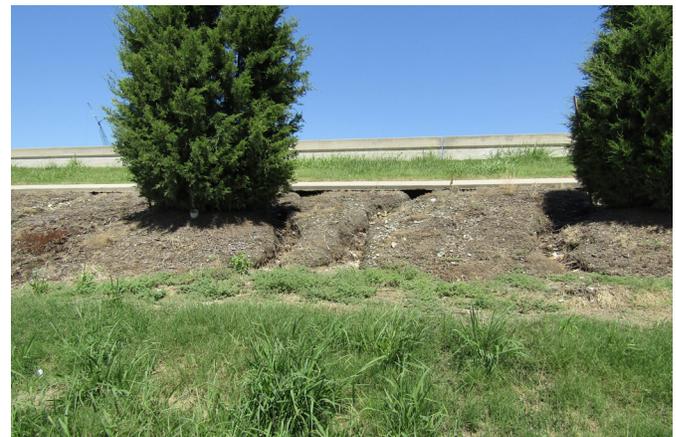
Erosion was noted in various areas throughout the corridor in landscaped areas.

Figure 23: Erosion in Landscape Areas (NB mainlanes at Legacy Drive)

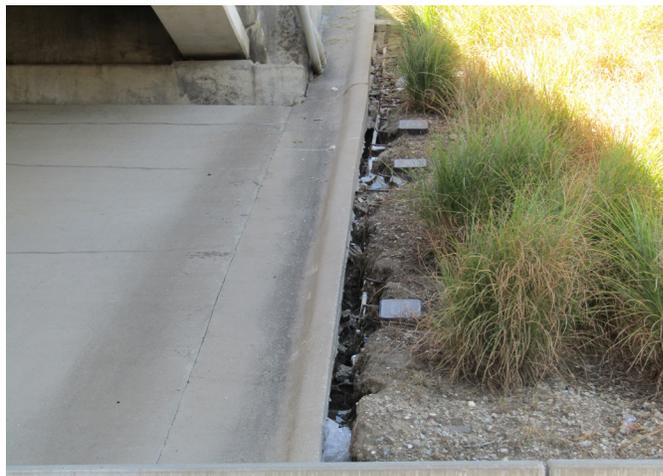
Erosion was noted near columns and abutment riprap at several bridges throughout the System. Water levels were high during this year's inspections.

Figure 24: Erosion near Bridge Abutment at Josey Lane

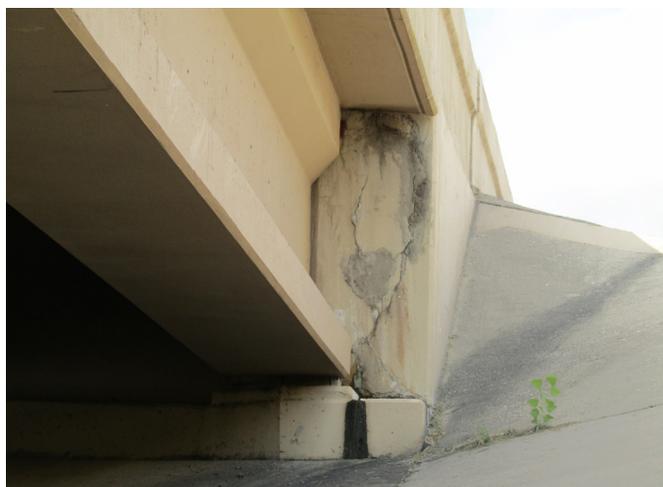
Abutment backwall cracking was observed at several locations throughout the corridor. The cracking appears to be aesthetic in nature, not affecting the structural integrity of the bridge.

Figure 25: Bridge Backwall Cracking, West of Ridgemont Drive

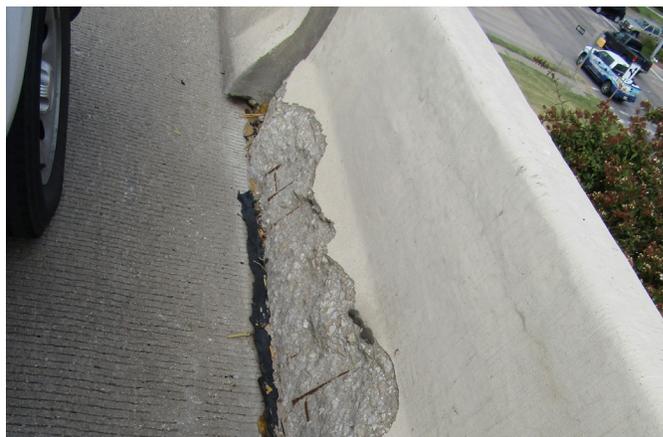
Figure 26: Concrete Barrier Spalling (SB on MacArthur Blvd. Bridge)

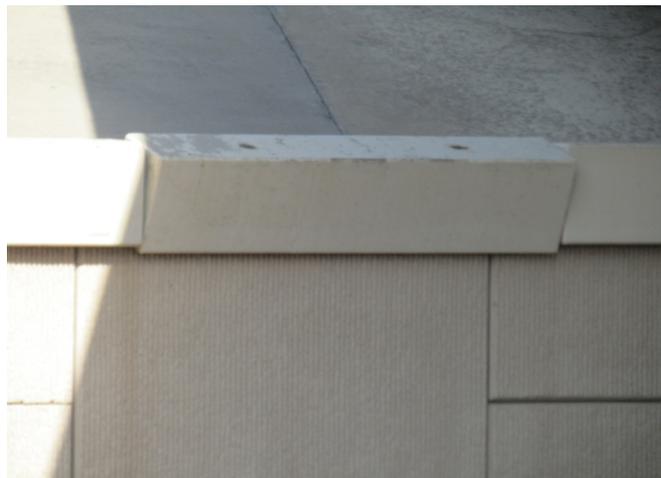
Figure 27: Coping out of Position (Denton Tap Road, EB turnaround)

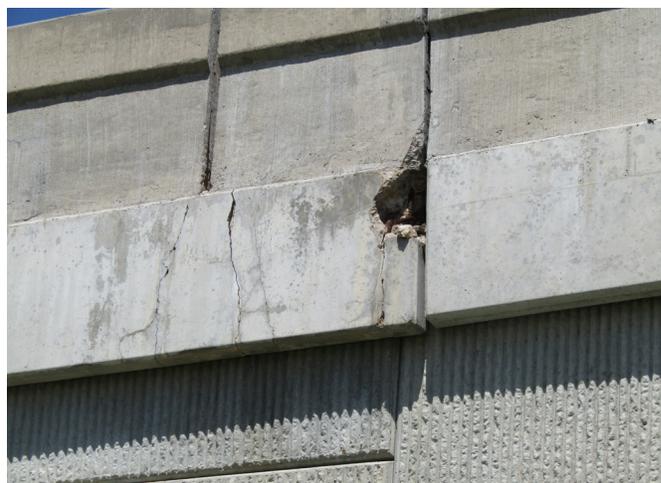
Figure 28: Coping Cracked and Spalling (SB lanes, bridge at Spring Creek Pkwy)

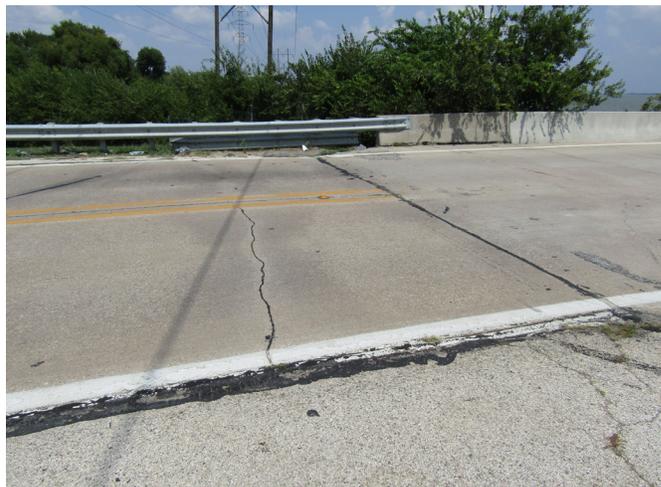
Figure 29: Faded Pavement Markings at Bridge & Road Transition (east end of bridge)

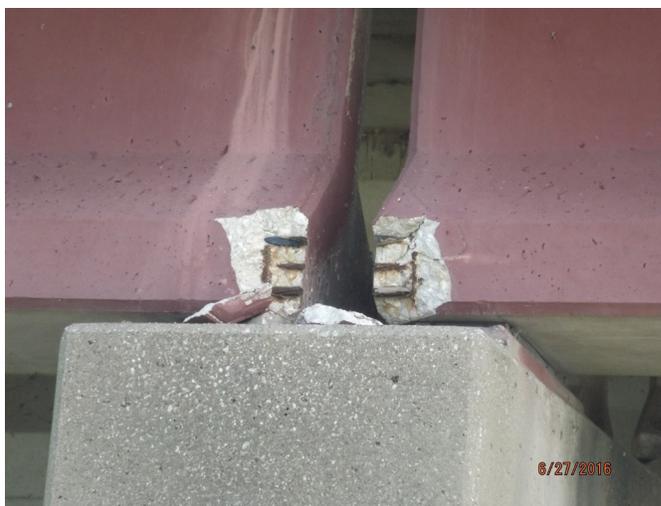
Figure 30: Bridge Beams Spalling in Multiple Locations

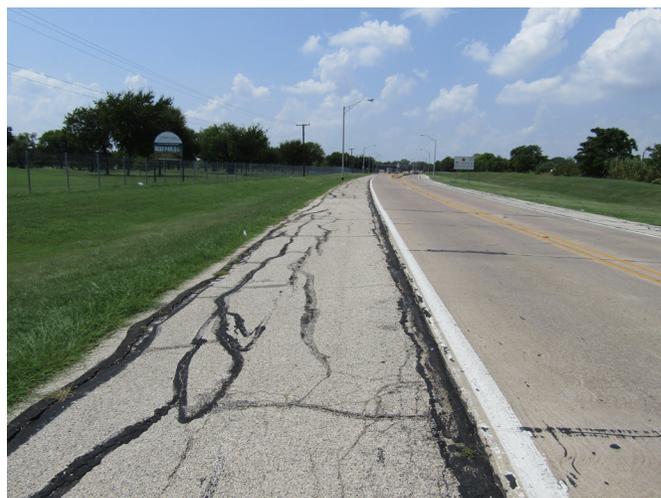
The asphalt shoulders on both approaches to the bridge have degraded causing cracking and spalling.

Figure 31: Shoulder Deterioration at Multiple Locations

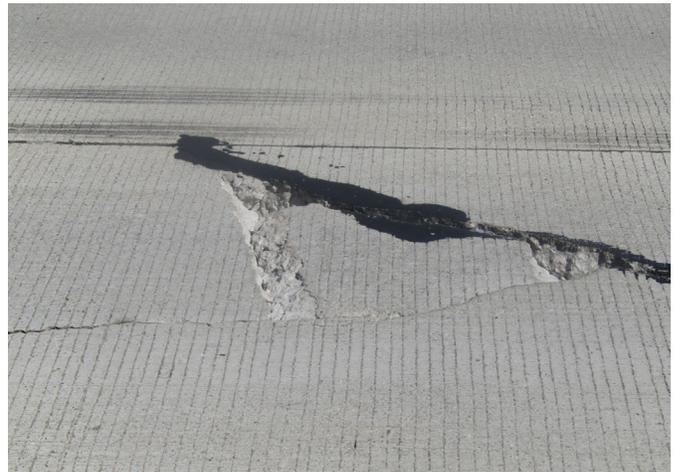
Figure 32: Mainlane Concrete Damage (EB lanes at east end of bridge)

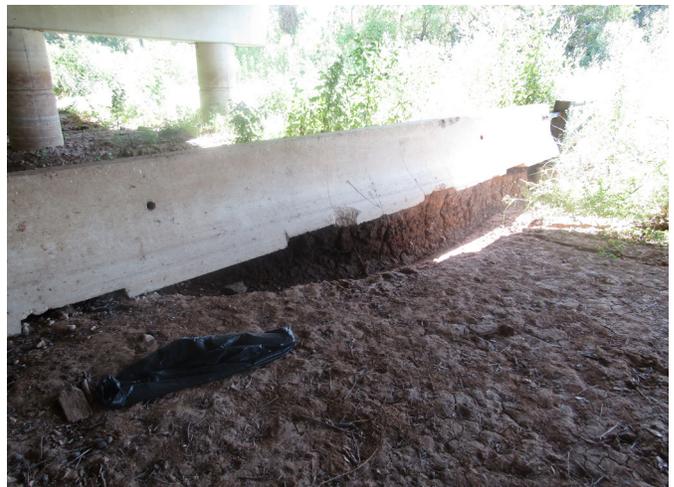
Figure 33: Erosion under Concrete Barrier (west end of bridge under main lanes)

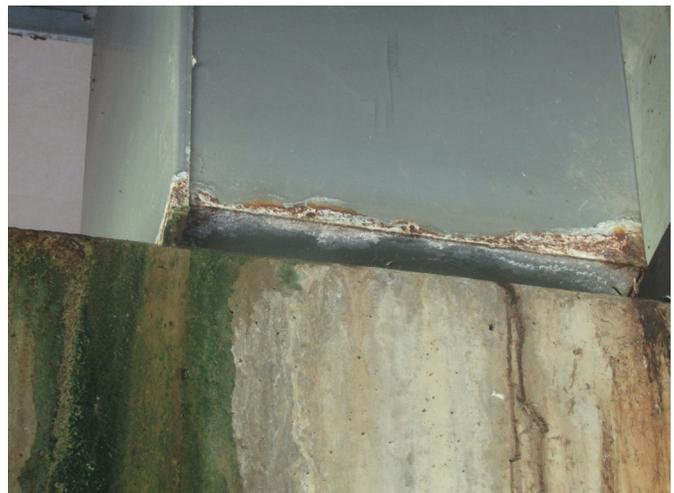
Water levels high during this year's inspection. On the west end, a water filtration box has corroded and is leaking.

Figure 34: Leaking Filtration Box (west end of bridge under main lanes)

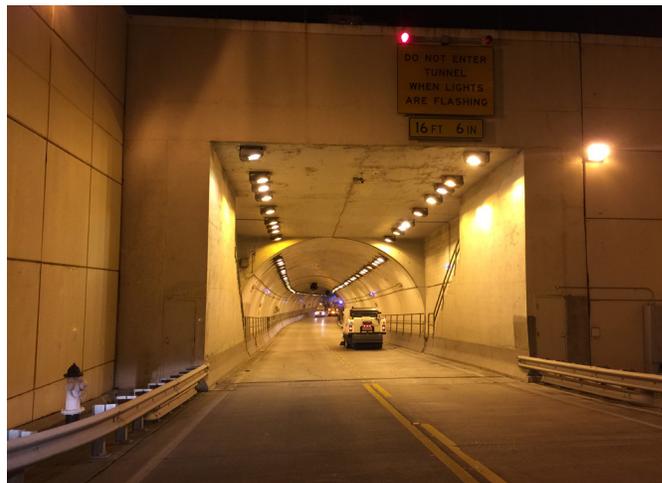
Figure 35: Faded Pavement Markings at East End of Tunnel

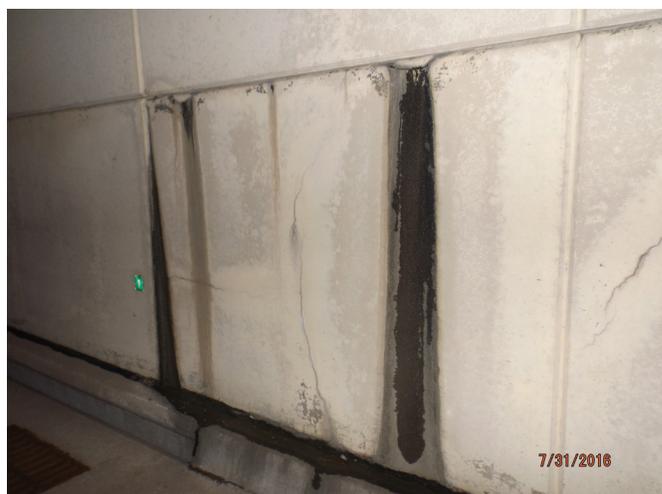
Wall observations include water seepage through walls, and vegetation growth and leaking joints between panels. Water was observed seeping between panels on both walls on the west end and the north wall on the east end. Water is also seeping through the bricks on the south wall on the east end. On the west end seals between panels are missing from the north side wall.

Figure 36: Water Seeping between Panel Wall at West End of Tunnel

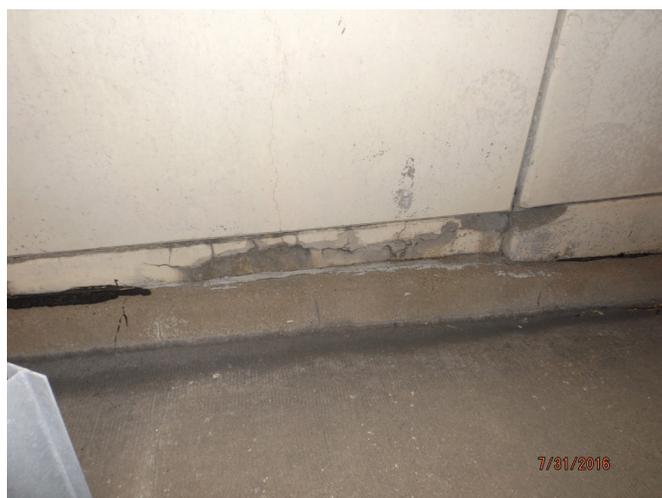
Figure 37: Coping of Wall Panels at West End of Tunnel
