ATKINS

ANNUAL INSPECTION REPORT SYSTEM

Fiscal Year 2020

September 30, 2020

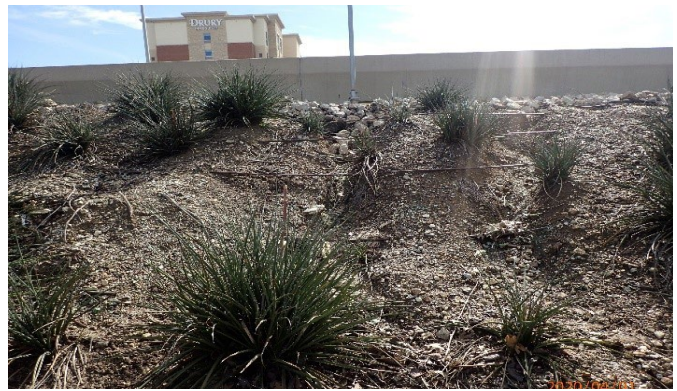
Minor barrier spalling was observed at various locations throughout the corridor as illustrated in Figure 2. There were multiple areas of erosion under bridges and landscape areas as illustrated in Figure 3.

Figure 3: DNT planting bed erosion at Gaylord Parkway

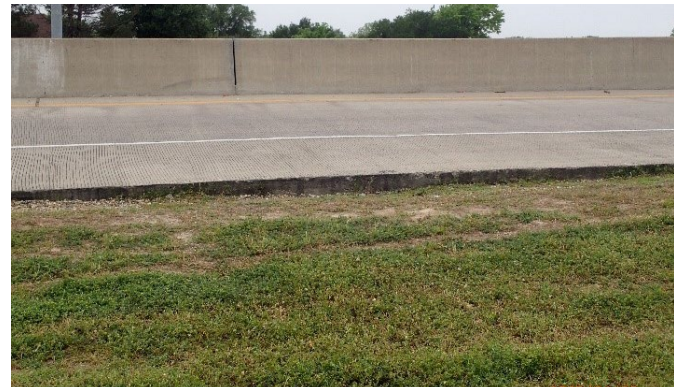
There are multiple isolated locations of pavement edge drop offs as illustrated in Figure 4. Also noted were areas of curb spalling as illustrated in Figure 5. Delineation was missing on the metal beam guard fence in one location as illustrated in Figure 6.

Figure 4: DNT pavement edge dropoff SB to WB IH-635

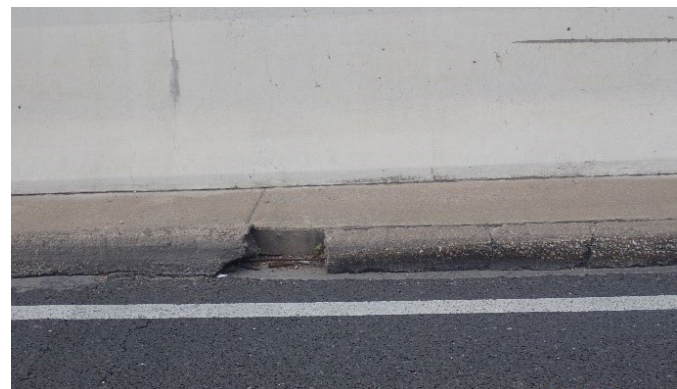
Figure 5: DNT curb spall NB south of University Blvd.

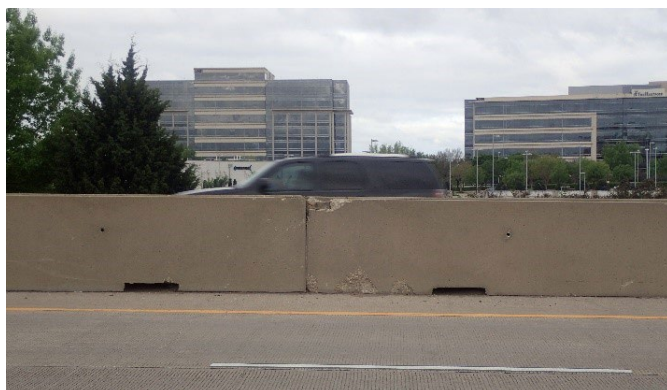
Figure 2: DNT barrier wall spall NB north of Gaylord Pkwy

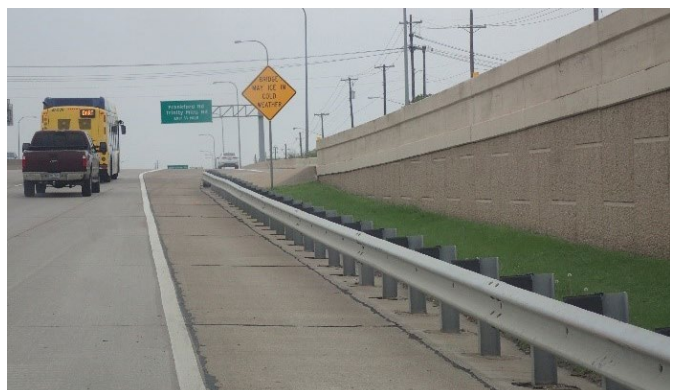
Figure 6: DNT delineation missing on MBGF NB south of PGBT

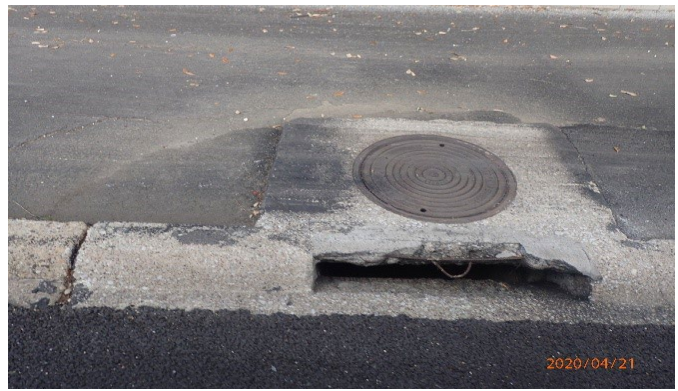
A recurring observation from the previous year inspection is broken curb inlets on the section South of IH-635. Some locations have exposed reinforcement as illustrated in Figure 7. A separate report was provided

Figure 7: DNT curb inlet damage with steel exposed SB north of Bordeaux

to the MMC showing all locations of inlet damage to assist in the preparation of a project to repair these areas.

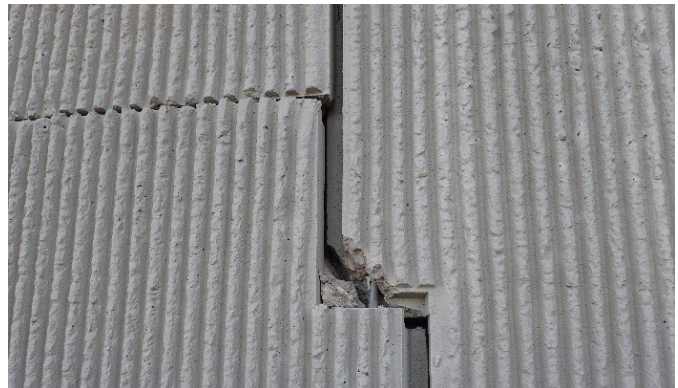
Wall panels and copings were observed with minor spalling at various locations (Figures 8 and 9).

Figure 8: DNT retaining wall panel spall SB at Alpha Rd.

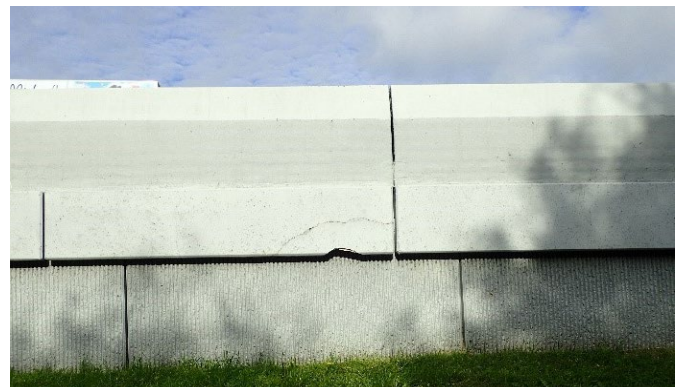
Figure 9: DNT wall coping cracking and spalling SB SRT to NB DNT

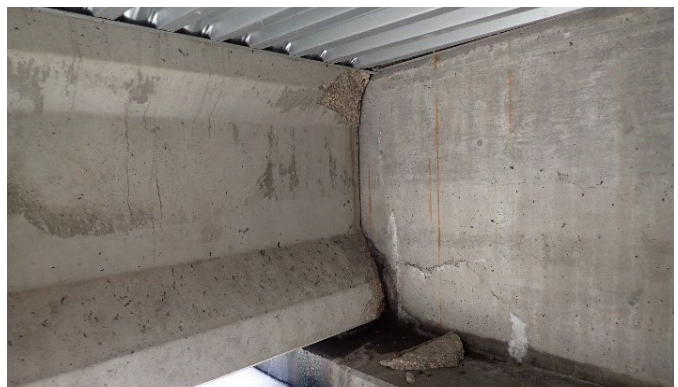
One observation noted was areas where the abutment backwall and the bridge beams were pushed together causing spalling on the beam ends (Figure 10). There was no further progression of the spalling in this year's inspection.

Figure 10: DNT beam spall and touching backwall NB at Main St.

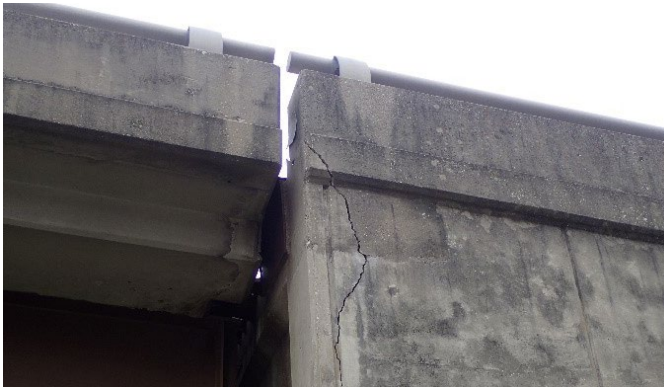
Cracking in the abutment backwall was observed at various locations (Figure 11).

Figure 11: DNT bridge abutment cracking at Harry Hines

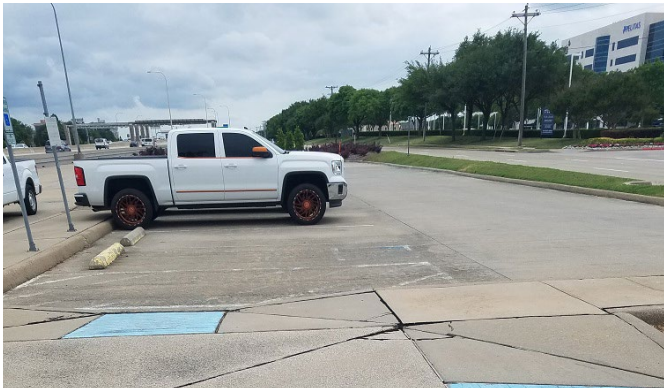
At MLP 3, located near Parker Road, there were pavement paint that was faded as illustrated in Figure 12 and stains on the ceiling tiles indicating a roof or mechanical leak.

Figure 12: DNT MLP3 – pavement paint faded

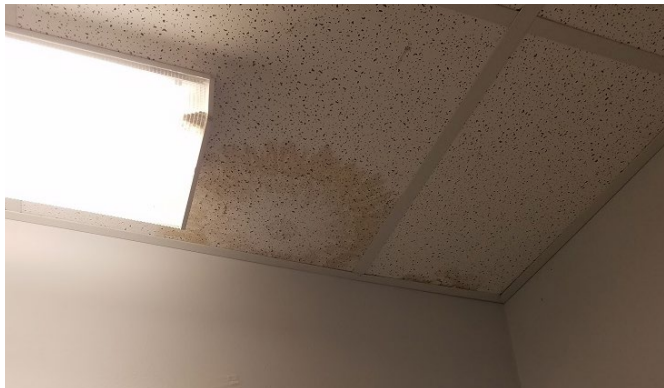
At MLP 4, located near Eldorado Parkway, observations include stains on ceiling indicating a roof or mechanical leak as illustrated in Figure 13 and paint spalling and rust at tube steel supports on the catwalk. There was also noted uneven sections of the roof indicating possible water damage. At the time of this report, a roof replacement contract was pending.

Figure 13: DNT MLP4 – stains on ceiling tile

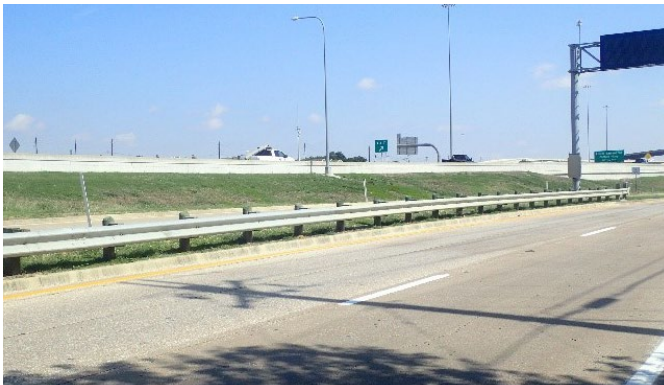
There were guardrails and concrete traffic barriers with missing delineation as noted in Figure 14. There were

Figure 14: PGBT missing delineation south of Tarrant Rd.

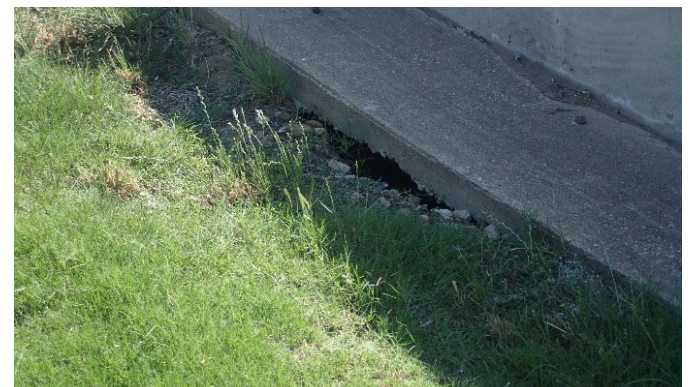
also noted areas of erosion on the roadside, around concrete appurtenances and under bridges as illustrated in Figure 15.

Figure 15: PGBT erosion under mow strip at Oakdale Rd.

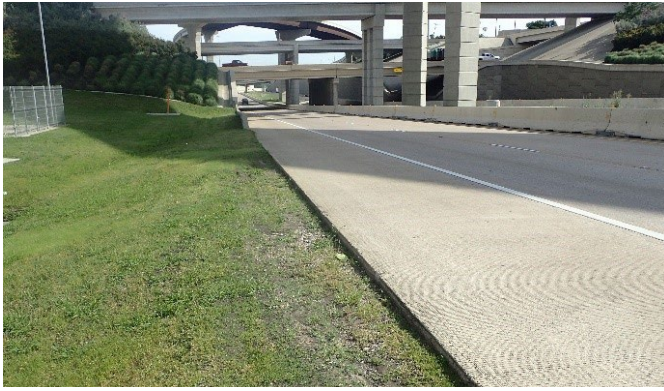
Figure 16: PGBT pavement edge dropoff west of Tarrant Rd.

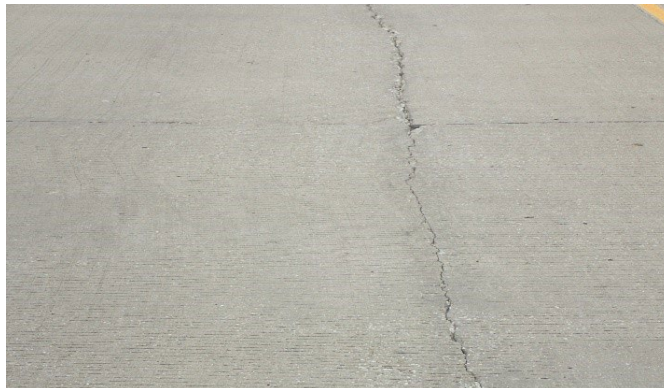
Figure 17: PGBT pavement crack at ramp from Las Colinas

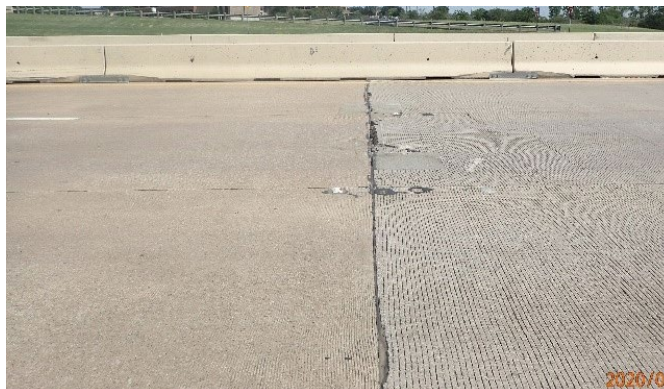
Figure 18: PGBT pavement spall north of Las Colinas

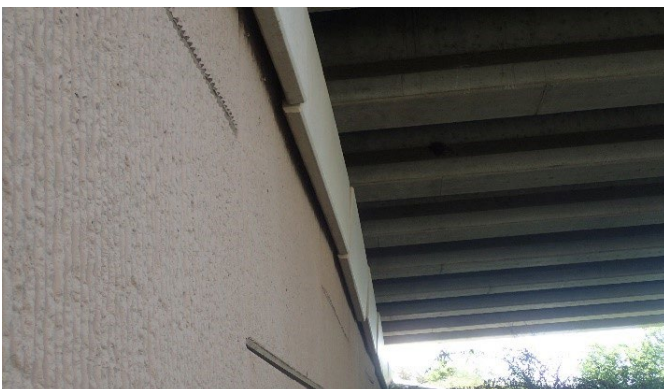
Retaining wall elements are generally in good condition. There were some observations of minor panel cracks and spalls on the retaining walls. One location noted movement in the coping as shown in Figure 19.

Figure 19: PGBT retaining wall coping movement north of Valley View

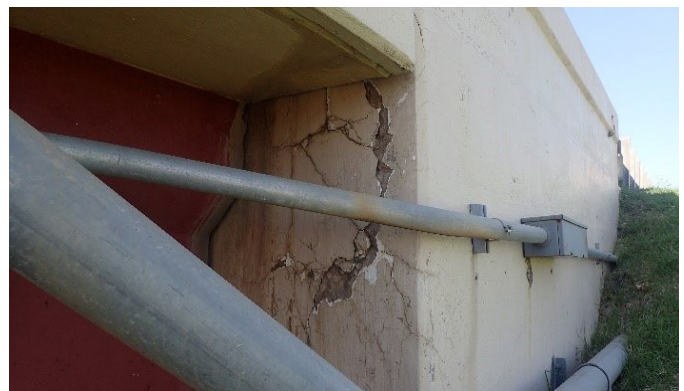
Figure 20: PGBT backwall cracking and spalling at Royal Ln.

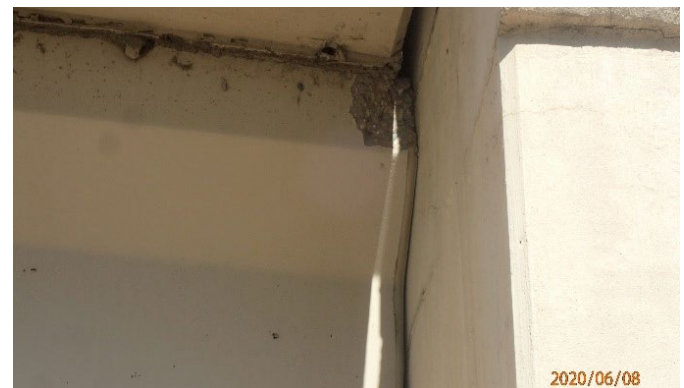
Figure 21: PGBT beam end spall at IH-30

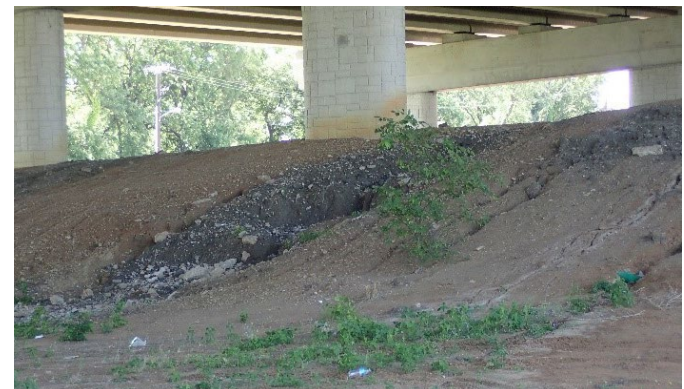
Figure 22: PGBT erosion around columns at Lower Tarrant Road

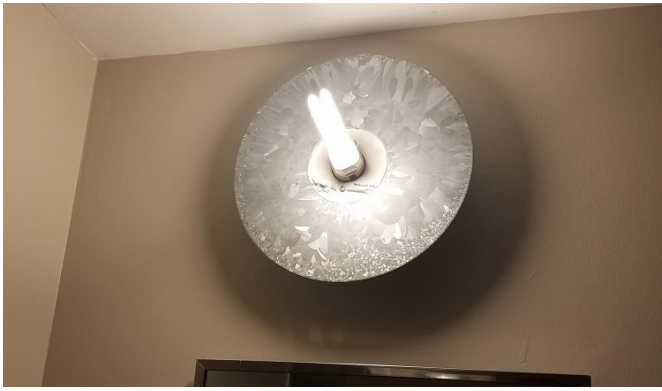
Figure 23: PGBT MLP06 lens missing from light fixture

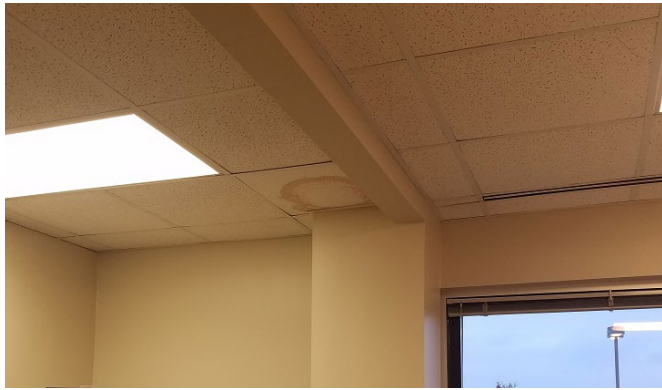
Figure 24: PGBT MLP07 stains on ceiling tile

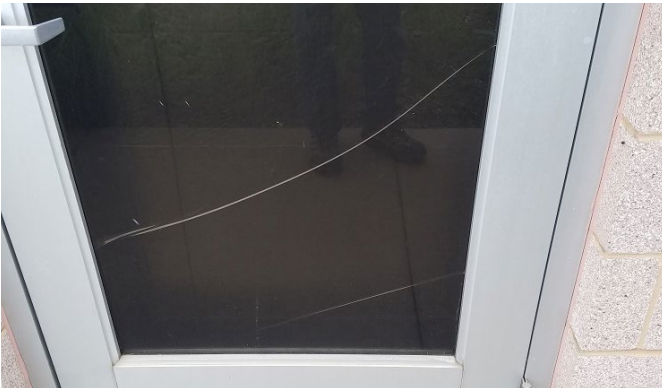
Figure 25: PGBT MLP08 rust development at door frame

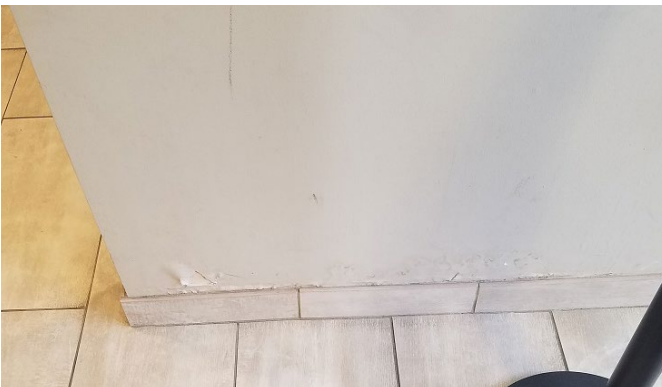
Figure 26: PGBT MLP10 water damage to wall

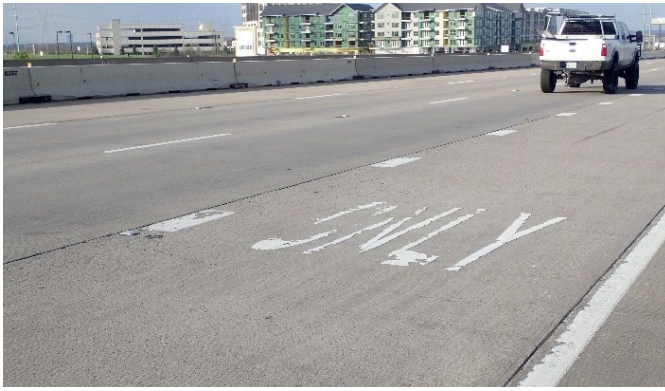
Figure 27: SRT faded striping SB ramp to Standridge Dr.

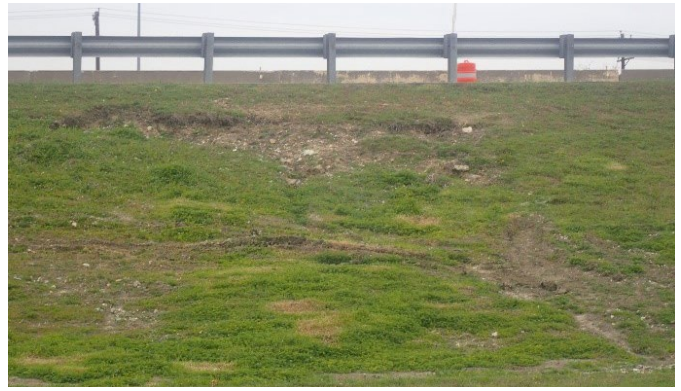
Figure 31: SRT embankment erosion NB FR at CR 149

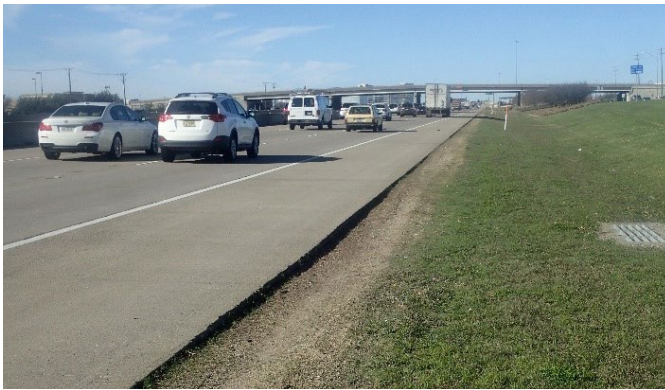
Pavement edge drop offs, as illustrated in Figure 28, were noted in various areas.

Figure 28: SRT pavement edge dropoff SB ramp to Stacy Rd.

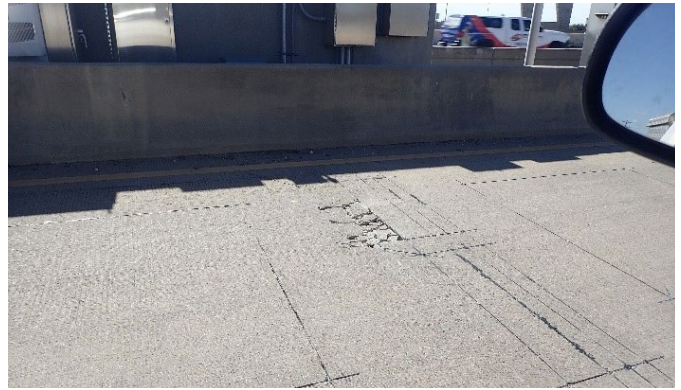
Figure 32: SRT pavement spall SB from Ohio Dr.

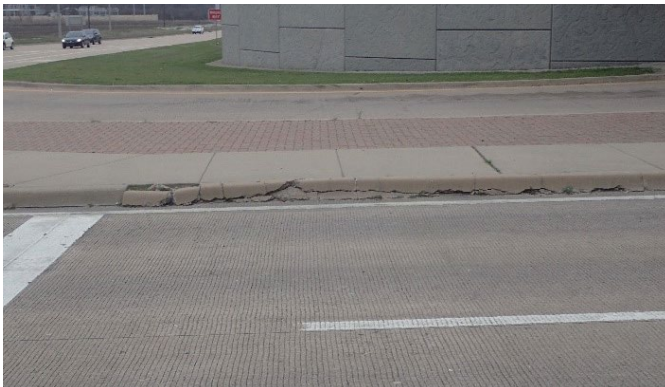
Curb damage, as illustrated in Figure 29, was observed at multiple locations at intersections and frontage roads.

Figure 29: SRT curb damage SB Watters Rd.

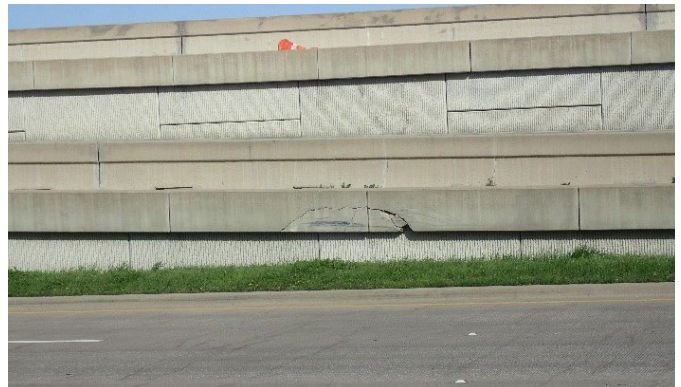
The retaining wall elements were in overall good condition. There was noted coping damage in a few areas as illustrated in Figure 33.

Figure 33: SRT coping damage SB FR to Josey Ln.

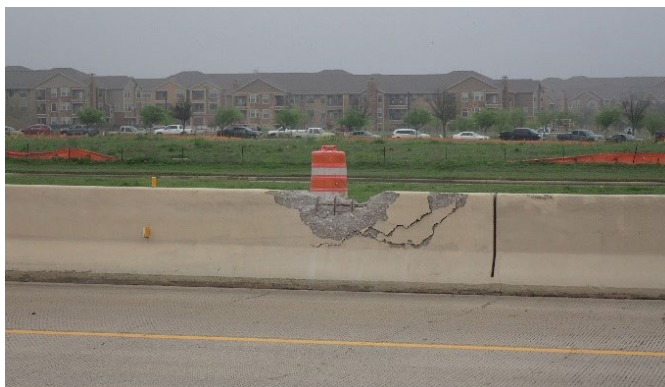
Minor barrier spalling was observed at various locations on the mainlanes as illustrated in Figure 30.

Figure 30: SRT barrier wall damage NB at Carrollton Pkwy.

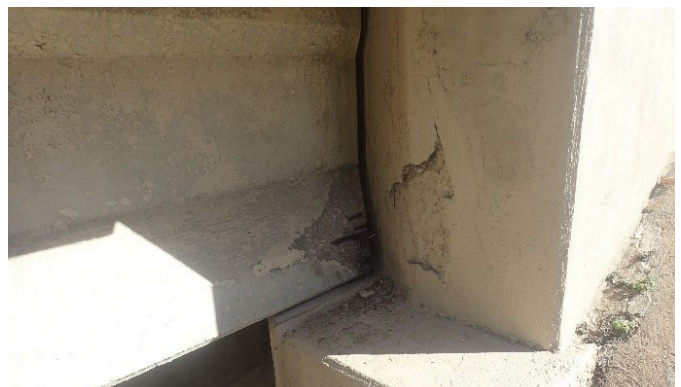
Bridges are in good condition with one recurring observation where the beams are pushing against the backwall causing minor spalling at the beam end and backwall as noted in Figure 34. This condition is being monitored by NTTA staff.

Figure 34: SRT beam and backwall spall NB at Park Highlands

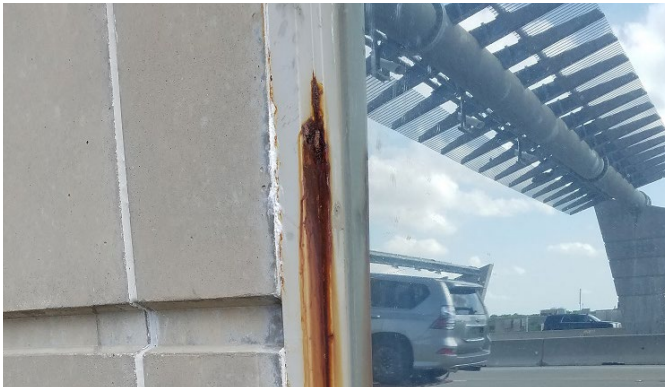
Figure 35: SRT MLG02 rust development at window frame

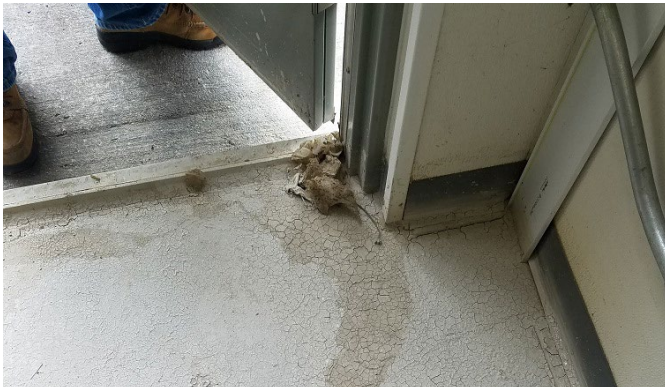
Figure 36: SRT MLG03 water intrusion into building

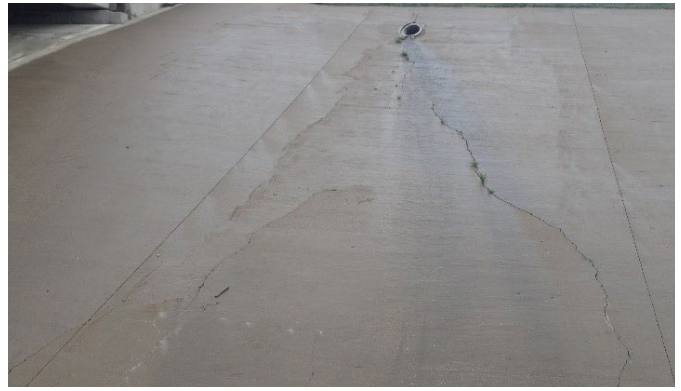
Figure 37: CTP riprap cracking at FM 917

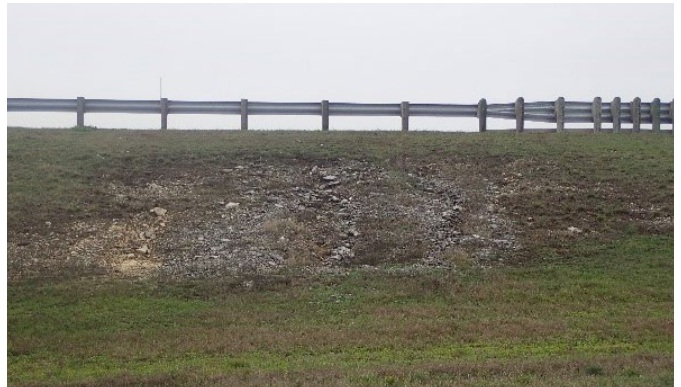
Figure 38: CTP embankment erosion at NB ramp from FM 1187

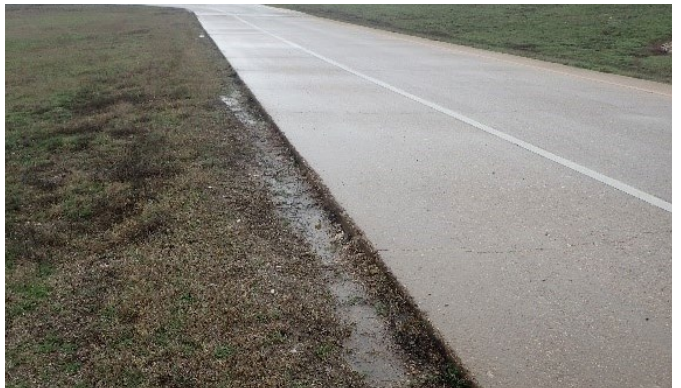
Figure 39: CTP pavement edge drop off SB ramp to FM 1902

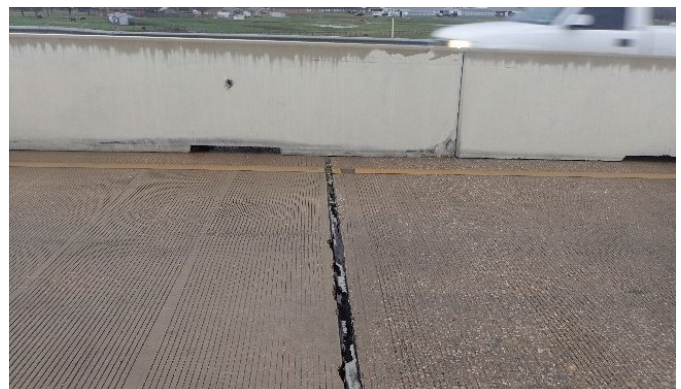
Figure 40: CTP pavement joint seal deterioration SB south of CR 1016

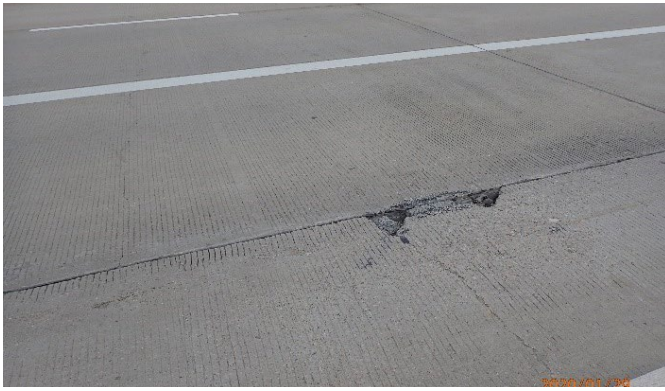
Figure 41: CTP pavement spall NB north of FM 1187

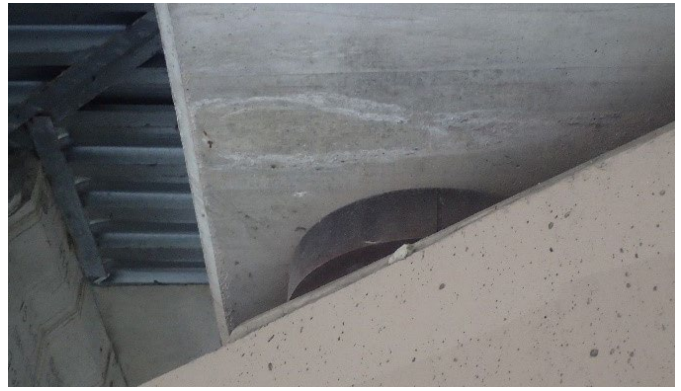
observations noted this year was minor bearing pad movement as illustrated in Figure 42. Also noted was minor backwall cracking as illustrated in Figure 43.

Figure 42: CTP bearing pad movement at relief bridge north of Hulén St.

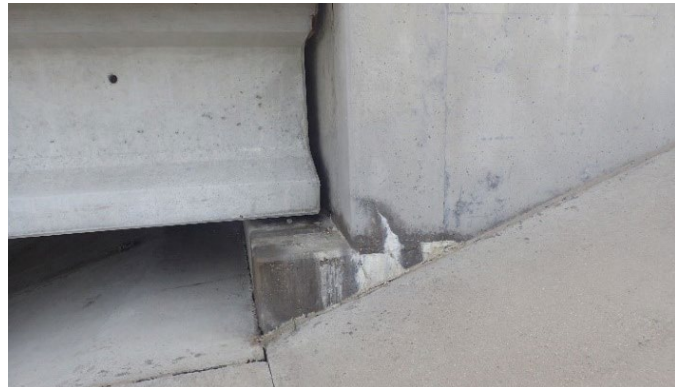
Figure 43: CTP backwall cracking SB south of CR 913

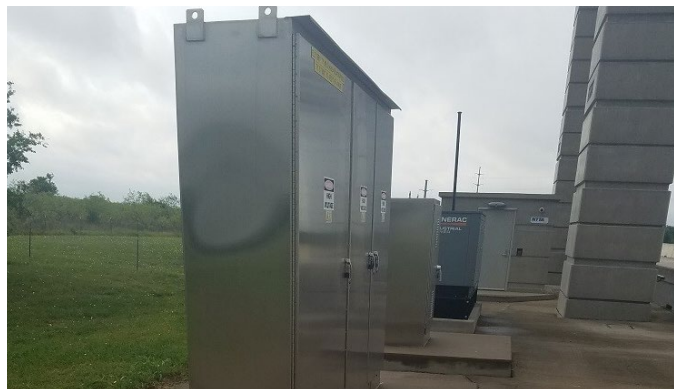
Facilities along the CTP corridor are in good condition with only a few minor findings. A cabinet is leaning and the perimeter concrete sealant is failing (Figure 44) at MLP3 due to settlement.

Figure 44: CTP MLP3 cabinet leaning and sealant failing due to settlement

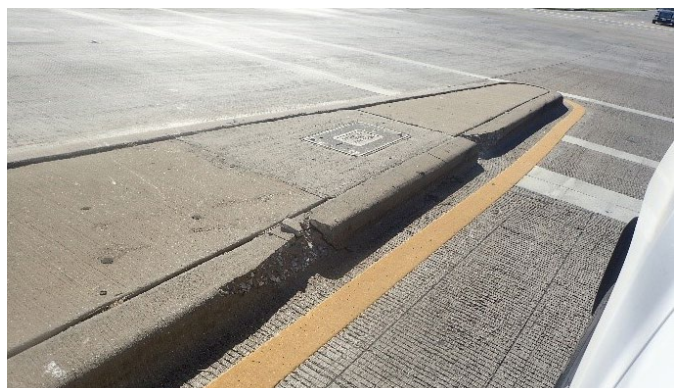
Observations noted on this years inspection included a pavement spall and curb damage as illustrated in Figure 45.

Figure 45: MCLB curb damage on east end

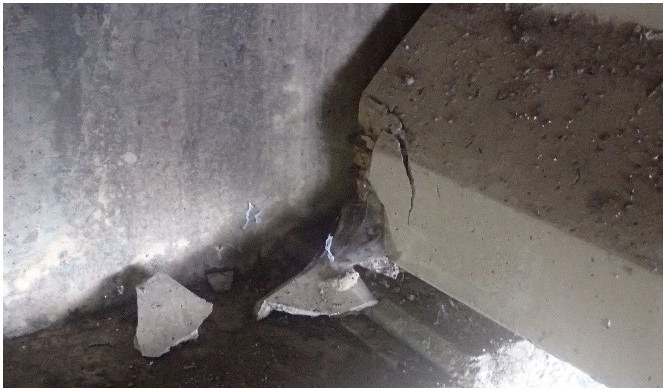
Bridge observations include interior and exterior bridge beam end spalling, as illustrated in Figure 46. There are hairline vertical and diagonal cracks with efflorescence on some of the bent caps. Also noted is moderate to heavy scaling on the concrete encasements on the columns.

Figure 46: MCLB beam end spalling at west abutment

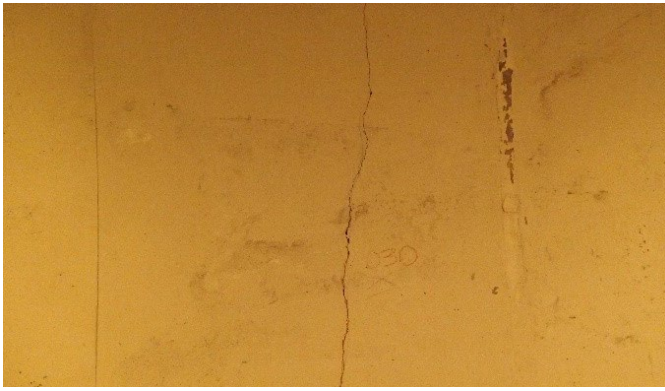
Figure 47: AATT wall cracking at multiple locations

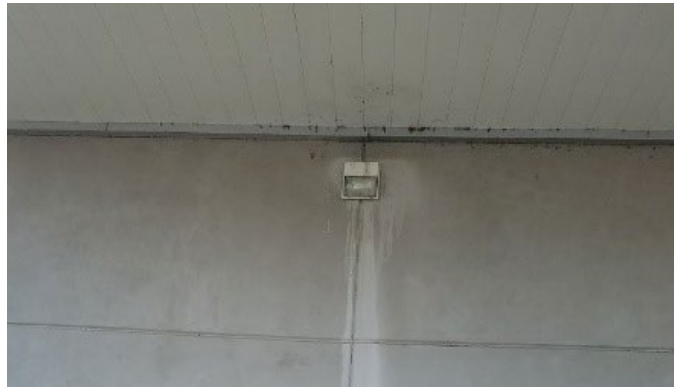
Figure 50: Frisco water intrusion into light fixture

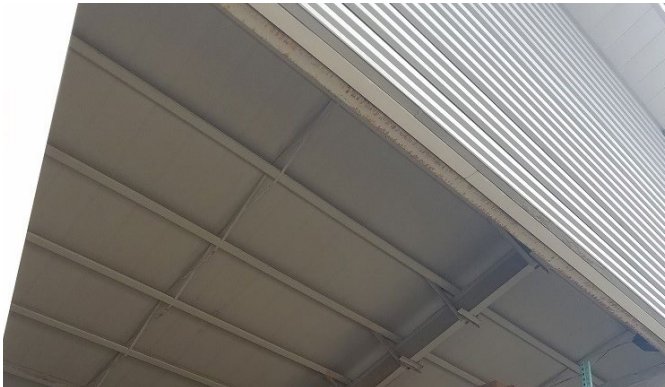
Figure 48: Ohio rust development on structural frame

Observations at the Ohio Drive Maintenance Service Center include gutter damage, rust on railings and structural frames (Figure 48), stains on ceiling indicating roof or mechanical leak (Figure 49) and rust development and paint failing at fuel island.

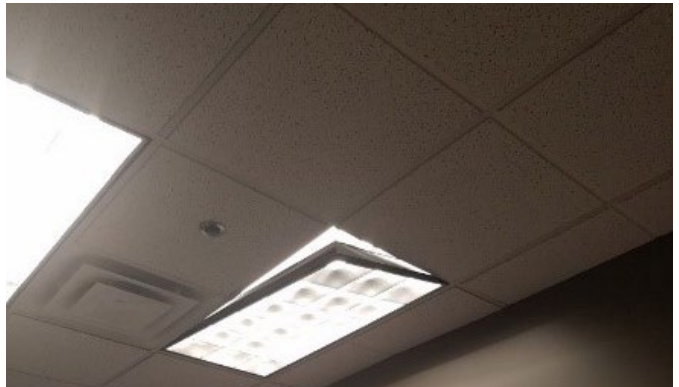
Figure 51: Gleneagles 5900 light fixture damage

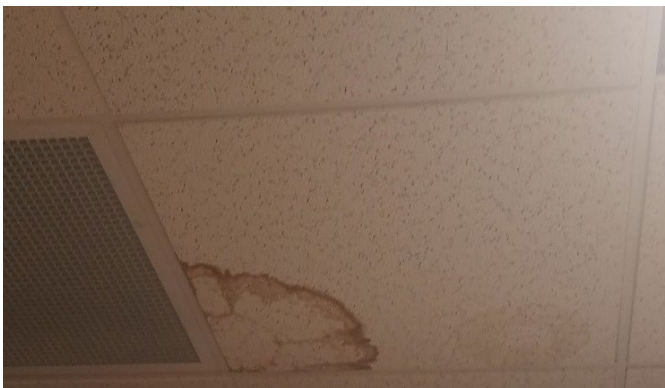
Figure 49: Ohio stain on ceiling indicating leak

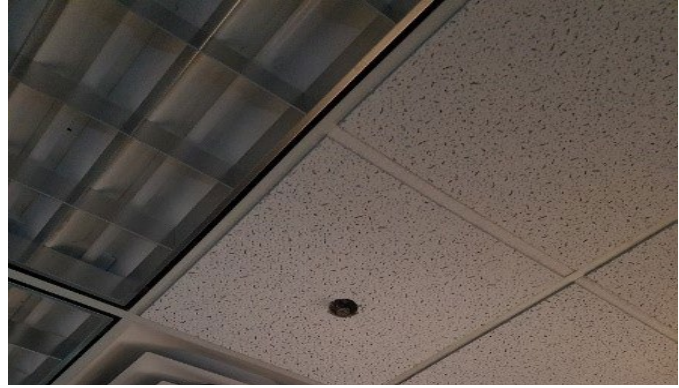
Figure 52: Gleneagles 5900 sprinkler head missing

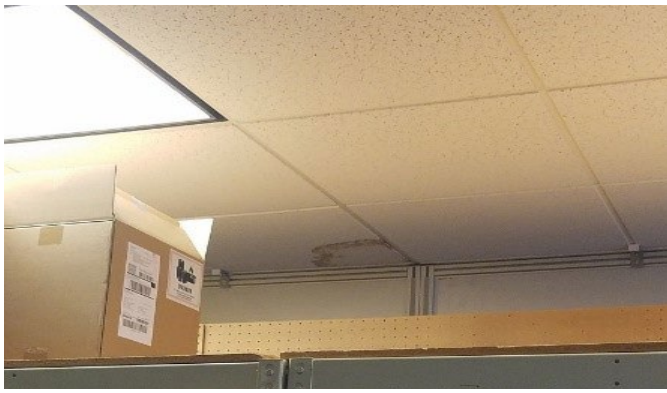
Observations at the Gleneagles Office Center at 5910 West Plano Parkway include water-stained ceiling tiles (Figure 53), masonry cracking, sprinkler head missing, vinyl wall covering peeling, multiple lights burnt out, door closure missing cover plate, and cover plates missing from electrical boxes.

Figure 53: Gleneagles 5910 water-stained ceiling tiles
