# ANNUAL INSPECTION REPORT SYSTEM

Fiscal Year 2019

September 30, 2019

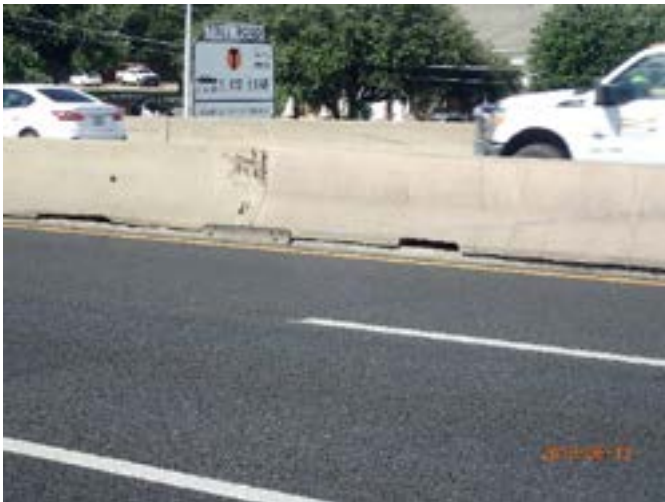
Minor barrier spalling was observed at various locations throughout the corridor as noted in **Figure 2**. There were multiple areas of erosion around riprap and landscape areas as illustrated in **Figure 3**.

Figure 2: DNT barrier wall spall NB south of Trinity Mills Road

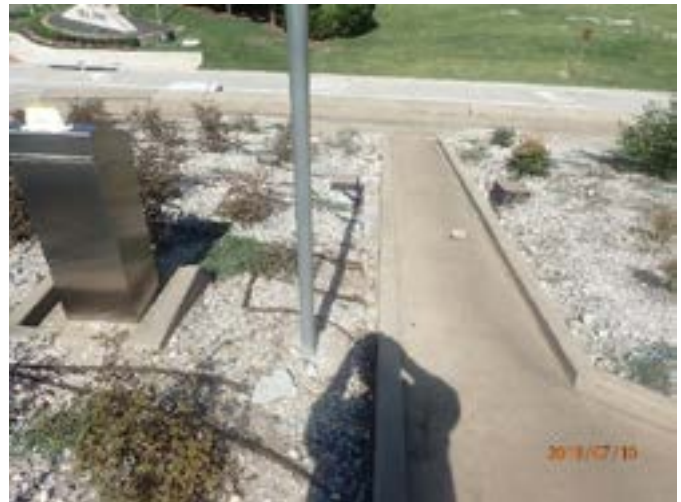
Figure 3: DNT planting bed erosion SB at Gaylord Parkway

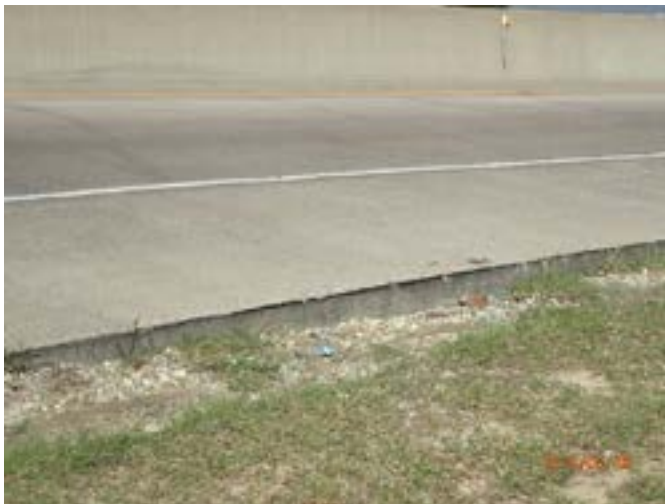
There are multiple isolated locations of pavement edge drop offs as illustrated in **Figure 4**. Also noted was an area of cracking in the foundation of the guard fence as noted in **Figure 5**. Delineation was missing on the guard fence in one location as noted in **Figure 6**.

Figure 4: DNT pavement edge drop off

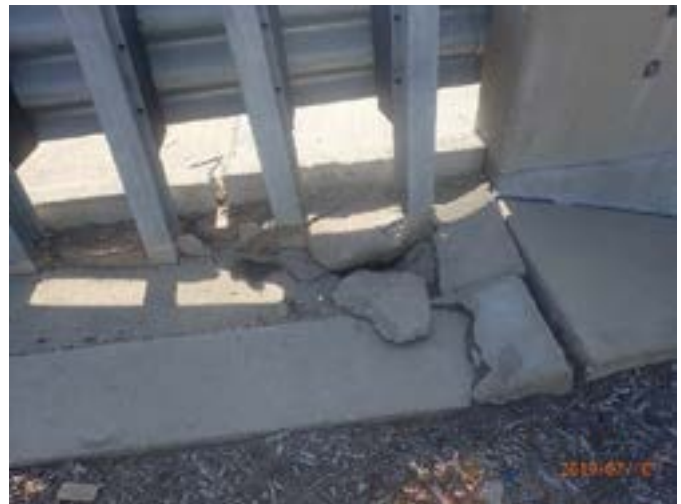
Figure 5: DNT MBGF foundation cracking SB north abutment at Main Street

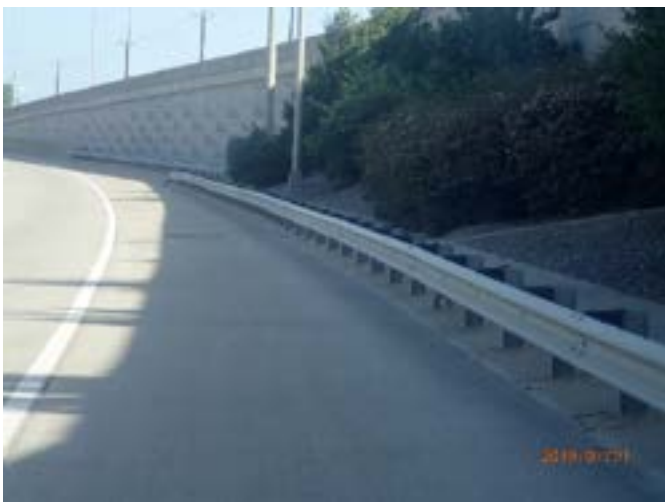
Figure 6: DNT delineation missing on MBGF NB north of Stonebrook Parkway

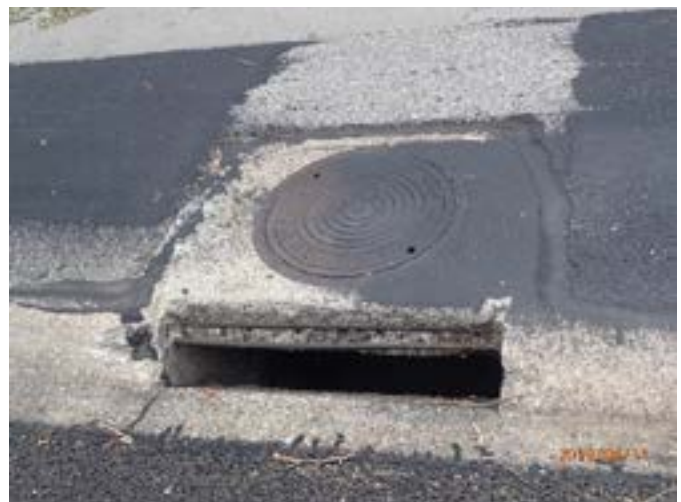
A recurring observation from the previous year inspection is broken curb inlets on the section South of IH 635. Some locations have exposed reinforcement as illustrated in **Figure 7**.

Figure 7: DNT curb inlet damage with steel exposed NB south of Lovers Lane

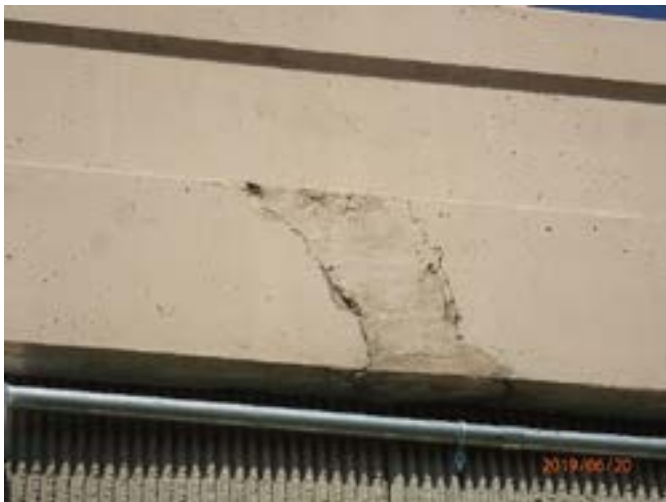
Wall panels and copings were observed with minor spalling at various locations (**Figures 8 and 9**).

Figure 8: DNT coping damage NB north of Harvest Hill Road

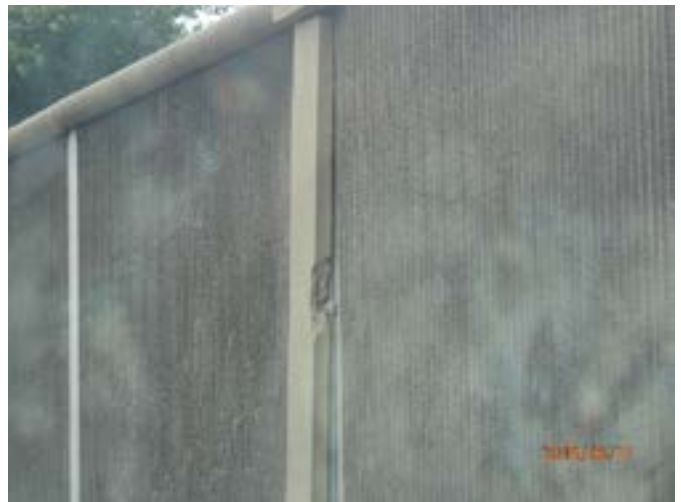
Figure 9: DNT sound wall damage

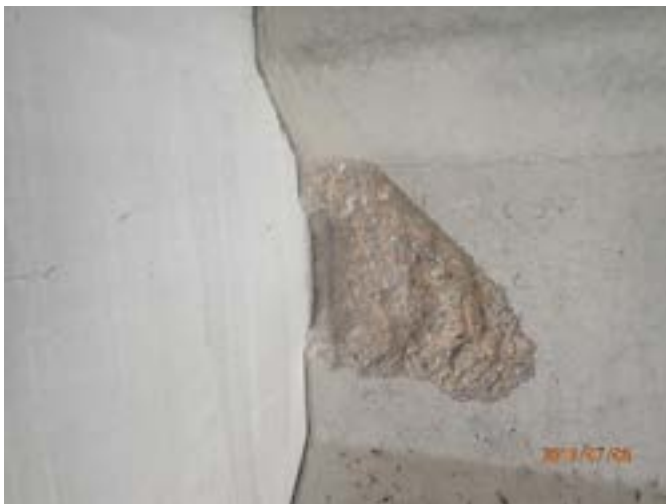
One observation noted was areas where the abutment backwall and the bridge beams were pushed together causing spalling on the beam ends (**Figure 10**). There was no further progression of the spalling in this year's inspection.

Figure 10: DNT beam spall SB at Panther Creek

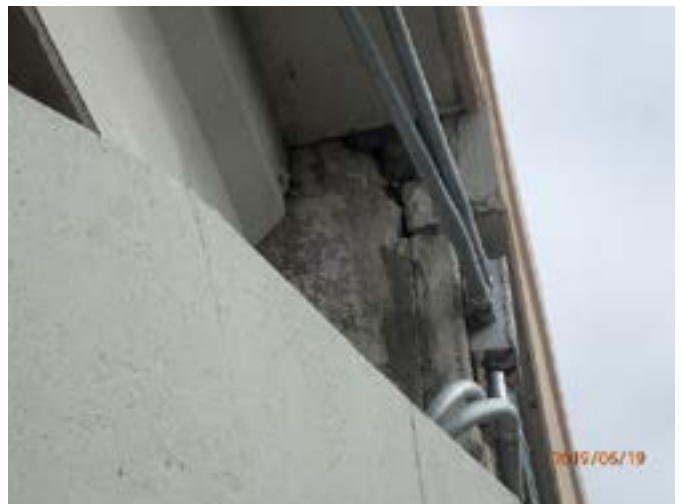
Cracking in the abutment backwall was observed at various locations (**Figure 11**).

Figure 11: DNT backwall cracking NB at Alpha Road

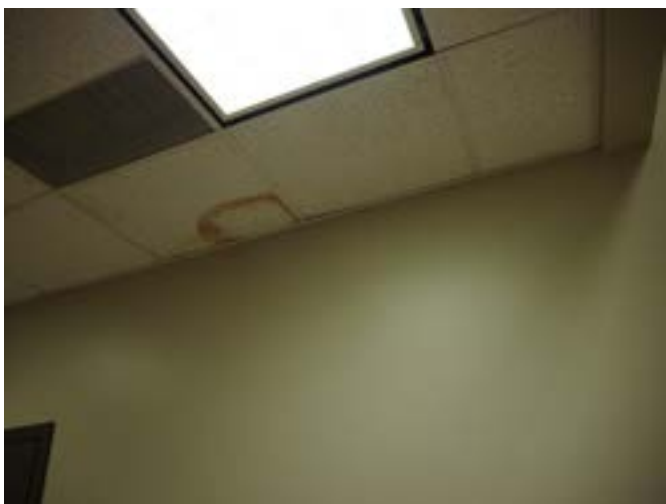
At MLP 3, located near Parker Road, there were stains on the ceiling tiles indicating a roof or mechanical leak as noted in **Figure 12**.

Figure 12: DNT MLP3 – staining on ceiling tile

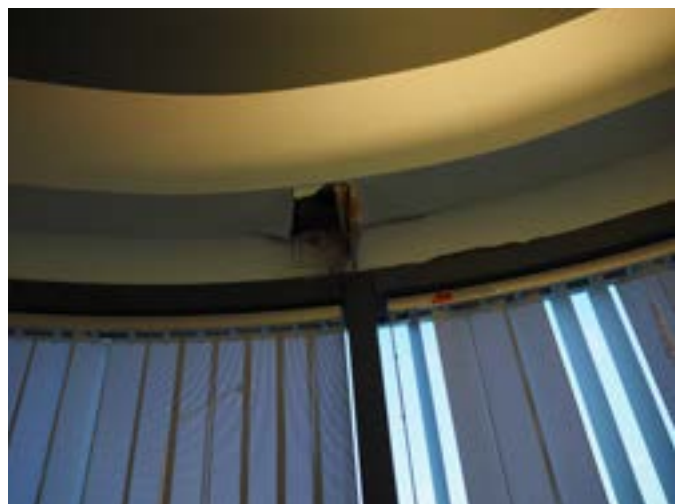
At MLP 4, located near Eldorado Parkway, observations include leaks causing water damage on ceilings and at windows (**Figure 13**), rust on exterior railings, and uneven sections of roof indicating possible water damage.

Figure 13: DNT MLP4 damage from roof leaks

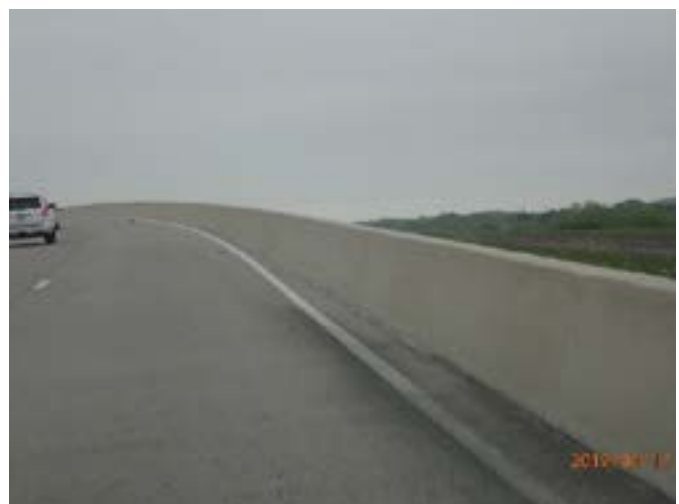
There were areas with missing delineation as noted in **Figure 14**. There were also noted areas with curb damage as illustrated in **Figure 15**.

Figure 14: PGBT missing delineation

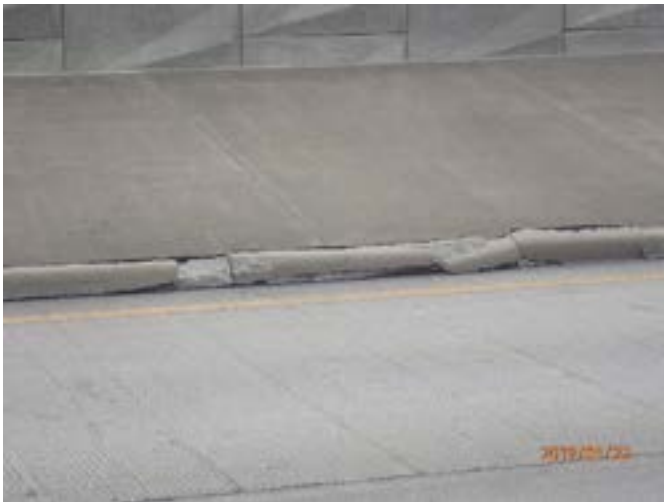
Figure 15: PGBT damaged curb

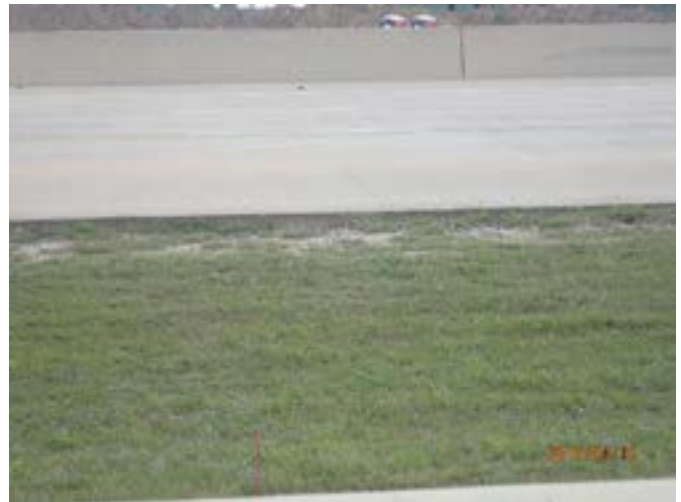
Pavement edge drop offs (**Figure 16**) and pavement cracking and spalling (**Figures 17 and 18**) was observed at various locations throughout the corridor.

Figure 16: PGBT pavement edge drop off

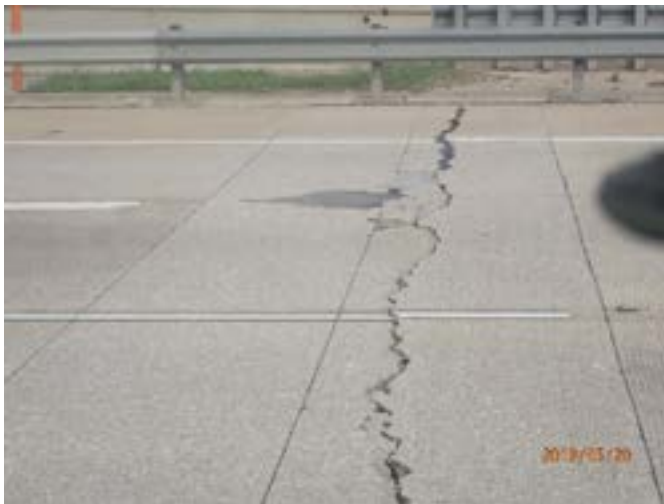
Figure 17: PGBT pavement cracking

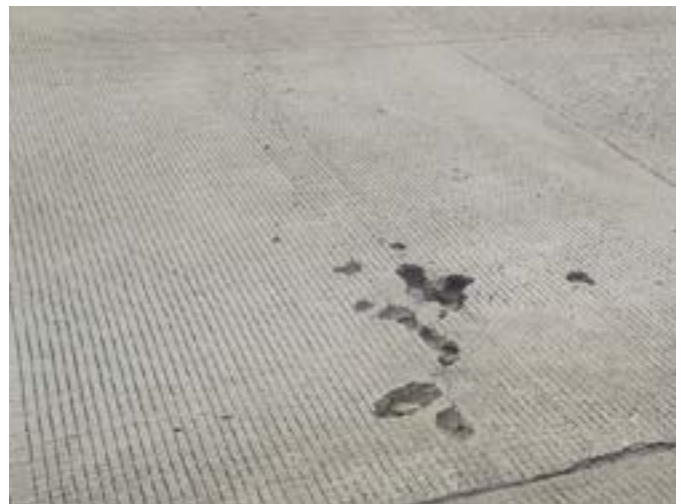
Figure 18: PGBT pavement spalling

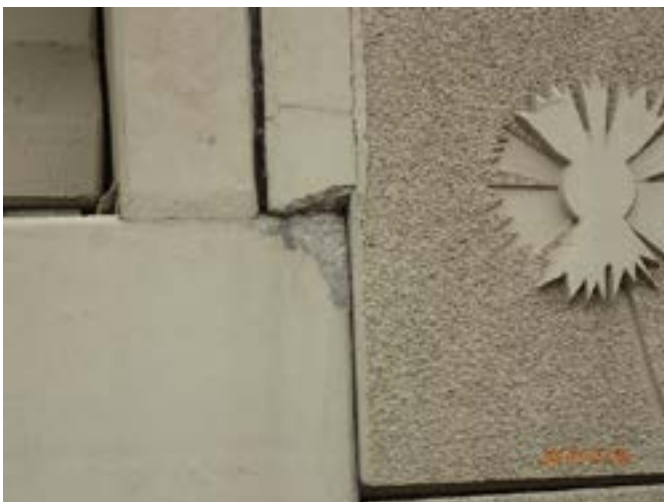
One location with spalling and exposed steel was noted (**Figure 19**).

Figure 19: PGBT wall spall with exposed steel

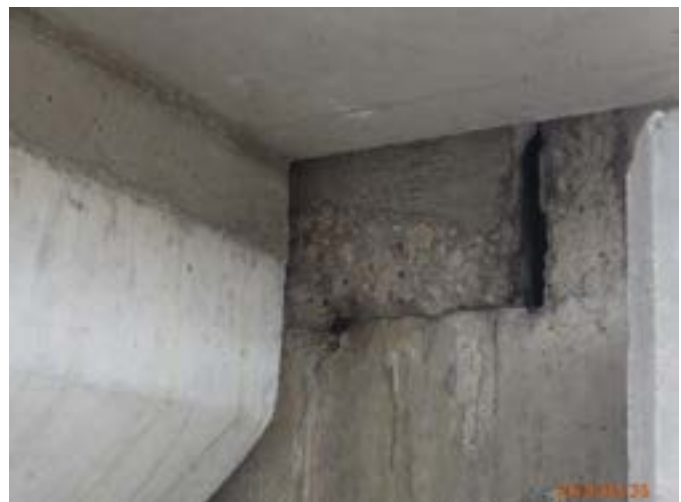
Bridge observations include abutment backwall cracking and spalling (**Figure 20**). Also noted was bearing pad movement as illustrated in **Figure 21**.

Figure 20: PGBT abutment backwall spall NB at Rowlett Creek

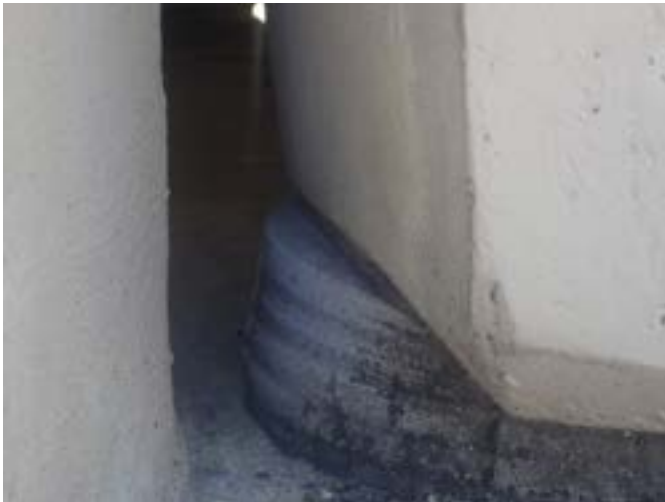
Figure 21: PGBT bearing pad movement

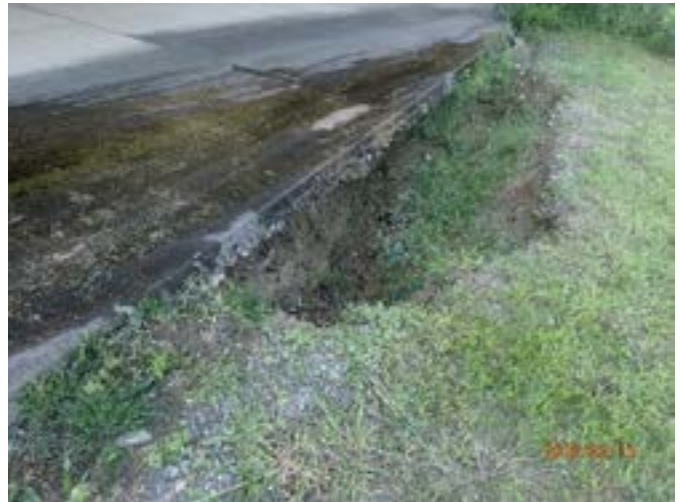
Erosion around bridge riprap and under bridges (**Figure 22**). Backwall cracking and spalling and bridge bent caps with minor cracking as illustrated in **Figures 23 and 24**.

Figure 22: PGBT erosion at bridge riprap WB at Royal Lane

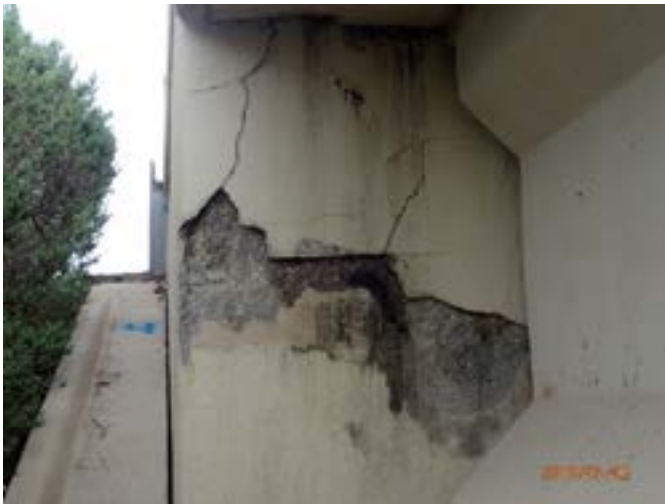
Figure 23: PGBT back wall cracking and spalling at Brand Road

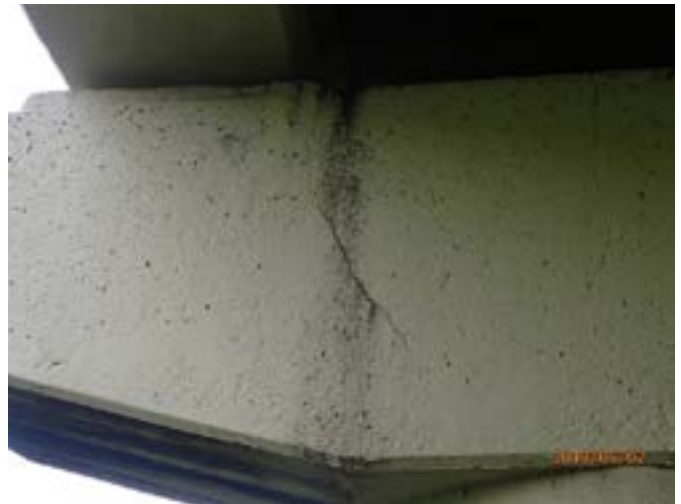
Figure 24: PGBT minor bent cap cracking at Brand Road

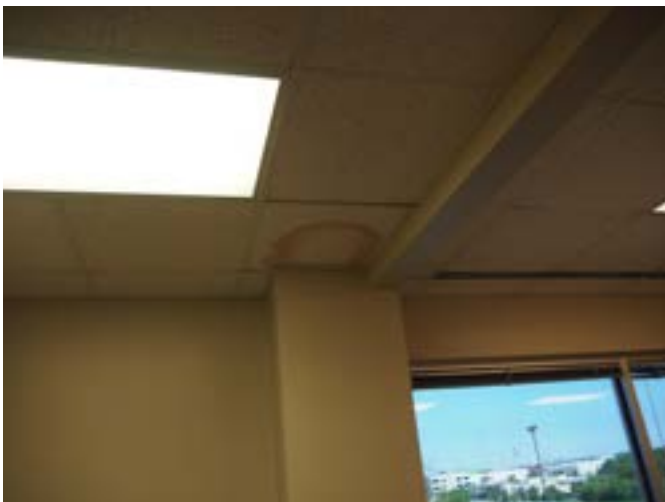
Observations identified throughout the facilities included cracking in masonry, evidence of mechanical leaks, burned out lamps and paint peeling from a stairway as illustrated in **Figures 25 and 26**.

Figure 25: PGBT MLP07 stain on ceiling indicating leak

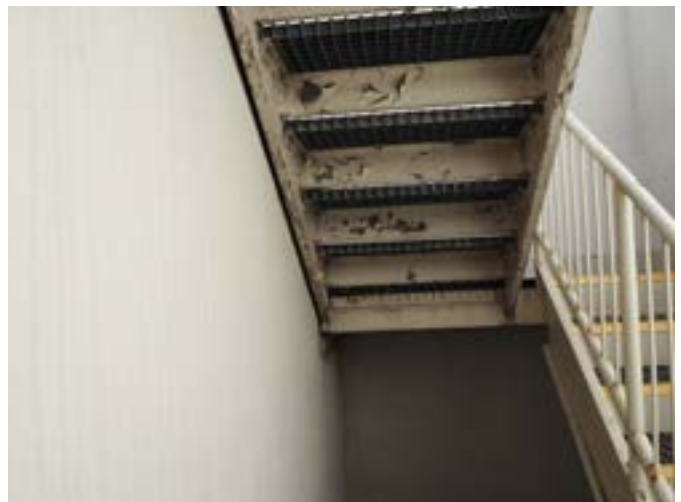
Figure 26: PGBT MLP06 paint peeling from stairway

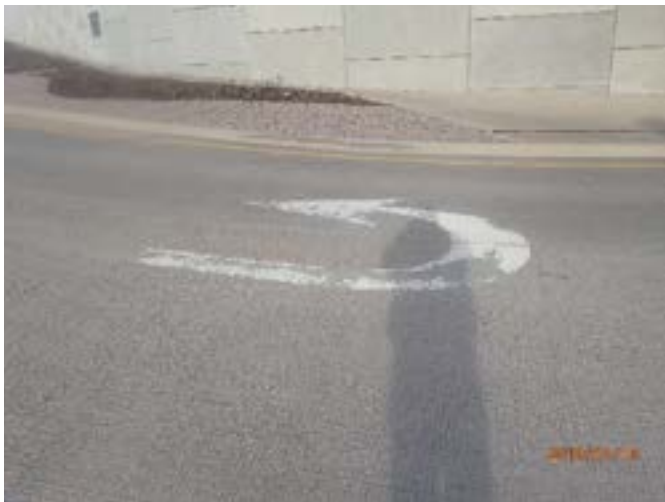
Figure 27: SRT faded pavement markings

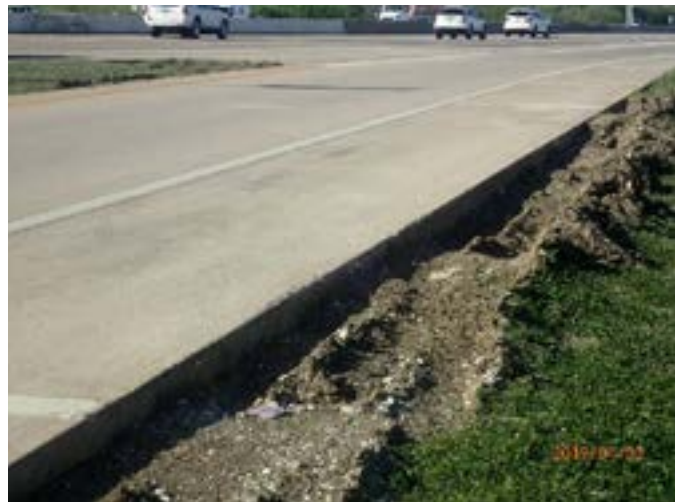
Pavement edge drop offs, as illustrated in **Figure 28**, were noted in various areas.

Figure 28: SRT pavement edge drop off

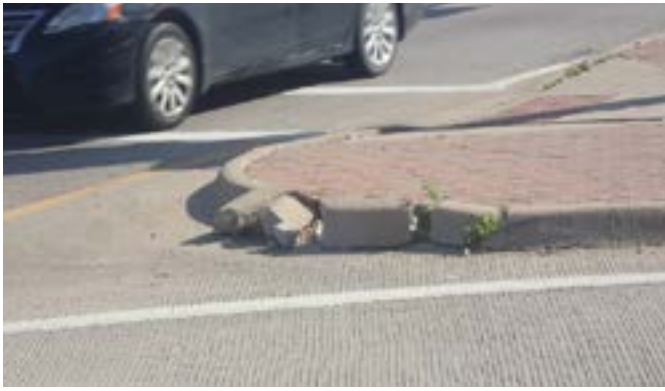
Curb damage, as illustrated in **Figure 29**, was observed at multiple locations at intersections and frontage roads.

Figure 29: SRT curb damage

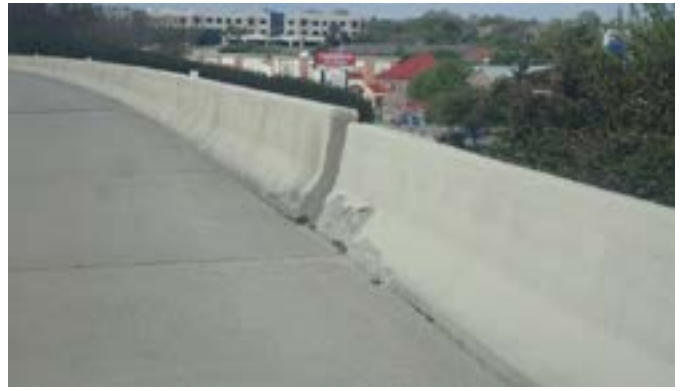
Minor barrier spalling was observed at various locations on the mainlanes as illustrated in **Figure 30**.

Figure 30: SRT Barrier spall SB South of MacArthur Boulevard

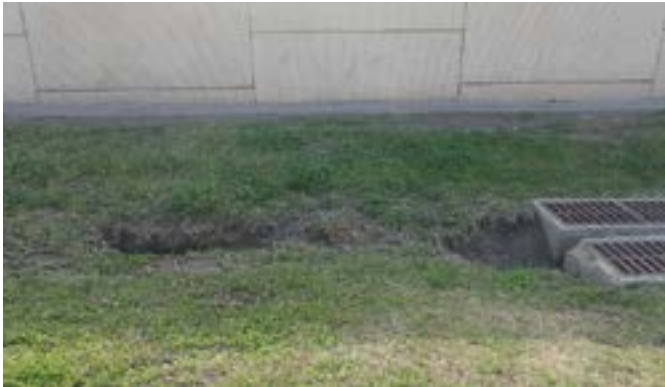
There were locations with erosion around concrete appurtenances as noted in **Figure 31**. Also noted were areas of pavement cracking as illustrated in **Figure 32**.

Figure 31: SRT erosion at drop inlet NBML at Old Denton Road

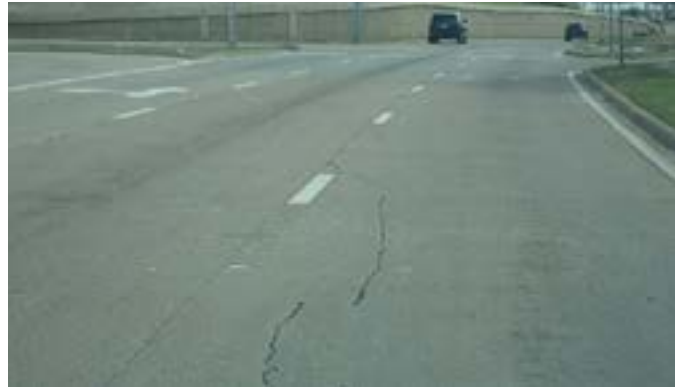
Figure 32: SRT pavement cracking NBFR at MacArthur Boulevard

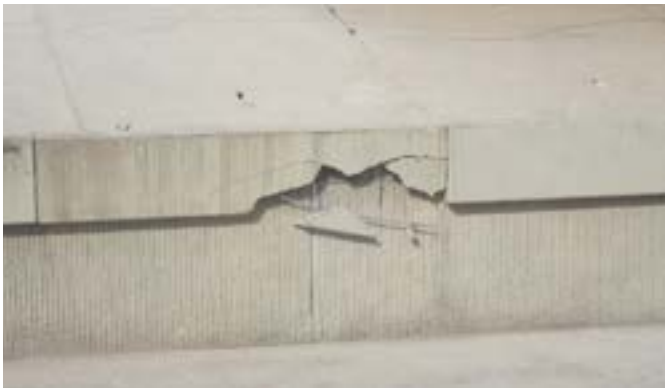
The retaining wall elements were in good condition. There was noted coping damage in a few areas as illustrated in **Figure 33**.

Figure 33: SRT coping damage NBML at Castle Hills

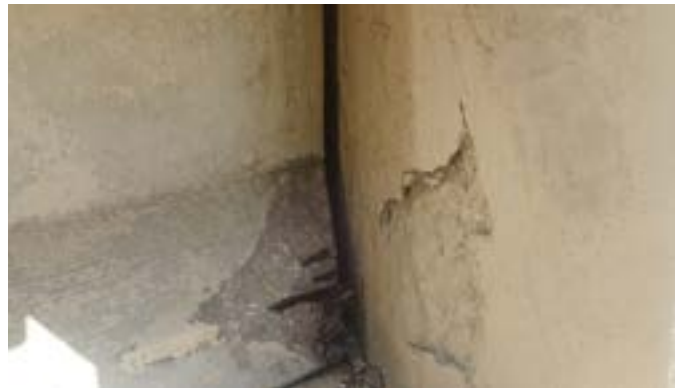
One observation noted on the bridge inspection was where the abutment backwall and the bridge beams meet spalling as noted in **Figure 34**. This condition is being monitored by NTTA staff.

Figure 34: SRT beam and backwall spalling NBFR relief bridge

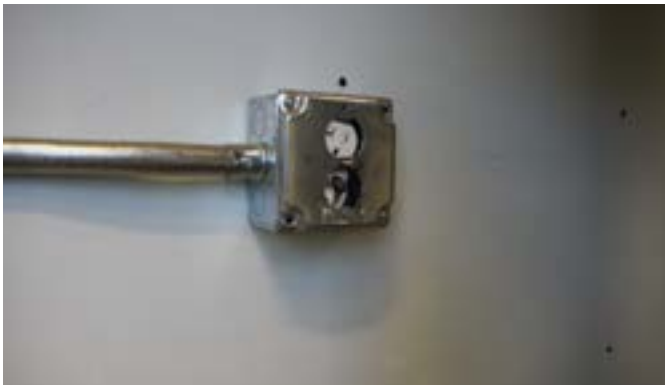
There were several observations noted on mainlane gantries including electrical outlet damage at MLG1 and gap at door threshold at MLG2 as shown in **Figures 35 and 36**.

Figure 35: SRT MLG1 electrical outlet damage

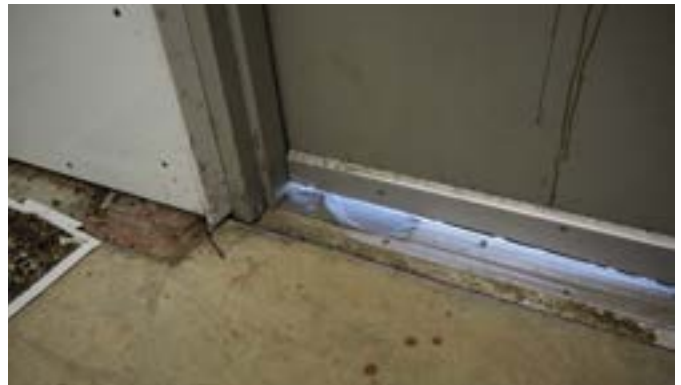
Figure 36: SRT MLG2 gap at door threshold

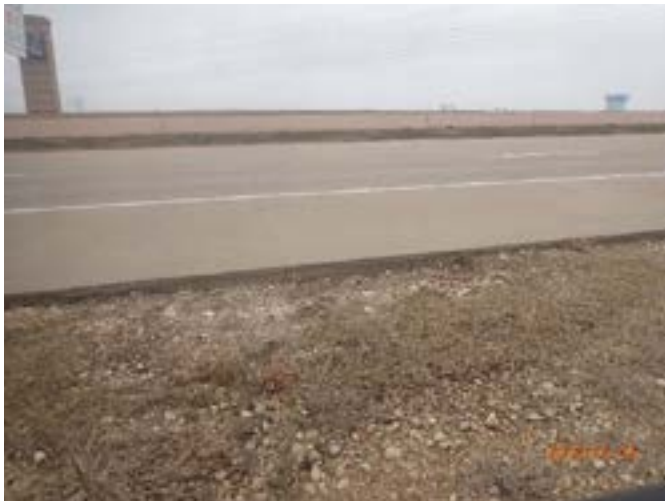
The recurring observations noted on this year's inspection were: erosion on slope embankment, ditch lines and around structures and riprap, pavement edge drop offs (**Figure 37**), pavement joint damage, minor concrete barrier spalling and riprap cracking.

Figure 37: CTP pavement edge drop off

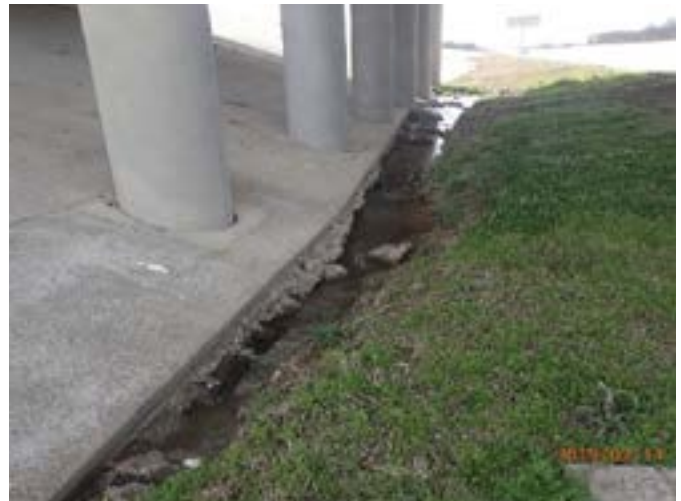
Areas with erosion at structures were noted at various locations as illustrated in **Figures 38 and 39**. Additionally, erosion was observed on slope embankments and in ditch lines as illustrated on **Figure 40**. There were also noted areas with pavement joint damage as illustrated in **Figure 41**.

Figure 38: CTP erosion at riprap toe

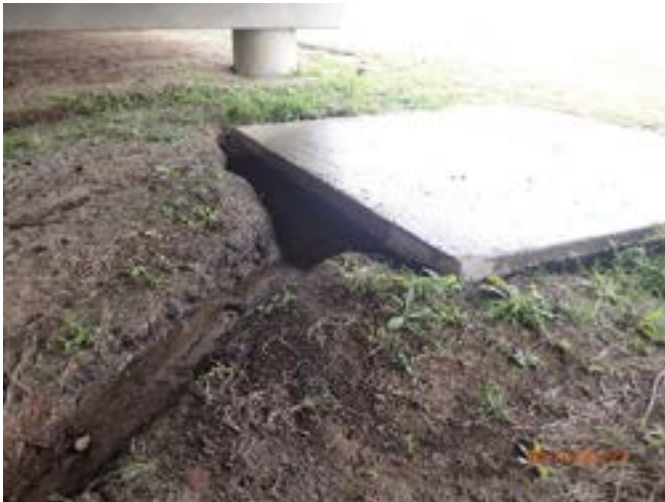
Figure 39: CTP erosion at structure

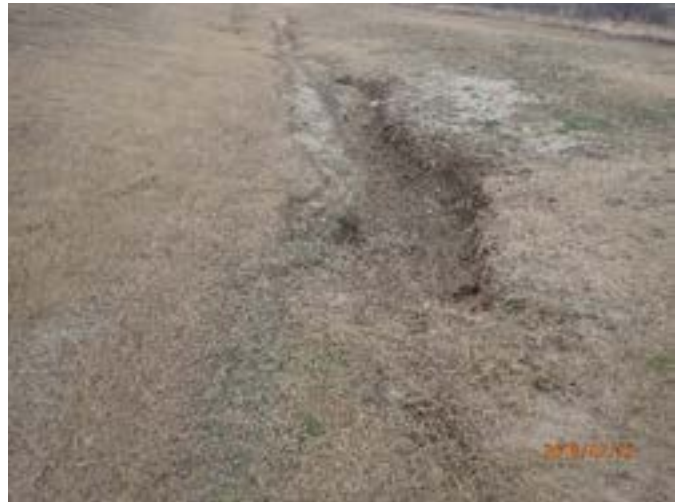
Figure 40: CTP erosion in ditchline

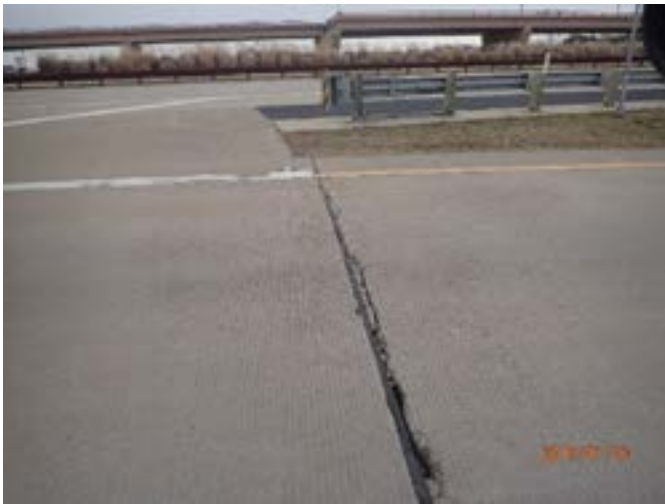
Figure 41: CTP pavement joint damage

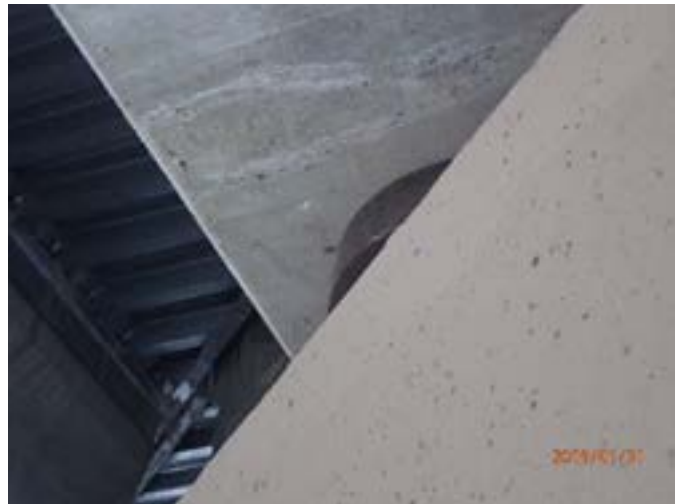
The majority of the bridge elements are in like new condition with only a few issues observed. One of the observations noted this year was minor bearing pad movement as illustrated in **Figure 42**. Also noted was minor backwall cracking as illustrated in **Figure 43**.

Figure 42: CTP bearing pad movement

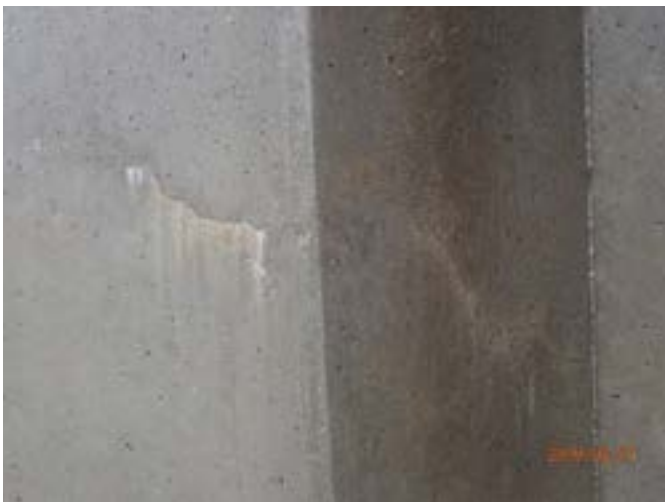
Figure 43: CTP backwall cracking

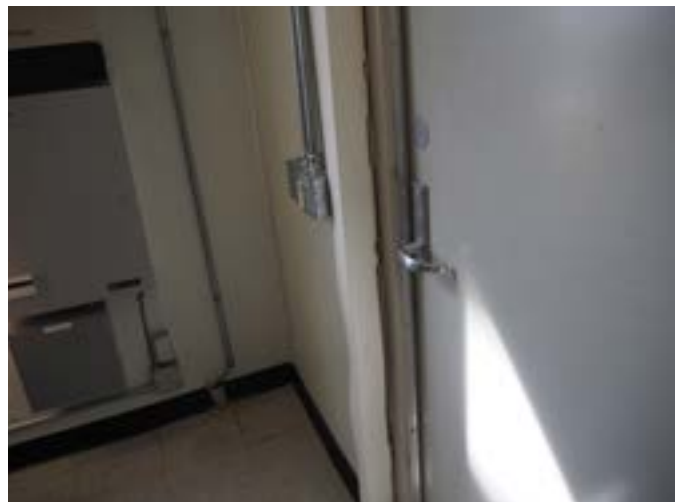
Loose trim at a doorway was noted on MLG01 fiber hut in this year's inspection as noted in **Figure 44**.

Figure 44: CTP loose trim at door at FH MLG01

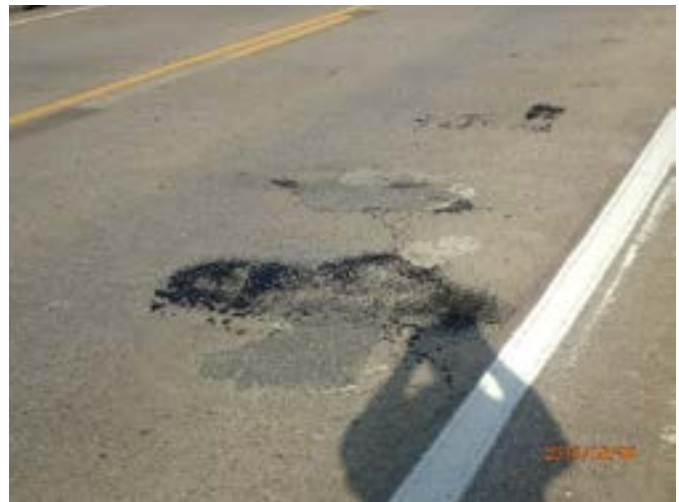
One observation noted this year is a pavement failure on the bridge deck surface treatment as noted in **Figure 45**.

Figure 45: MCLB pavement failure in deck surface treatment

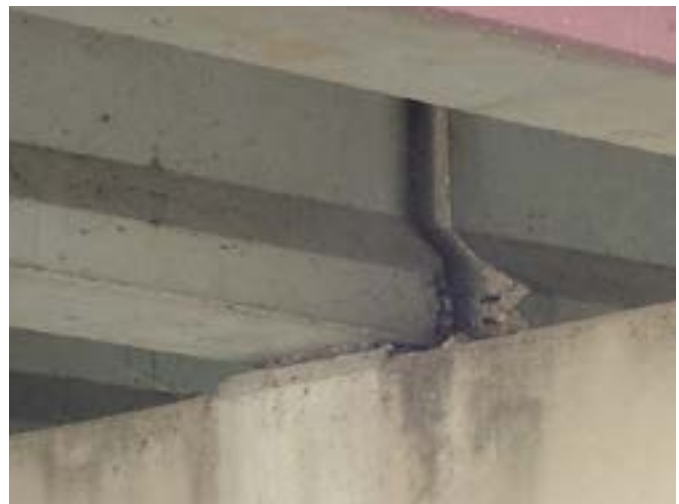
Bridge observations include interior and exterior bridge beam end spalling with exposed reinforcement, as illustrated in **Figure 46**. There are hairline vertical and diagonal cracks with efflorescence on some of the bent caps. Also noted is moderate to heavy scaling on the concrete encasements on the columns. There is a bridge column collar repair assessment planned for 2020.

Figure 46: MCLB beam spalling with exposed steel at bent 12

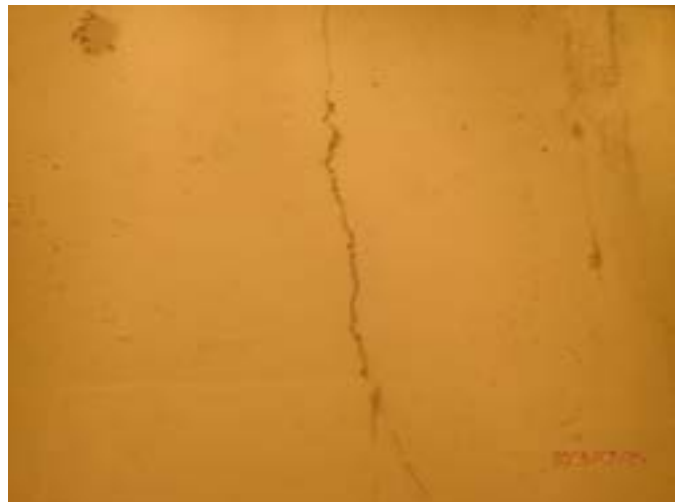
Observations concerning the tunnel walls include cracking at multiple locations (**Figure 47**). There were a few locations with wall spalling along the tunnel.

Figure 47: AATT wall cracking

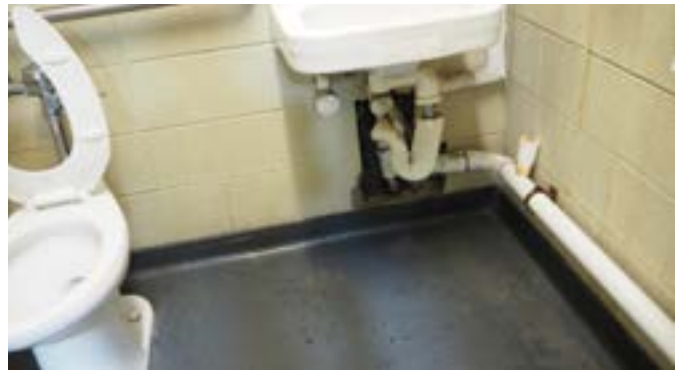
Observations at the Ohio Drive Maintenance Service Center include rust developing on patio railing, door threshold, curb edging, and canopy structure; soil settlement along wall (**Figure 48**); cover missing from door closure; and hole in the wall at the sink plumbing (**Figure 49**).

Figure 49: OHIO hole in wall at sink plumbing

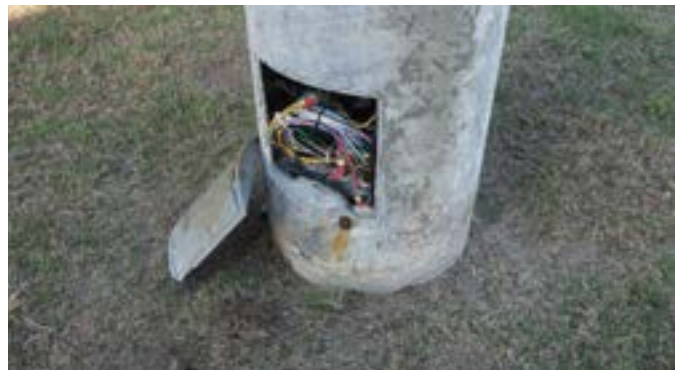
Observations at the Frisco Maintenance Service Center include rust at galvanized canopy and pre-cast panels, settlement crack in drywall, and cover plates missing from outlet and pull box (**Figure 50**).

Figure 50: FRISCO cover plate missing from pull box

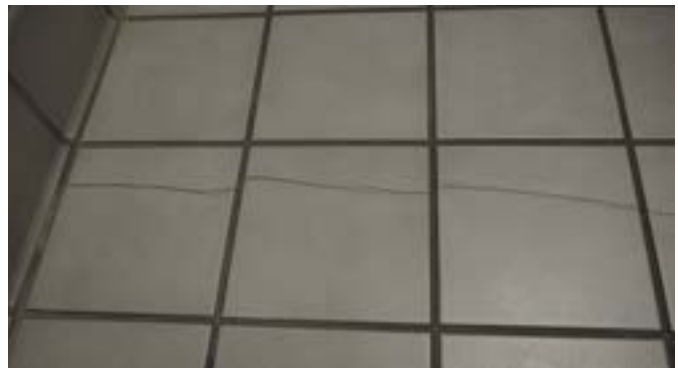
Figure 51: Gleneagles 5900 crack in floor tile

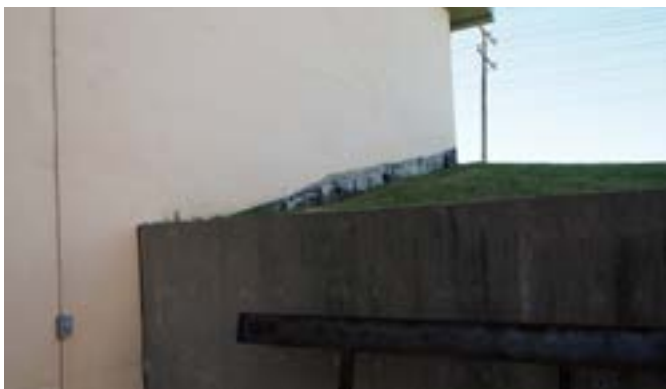
Figure 48: OHIO soil settlement along wall

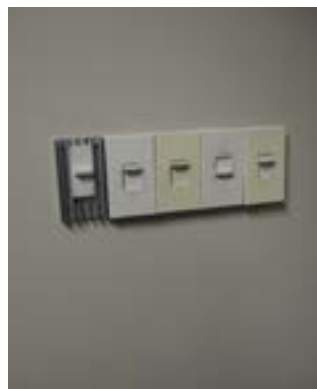
Figure 52: Gleneagles 5900 cover plate missing from light switch

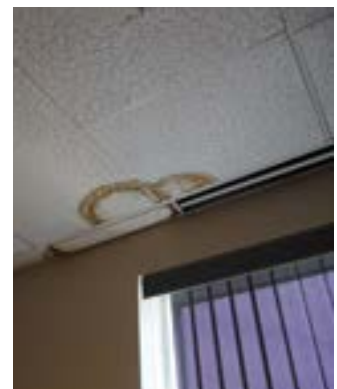
Observations at the Gleneagles Office Center at 5910 West Plano Parkway include damaged and water-stained ceiling tiles (**Figure 53**), masonry cracking, ADA kick panel loose at sink, multiple lights burnt out, door closure missing cover plate, and tree growth in exterior gutter.

Figure 53: Gleneagles 5910 water-stained ceiling tiles
