ANNUAL INSPECTION REPORT SYSTEM

FISCAL YEAR 2018

Prepared by Atkins North America, Inc.
General Engineering Consultant

September 2018

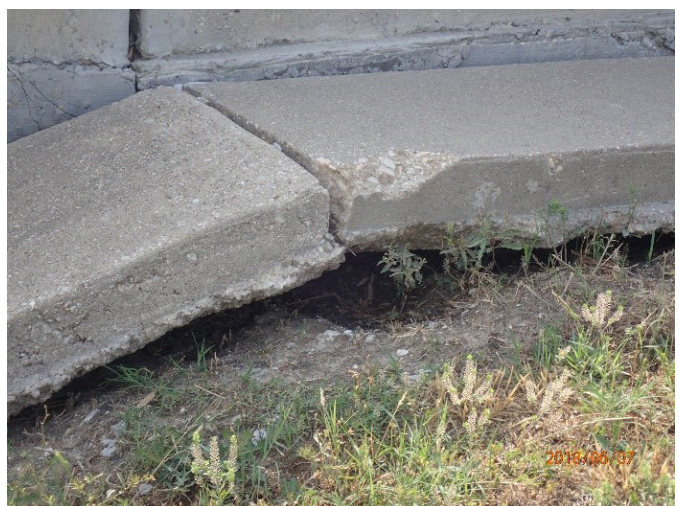
Minor barrier spalling was observed at various locations throughout the corridor. There were multiple areas of erosion around riprap and landscape areas as illustrated in Figure 2.

Figure 2: Erosion at Mow Strip SB DNT at Cotton Gin Road.

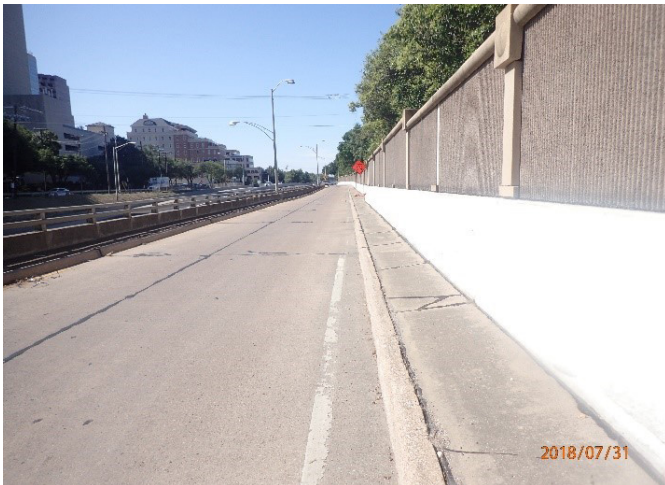
There are multiple isolated locations of missing pavement markings (Figure 3). Faded signs were noted (Figure 4). Loss of retro-reflectivity on these signs was noted during the night inspection.

Figure 3: Faded Striping at SB Entrance Ramp from Northwest Highway.

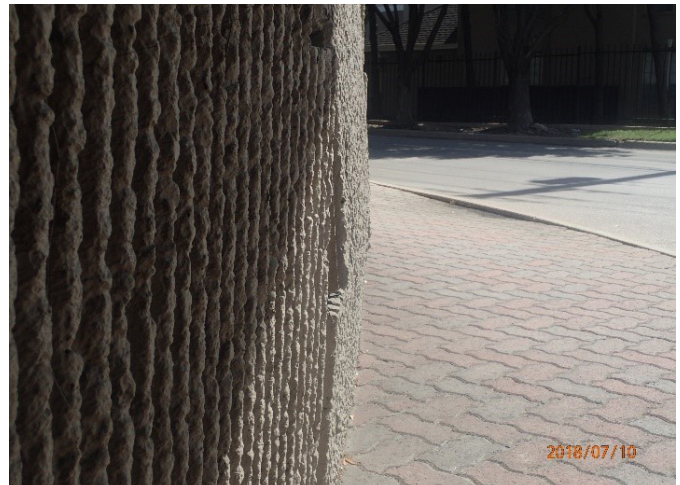
There were locations with wall panel cracking and movement (Figure 6). Other minor aesthetic conditions such as peeling paint was observed.

Figure 6: Retaining Wall Movement NB DNT at NE Corner of Quorum.

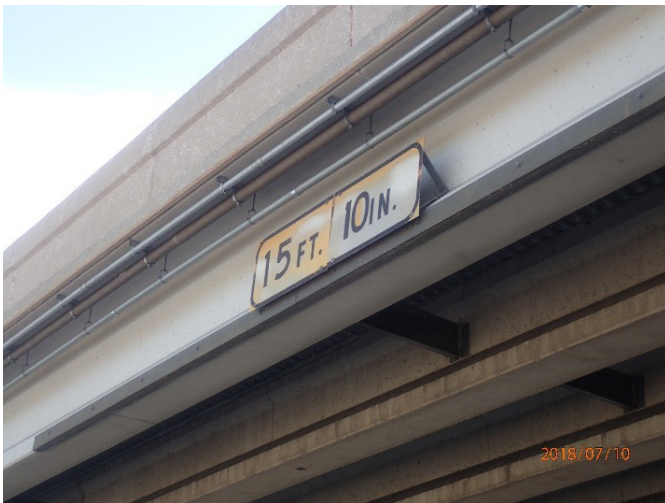
Figure 4: Clearance Sign Faded at EB Briargrove.

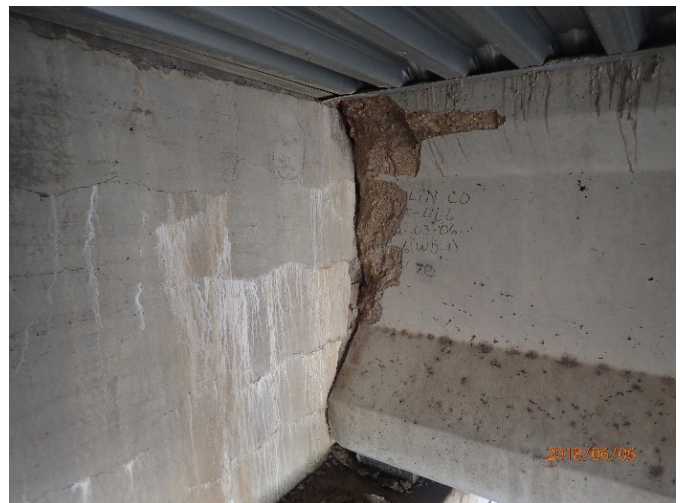
One observation noted was areas where the abutment backwall and the bridge beams were pushed together causing spalling on the beam ends (Figures 7 and 8).

Figure 7: Beam end spalling and backwall cracking NB DNT at Rock Hill South Abutment.

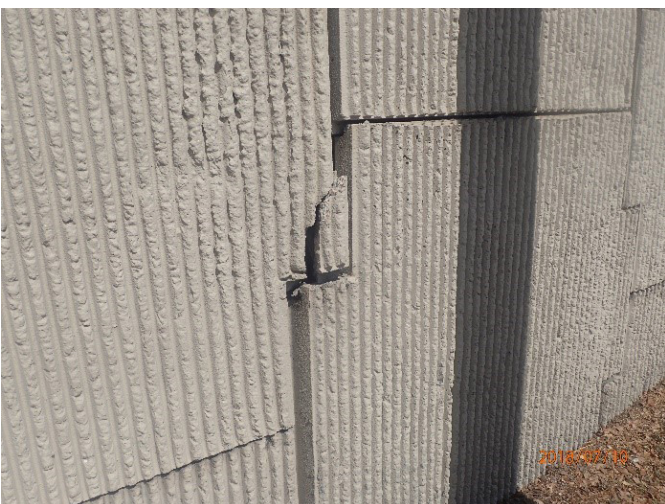
Wall panels and copings were observed with minor spalling at various locations (Figure 5).

Figure 5: Minor Wall Panel Spall at NB DNT at Spring Valley.

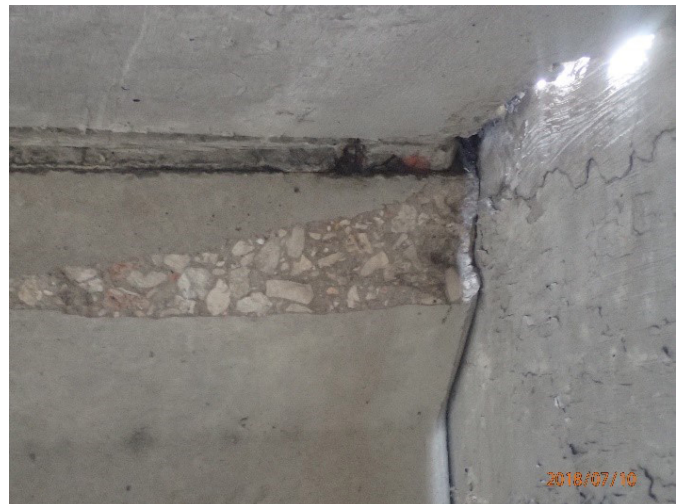
Figure 8: Beam end spalling SB DNT at Spring Valley.

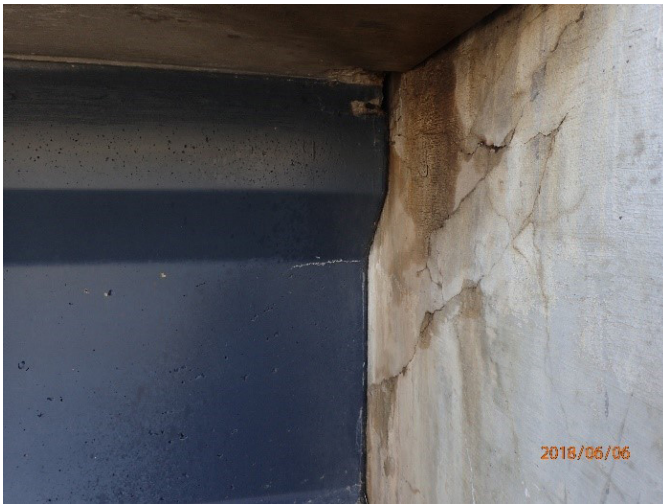
Cracking in the abutment backwall was observed at various locations (Figure 9).

Figure 9: Backwall Cracking SB DNT at Rock Hill.

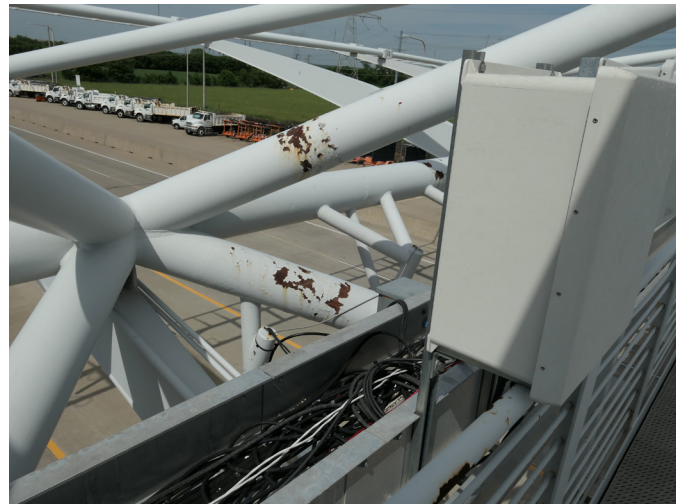
At MLP 4, located near Eldorado Parkway, observations include leaks causing water damage on ceilings and at windows, rust on exterior railings (Figure 10), and uneven sections of roof indicating possible water damage.

Figure 10: MLP 4 Rust on exterior railings

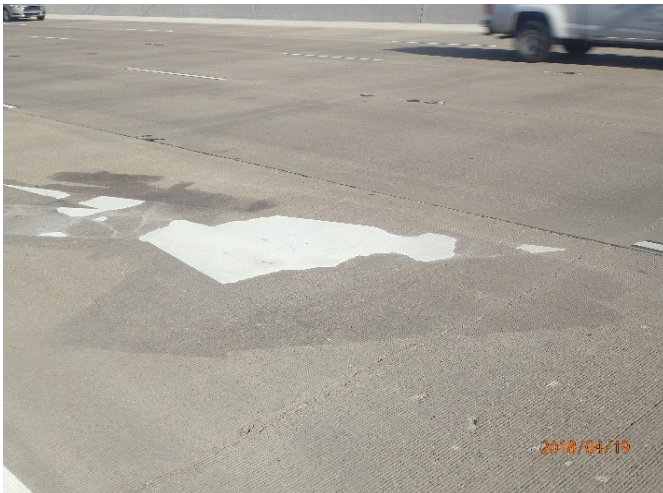
There were areas with missing or nonreflective pavement markings (Figure 11). These locations were typically observed on frontage roads and ramps.

Figure 11: Striping Cracked & Missing (arrow) EB PGBT E of Water View.

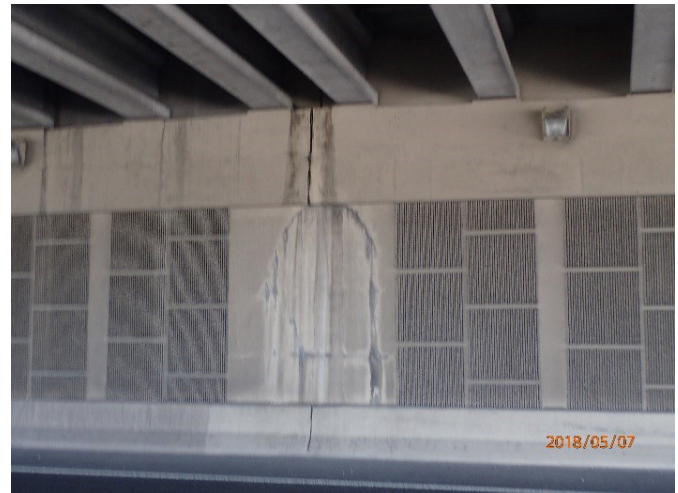
Figure 13: Retaining Wall Cracking EB PGBT under Old Denton Road.

One location with cracking and evidence of water seepage (Figure 13).

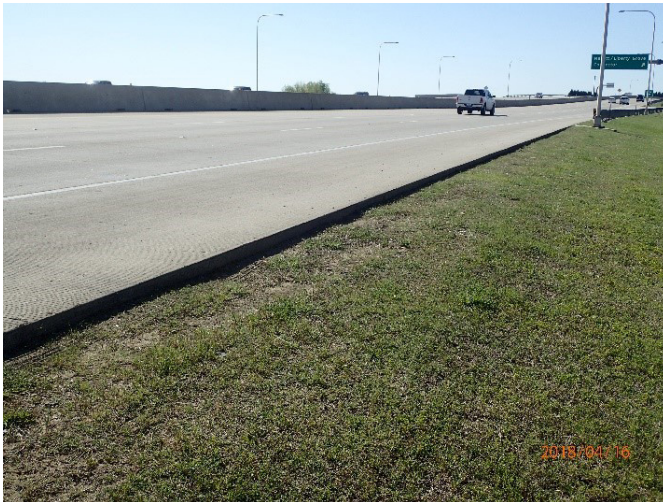
Pavement edge drop offs (Figure 12) and pavement cracking and spalling was observed at various locations throughout the corridor without a concentration in any specific area.

Figure 12: Pavement Edge Drop Off North of Merritt Road.

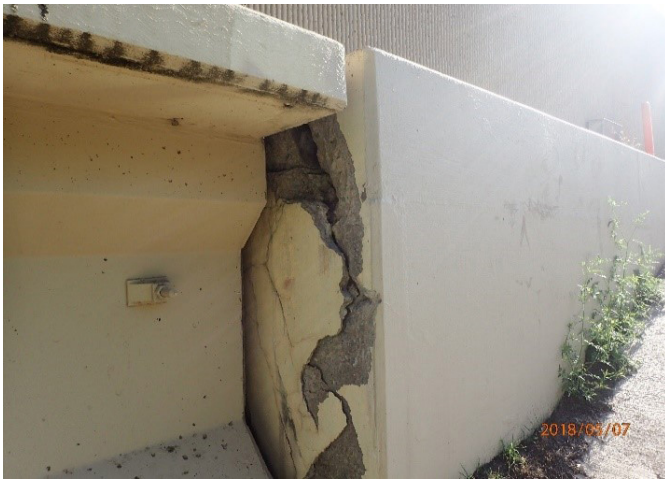
Bridge observations include abutment backwall cracking and spalling (Figure 14). Also noted was cap cracking as illustrated in Figure 15.

Figure 14: Backwall Cracking & Spalling EB Relief Bridge between Preston and DNT.

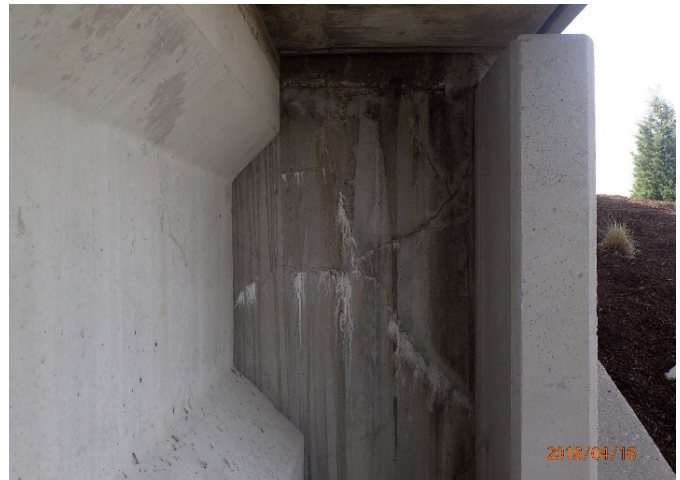
Erosion around bridge riprap and under bridges (Figure 16). Backwall cracking with efflorescence and bridge bent caps with minor spalls as illustrated in Figure 17 and 18.

Figure 17: Cracks with Efflorescence SBML North of Valley View Lane.

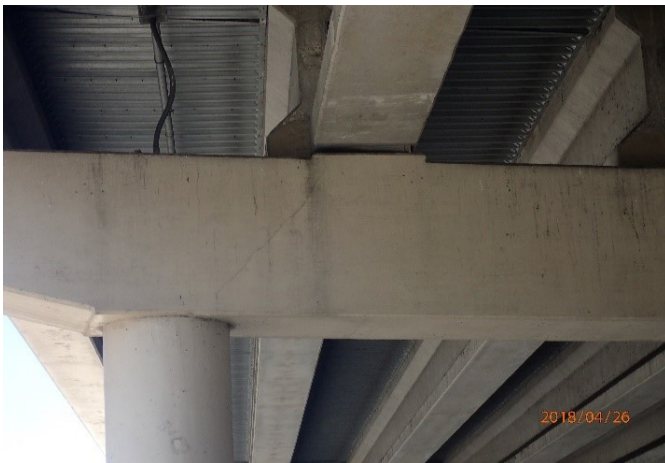
Figure 15: Cap Cracking EB Center Bent to Coit Road.

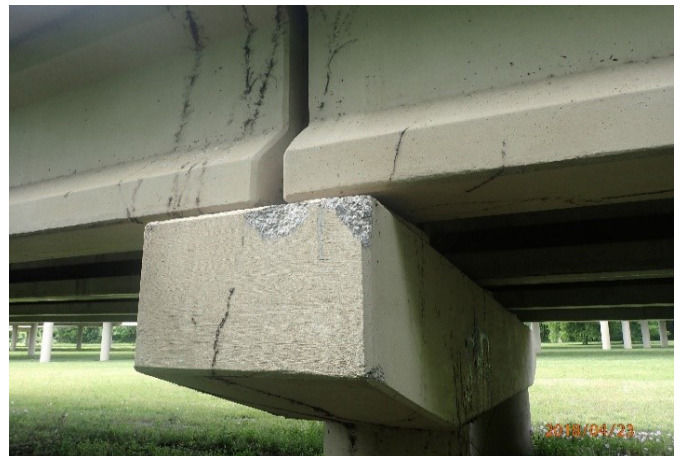
Figure 18: Cap Damage WB Exit Ramp to Brand Road.

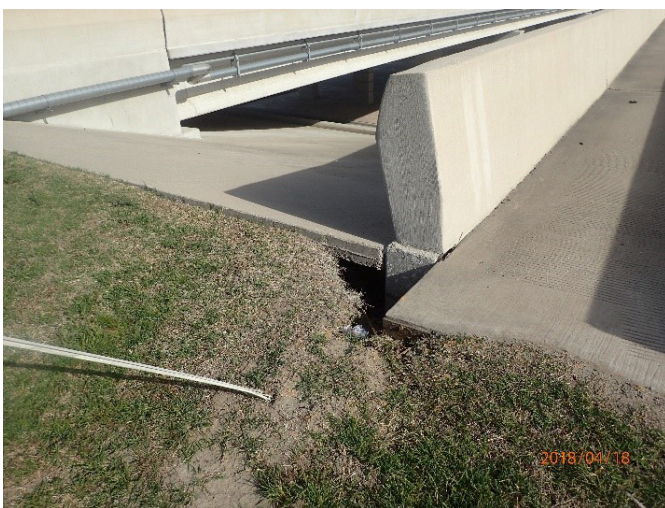
Figure 16: Erosion & Undermining of Riprap at Merritt Road.

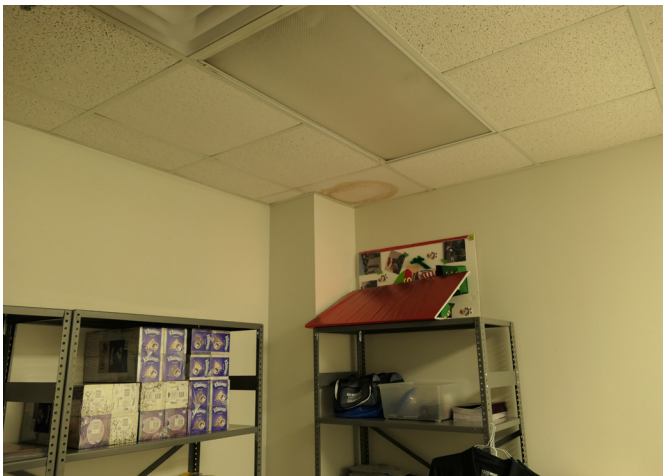
Observations identified throughout the facilities included deteriorating paint on exterior gates and interior stairs, evidence of water leaks, cracking in masonry walls, and rust developing on steel around windows as illustrated in Figures 19, 20, and 21.

Figure 19: MLP7 Evidence of water intrusion.

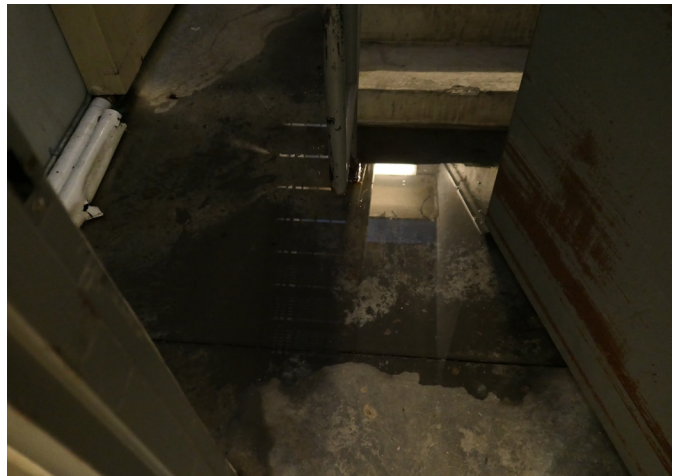
Figure 20: MLP7 Standing Water at Booth Access Stairs.

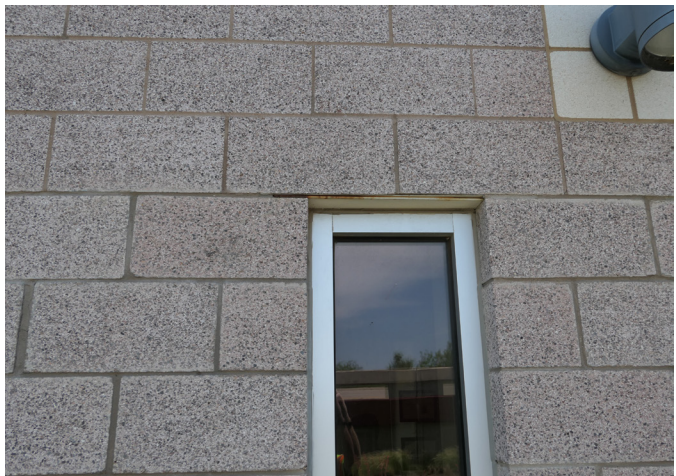
Figure 21: MLP10 Rust on Steel around window frame.

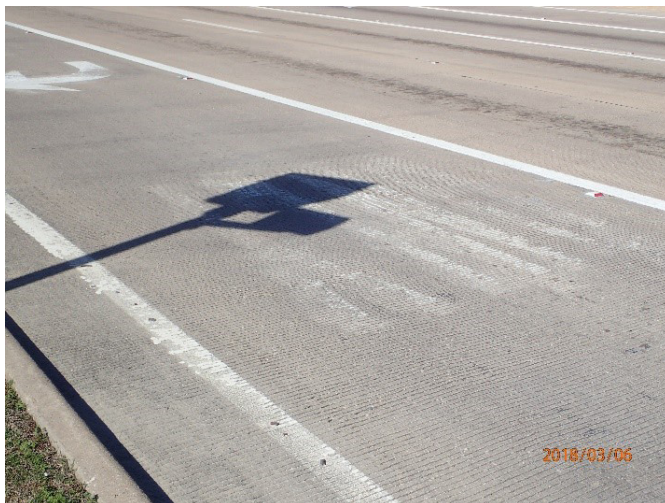
Figure 22: Faded Striping and Graphics NBFR West of Custer Road.

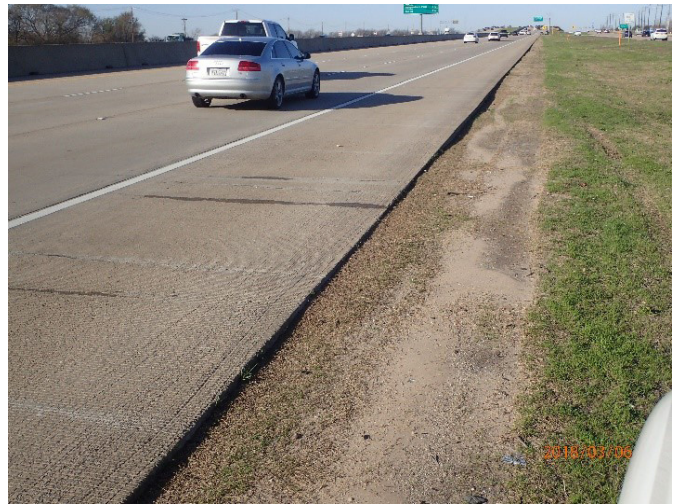
Pavement edge drop-offs, as illustrated in Figure 23, were noted throughout the corridor.

Figure 23: Pavement Edge Drop-off SBML at County Road 149.

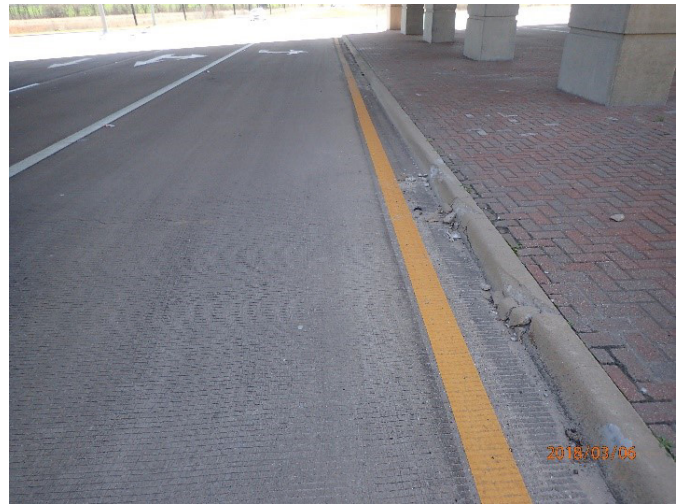
Curb damage, as illustrated in Figure 24, was observed at intersections and frontage roads.

Figure 24: Broken curb at Hardin Blvd.

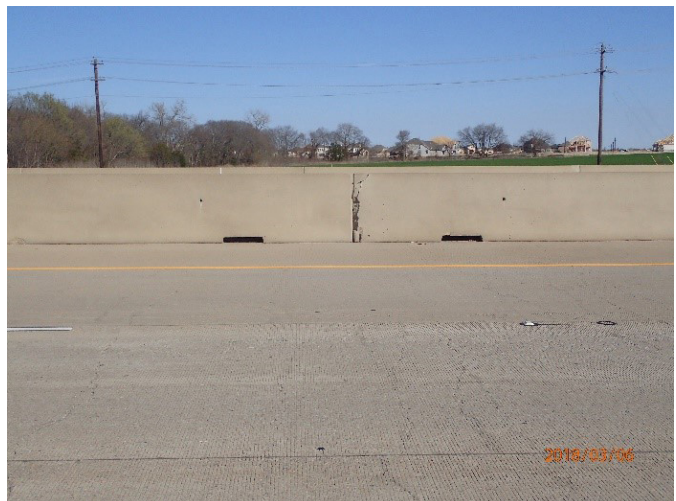
Minor barrier spalling was observed at various locations on the mainlanes as illustrated in Figure 25.

Figure 25: Barrier Spall NB West of Lake Forest Drive.

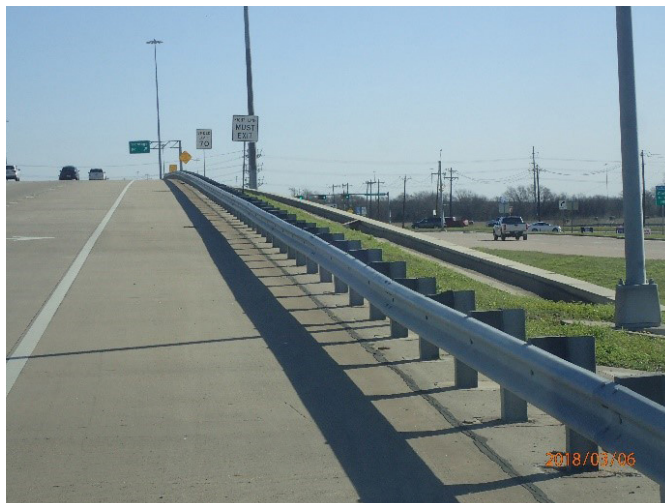
There were locations with erosion around concrete appurtenances as noted in Figure 26. Also noted were areas of missing delineation on guardrails and bridge rail as illustrated in Figure 27.

Figure 27: Missing Delineation at NBML West of Hardin Blvd.

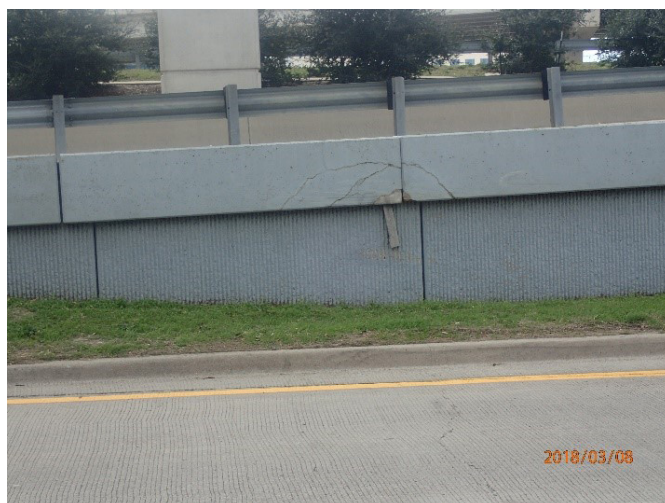
The retaining wall elements are in like-new condition. Minor coping damage as noted in a few areas as illustrated in Figure 28.

Figure 28: Minor Coping Damage SBFR East of Dallas North Tollway.

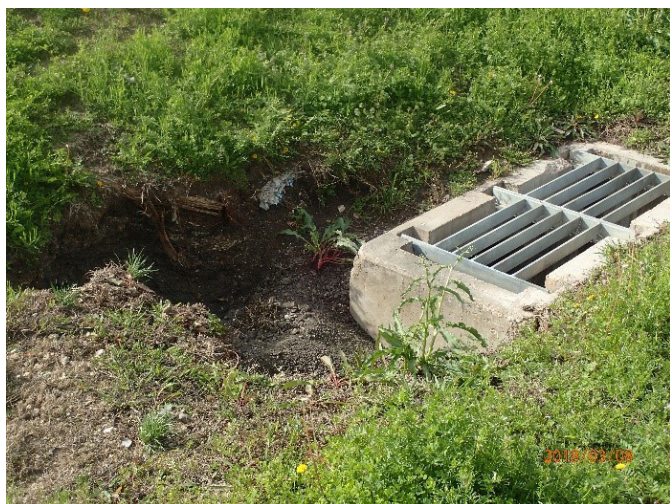
Figure 26: Erosion around Drop Inlet East of Paige Road.

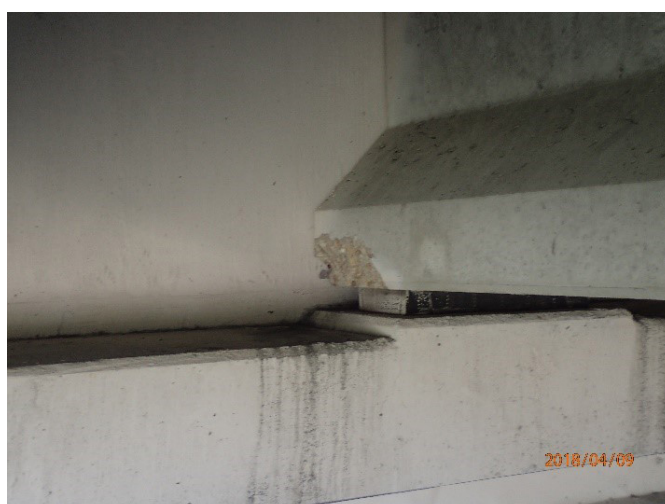
The bridge elements are in like-new condition. One observation noted was where the abutment back-wall and the bridge beams were pushed together causing the beam ends to spall (Figure 29). This condition is being monitored by NTTA staff

Figure 29: Beam end spalling at SBML @ Huffines Blvd. bridge.

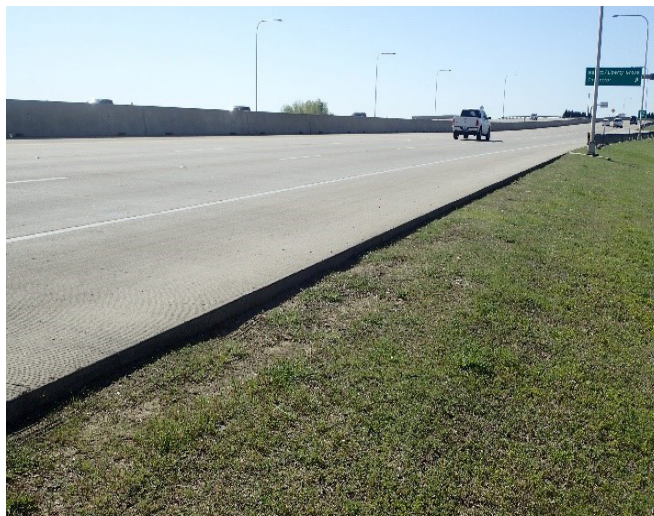
The recurring observations noted on this year's inspection were: erosion on slope embankment, ditch lines and around structures, pavement edge drop-offs (Figure 30), unsealed joints, and minor concrete barrier spalling.

Figure 30: Example of Pavement Edge Drop Off at various locations.

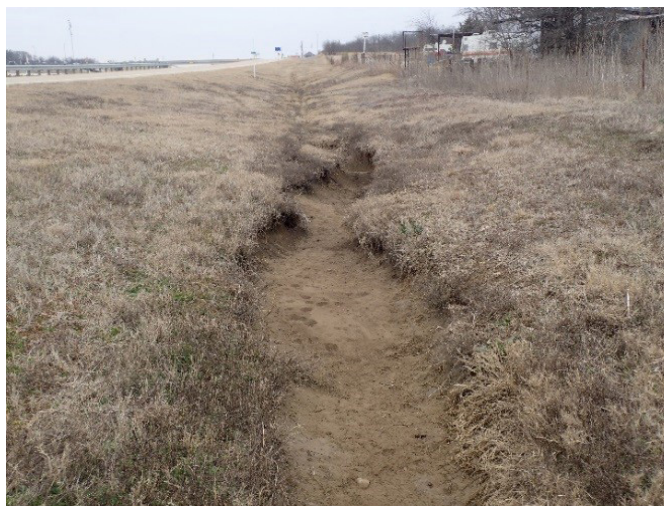
The inspection revealed areas with ditch-line erosion as illustrated in Figure 31. Additionally, erosion was observed around the luminaire concrete rip rap as illustrated on Figure 32.

Figure 31: Ditchline Erosion NB Exit Ramp to FM 917

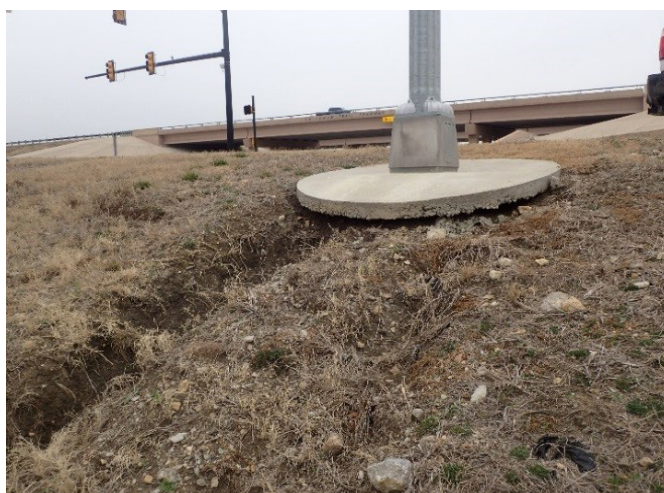
Figure 32: Erosion Around Luminaire Riprap SB Ramp from Sycamore School Road

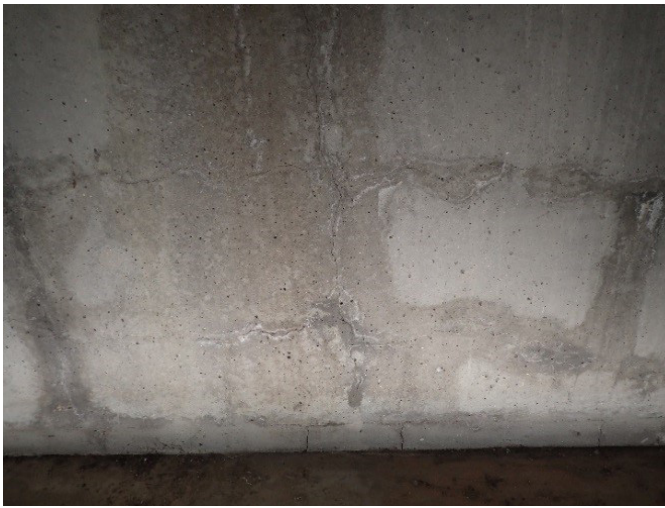
The majority of the bridge elements are in like new condition with only a few issues observed. One of the observations noted this year was minor cracking in the backwalls as illustrated in Figure 33.

Figure 33: Bridge Backwall Cracking at Sparks Drive.

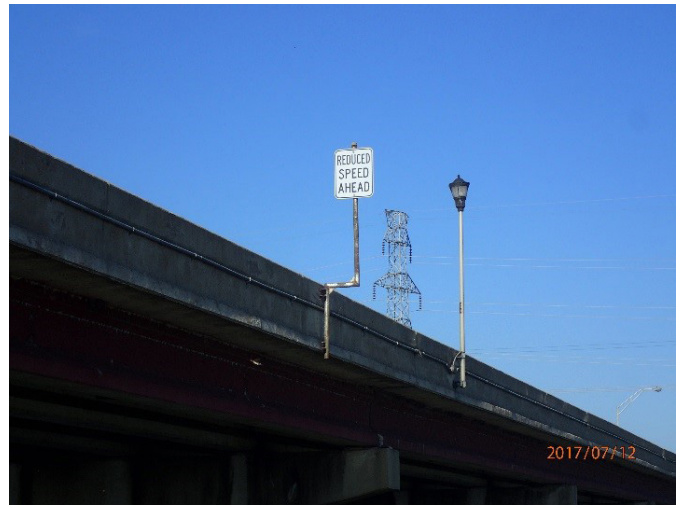
Bridge observations include interior and exterior bridge beam end spalling with exposed reinforcement, as illustrated in Figure 34. There are hairline vertical and diagonal cracks with efflorescence on

Figure 34: Rusty sign posts on bridge.

some of the bent caps. Also noted is moderate to heavy scaling on the concrete encasements on the columns. There is a structure repair project planned in 2018 but had not started as of the inspection.

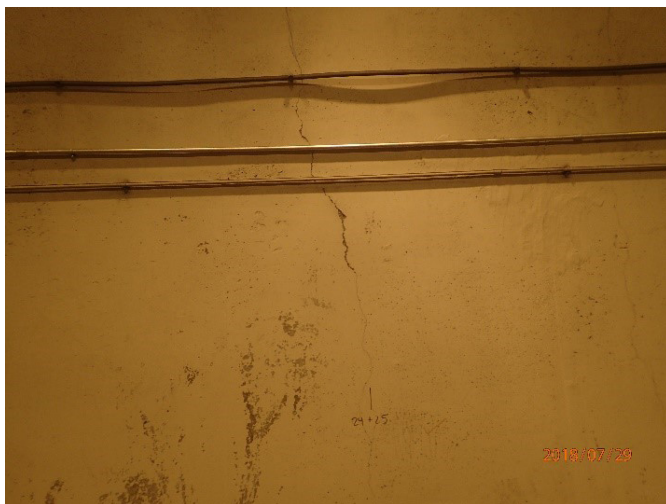
Observations concerning the tunnel walls include cracking at multiple locations (Figure 35). There were a few locations with wall spalling along the tunnel.

Figure 35: Cracking on tunnel wall.

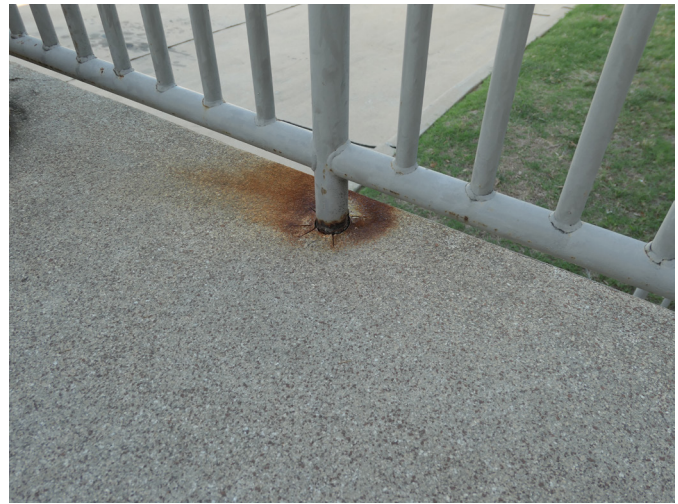
Observations at the Ohio Drive Maintenance Service Center include damage to roof fascia, paint delamination on interior wall, rust stains on the concrete from the pipe hand rails (Figure 36), rust developing on gutters, corrosion and missing cover plate at electrical box, and water leaks.

Figure 36: Rust Damage to Pipe at Ohio Drive Maintenance Service Center.

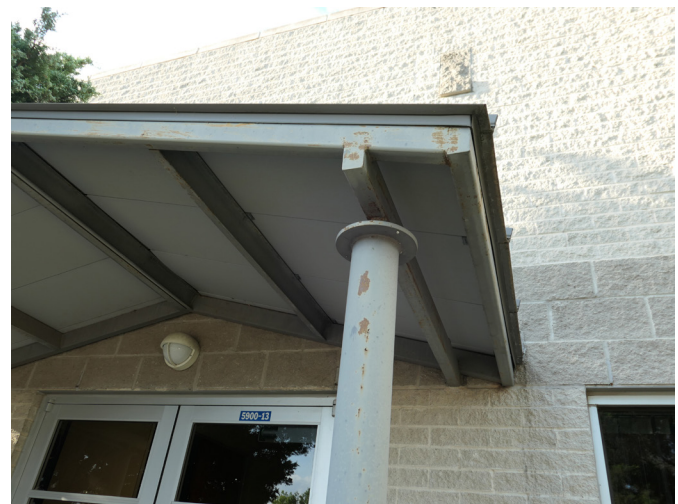
Observations at the Gleneagles Office Center at 5900 West Plano Parkway include rust on the west entry canopy (Figure 37), water stains on ceiling tiles, minor wall damage, parking canopy damage, cracked ceiling tile, lights not functioning, and concrete curb cracking.

Figure 37: Rust on West Entry Canopy at Gleneagles Office Center.
