# ANNUAL INSPECTION REPORT SYSTEM

FISCAL YEAR 2014

Prepared by Atkins North America, Inc.  
General Engineering Consultant

September 2014

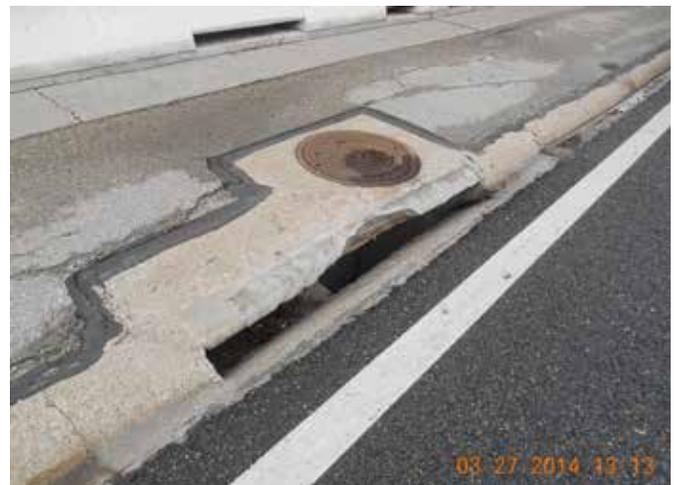
Figure 3: Damaged Inlet Sta. 262+00

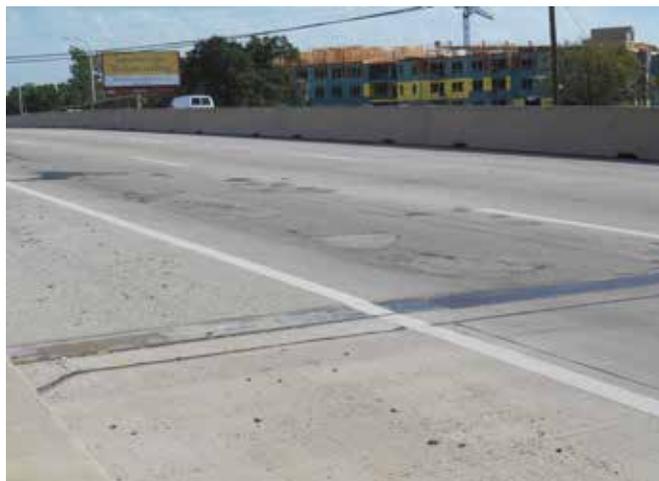
Spalling was observed on the deck of the main lane overpass bridges at Lemmon Avenue and Maple/Knight Street. Additionally, spalling was observed under the deck of the overpass at Harvest Hill Road at the north abutment.

**Figure 4: Degrading Bridge Deck at Maple/Knight**

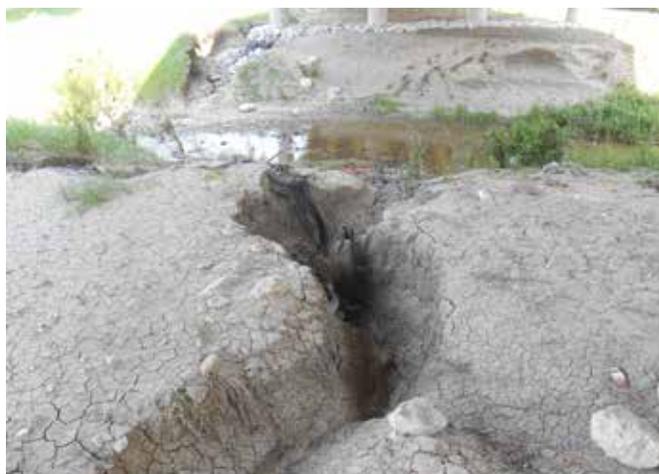
Erosion was noted under several of the main lane bridges on the northern section of the corridor. The areas of erosion include under the main lane bridge over Stewart Creek and Panther Creek. Erosion was observed around several of the bent columns at Stewart Creek, and erosion at Panther Creek had created ruts.

**Figure 5: Erosion at Panther Creek**

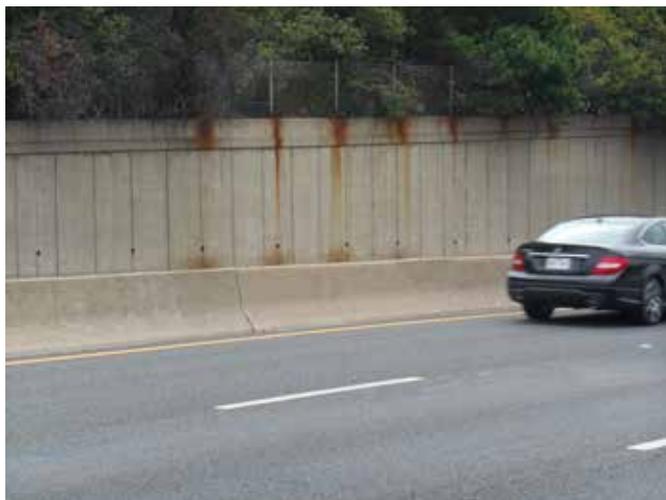
Rust stains on the walls were observed at the connections to the chain link fence posts at several main lane locations, primarily in the depressed sections from University Boulevard to Northaven Road.

**Figure 6: Fence Rust Staining Wall North of Northaven**

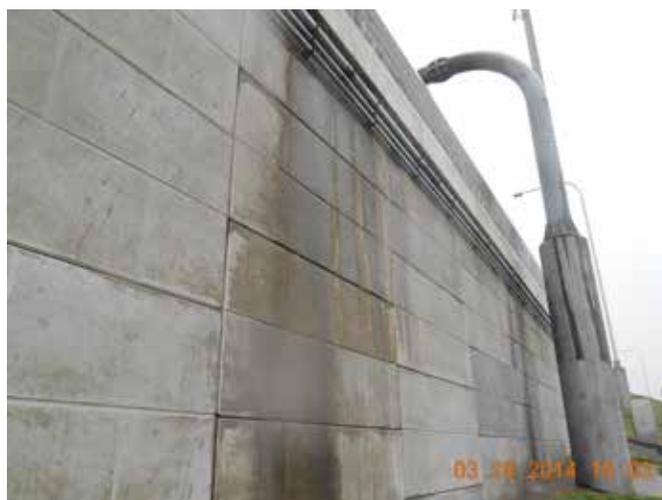
Water stains on the retaining wall was noted at several bridge abutments on the south end including: Walnut Hill Lane, Park Lane, Oak Lawn Avenue, Northwest Highway, University Boulevard, Mockingbird Lane, Beverly Drive, Bordeaux Avenue, and Cedar Springs Road.

**Figure 7: Water Stains on Retaining Wall at Oak Lawn Avenue**

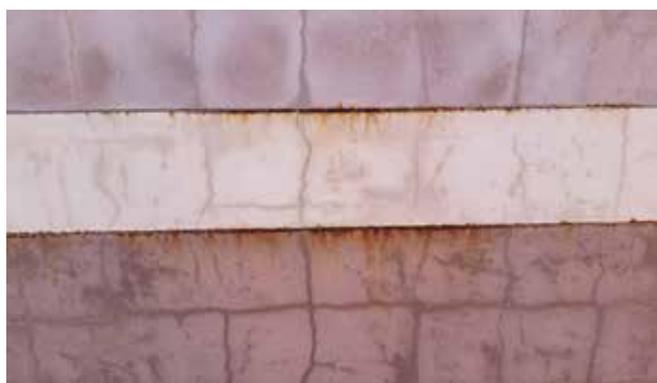
Figure 8: Rust Stains on CMU Wall at MLG 3

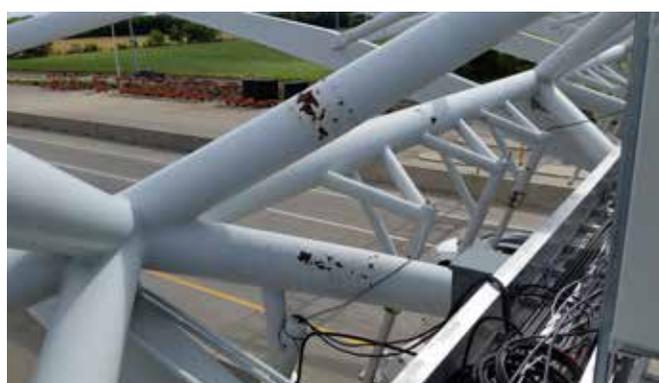
Figure 9: Gantry Light Surface Rust at MLP 4

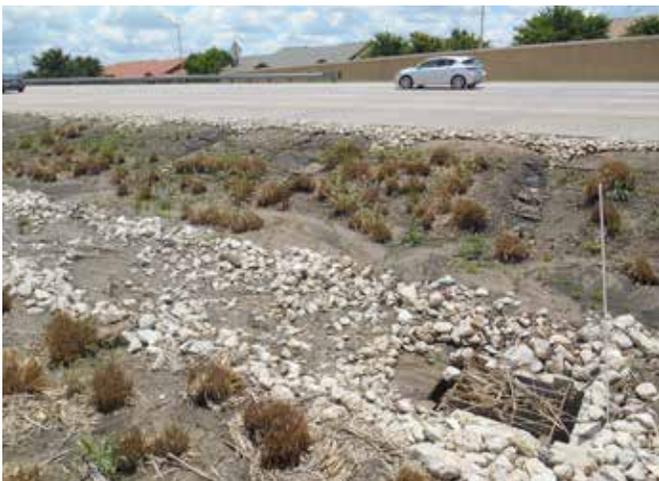
Erosion was observed throughout the corridor in the center median. Erosion in some areas caused edge drop offs.

**Figure 10: Erosion in the Center Median Near Coit**

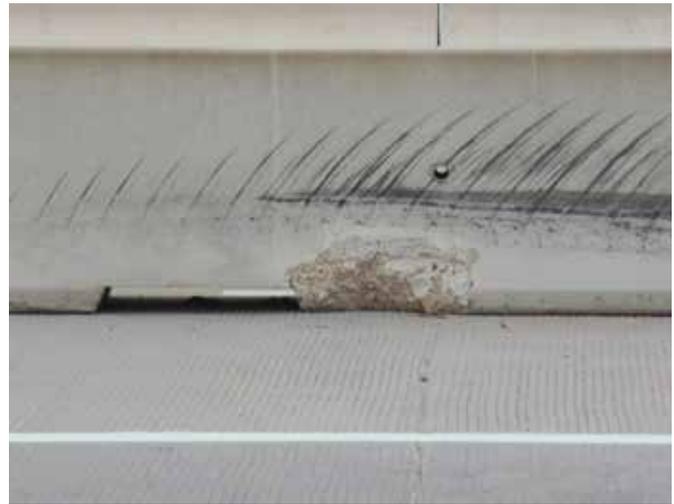
**Figure 11: Rail Damage North of Belt Line**

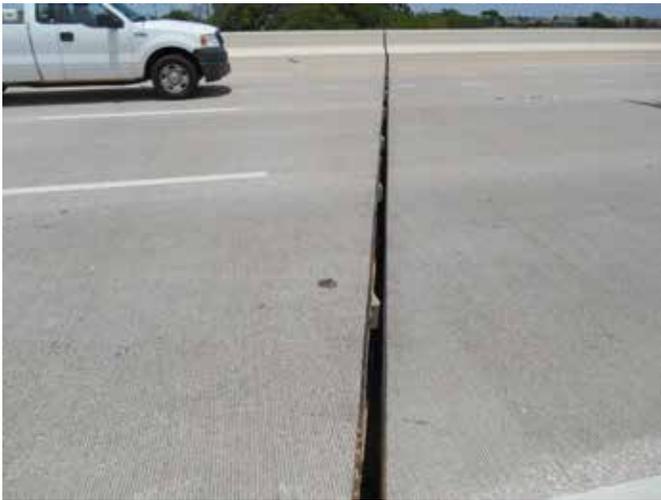
Missing or degrading seals were observed on the centerline and joints of several bridges. Most notably the bridge over Brand Road and Spring Creek is missing seals at most of the joints.

**Figure 12: Missing Seal at Bridge over Brand Road**

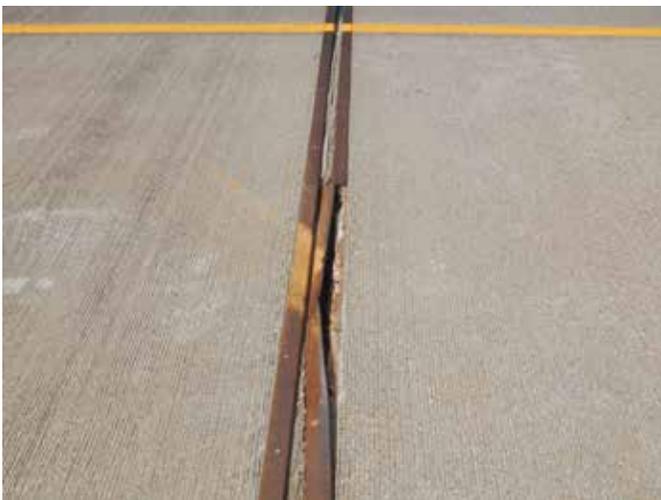
Damaged armor joints were observed on the bridge near Hutton Branch and Belt Line Road.

**Figure 13: Damaged Armor Joint at the Bridge over the DNT Interchange**

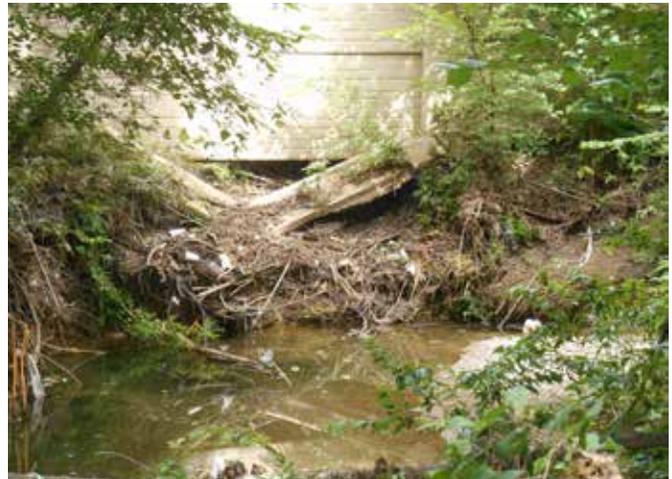
Creek encroachment on a sound wall was observed near MLP 8. The creek behind the wall has eroded the bank up to one of the columns.

**Figure 14: Creek Encroachment near MLP 8**

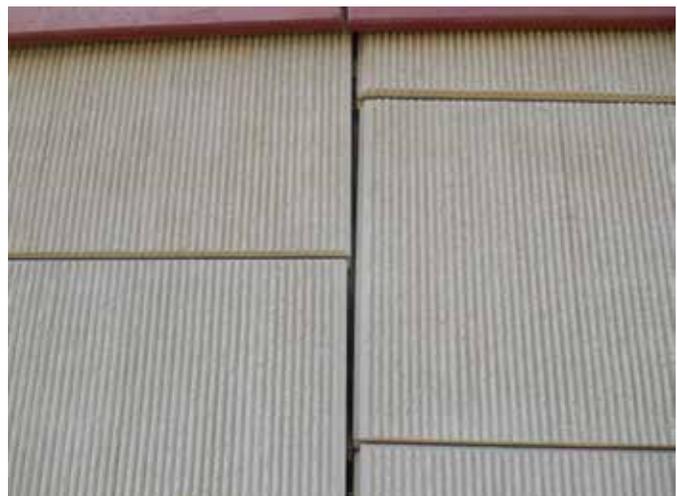
Panel misalignment was observed on the east side of Dickerson Parkway, southeast ramp abutment at US-75, and at westbound to northbound direct connector ramp abutment at the IH-35E interchange.

**Figure 15: Panel Misalignment EB PGBT to EB IH 635**

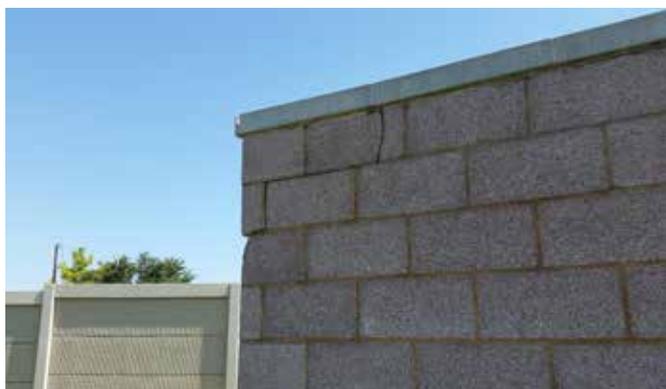
Figure 16: Cracking CMU Wall MLG 8

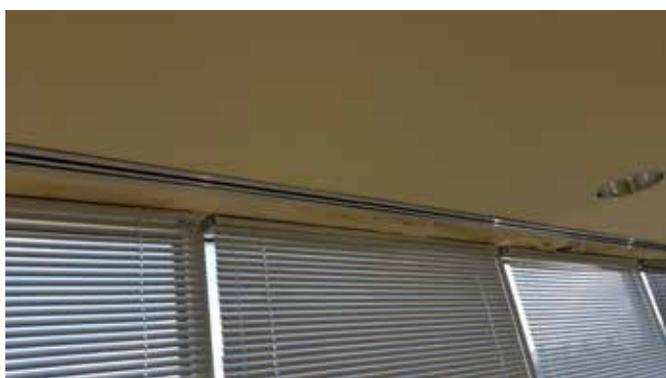
Figure 17: Water Damage on Ceiling MLG 7

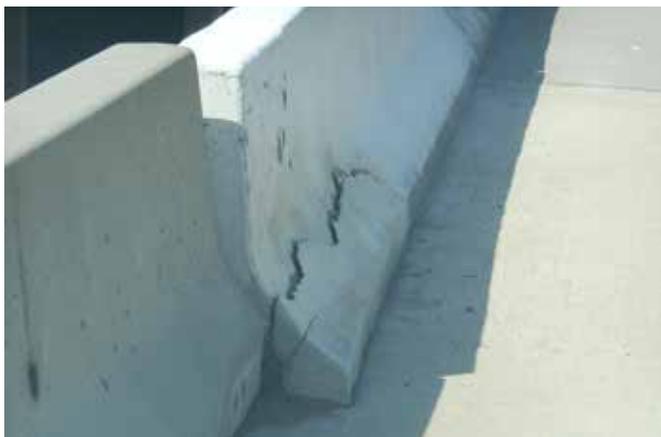
Barrier spalling and cracking was observed throughout the roadway, particularly on the center median barrier, with rebar exposed at several locations.

**Figure 18: Rail Damage West of Huffines**

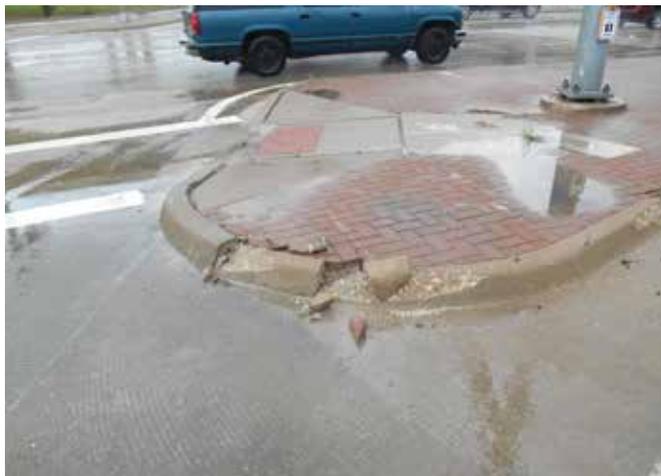
Curb damage was observed throughout both frontage roads and on most of the cross street underpasses.

**Figure 19: Damaged Curb at the Preston Road Intersection**

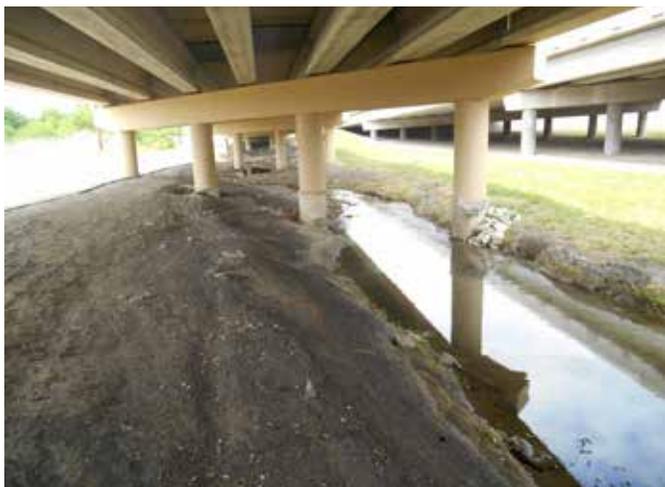
Figure 20: Erosion near White Rock Creek

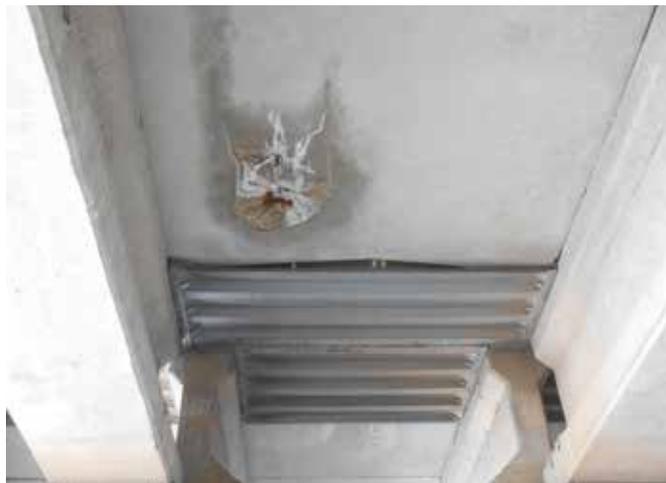
A deck spall was observed under the FM 2281 (Old Denton Road) bridge on the north side.

Figure 21: Deck Spall under FM 2281 Bridges

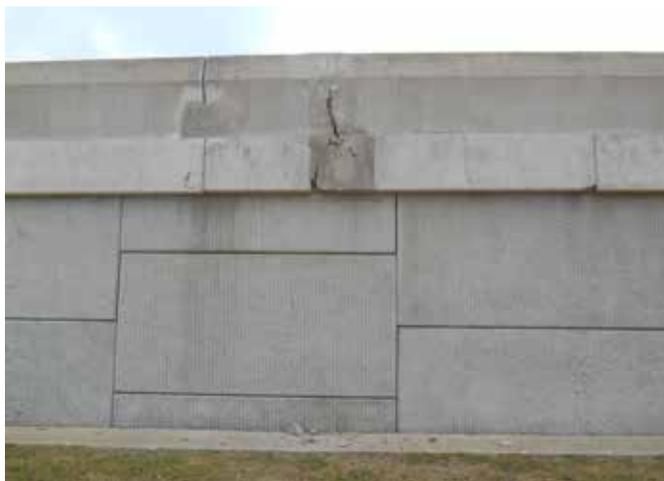
The coping has been damaged on the north side wall at Spring Creek Parkway, the westbound frontage road east of Hillcrest Road, and on the eastbound frontage road west of Rowlett Cemetery Road. These areas are minor and aesthetic in nature.

Figure 22: Damaged Coping East of Hillcrest Road

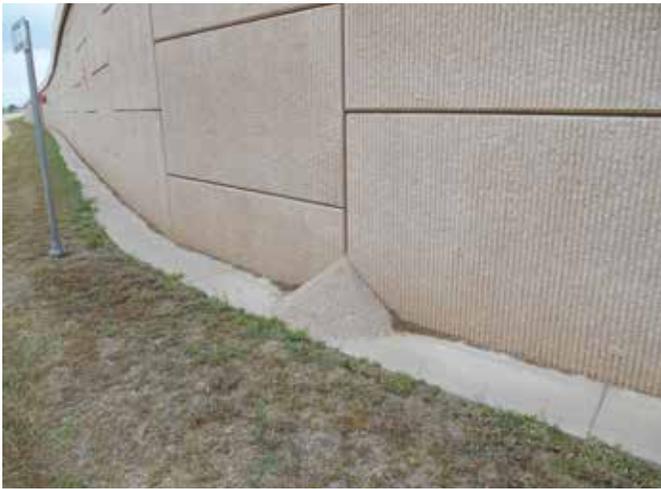
**Figure 23: Backfill coming through Wall at Denton Tap Road**

The backfill is coming through the retaining wall on the west side of Denton Tap Road.

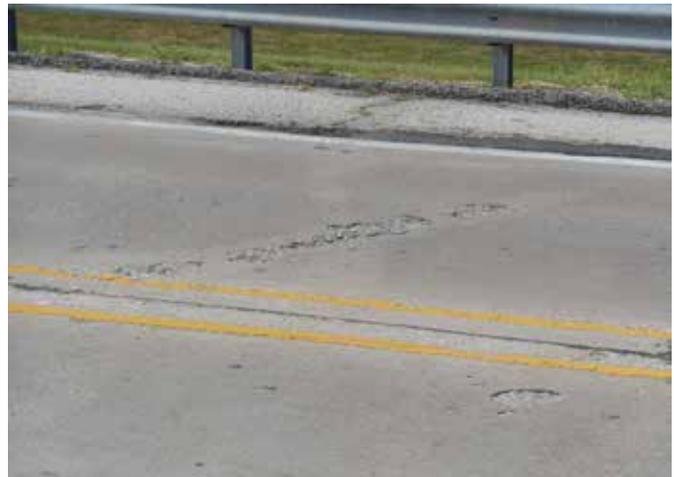
Pavement degradation was observed on both the east and west approaches. Specifically, the east approach slab, as well as the pavement near the

**Figure 24: Pavement Degradation East End**

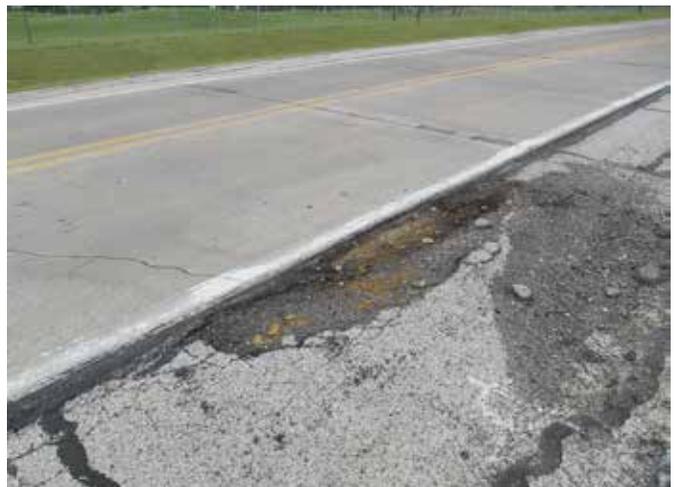
**Figure 25: Shoulder Degradation West End**

gantry on the western approach, showed cracking and spalling. Asphalt shoulders on each approach have deteriorated. The pavement markings are also fading across the bridge.

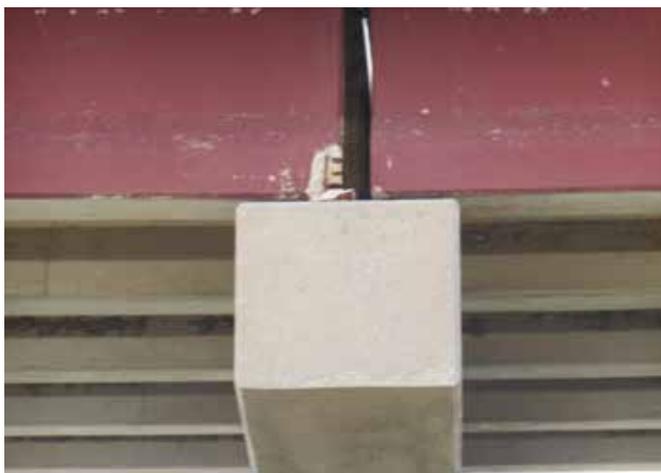
Notable bridge observations included minor spalling at beam ends and at column casings.

Figure 26: Beam Spalling

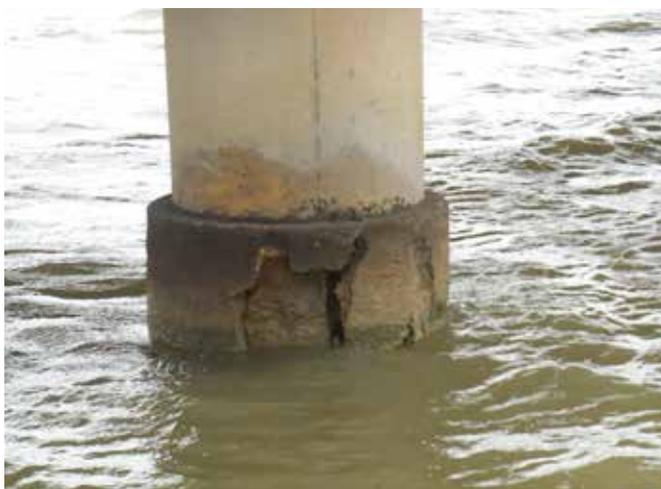
Figure 27: Column Sacrificial Protection Spalling

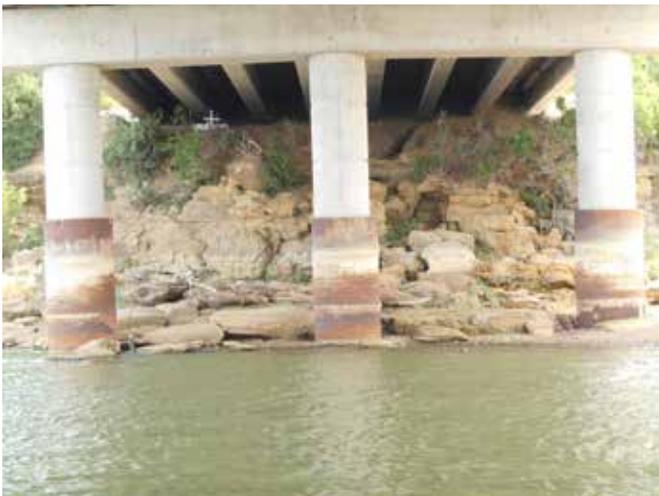
Figure 28: Erosion on the West End

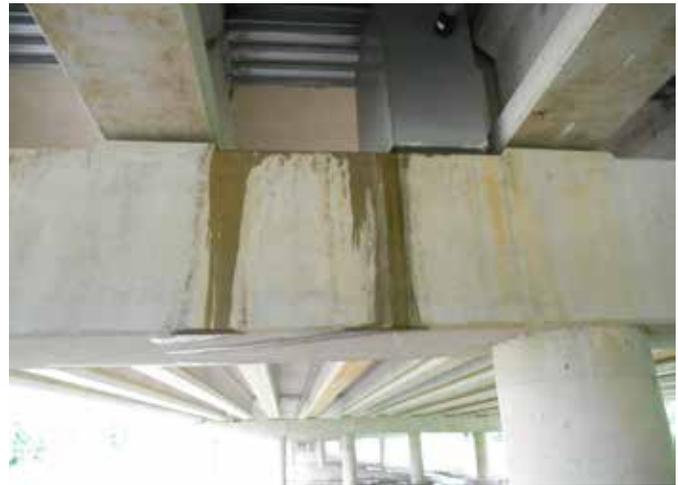
Figure 29: Filter Box Leaking on the East End

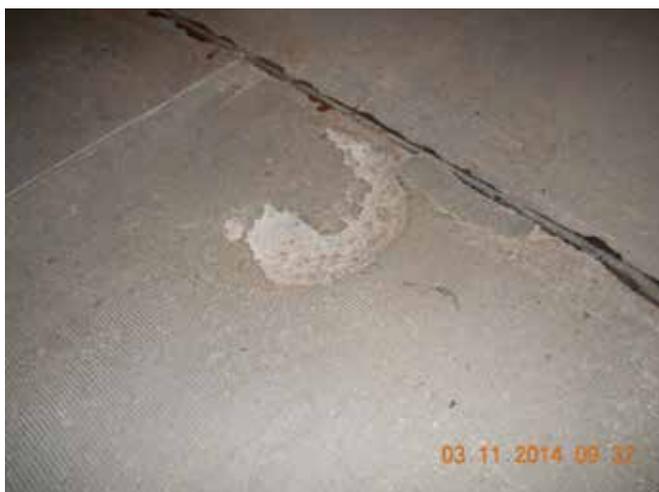
Observations on the roadway included pavement spalling and faded pavement markings. The pavement spalling was observed on the west end near the gantry, and the pavement markings on the entire roadway are faded.

Figure 30: Pavement Spalling on the West End

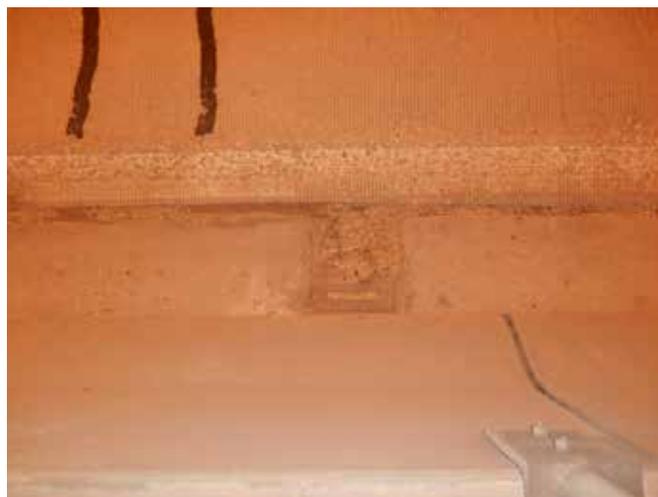
Figure 31: Debris in Drain Near the West End
