ANNUAL INSPECTION REPORT SPECIAL PROJECTS SYSTEM

FISCAL YEAR 2013

Prepared by Atkins North America, Inc.
General Engineering Consultant

May 2013

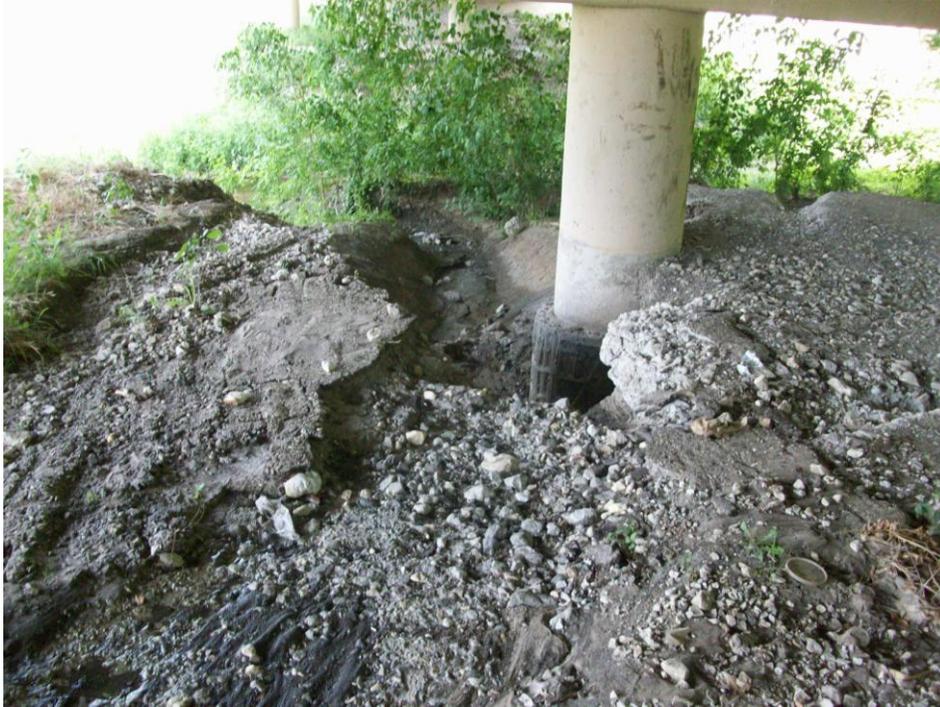
Figure 3: Erosion under Northbound Frontage Road Bridge over South Fork of Cottonwood Creek Tributary

The other area of concern is under the northbound frontage road bridge north of Pioneer Parkway. This bridge crosses the south fork of a Cottonwood Creek tributary. As evidenced from Figure 3, the erosion has exposed a drill shaft column. This erosion is caused by runoff originating from the east side of the southern abutment.

The NTTA Maintenance Department, GEC, and MMC, met to review this area and all agreed that this is an area that requires additional attention. The Maintenance Department committed to repairing this area in the next fiscal year.

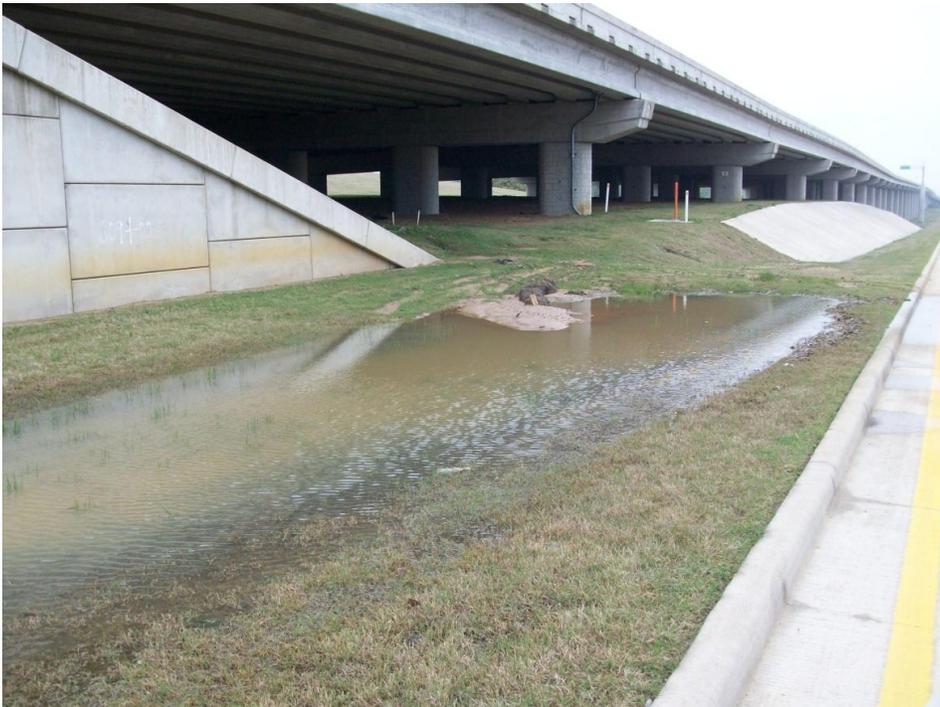
Figure 4: Ponding along Northbound Frontage Road Bridge north of Shady Grove Road

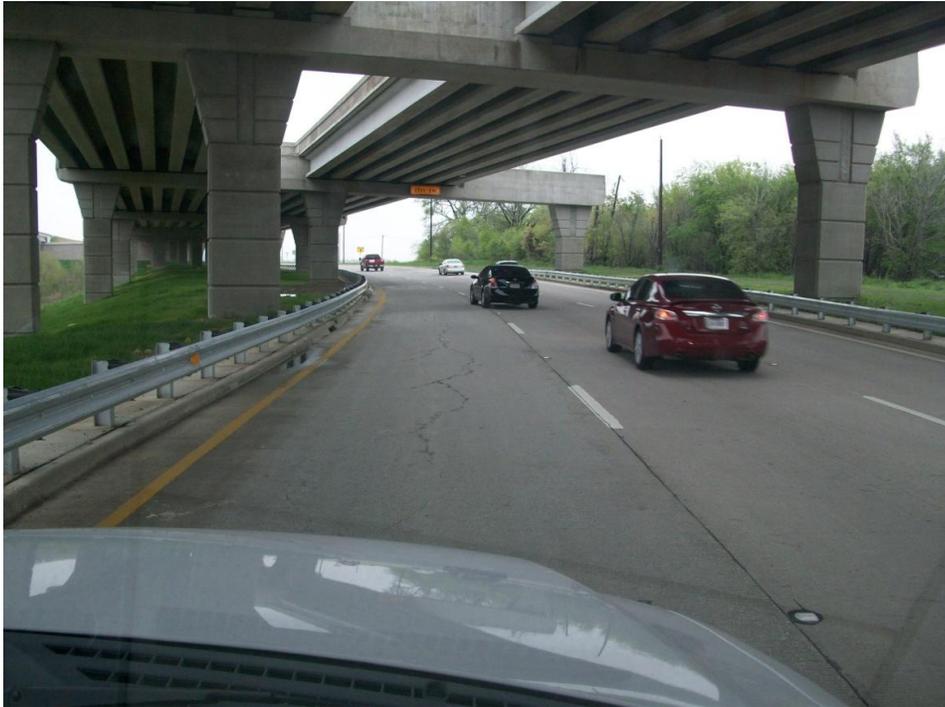
Consistent with the age of the roadway, a few isolated areas of pavement cracking were observed relative to the condition of the pavement.

Figure 5: Transverse Cracking on Northbound Frontage Road at IH-20 Interchange

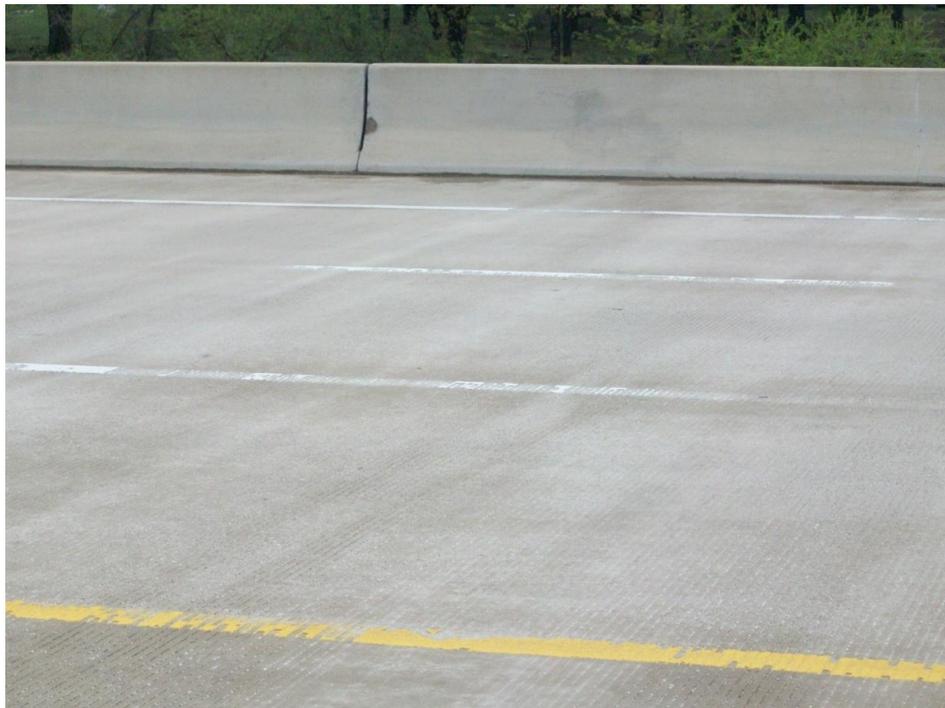
The pavement markings on the frontage roads and main lanes constructed during Phases 1–3 have begun to fade and chip. Phases 1 and 2 opened to traffic in August 2009 and Phase 3 opened in April 2010. The pavement markings on these three phases, which include all frontage roads and the main lanes from SH 183 to Egyptian Way, are field-applied thermoplastic. The Phase 4 main lanes contain prefabricated tape markings and are in generally good condition.

Figure 6: Pavement Markings on Main Lanes, Phases 2 and 3 – Typical

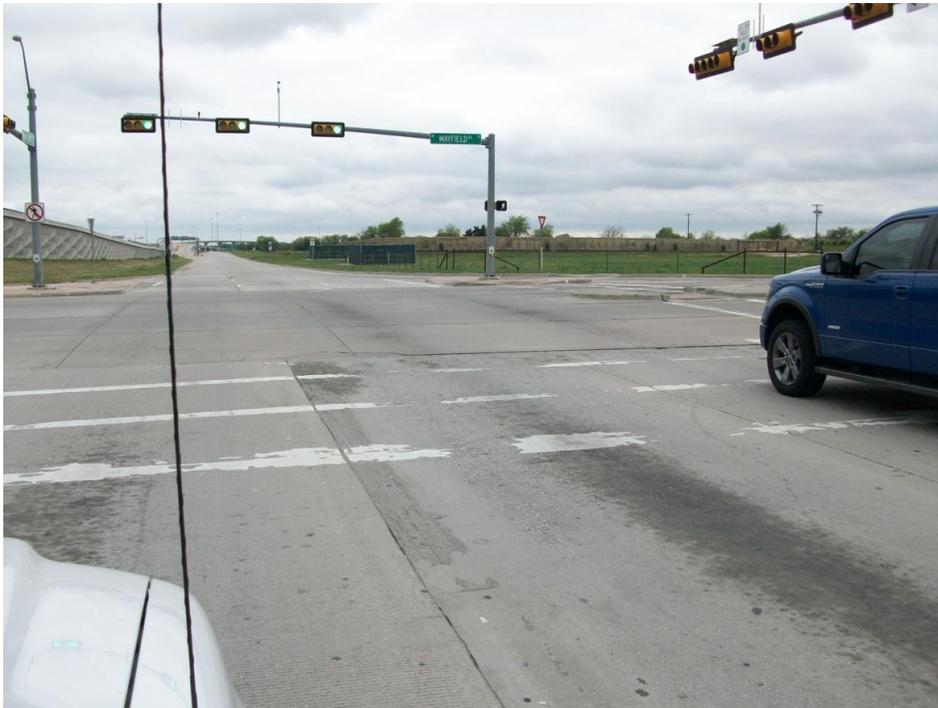
Figure 7: Pavement Markings on Southbound Frontage Road at Mayfield Road

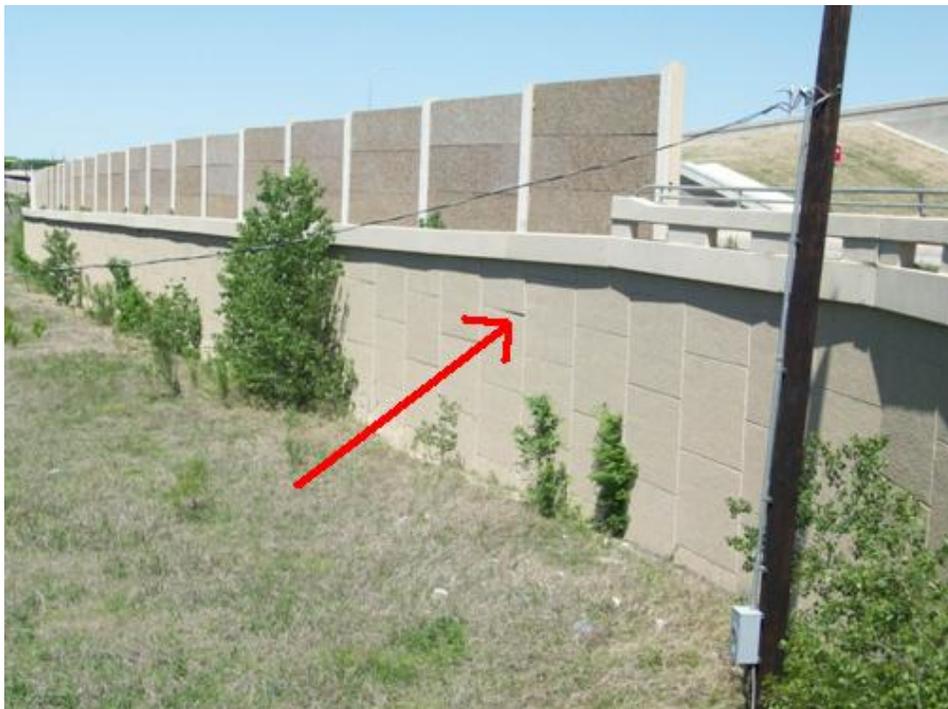
The majority of retaining walls are in like-new condition. However, one area of concern is the retaining wall supporting the west side of the Southbound Frontage Road (SBFR) as well as the north side of Egyptian Way. Several wall panels on this mechanically stabilized earth (MSE) wall are out of alignment and an adjacent Johnson Creek tributary is encroaching on the wall at several locations. Last year's inspection report also mentioned the encroachment as a concern.

Figure 8: West Side of Southbound Frontage Road north of Egyptian Way

The cause of the misaligned panels is inconclusive as the wall may have been constructed without the proper alignment. Without an additional engineering investigation of the wall, potential causes cannot be determined.

The NTTA Maintenance Department, GEC, and MMC met to review this area and all agreed that this is an area that requires additional repair of the mowing strip and monitoring of the wall. The Maintenance Department committed to repairing this area in the next fiscal year and providing additional monitoring of the wall.

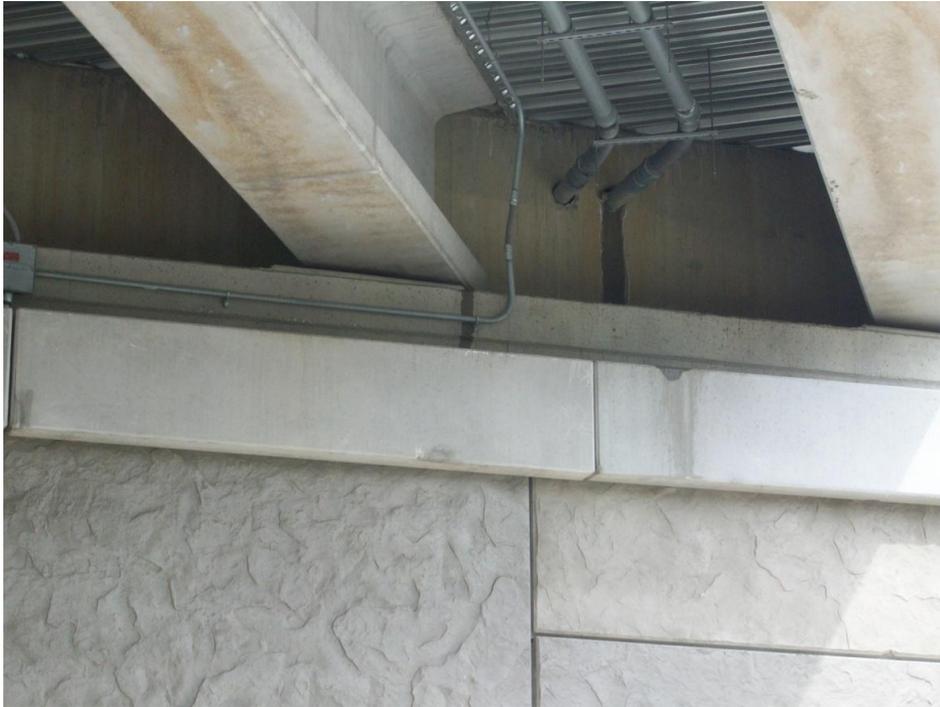
The majority of bridge elements are also in like-new condition with no significant issues observed. A minor issue relating to aesthetics includes leakage from underhang conduit onto the abutment backwalls at Jefferson and Dalworth Streets. Also, debris in the armor joints was observed.

Figure 9: Leak at conduit – East Side of Main Lane Underpass at Dalworth Street

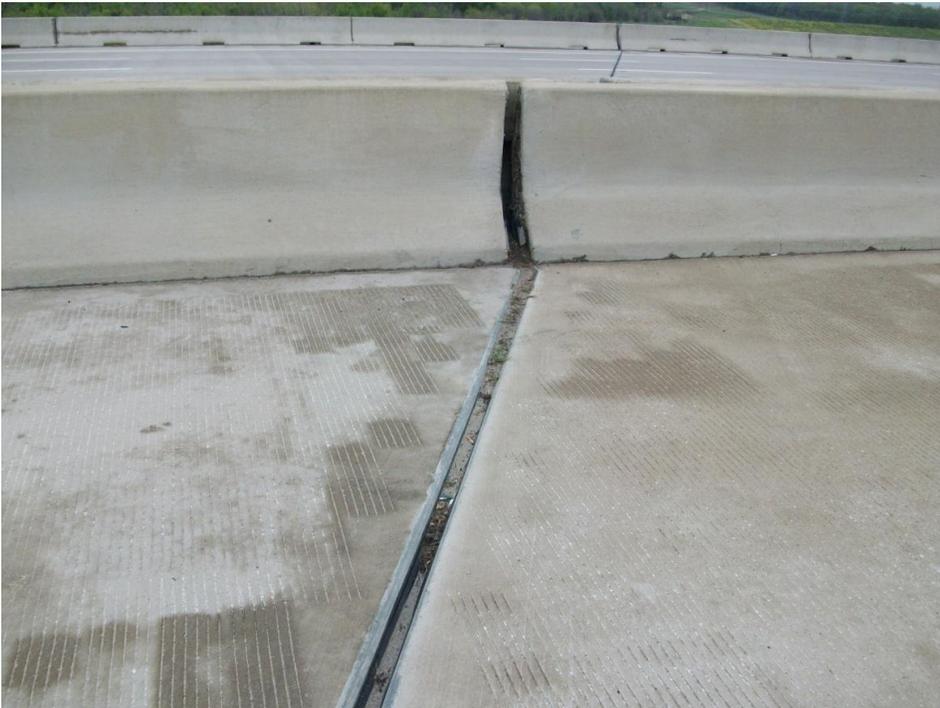
Figure 10: Debris in Shoulder of Armor Joint – Typical

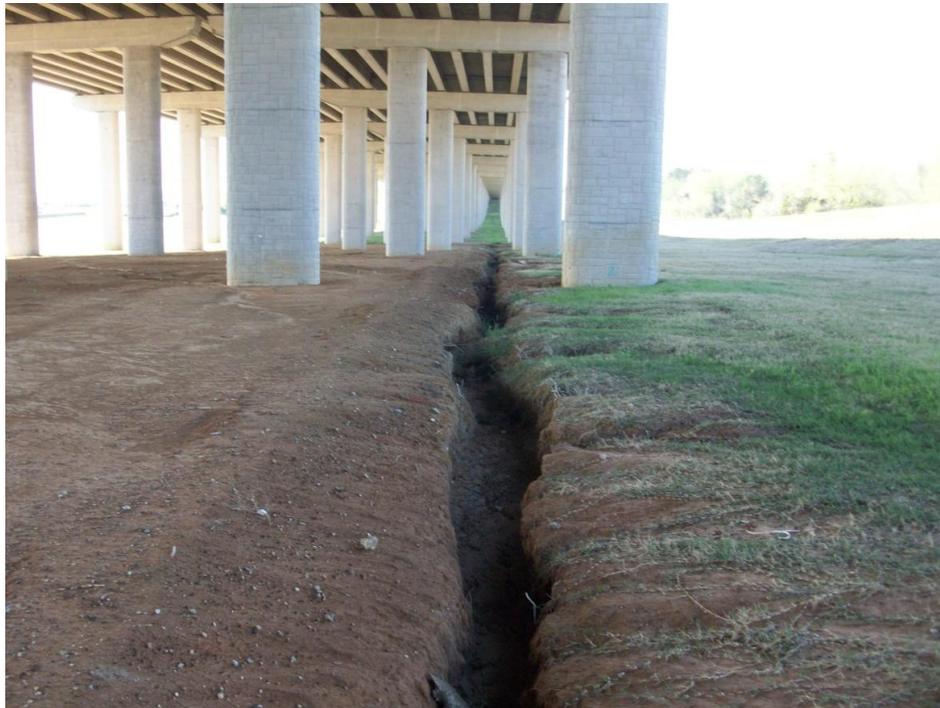
The area under the southbound mainline bridge from Rock Island Road southward shows significant erosion. This erosion has caused deep rutting that may begin to undermine the bridge column supports if left unattended over time. The rutting has begun to encroach on the westernmost column of the bridge.

Figure 11: Erosion under Southbound Mainline Bridge
South of Rock Island Road (Facing South)

The NTTA Maintenance Department, GEC, and MMC met to review this area and all agreed that this is an area that requires additional attention. The Maintenance Department committed to repairing this area in the next fiscal year.

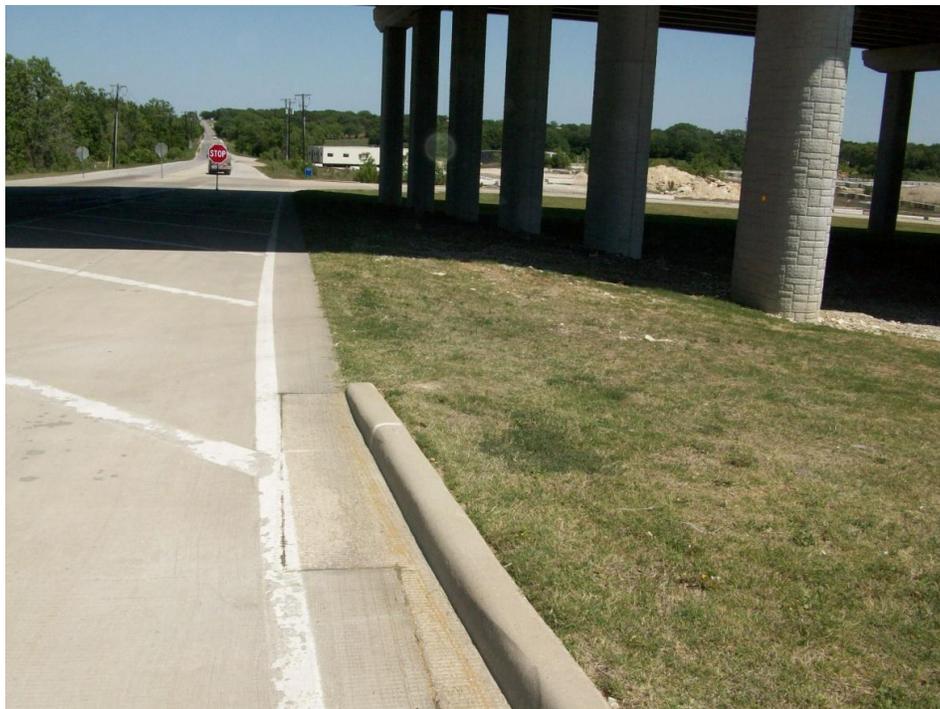
Figure 12: South Side of Rock Island Road
without Curb (Facing East)

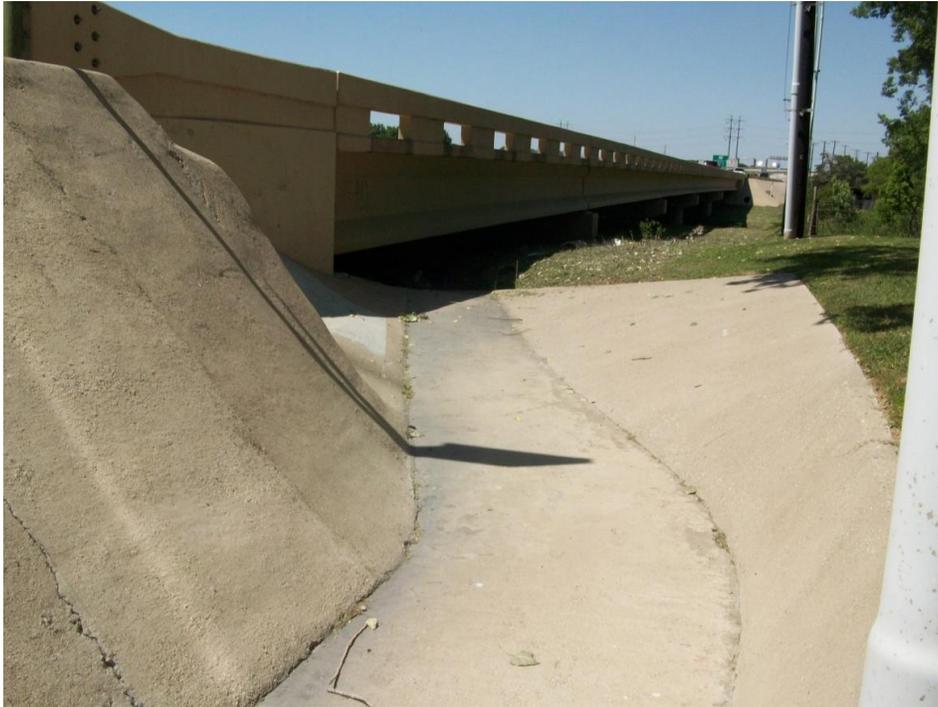
Figure 13: Southeast corner of Northbound Frontage Road bridge over Cottonwood Creek Tributary (Facing Northwest)

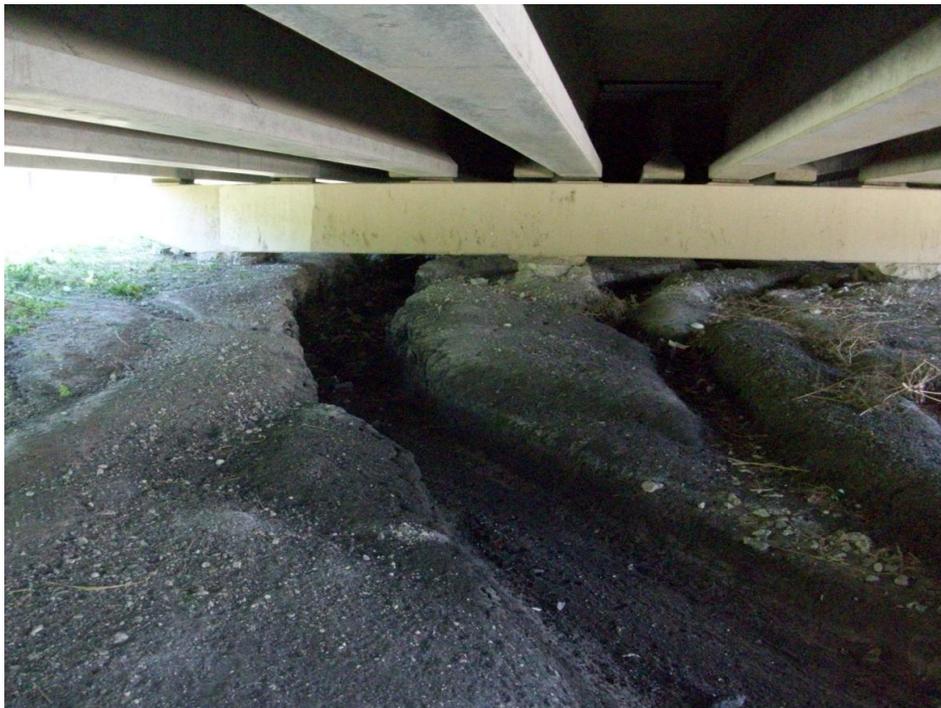
Figure 14: Northbound frontage road bridge over Cottonwood Creek Tributary (Facing South)

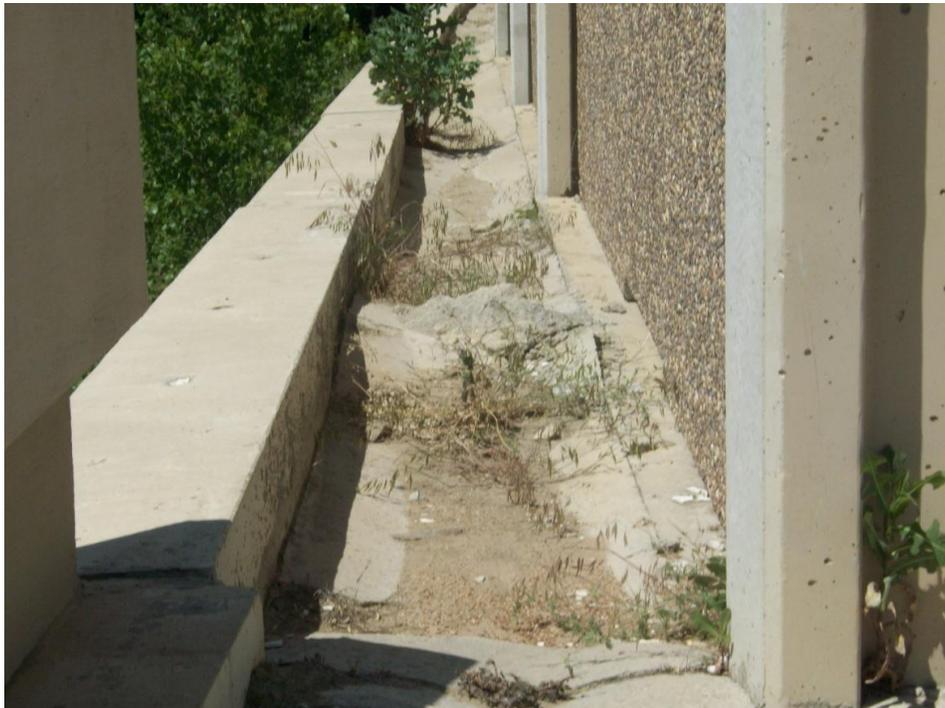
Figure 15: Mowing strip between Retaining Wall and Sound Wall on West Side of Northbound Frontage Road North of Egyptian Way (Facing North)

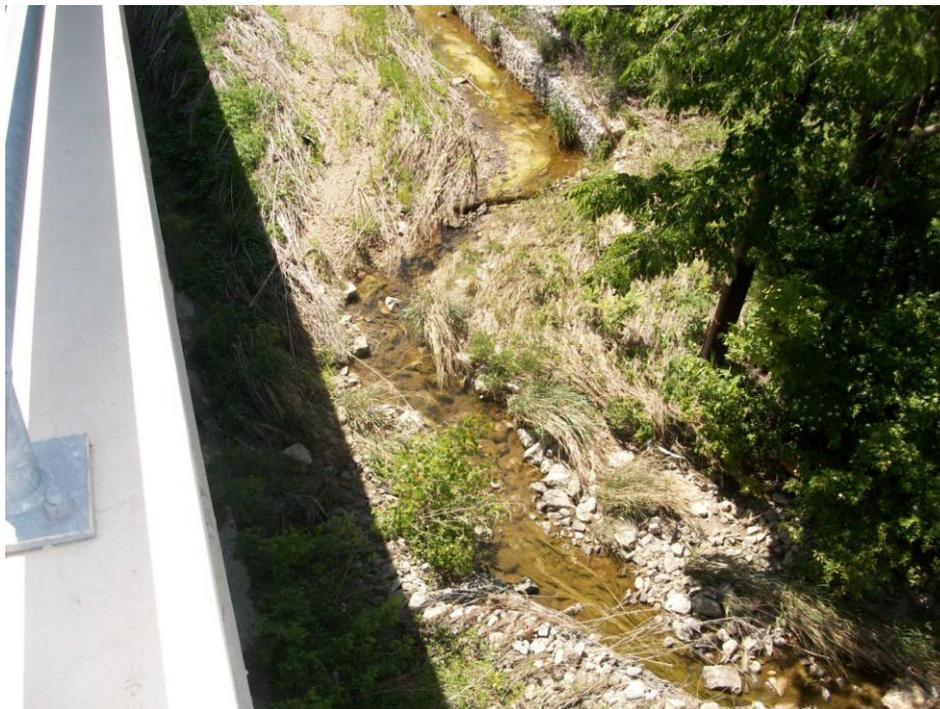
As mentioned, Figure 9 shows the misaligned panels in the MSE wall supporting the west side of the southbound frontage road just north of Egyptian Way. A sound wall also runs along the top of the retaining wall. The riprap between the retaining wall and sound wall has begun to crack directly above the misaligned panels. Additionally, a Johnson Creek tributary encroaches on the retaining wall at several locations.

Figure 16: Encroachment from Johnson Creek Tributary on Retaining Wall on North Side of Egyptian Way

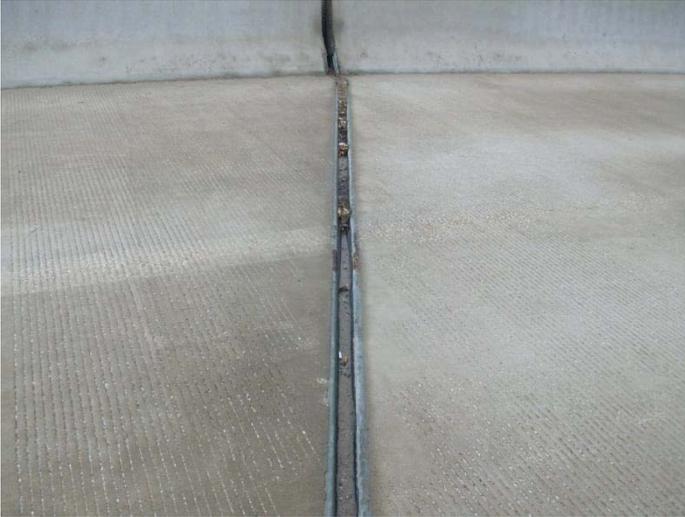
1

Debris in armor joints – NBML/NBFR – Corridor Wide

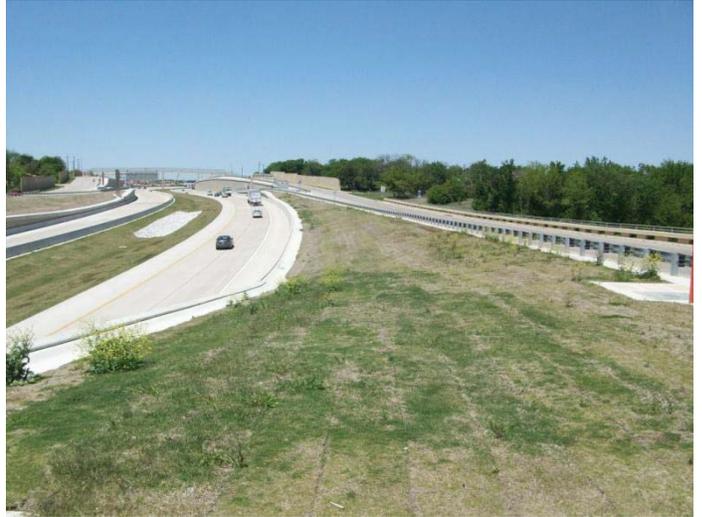
2

Grass dead/not established – NBML/NBFR – Corridor Wide

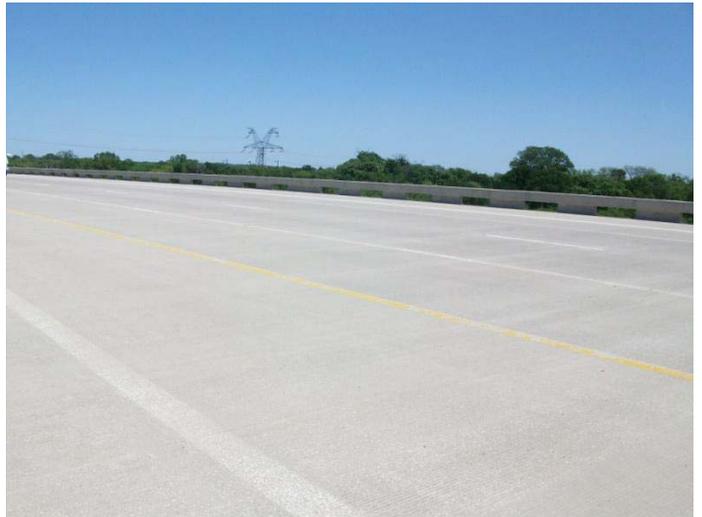
4

Faded pavement markings – NBML – North Carrier Parkway to SH 183– Sta 463+00 to 709+00

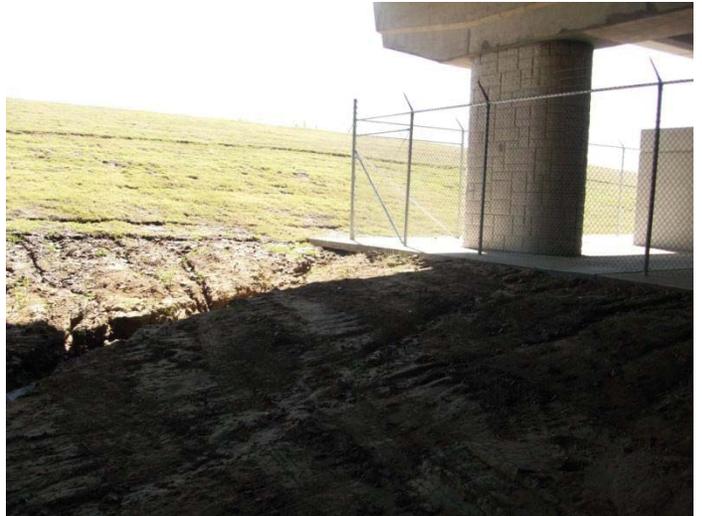
6

Erosion under sand stockpile pavement – Lower Tarrant/Trinity/Oakdale Bridge – Bent 57 – Sta 557+00

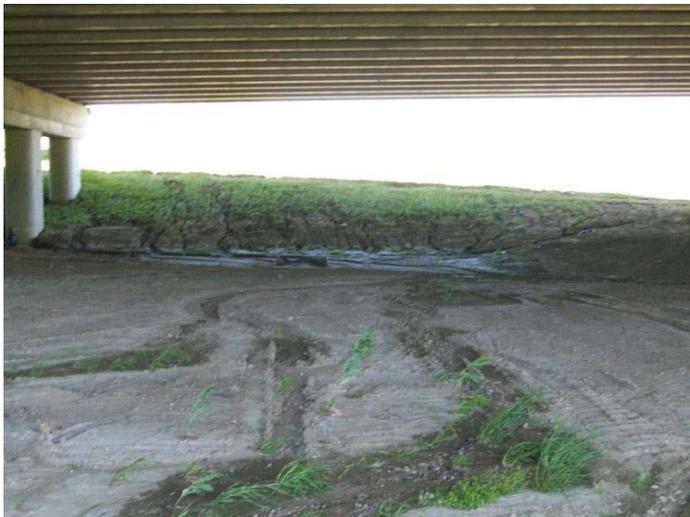
7

Erosion – Lower Tarrant/Trinity/Oakdale Bridge – Bent 58
– Sta 558+00

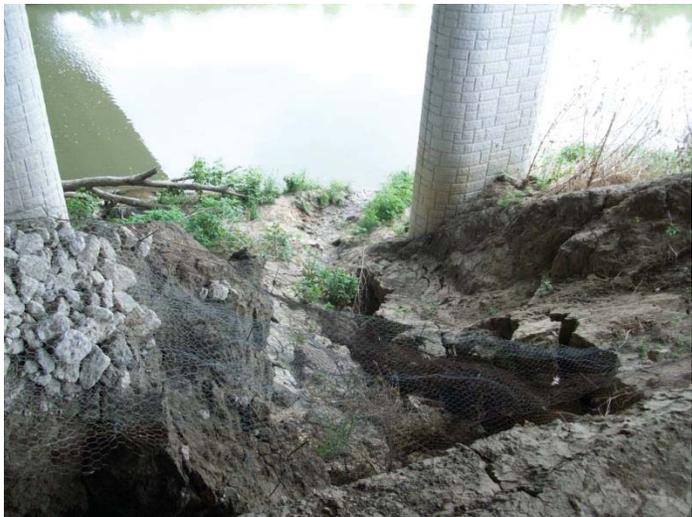
8

Erosion – Lower Tarrant/Trinity/Oakdale Bridge – Bent 28
– Sta 523+00

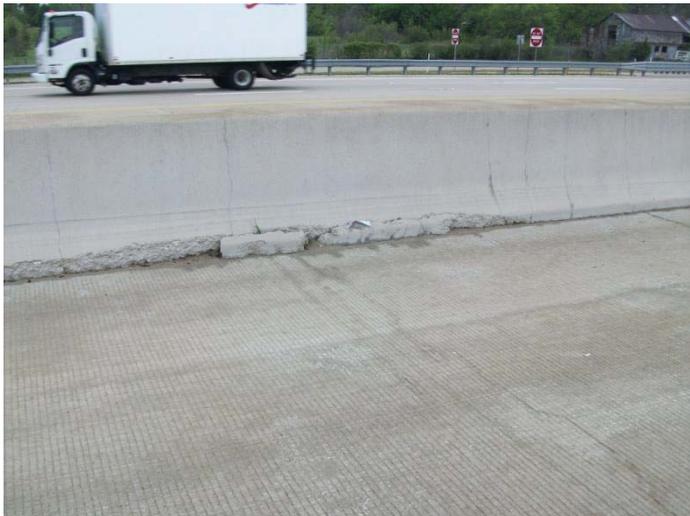
9

Spalling on center median – NBML North of Shady Grove
Road – Sta 600+00

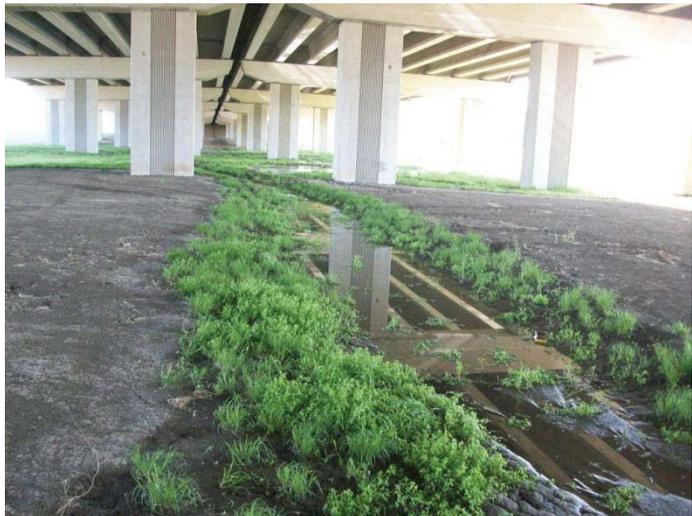
10

Standing water – Rock Island/TRE/Conflans Bridge –
Bent 46 – Sta 662+00

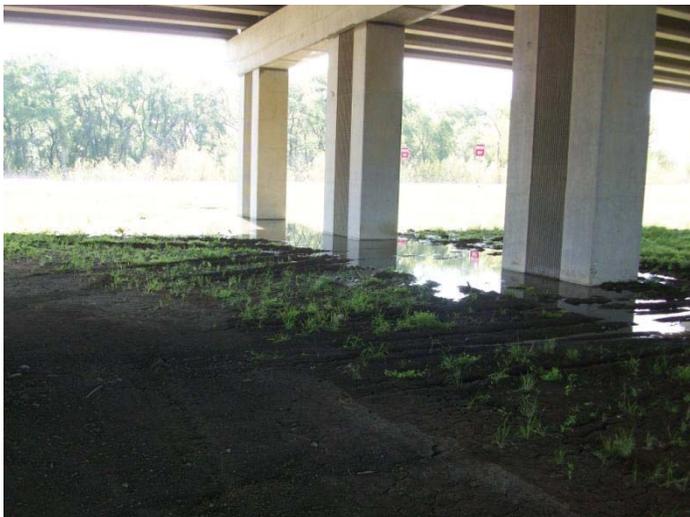
11

Standing water – Rock Island/TRE/Conflans Bridge –
Bent 48 – Sta 547+00

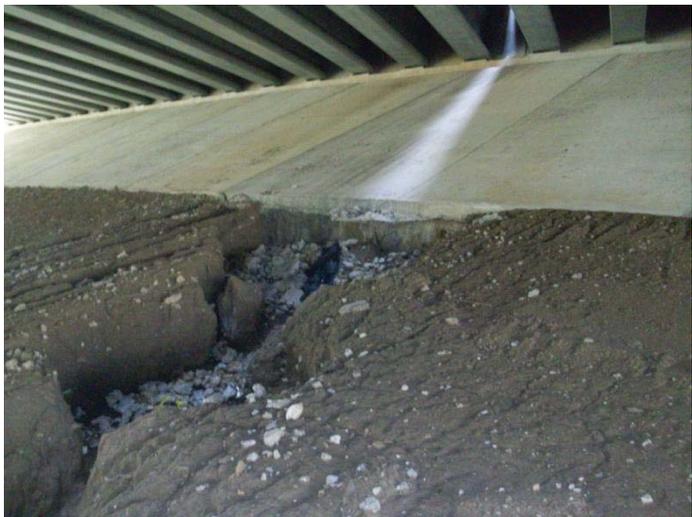
12

Erosion – Carrier Parkway and Johnson Creek Bridge –
Abutment 17 – North of Egyptian Way – Sta 475+00

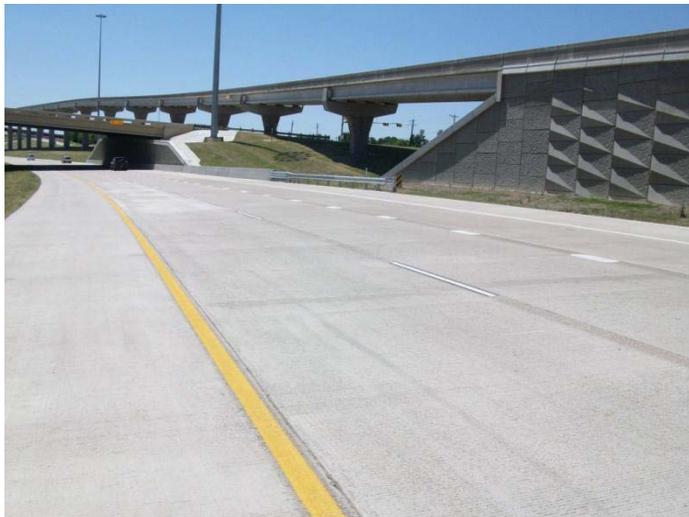
13

Various buttons missing – NBML – I-20 to North Carrier Parkway – Sta 111+00 to 463+00

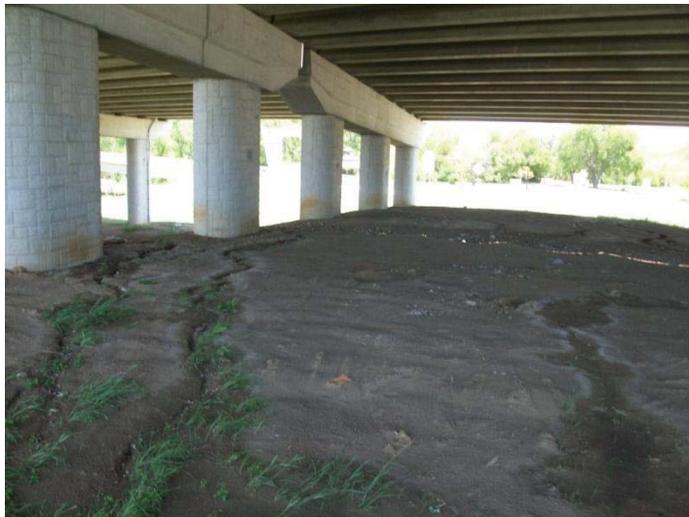
14

Erosion – Lower Tarrant/Trinity/Oakdale Bridge – Bent 4 – Sta 495+00

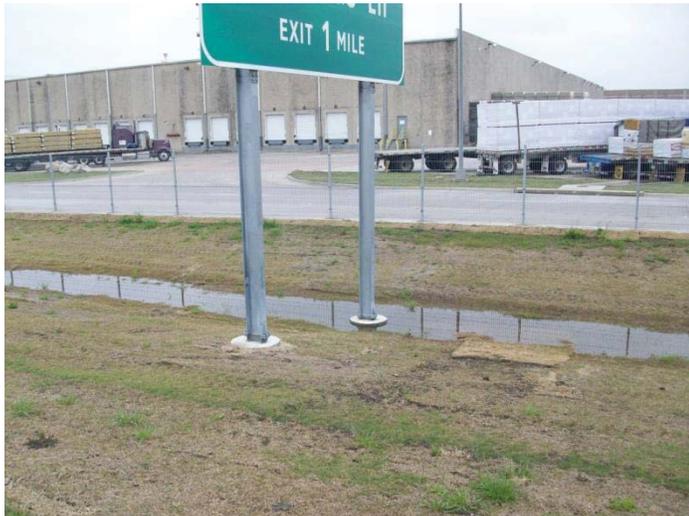
15

Standing water – Median between SBML and SBFR North of Dickey Road – Sta 315+00

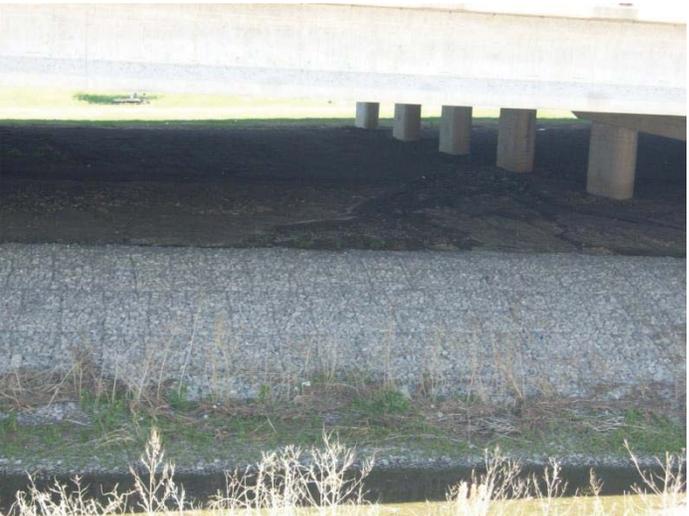
16

Erosion – Johnson Creek Bridge (North of Egyptian Way) – Bent 3 – Sta 458+50

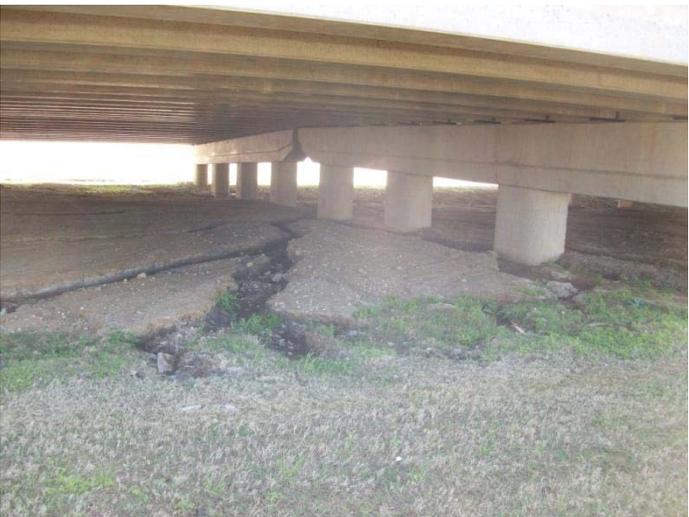
17

Erosion – Lower Tarrant/Trinity/Oakdale Bridge – Bent 60 – Sta 561+00

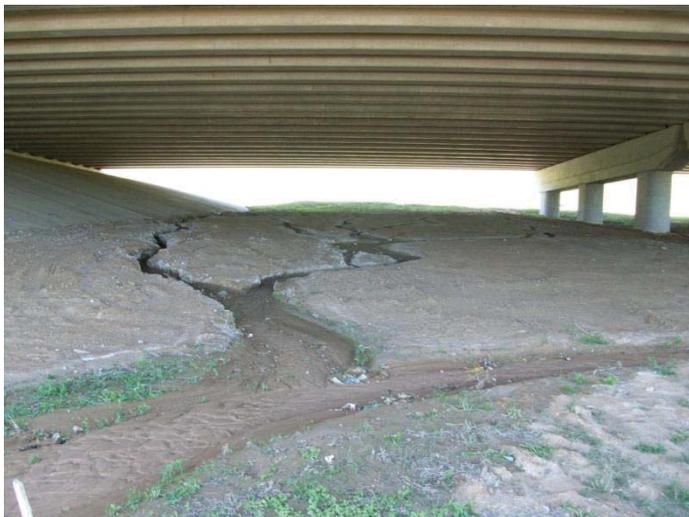
18

Erosion – Rock Island/TRE/Conflans Brige – Bent 2 – Sta 609+00

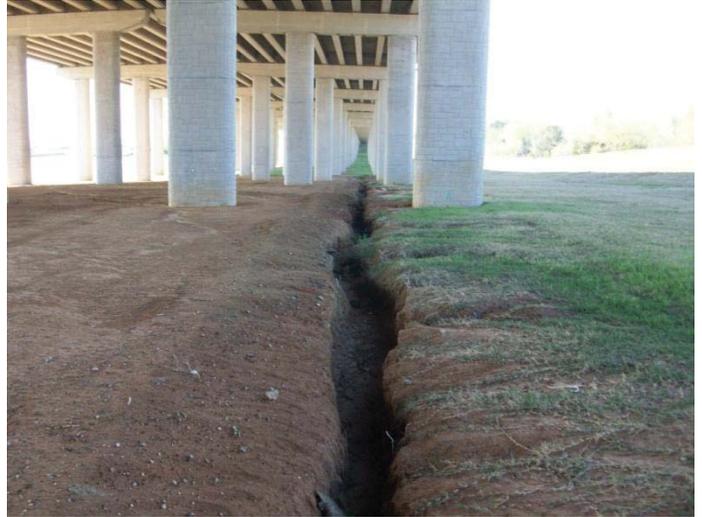
20

Erosion – Rock Island/TRE/Conflans Bridge – Bent 21 – Sta 633+00

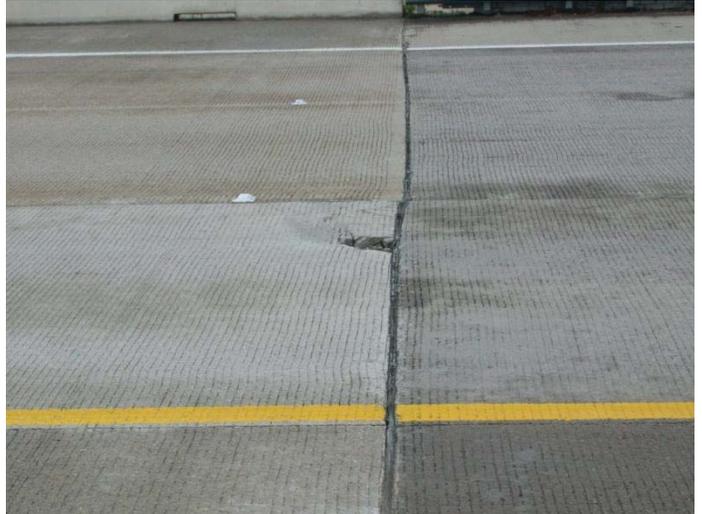
22

Concrete popout – SBML North of Conflans Road – Sta 672+00

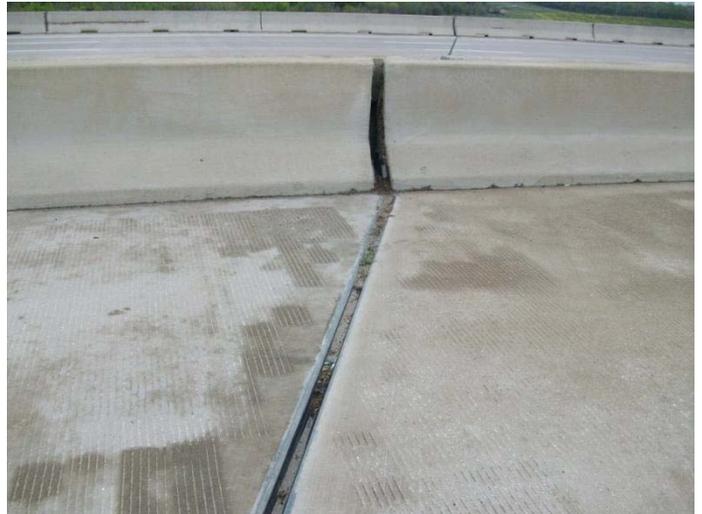
24

Debris in armor joints – SBML/SBFR – Corridor Wide

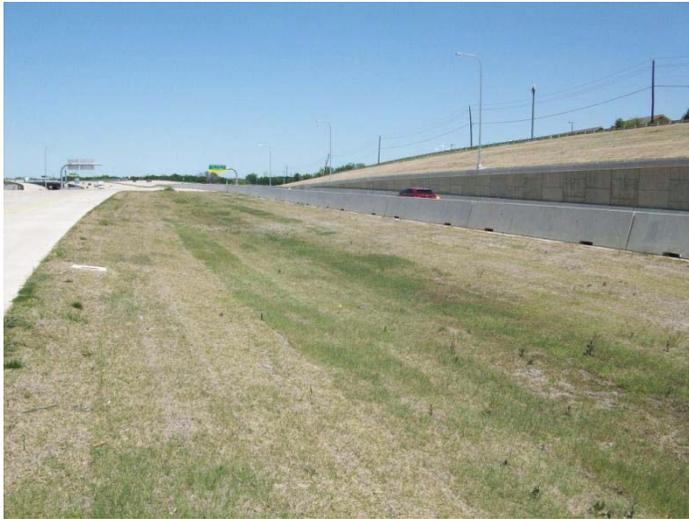
25

Grass dead/not established – SBML/SBFR – Corridor Wide

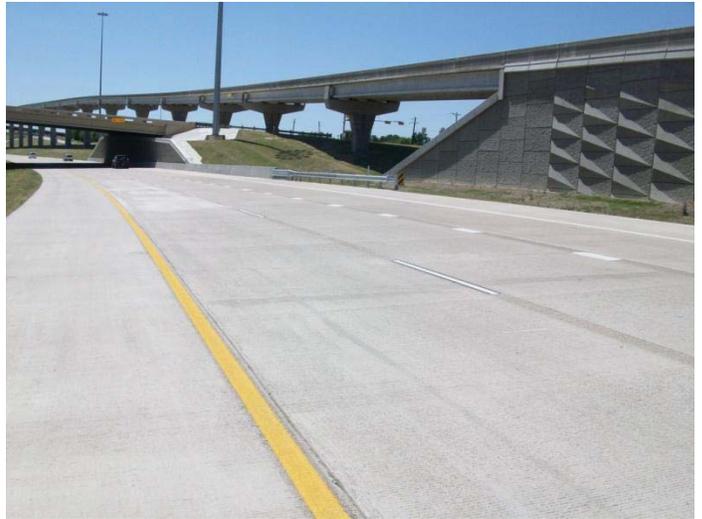
26

Various buttons missing – SBML – I-20 to North Carrier Parkway – Sta 111+00 to 463+00

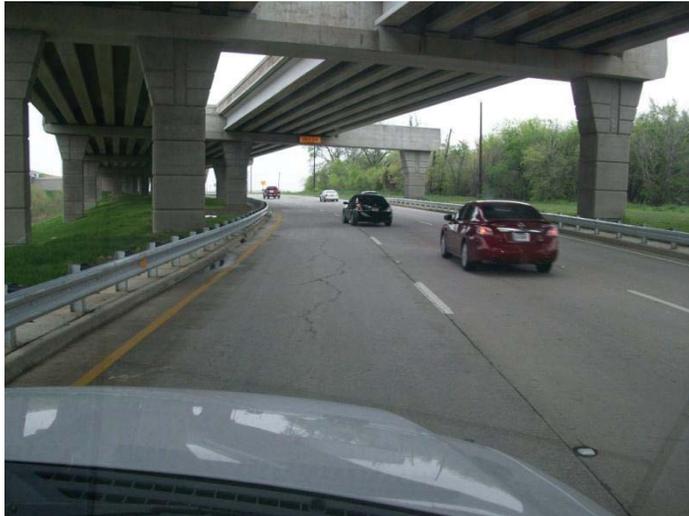
27

Longitudinal cracking – NBFR Under I-20 Interchange – Sta 114+00

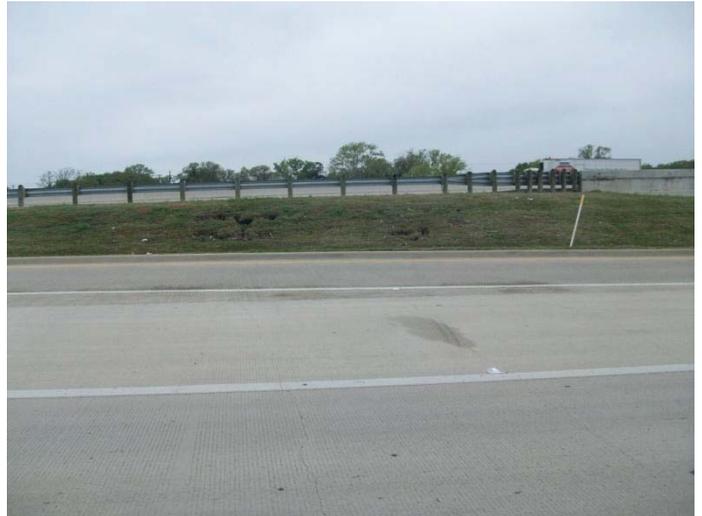
28

Erosion on embankment – NBFR South of Trinity Boulevard – Sta 570+00

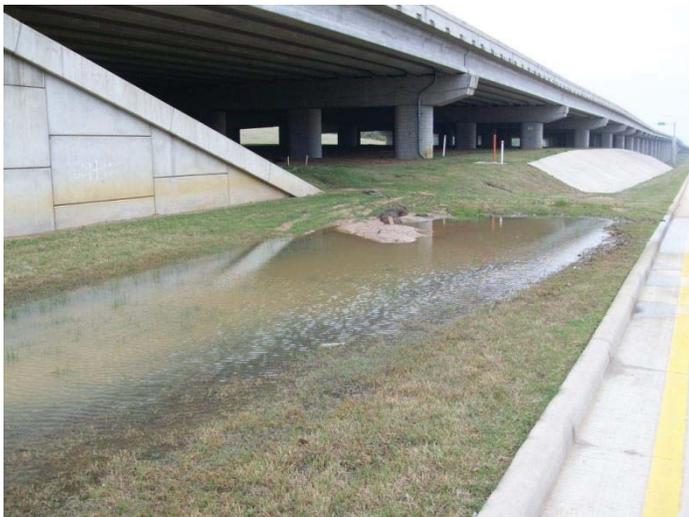
29

Standing water – NBFR North of Shady Grove – Sta 609+00

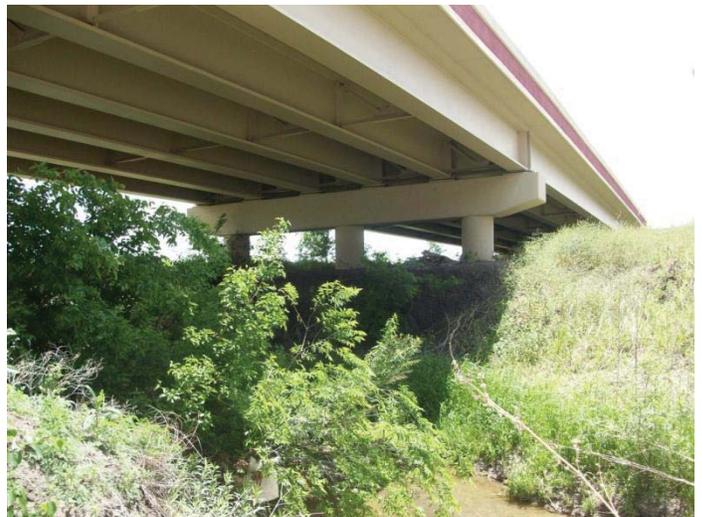
30

Erosion – NBFR Bridge over Kirby Creek – Bent 3 – North of Mayfield Road – Sta 176+00

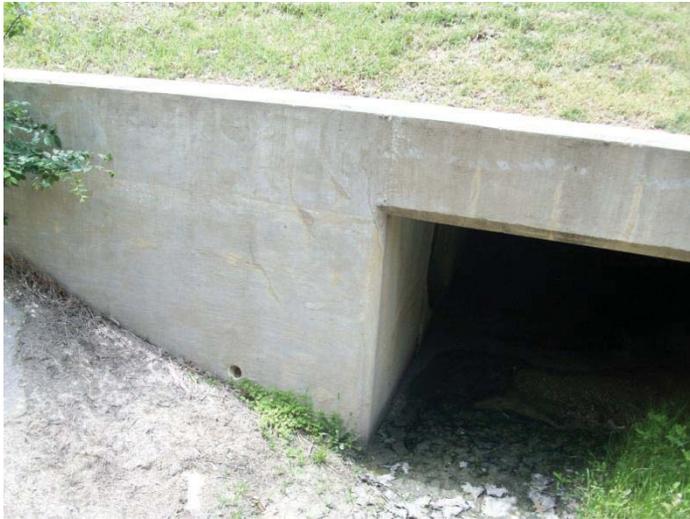
31

Concrete cracking – Upper left corner of culvert – East side of NBFR – South of Carrier Parkway – Sta 221+00

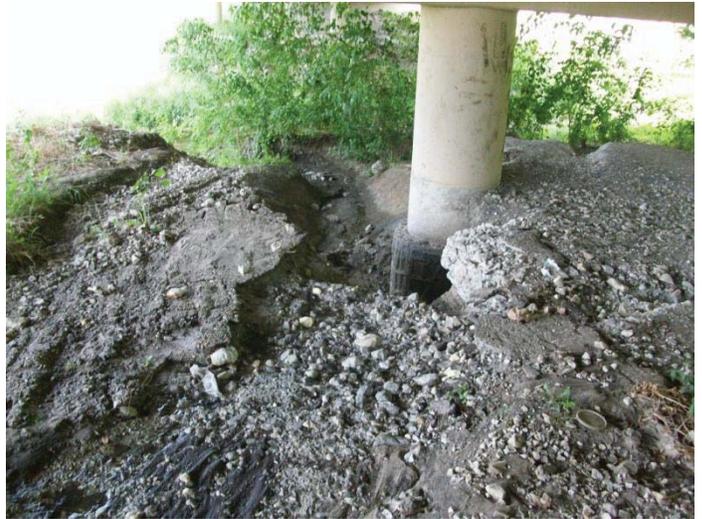
32

Erosion – NBFR Bridge over South Fork of Cottonwood Creek – North of Pioneer Parkway – Sta 246+00

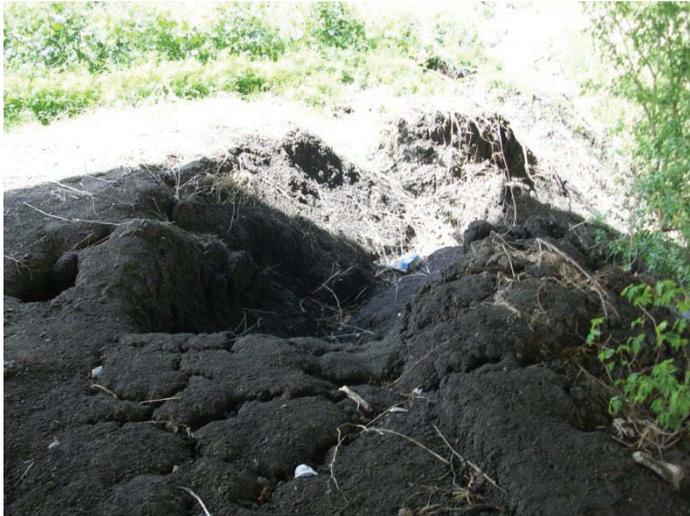
33

Erosion – Kirby Creek Frontage Road Bridge – Bent 3 – South of Warrior Trail – Sta 175+00

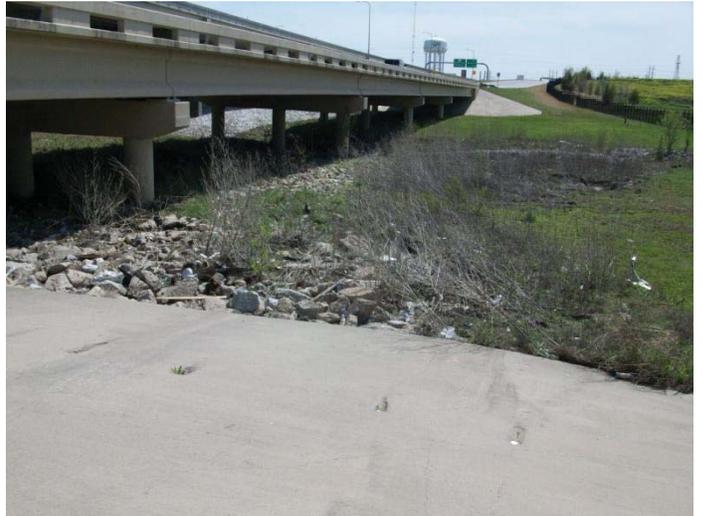
34

Litter – NBFR/SBFR Bridge over Cottonwood Creek – South of 14th Street – Sta 298+50

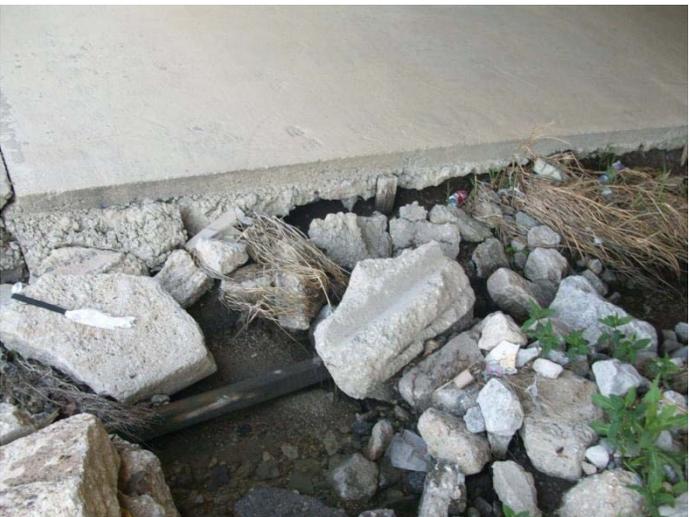
35

Erosion under abutment riprap – SBFR Bridge over Cottonwood Creek – South of 14th Street – Sta 298+50

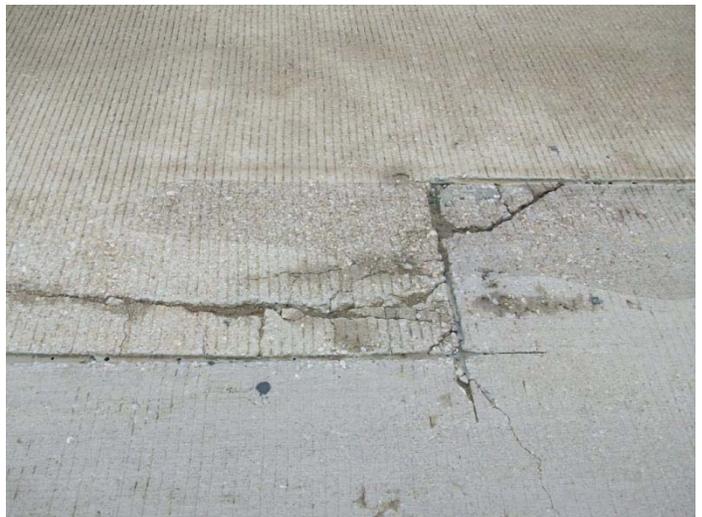
36

Edge cracking – SBFR North of Egyptian Way – Sta 443+00

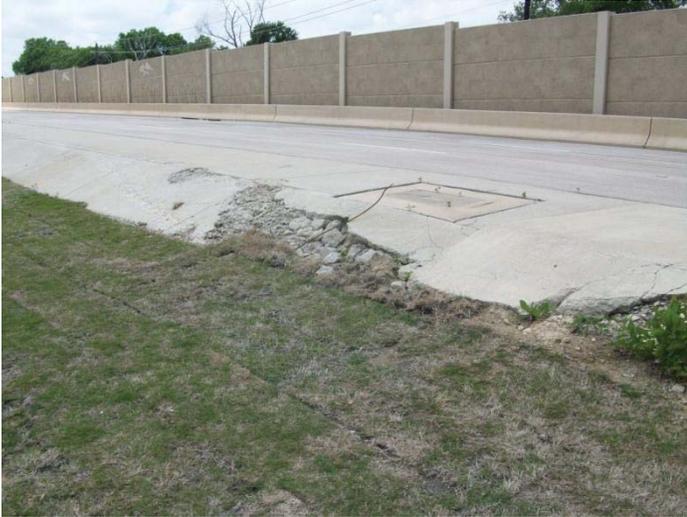
37

Riprap failure – SBFR – North of Egyptian Way – Sta 451+00

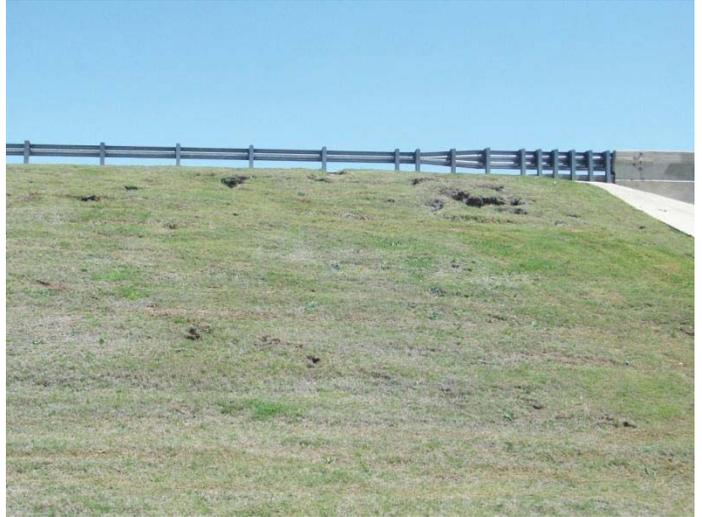
38

Erosion on embankment – SBFR North of Shady Grove – Sta 590+00
