ANNUAL INSPECTION REPORT SPECIAL PROJECTS SYSTEM

FISCAL YEAR 2013

Prepared by Atkins North America, Inc.
General Engineering Consultant

May 2013

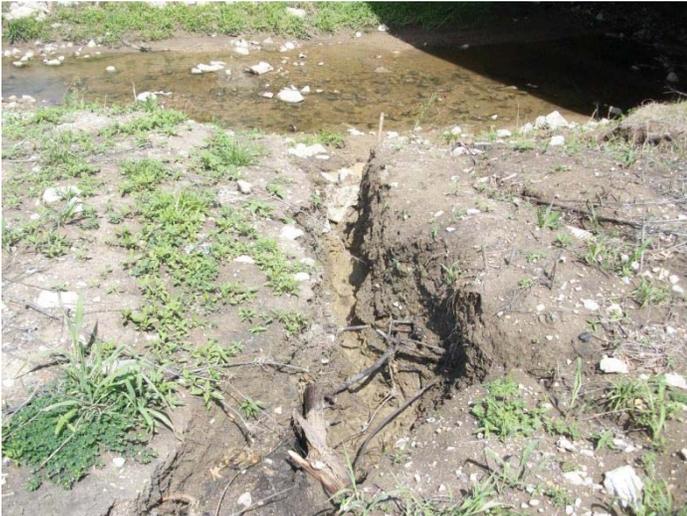
39

Erosion – Between SBFR and SBML South of 14th Street – Sta 286+00

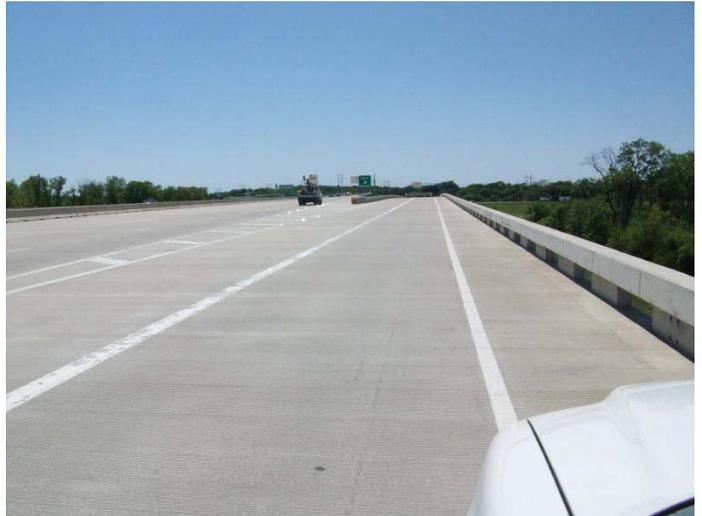
40

Faded pavement markings – SBML Off-Ramp Gore to Lower Tarrant/Trinity

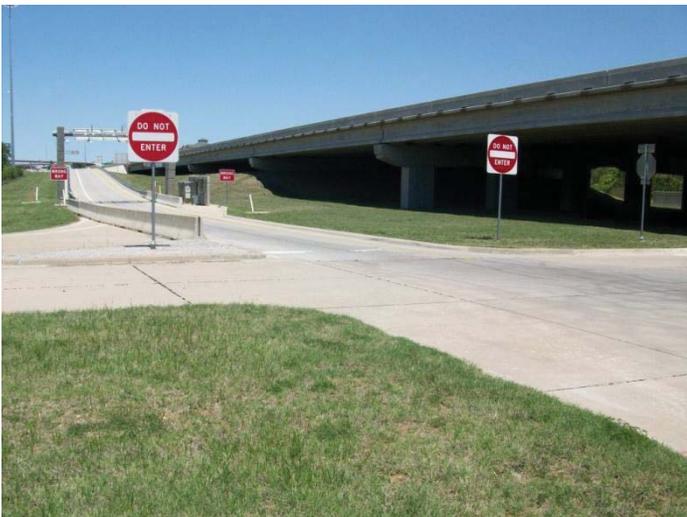
41

Faded pavement markings – Conflans Intersection at SB Off-Ramp

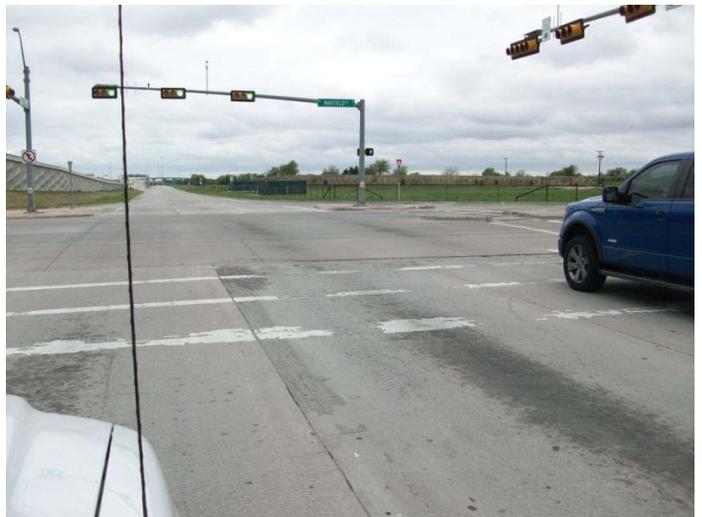
42

Faded pavement markings – Mayfield Intersection with SBFR

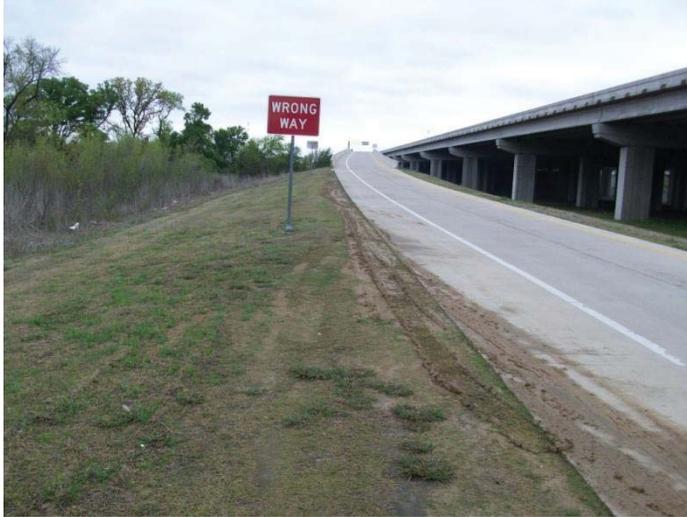
43

Edge drop-off – SB Off-Ramp to Conflans Road

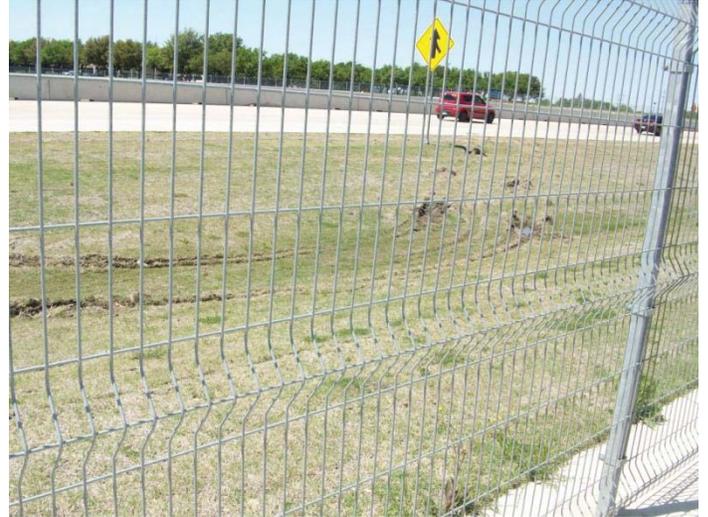
44

Rutting – Median between NBML and NBFR – NB Off-Ramp to Marshall Drive

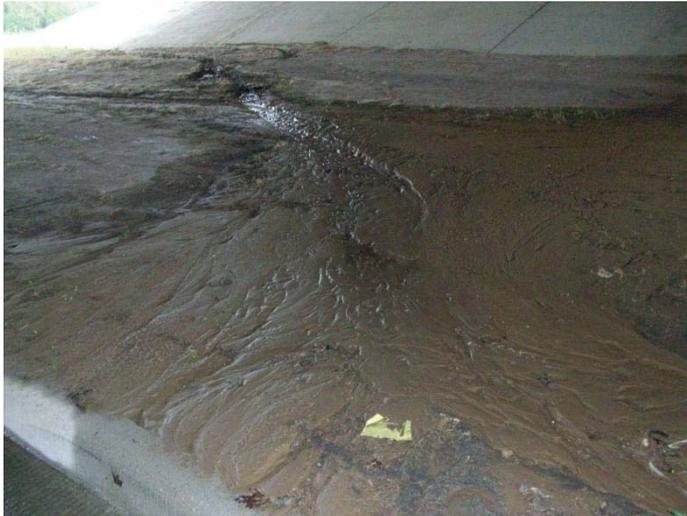
45

Erosion – SB to NB U-Turn at Shady Grove

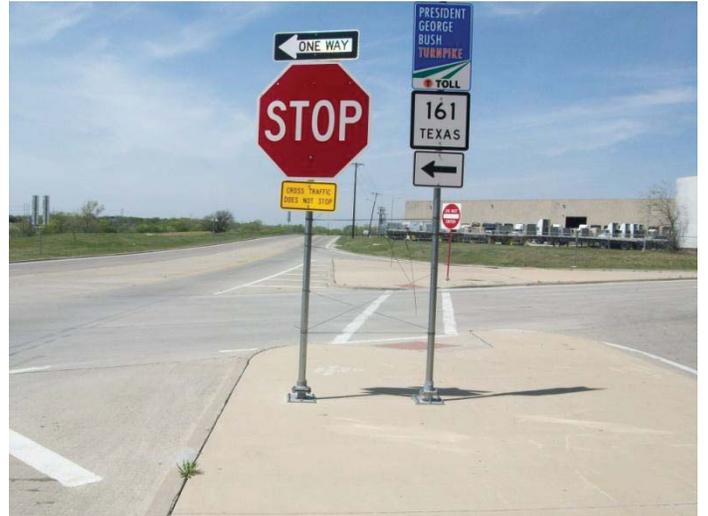
46

Signs not properly supported – SB to NB U-Turn Median at Dickey Road

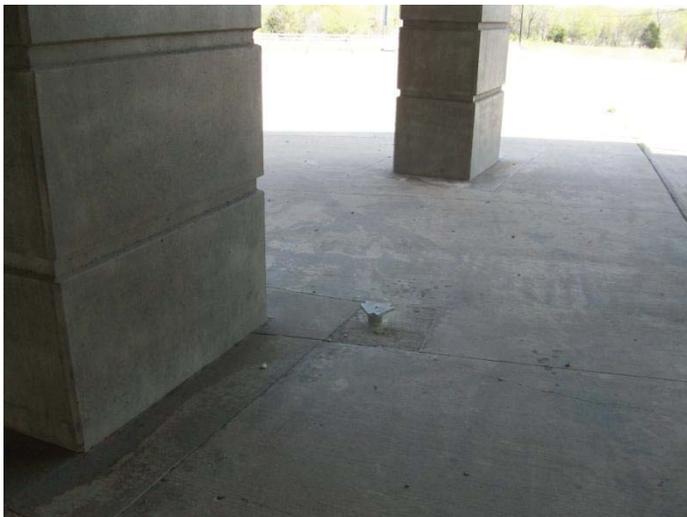
47

Base plate missing sign – SB to NB U-Turn Median at Dickey Road

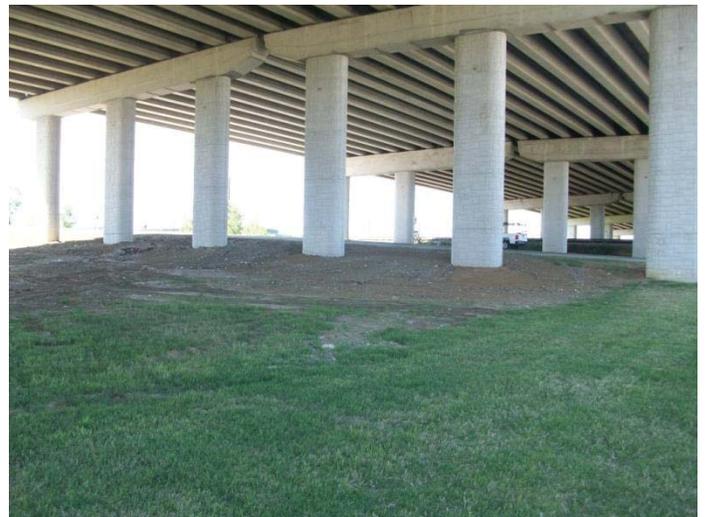
48

Erosion – South side of Rock Island Road

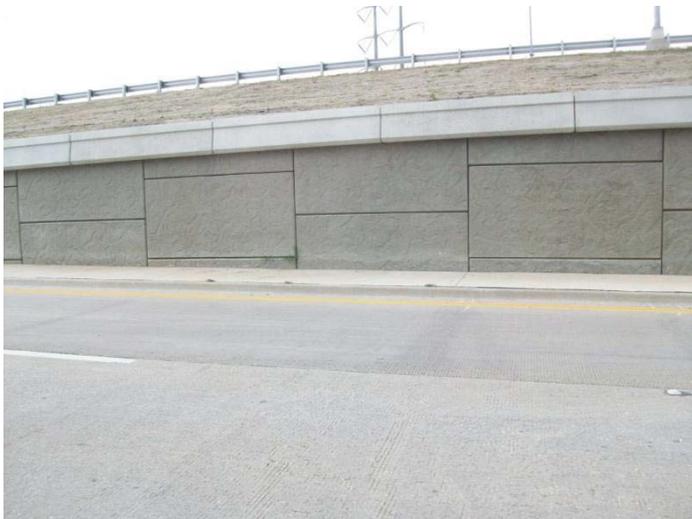
49

Grass growing between panels – NBFR South of Marshall Drive – Sta 267+00

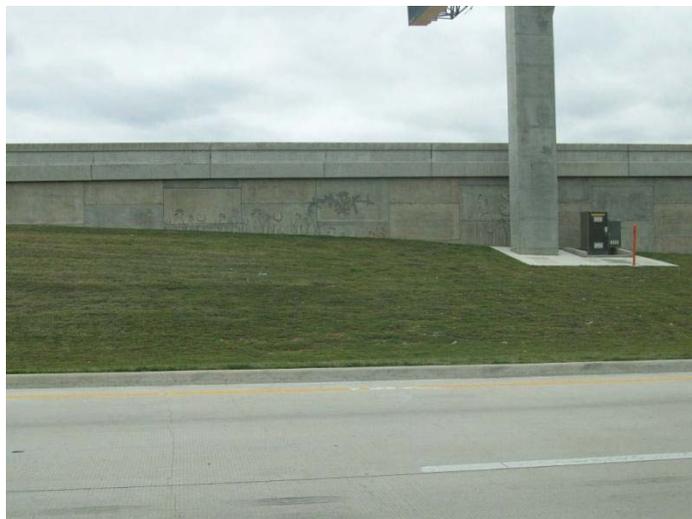
50

Graffiti on panels – NBFR South of Lower Tarrant – Sta 485+00

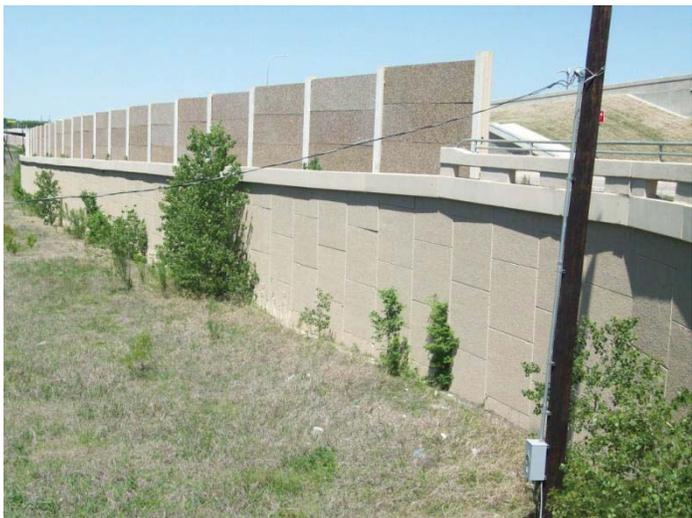
51

Panel movement – West Side of SBFR North of Egyptian Way

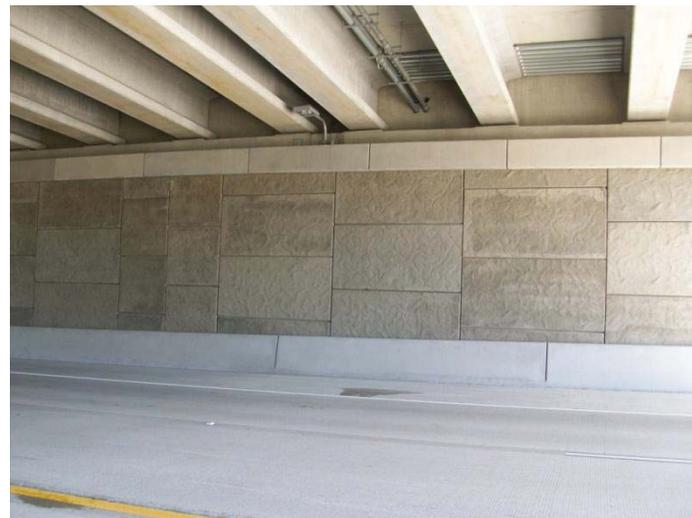
52

Pipe leakage – NBML Underpass at Jefferson Street

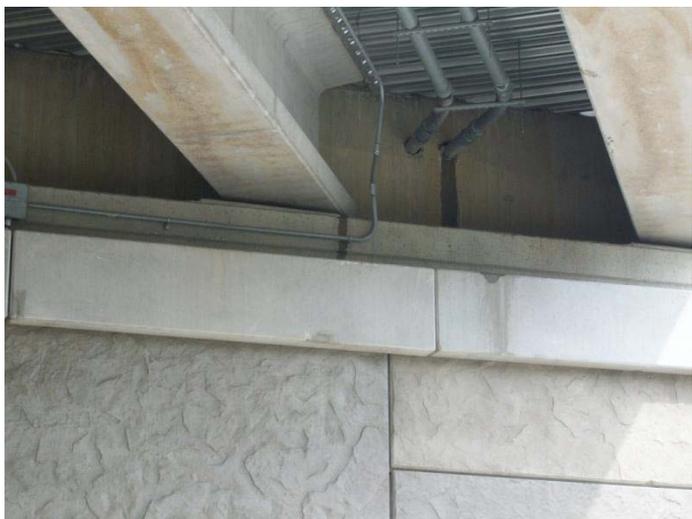
53

Pipe leakage – NBML Underpass at Dalworth Street

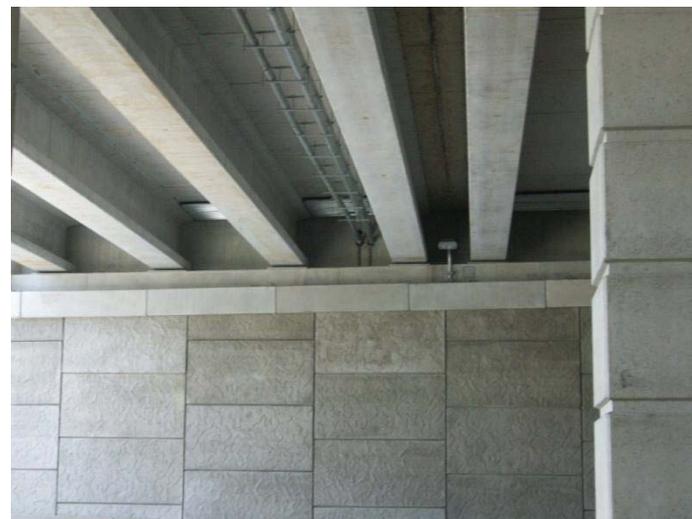
54

Pipe leakage – SBML Underpass at Jefferson Street
