# Dallas North Tollway Extension

## Phase 4B/5A

### From FM 428 to FM 121

Historic-age Resources Due Diligence Report

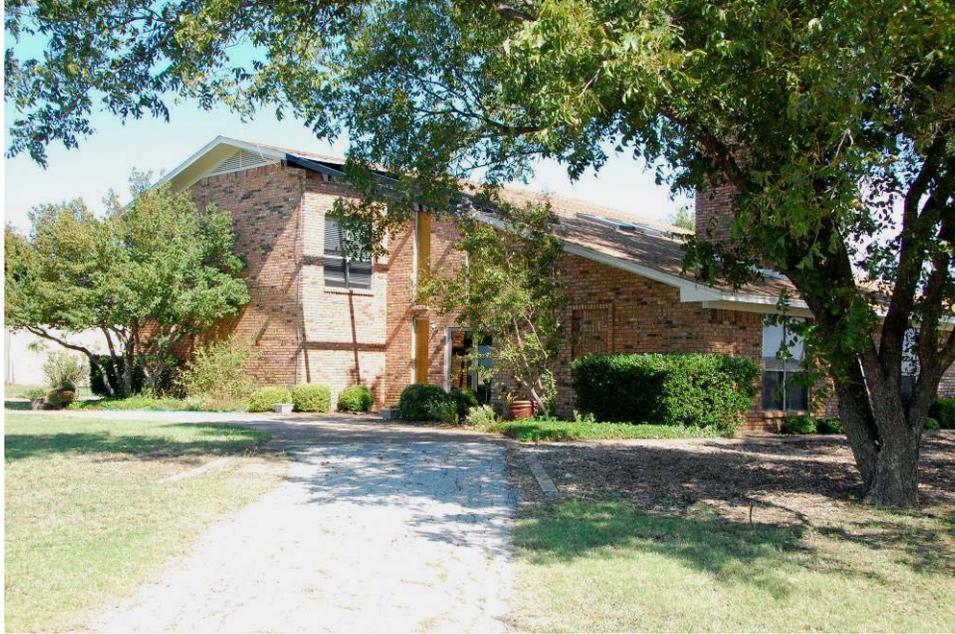
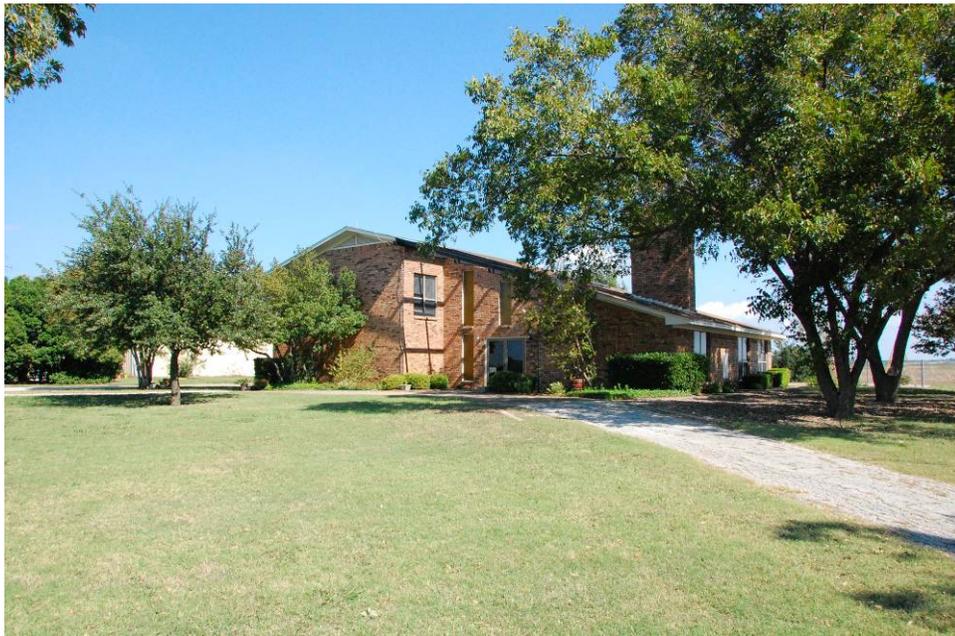
**Description:** Two-story, brick, U-shaped residence with gable and shed roof, and exterior chimney.

**View northeast.**

**View east.**

Location 1 is a farmstead with three historic-age resources including an inhabited residence (1A), a metal barn currently in use (1B), and a wood/metal barn not in use (1C). The residence and metal barn are in good condition, but the wood/metal barn is in severely deteriorated condition with pervasive holes in the roof and missing boards and/or metal panels on the sides. These aspects of Resource 1C's condition indicate it no longer maintains the integrity of design, setting, materials, workmanship, feeling, and association; therefore, this resource is recommended Not Eligible for the NRHP under Criterion C. In addition, Resources 1A – 1C are not associated with a known significant individual nor are they associated with events that have made a significant contribution to the broad patterns of our history; accordingly, all three of these resources are recommended Not Eligible for the NRHP under Criteria A and B.

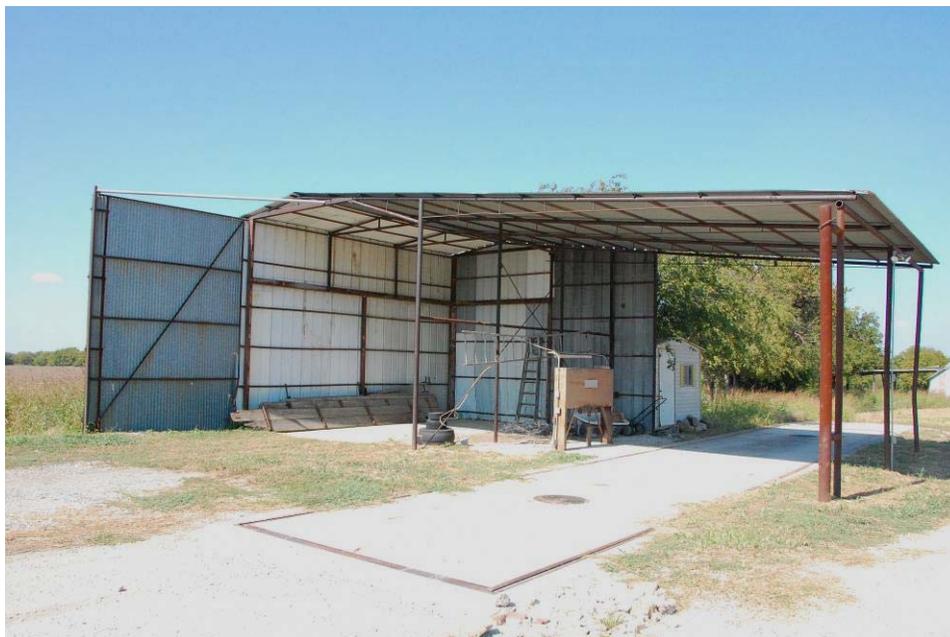
**Description:** One-story metal barn with two bays, gable roof and shed extension.

**View northwest.**

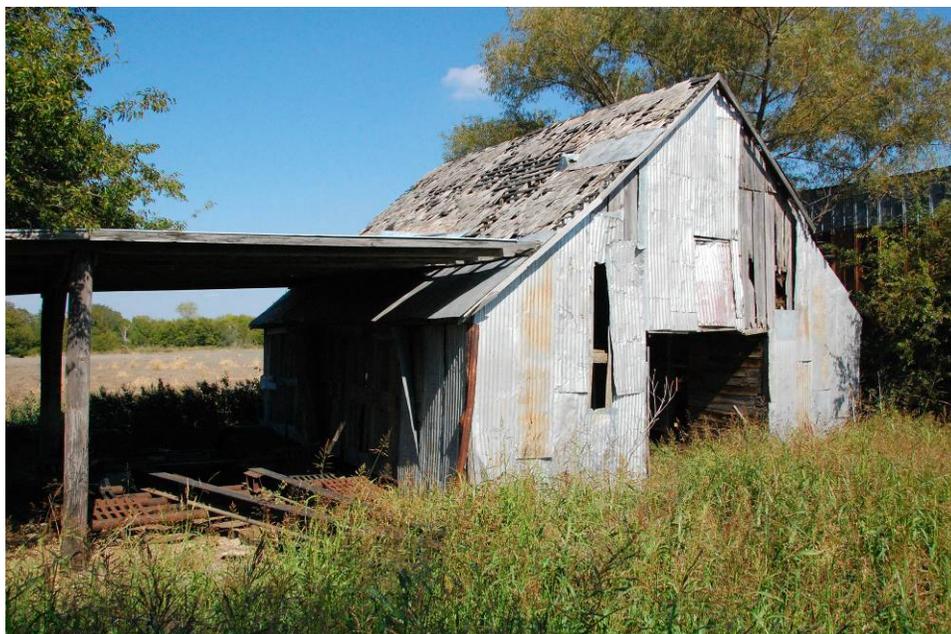
**Location ID:** 1C

**Description:** One-story wood and metal barn with steeply-pitched gable roof.

**View northeast.**

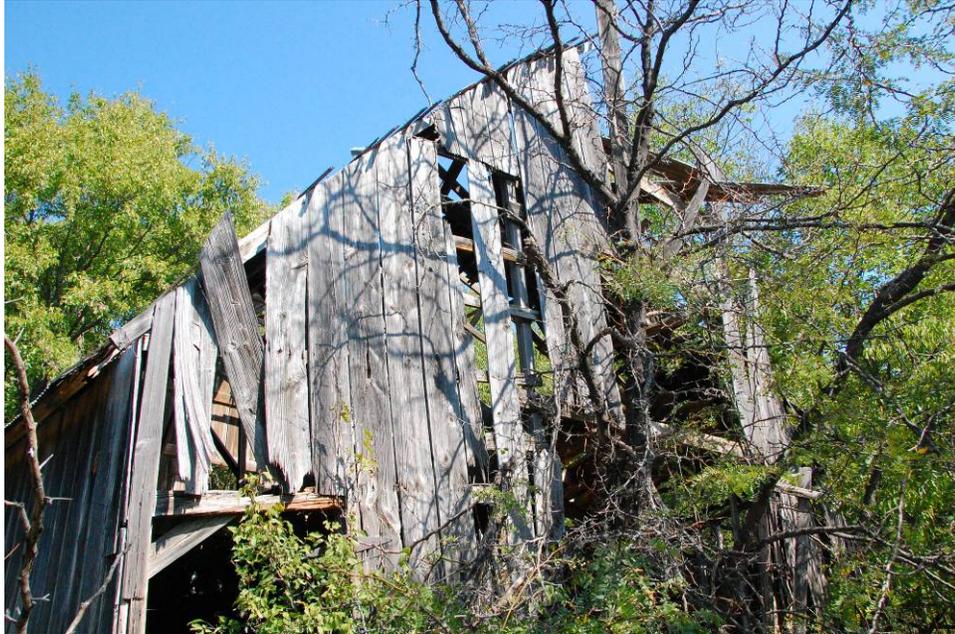
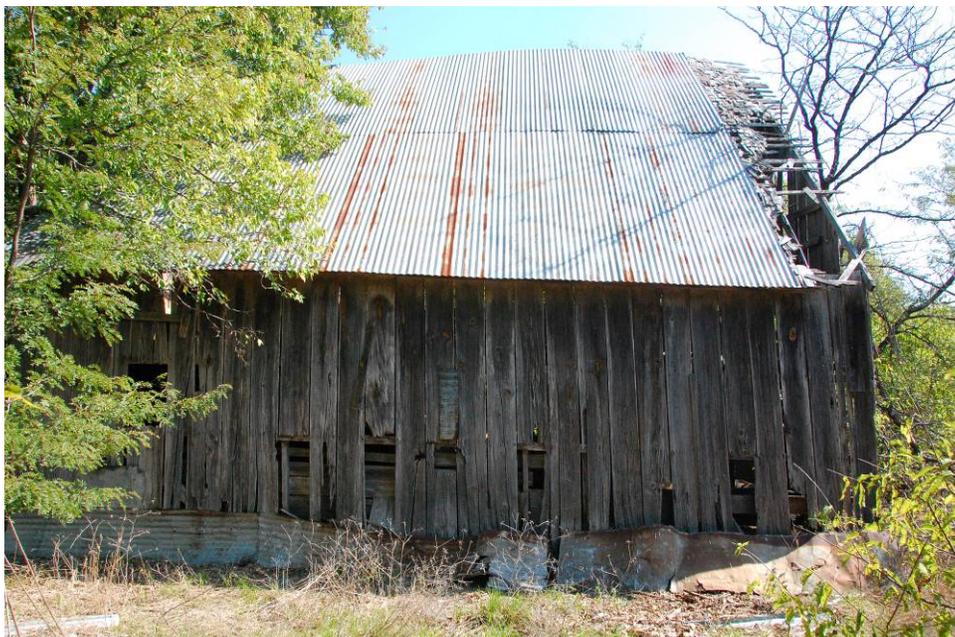
**Description:** Two-story barn, rectangular plan with front facing gable roof. Dimensional lumber frame with vertical board siding, deteriorated condition.

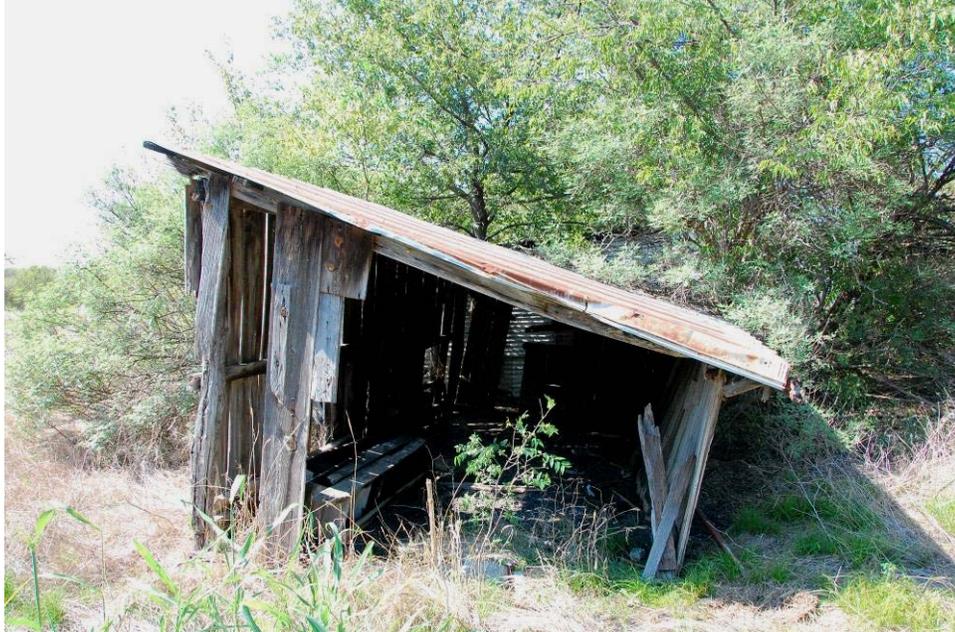
**Description:** One-story, rectangular, corrugated metal and wood shed roof chicken coop in disrepair.

**View west.**

Location 2 is an abandoned farmstead with a barn (2A), chicken coop (2B), horse shed (2C), and dwelling (2D) that are all in severely deteriorated condition. These four resources no longer maintain integrity of design, setting, materials, workmanship, feeling, and association because the roofs are partly or completely collapsed, doors/windows are open to the elements, and walls either have portions missing or are collapsed; therefore, these resources are recommended Not Eligible for the NRHP under Criterion C. The resources are not associated with a known significant individual nor are they associated with events that have made a significant contribution to the broad patterns of our history. These resources are also recommended Not Eligible for the NRHP under Criteria A and B.

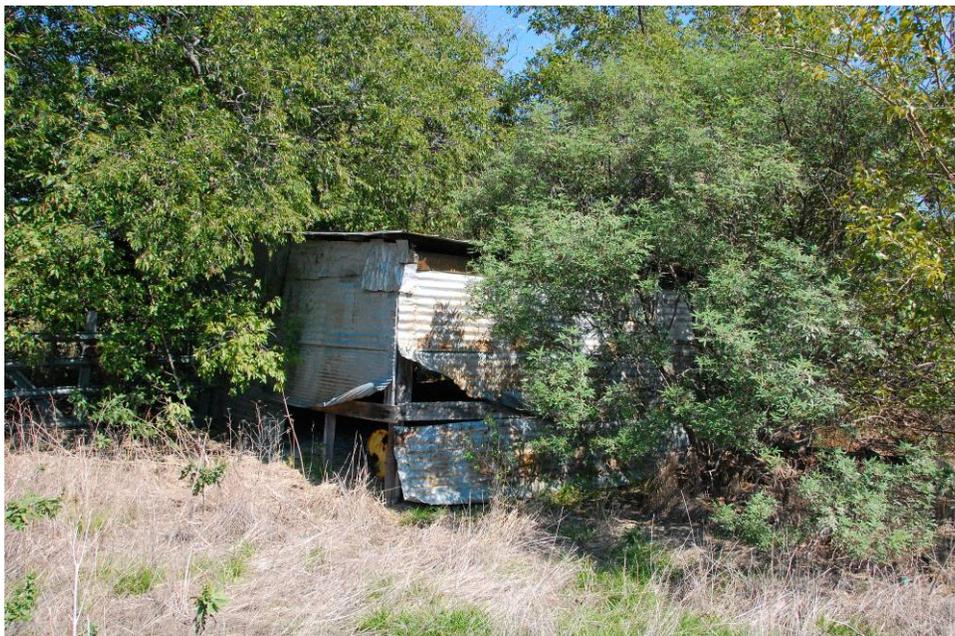
**Location ID:** 2D

**Description:** One-story, rectangular plan, gable roof residence with shed roof additions on the east and west facades. Standing structure represents original construction, later addition on south has collapsed. Hybrid construction consisting post and beam walls with gable rafters, exterior materials added over time consisting of vertical board, ship lap and finally stucco. Deteriorated condition.

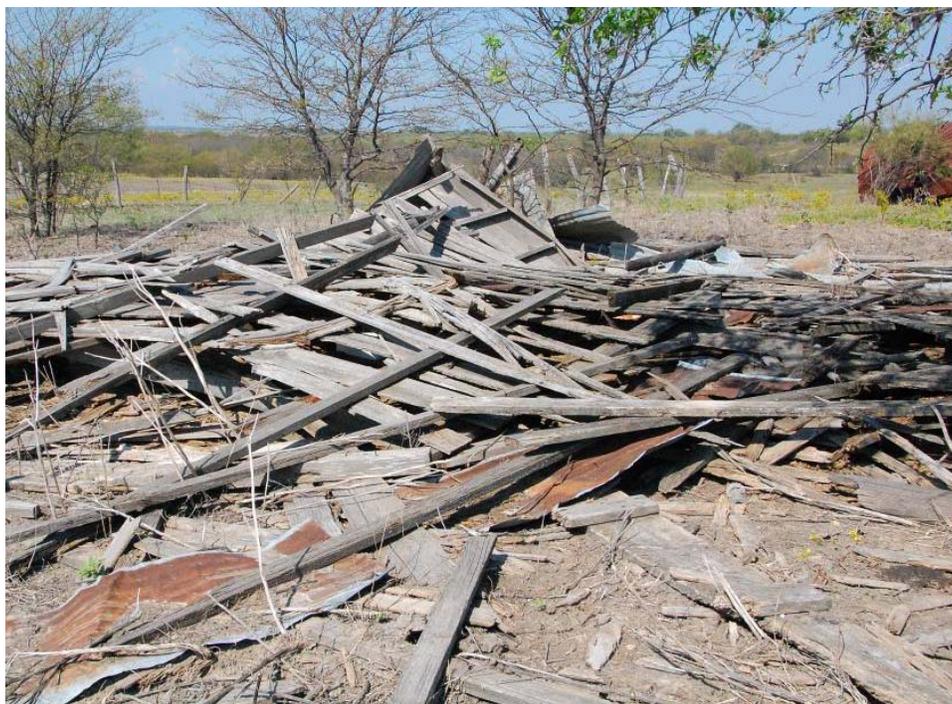
**Location ID:** 3A

**Description:** Collapsed residence, wood frame construction supported on bois d'arc post foundation.

Location 3 is an abandoned farmstead with a collapsed dwelling (3A) and concrete stock tank (3B) which is not functioning and in a general state of disrepair. The dwelling no longer maintains integrity of design, setting, materials, workmanship, feeling, and association because it is completely collapsed; therefore, this resource is recommended Not Eligible for the NRHP under Criterion C. The concrete stock tank is also recommended Not Eligible under Criterion C because it is in a state of general disrepair, is not functioning, and is not connected or associated with any significant historical resources. Both of these resources are not associated with a known significant individual nor are they associated with events that have made a significant contribution to the broad patterns of our history. Accordingly, these resources are recommended Not Eligible for the NRHP under Criteria A and B.

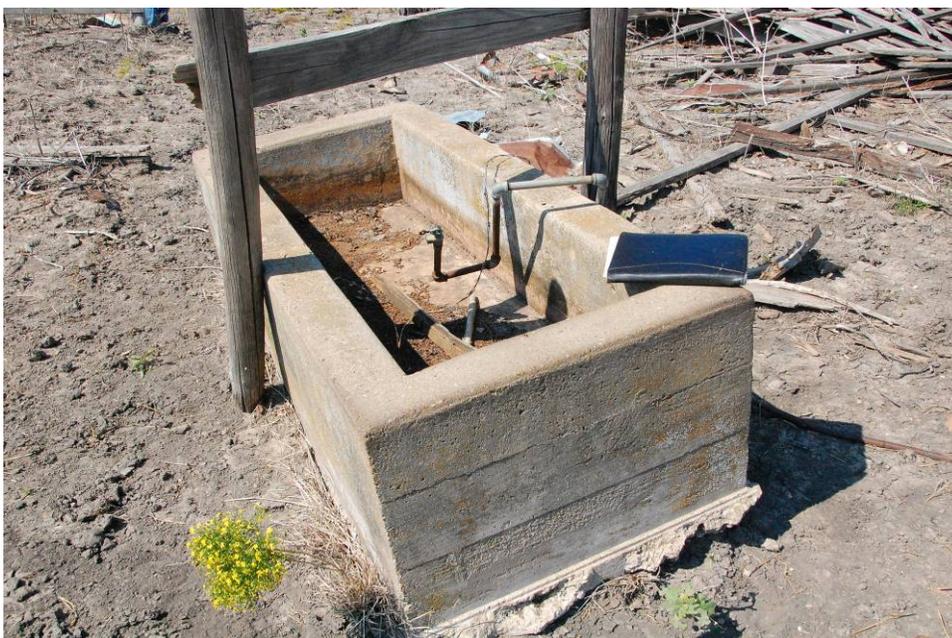
**Description:** Concrete stock tank.

**View west.**

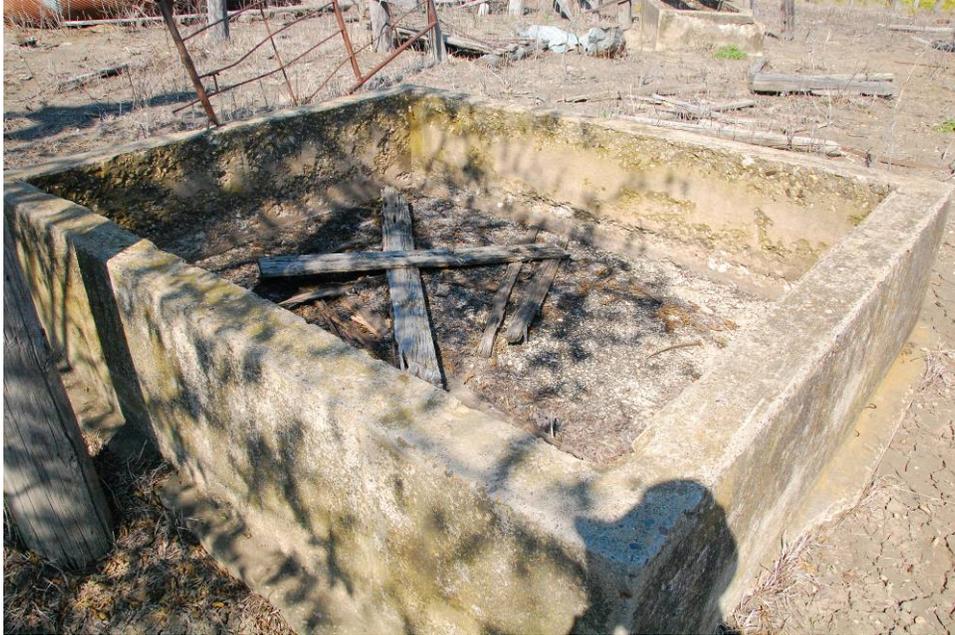
**Location ID:** 4A

**Description:** Concrete stock tank.

**View north.**

Location 4 is an abandoned farmstead with two concrete stock tanks (4A and 4B), a corrugated steel silo (4C), and a standing windmill (4D) that are all in disrepair. The concrete stock tanks are in a state of general disrepair (one with damage to a side wall), are not functioning, and are not connected or associated with any significant historical resources. The steel silo is missing its roof and door and is exposed to the elements, and the windmill, while intact, is in deteriorated condition and exhibits bullet holes in the wind vane. These four resources no longer maintain integrity of design, setting, materials, workmanship, feeling, and association because of their generally deteriorated condition and substantial damage to each; therefore, these resources are recommended Not Eligible for the NRHP under Criterion C. As these four resources are not associated with a known significant individual nor are they associated with events that have made a significant contribution to the broad patterns of our history, they are recommended Not Eligible for the NRHP under Criteria A and B.

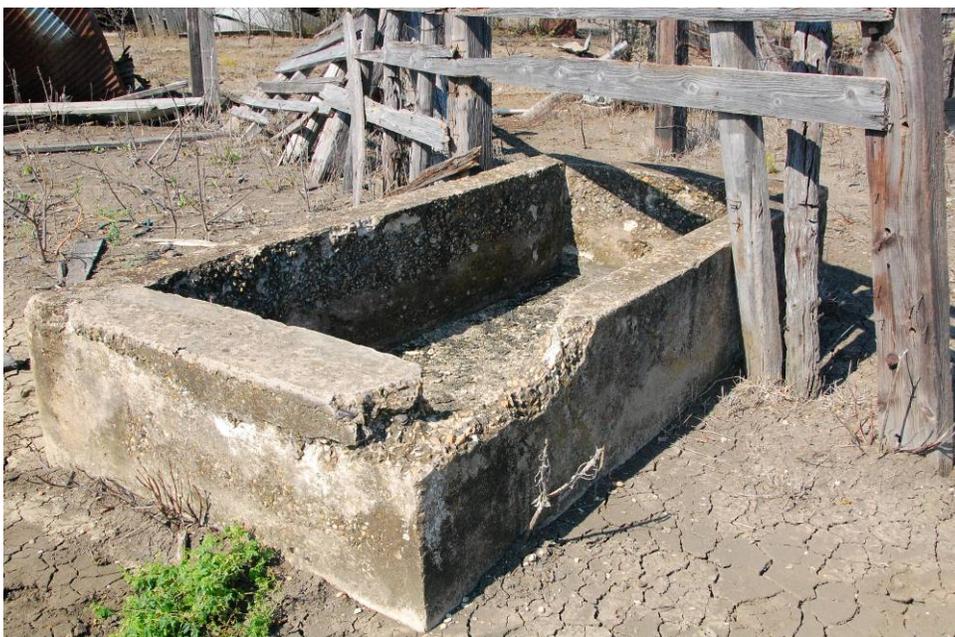
**Location ID:** 4B

**Description:** Concrete stock tank.

**View northwest.**

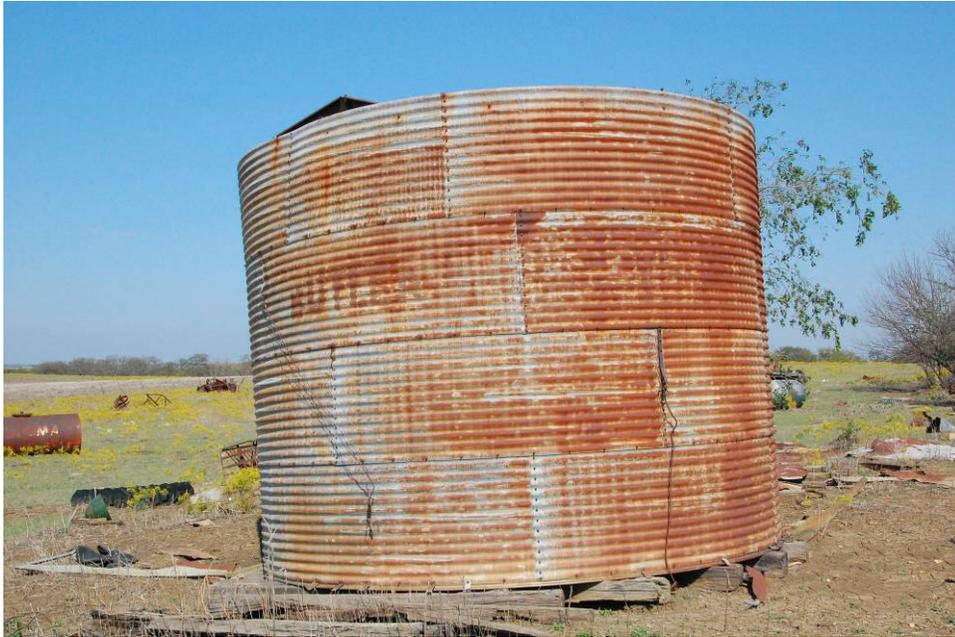
**Description:** Corrugated "Butler" steel silo.

**View northwest.**

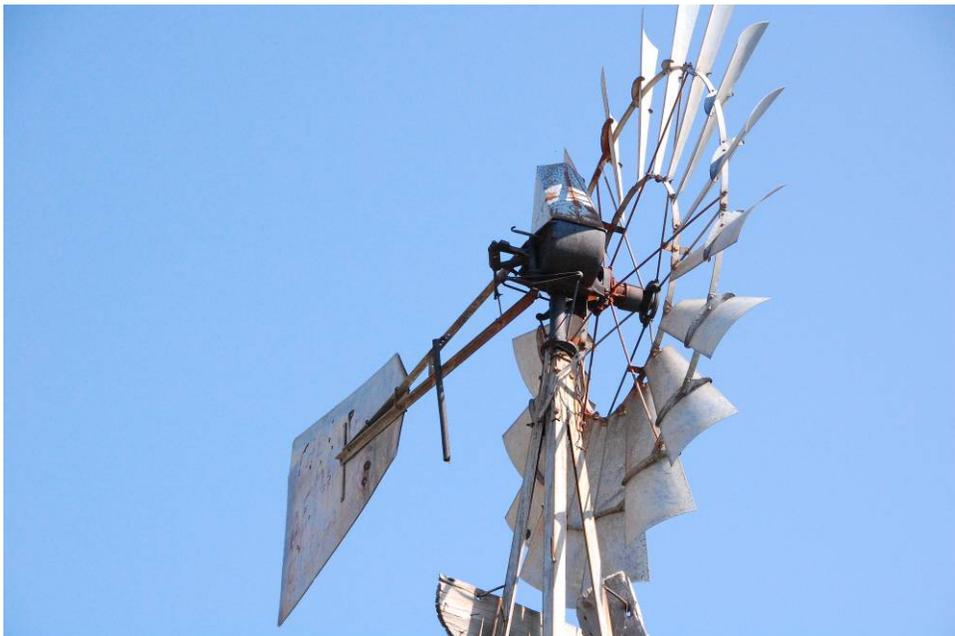
**Location ID:** 4D

**Description:** Aermotor 6-foot diameter windmill.

**View south.**

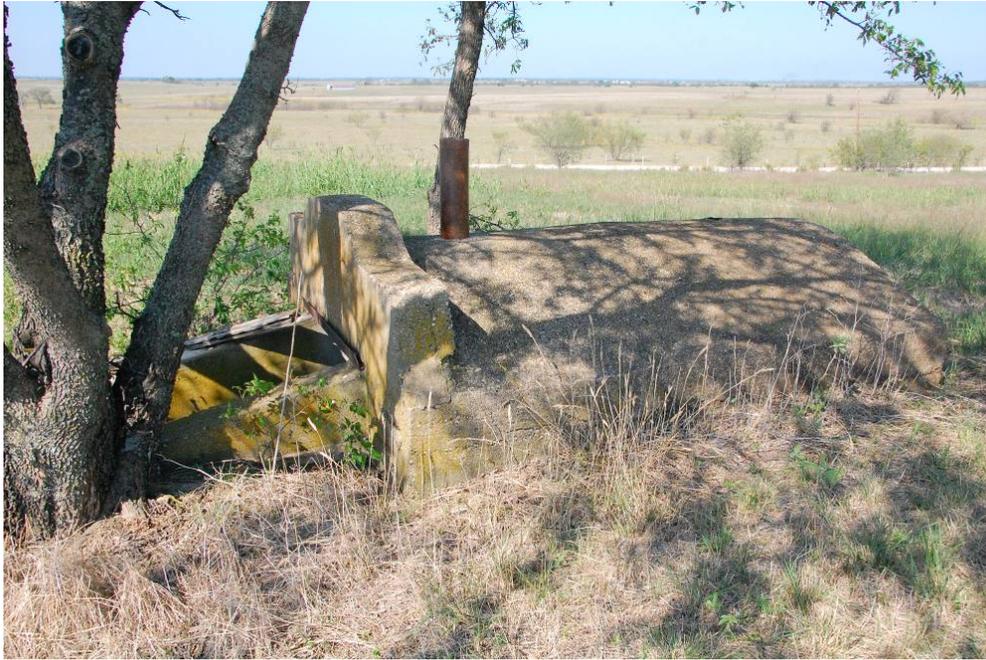
**Location ID:** 5A

**Description:** Storm/storage cellar. Cast in place concrete.

**View west.**

Location 5 is an abandoned farmstead with a concrete storm/storage cellar (5A), a cistern (5B), and two windmills (5C and 5D) that are all in disrepair. The storm/storage cellar is in a state of general deterioration with the entrance door missing and several inches of standing water in the bottom of the cellar; other than a natural gas pipe nearby, there are few vestiges of the farm house that was likely located near the cellar. The brick-lined cistern has been filled with soil and farm debris, and some of the bricks and plaster from the upper portion of this feature have fallen out of place. One of the windmills is collapsed and severely damaged. The remaining windmill is standing but is not functioning and exhibits bullet holes in its wind vane. All four of these resources no longer maintain integrity of design, setting, materials, workmanship, feeling, and association because of their generally deteriorated condition and substantial damage to each; therefore, these resources are recommended Not Eligible for the NRHP under Criterion C. As these four resources are not associated with a known significant individual nor are they associated with events that have made a significant contribution to the broad patterns of our history, they are recommended Not Eligible for the NRHP under Criteria A and B.

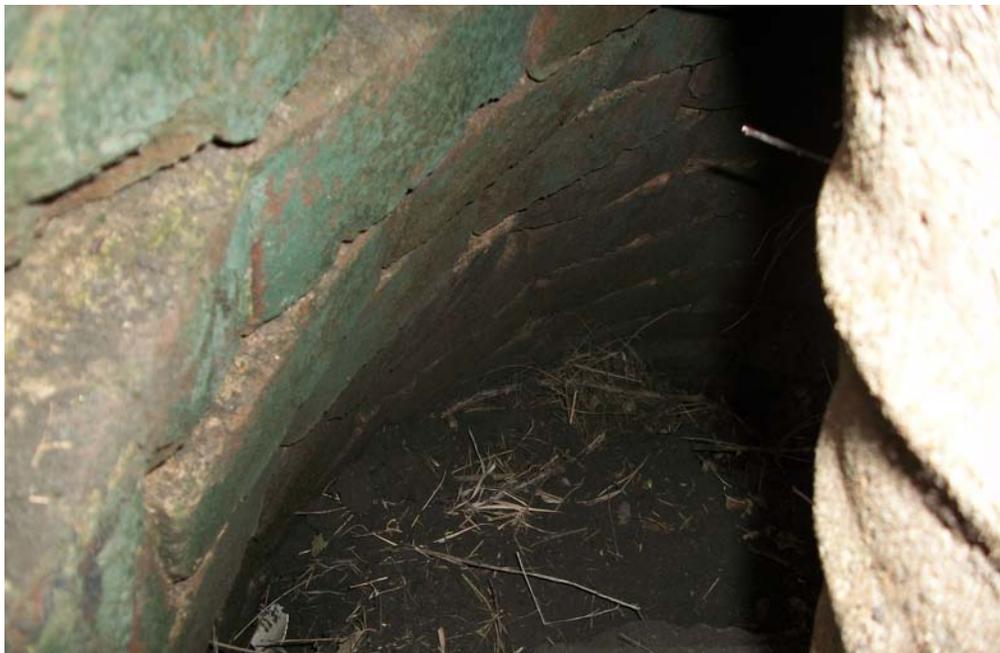
**Location ID:** 5B

**Description:** Brick-lined cistern with 30-inch surface opening, expanding to 5 feet, at least 8 feet deep.

**View from cistern opening, toward the north.**

5B	East of CR 9, north of CR 8		agri-cultural	cistern			c. 1930 — 1940s	filled with debris; brick lining partially collapsed	Not Eligible
5C	— Collin County — Old Celina, Ltd.		agri-cultural	windmill			c. 1940 — 1950s	collapsed and severely damaged	Not Eligible
5D			agri-cultural	windmill			c. 1940 — 1950s	general disrepair; bullet holes in wind vane	Not Eligible

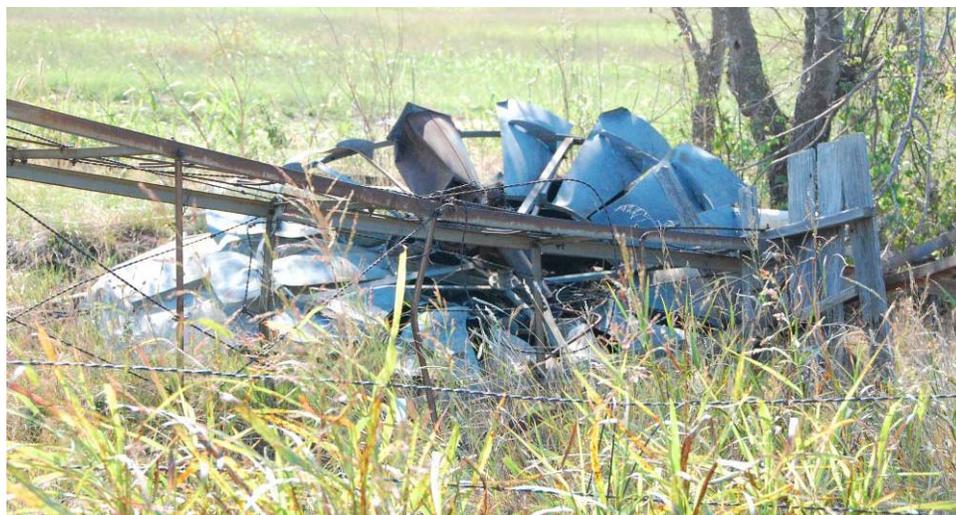
**Location ID:** 5C

**Description:** Collapsed Aermotor 6-foot diameter windmill.

**View southeast.**

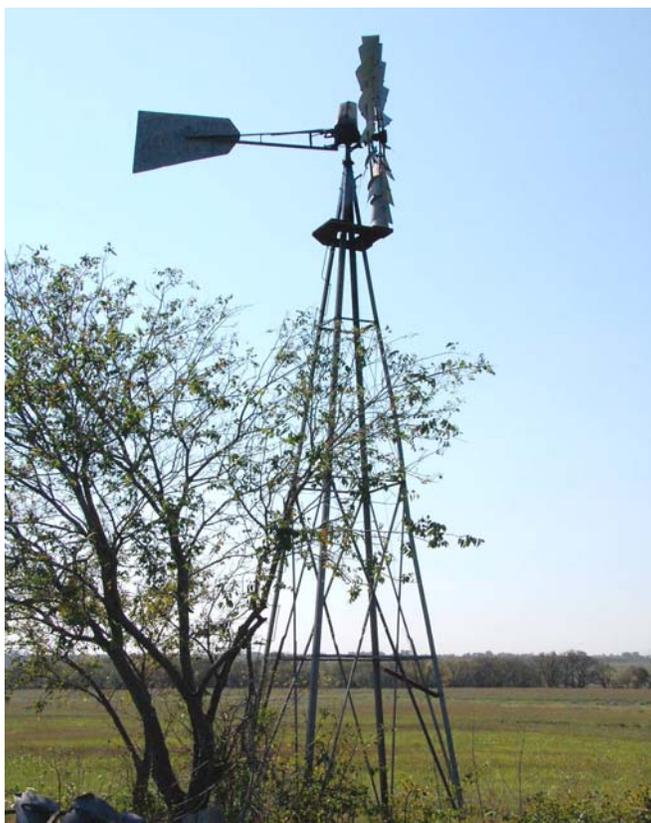
**Location ID:** 5D

**Description:** Standing Aermotor 6-foot diameter windmill, steel tower.

**View southeast.**

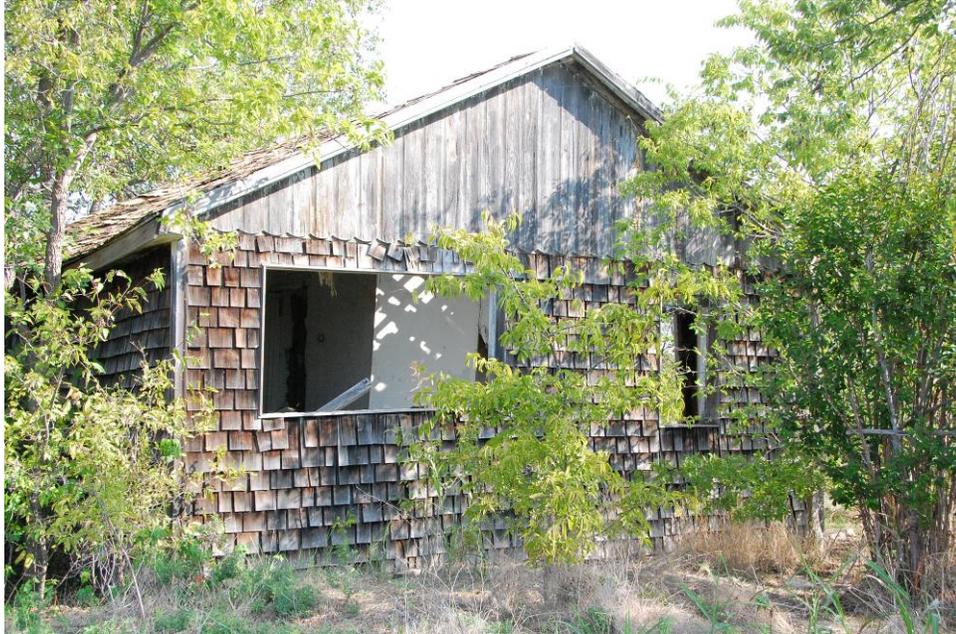
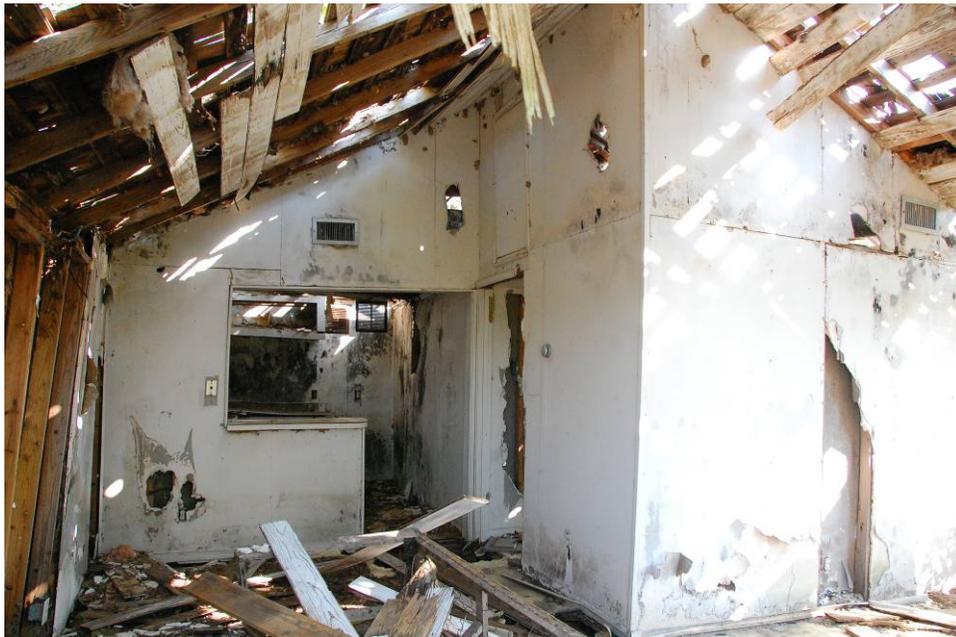
Concrete foundation. Closed soffits, modern mechanical system and interior finishes indicative of 1950s construction or significant renovation of existing structure. Deteriorated condition.

Location 6 is an abandoned farmstead with a dwelling (6A), barn (6B), concrete stock tank (6C), and windmill (6D) that are all in severely deteriorated condition. The dwelling and barn no longer maintain integrity of design, setting, materials, workmanship, feeling, and association because of holes in walls and roofs, and open doors and windows that have exposed the building interiors to the elements and resulted in a generally deteriorated condition; therefore, these

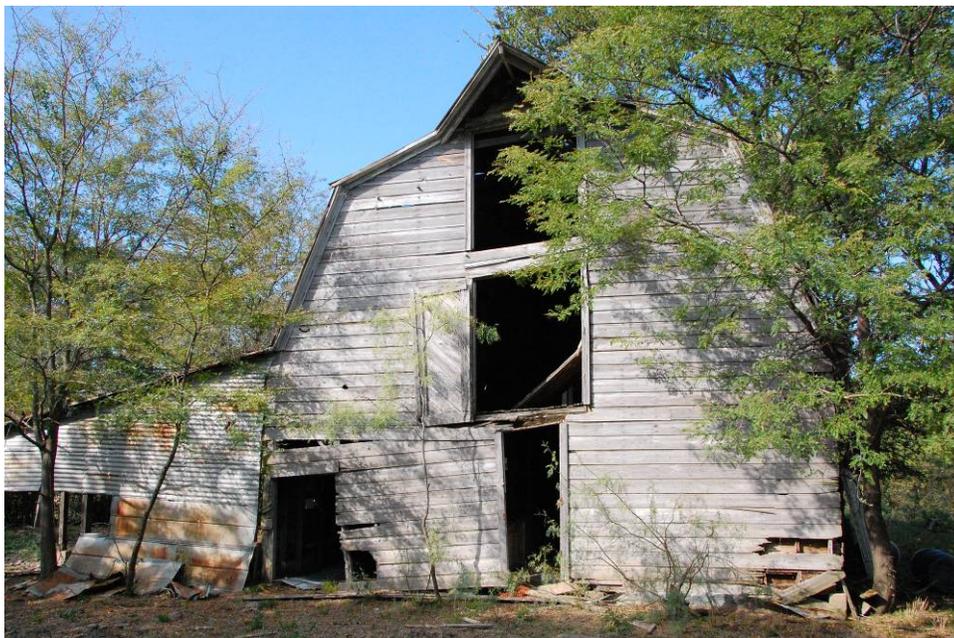
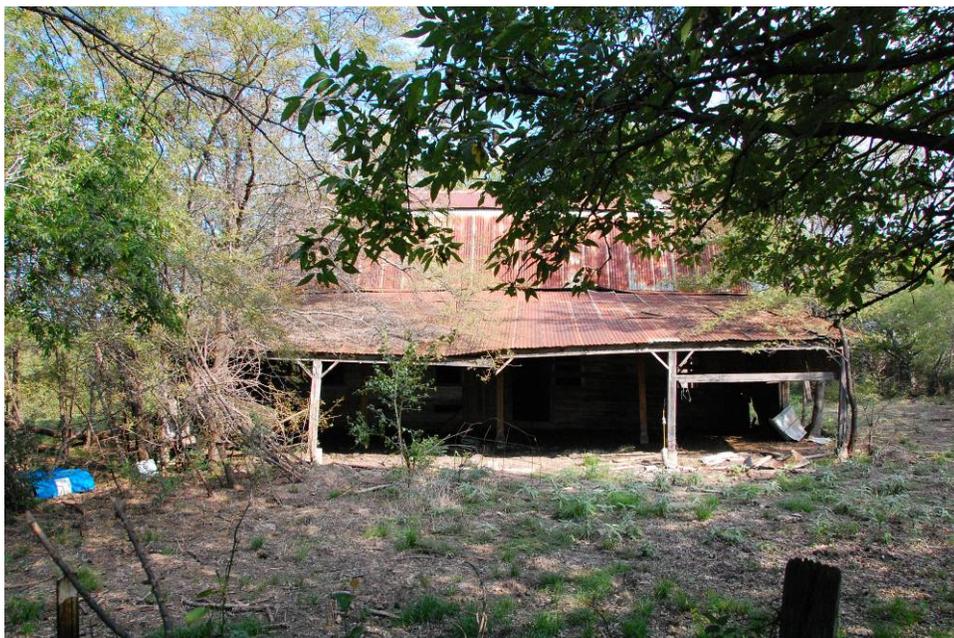
**Location ID:** 6B

**Description:** Two-story, rectangular plan barn with gambrel roof and shed addition on south, horizontal shiplap wood siding on principal structure, corrugated steel on shed addition. Concrete pier foundation. Deteriorated condition.

resources are recommended Not Eligible for the NRHP under Criterion C. The stock tank and windmill are also recommended Not Eligible under Criterion C because the stock tank is not functioning and in a general state of disrepair, and the windmill is missing its fan blades and has bullet holes in the wind vane. All four of these resources are not associated with a known significant individual nor are they associated with events that have made a significant contribution to the broad patterns of our history, and are also recommended Not Eligible for the NRHP under Criteria A and B.

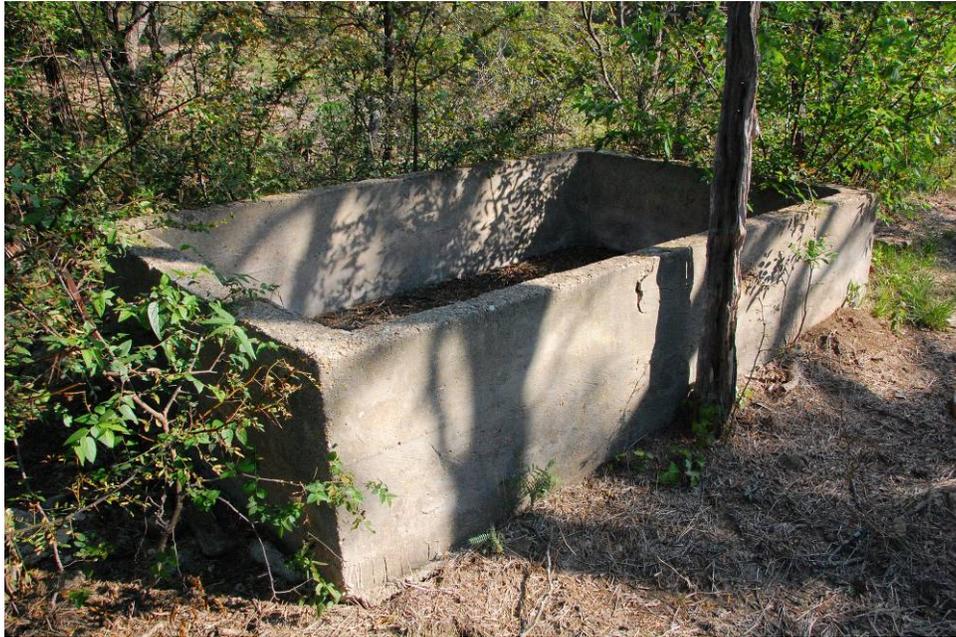
**Description:** Concrete stock tank.

**View northeast.**

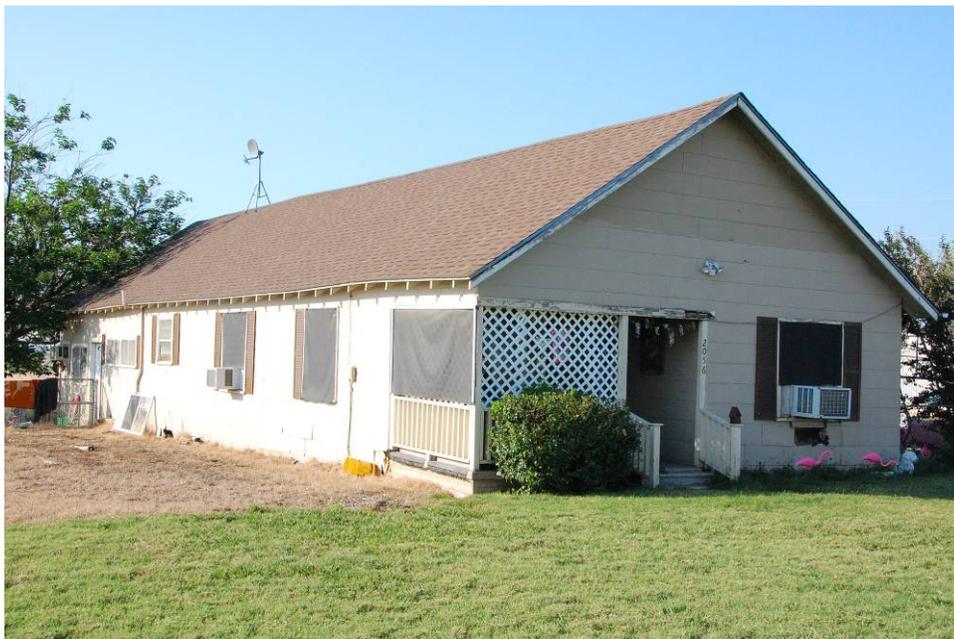
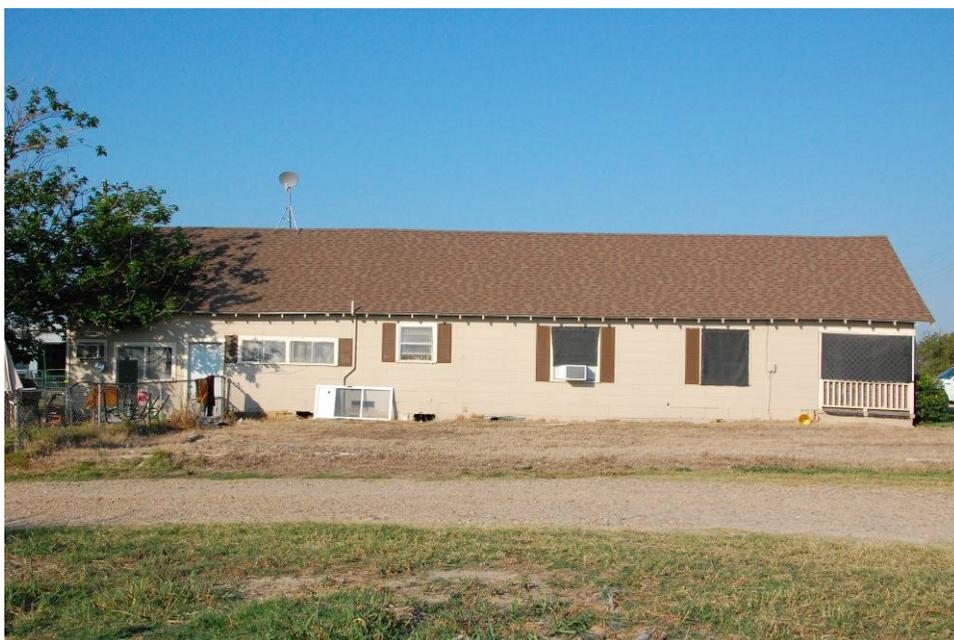
**Location ID:** 7A

**Description:** One-story, rectangular plan residence with front facing gable roof, asbestos siding.  
Concrete foundation. Exposed rafter tails indicative of 1930s construction with later alterations  
and window replacement.

Location 7 is an operational farmstead with seven historic-age resources including an inhabited residence (7A), four corrugated steel silos not apparently in use (7B), and five barn or shed structures that appear to be currently in use (7C – 7G). The residence is in fair condition, but exhibits evidence of deterioration and modification (e.g., satellite dish, enclosed porch, and changes to windows). The four steel silos are generally intact, but the door is missing from one structure and the roofs of all silos are heavily rusted. Portions of four of the barns (7C – 7F) are exposed to the elements as the result of missing doors and/or gaps in walls and roofs, and all exhibit a generally deteriorated condition. One barn (7G) is in reasonably good condition. The general condition of Resource 7A – 7F indicate these structures no longer maintain the integrity of design, setting, materials, workmanship, feeling, and association; therefore, these resources are recommended Not Eligible for the NRHP under Criterion C. In addition, all seven resources are not associated with a known significant individual nor are they associated with events that have made a significant contribution to the broad patterns of our history; accordingly, all of these resources are recommended Not Eligible for the NRHP under Criteria A and B.

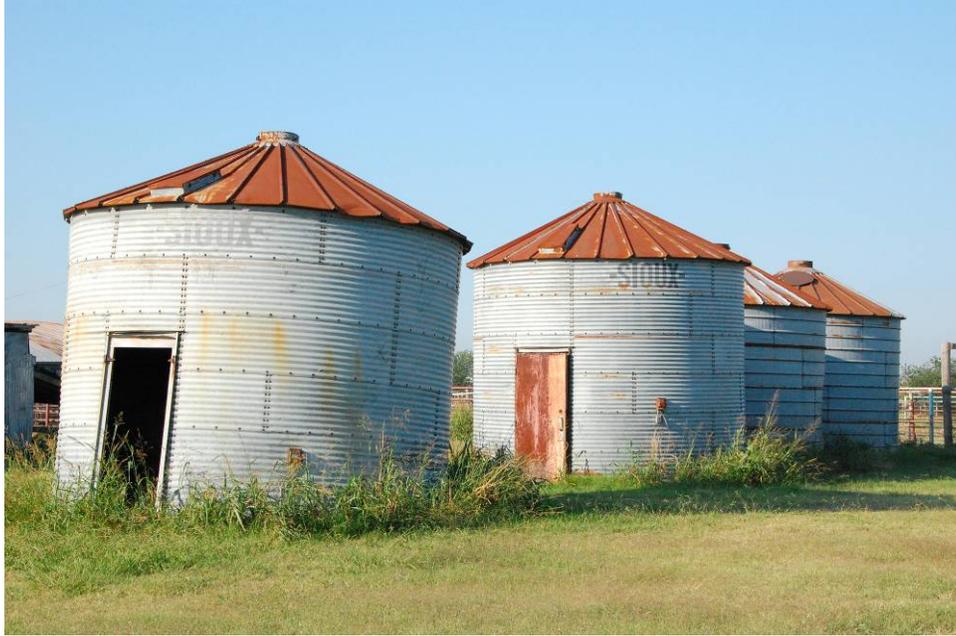
**Description:** Four corrugated “SIOUX” steel silos.

**View west.**

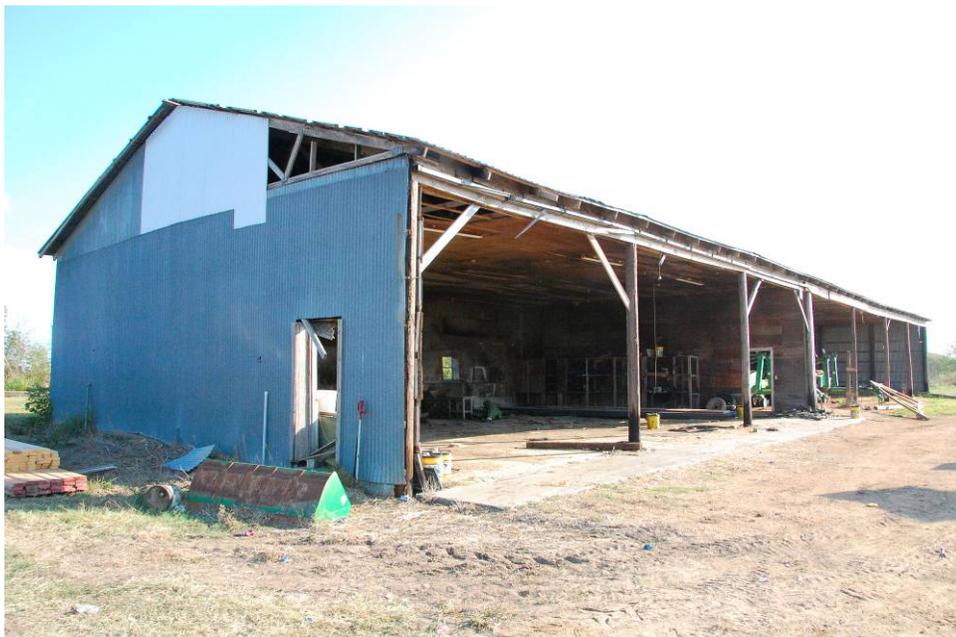
**Location ID:** 7C

**Description:** Gable roof pole barn (equipment storage and shop) with prefabricated plate truss roof structure. Corrugated steel siding and roofing panels.

**View southwest.**

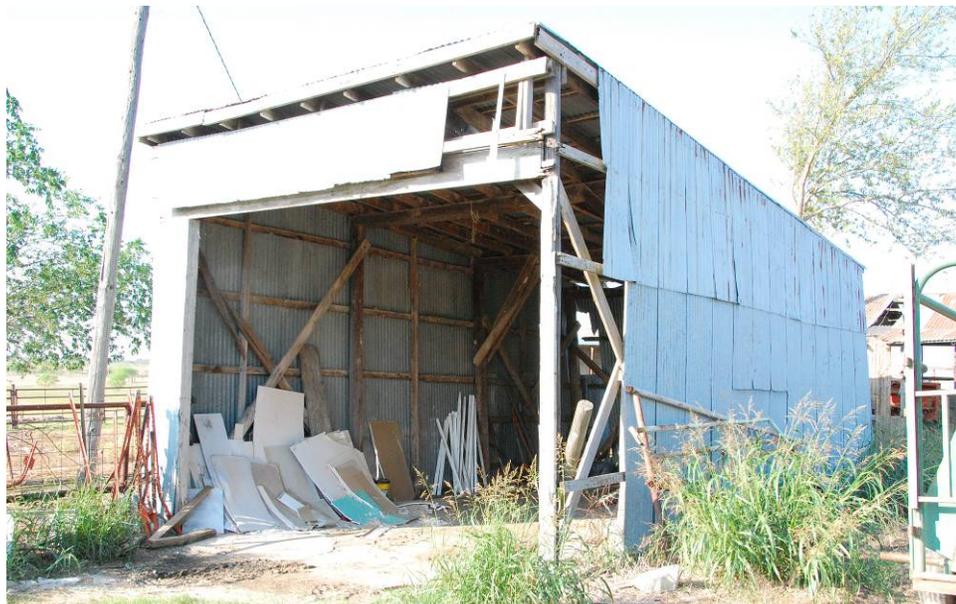
**Location ID:** 7D

**Description:** Shed roof pole barn (Storage Building) with dimensional lumber roof structure. Corrugated steel siding and roofing panels.

**View southeast.**

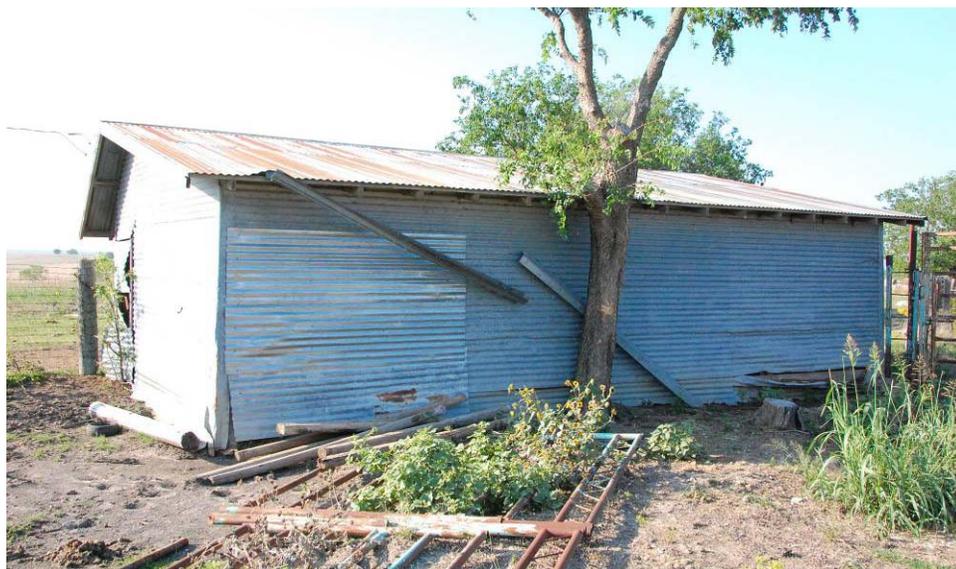
**Location ID:** 7E

**Description:** Gable roof pole barn (Horse Barn) with dimensional lumber roof structure. Corrugated steel siding and roofing panels.

**View southwest.**

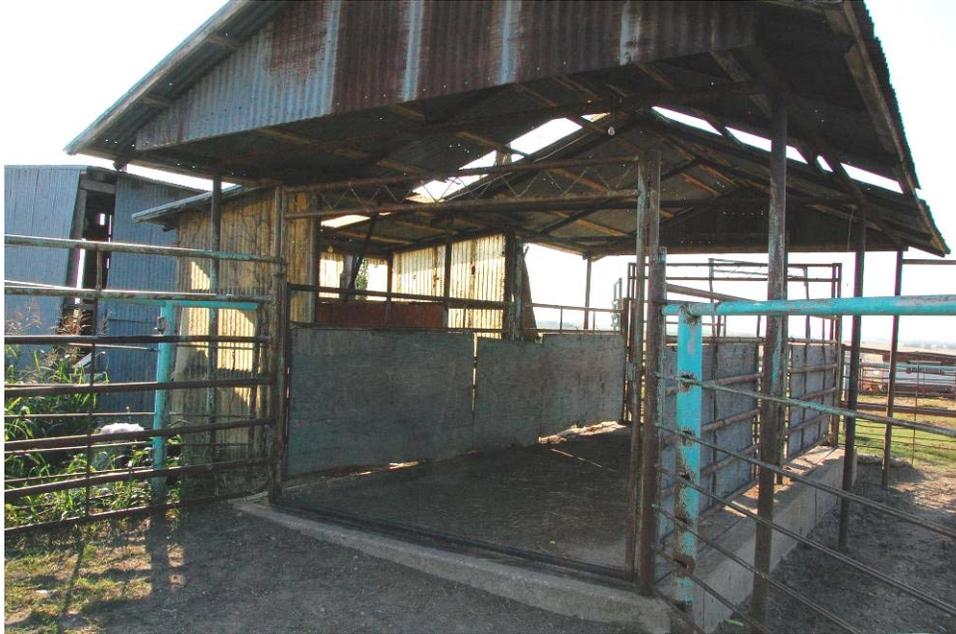
**Location ID:** 7F

**Description:** Gable roof steel pipe barn (Scale and Shelter Building) with dimensional lumber roof structure. Corrugated steel siding and roofing panels.

**View southeast.**

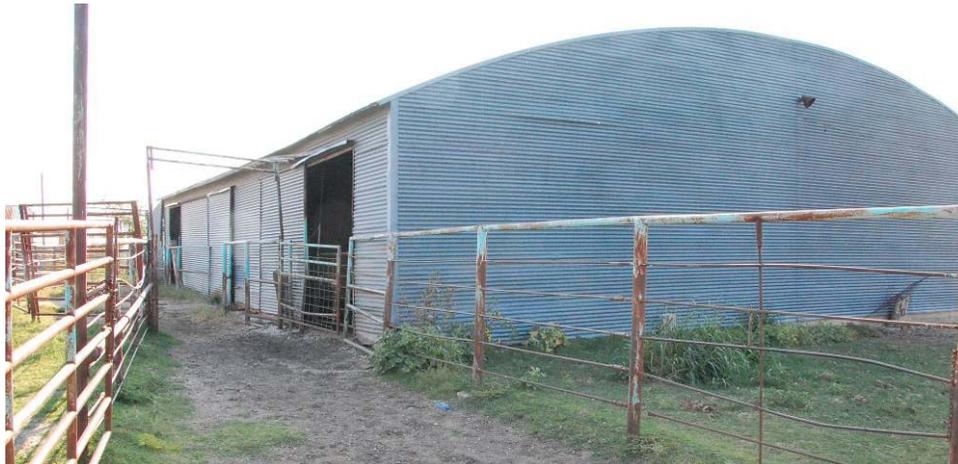
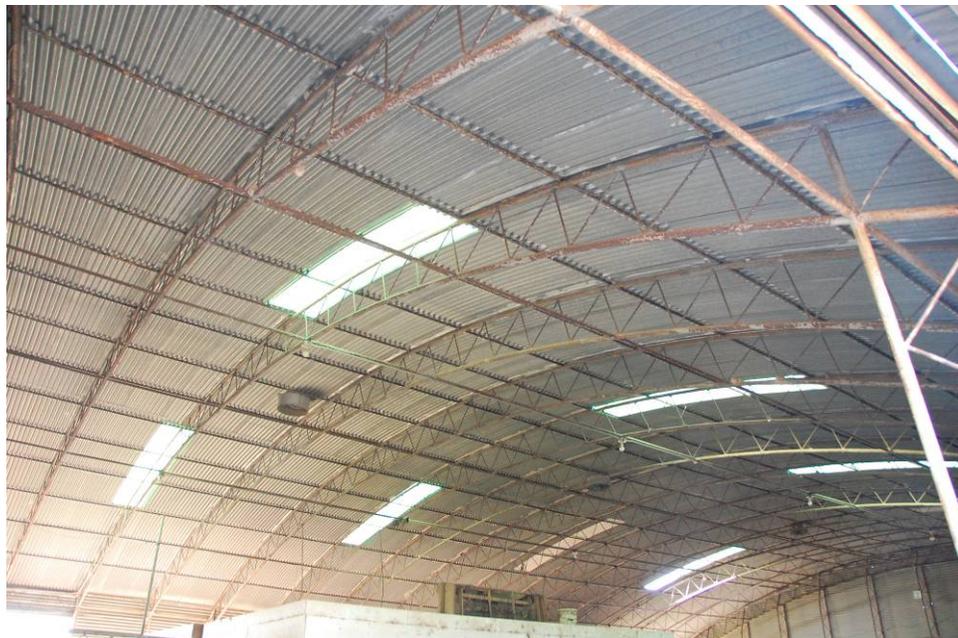
**Description:** Rectangular plan, barrel roof barn with corrugated steel siding and roof covering. Building structure is comprised of proprietary curved pipe and rod truss system. Wall system is similar construction.

**View east.**

**View southwest (interior).**
