# Dallas North Tollway Extension

## Phase 4B/5A

### From FM 428 to FM 121

Historic-age Resources Due Diligence Report

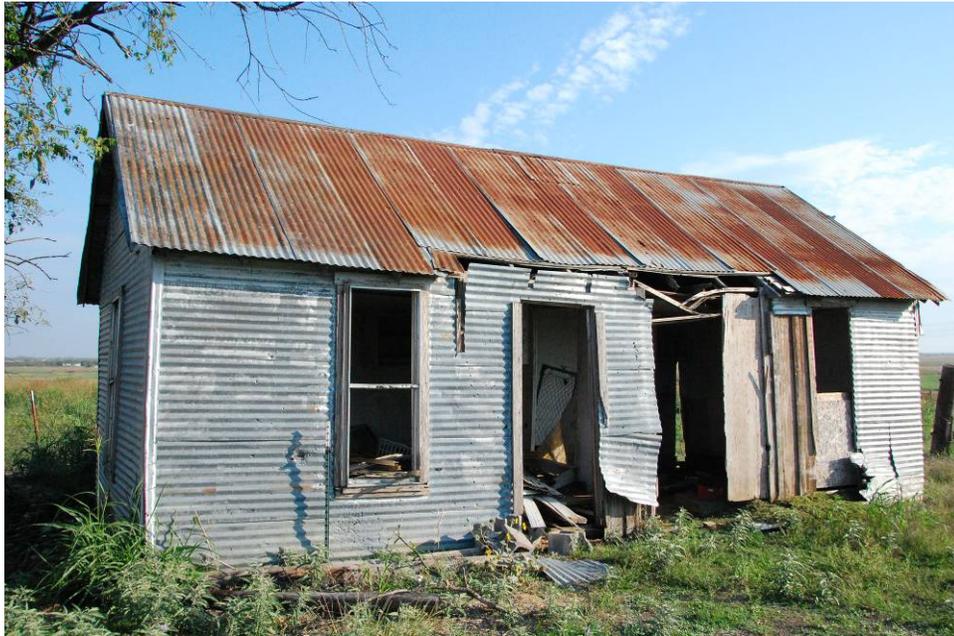
**Location ID:** 8A

**Description:** Rectangular plan, side facing gable roof two room, two family duplex dwelling with corrugated steel siding and roof covering. Wall construction is board and batten, no wall studs. Deteriorated condition.

Location 8 is an abandoned farmstead with a dwelling (8A) and adjacent barn (8B) that are both in severely deteriorated condition. The dwelling no longer maintains integrity of design, setting, materials, workmanship, feeling, and association because the windows and doors are missing, exposing the interior to the elements, and metal siding is partially missing from exterior walls. Similarly, the barn no longer maintains integrity of design, setting, materials, workmanship, feeling, and association because the roof and over half of all wall panels are missing. Therefore, these resources are recommended Not Eligible for the NRHP under Criterion C. As, these resources are not associated with a known significant individual nor are they associated with events that have made a significant contribution to the broad patterns of our history, they are also recommended Not Eligible for the NRHP under Criteria A and B.

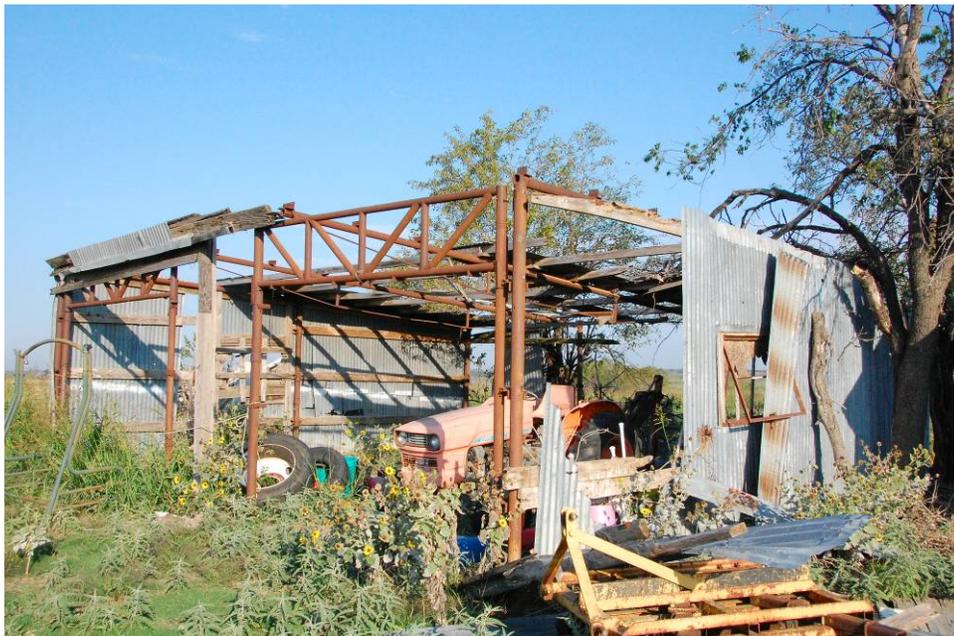
**Description:** Rectangular plan, pipe truss roof structure barn with corrugated steel siding and roof covering.

**View northwest.**

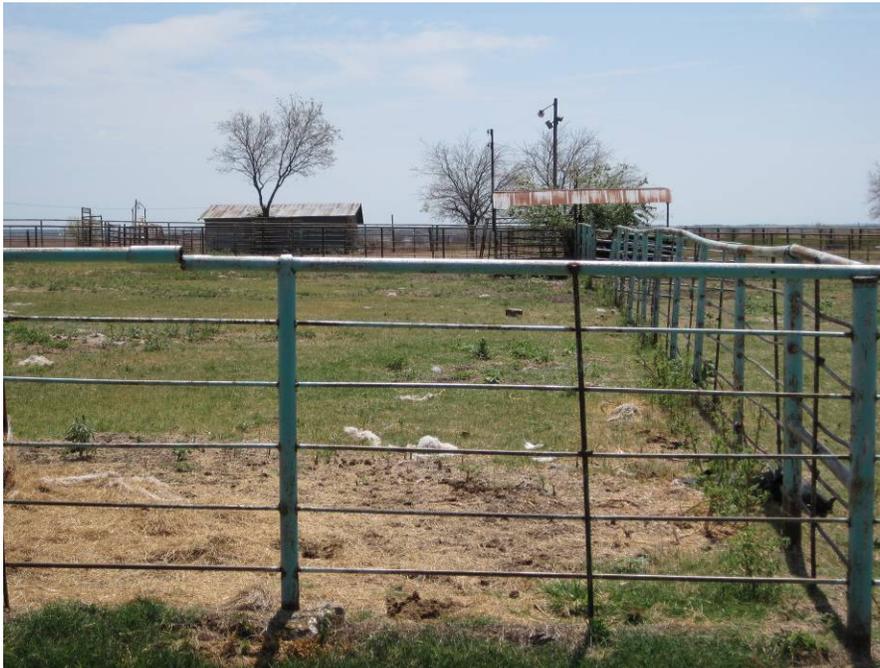
Near the northern terminus of the alignment, it joins and parallels Scharff Rd. at the intersection with Stiff Rd. At this point it passes near a group of historic structures that may correspond to those identified on the 1936 Grayson County Highway Map (**Figure 13**). The nearest of the structures is approximately 300' east of the project centerline, and could be impacted by construction.

Figure 13. Structure nearest the project centerline, south of Stiff Rd. and Scharff Rd.

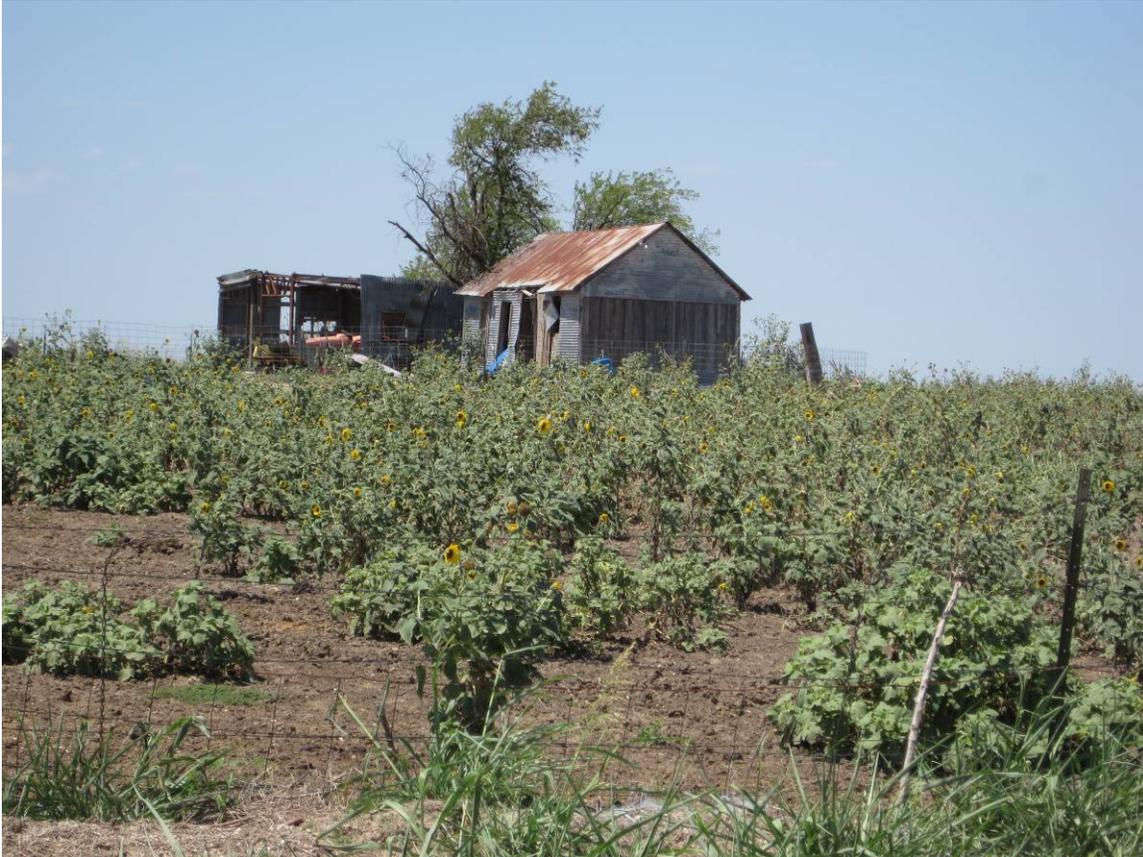
Figure 14. Historic structure west of Scharff Rd., approximately 150' from the project centerline.

Another structure was encountered along Scharff Rd., this time about 150' east of the centerline (**Figure 14**). The building likely corresponds to one plotted on the historic map. None of the other mapped structures along Scharff Rd. are standing today, nor was any evidence of them visible from the road. Like the other segments, this one passed through gently rolling terrain kept as a combination of improved pasture and plowed fields. The alignment continues to parallel this road until it terminates at FM121.

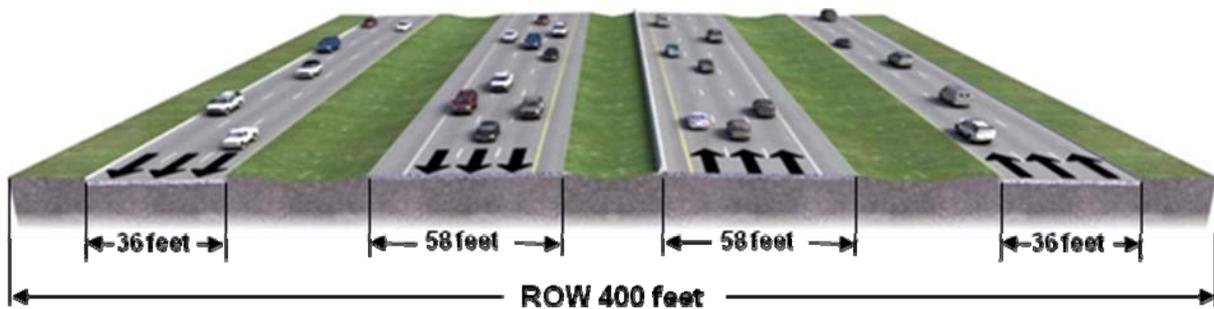
2  
3 Construction of six proposed DNT 4B/5A mainlanes (three lanes in each direction) and frontage  
4 roads (three lanes in each direction) would generally result in excavation of soil to a depth of  
5 5 feet (1.5 m) or less, but excavation to a maximum depth of 10 feet (3.0 m) may be required at  
6 some locations (**Figure 2**). Excavation of soil for mainlanes to a depth of up to 35 feet (10.7 m)  
7 would occur at five locations where the proposed tollway would pass under the following cross  
8 streets: County Road (CR) 54, FM 455, CR 60, a future street 0.5 mile (0.8 km) south of Stiff  
9 Chapel Road, and at Stiff Chapel Road; frontage roads at these locations would remain at  
10 grade.

13  
14  
15 **Figure 2. Representative cross section of the proposed DNT 4B/5A ROW showing three**  
16 **mainlanes and three frontage road lanes in each direction.**

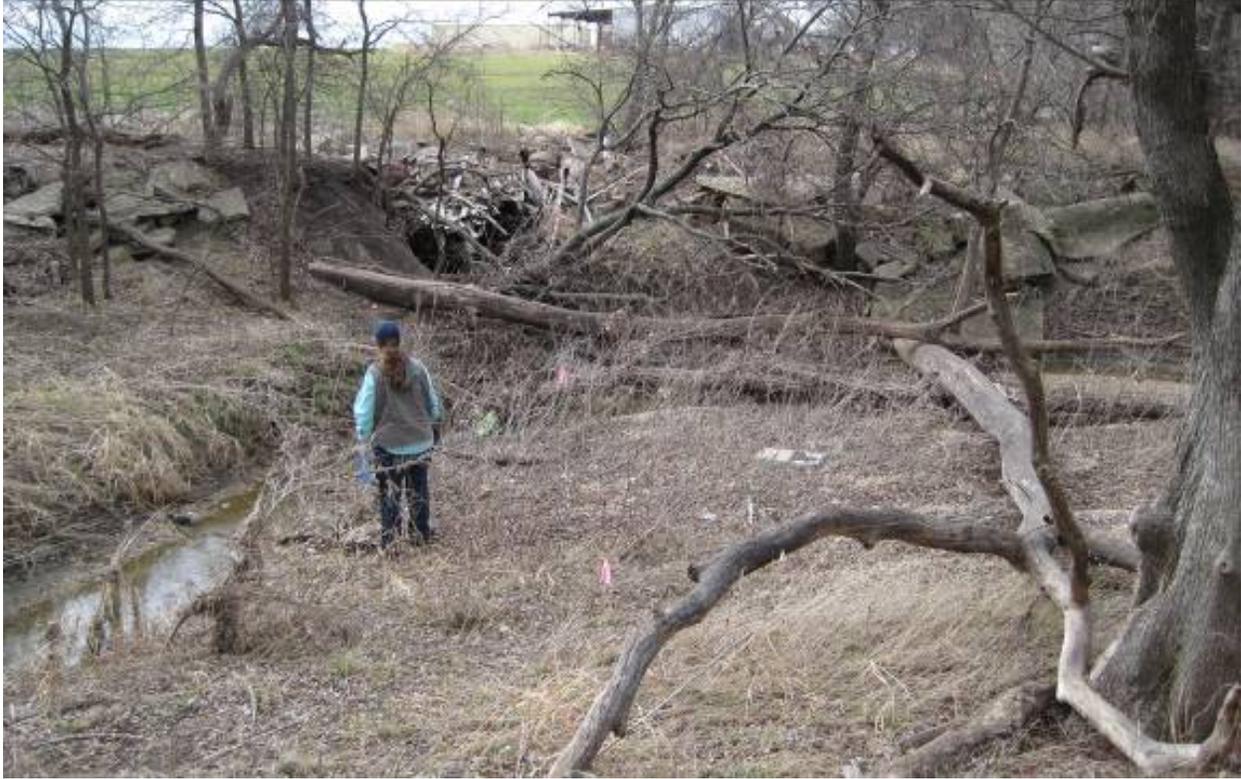
1 tests B217 through B221 were excavated on the upland edges and elevated areas near the  
2 channel edge. The topsoil was very dark gray clay loam with limestone pebbles, followed by  
3 dark gray clay loam with sand and gravel subsoil between 24 cmbs (9.4 inches) and 27 cmbs  
4 (10.6 inches). No cultural materials were recorded in the fields, channel, or shovel tests.  
5

6  
7  
8 **Figure 3. Unnamed tributary of Little Elm Creek, note the concrete and lumber debris,**  
9 **view is facing south.**  
10  
11

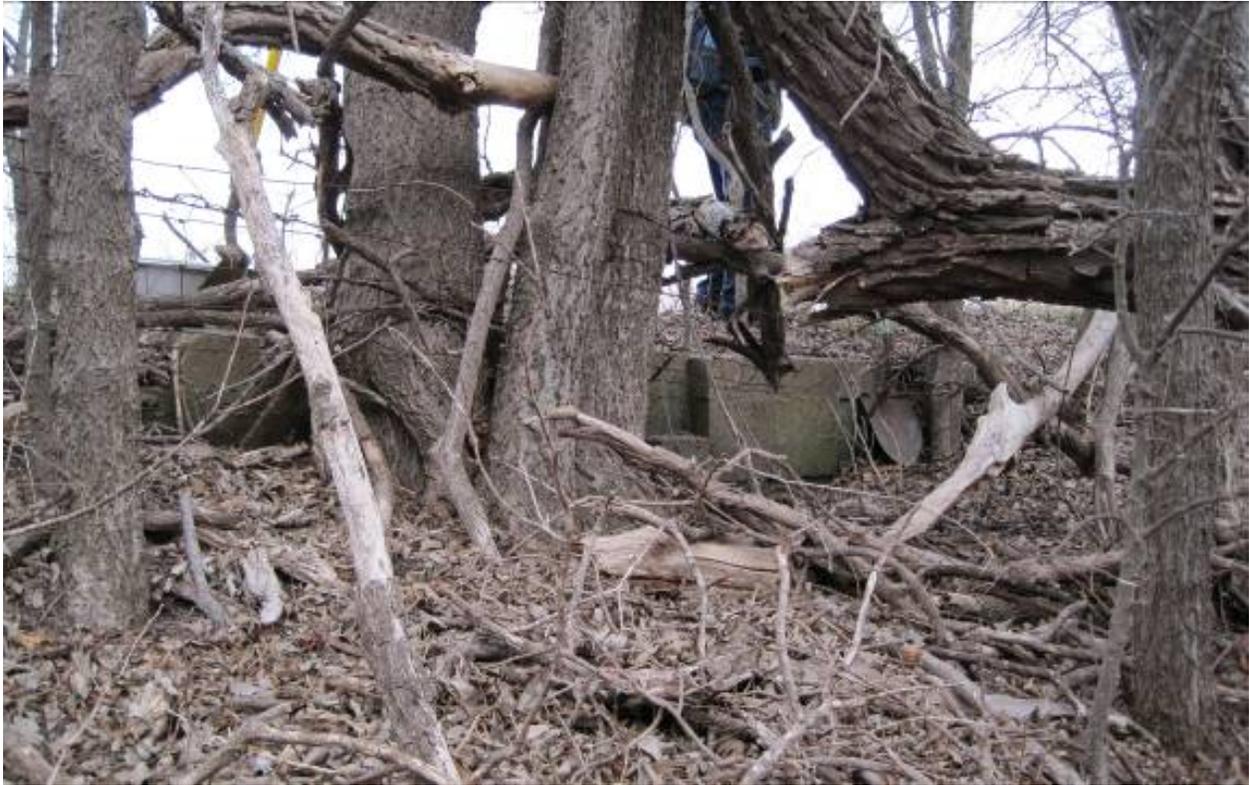
12 West of the drainage, the surveyors' route crossed through a pasture and a second plowed field  
13 to the edge of CR 54 where ground visibility ranged between 50% and 100%. At the edge of the  
14 plowed field and tree line, a historic feature was recorded (**Figure 4**). The feature was a  
15 concrete, brick and cinderblock retaining wall encountered on the edge of the 400-foot  
16 (121.9-m) ROW. It appears to be associated with the Historic Resource Location 1 in the  
17 Historic-Age Resource Due Diligence Report (HRDDR) (Terrell 2011:11). This retaining wall  
18 was most likely built to facilitate drainage of the pasture and to keep the soil from eroding  
19 downslope into the farmstead. No other historic artifacts were identified on the surface, and the  
20 majority of the historic resources including two barns, a garage, and a collapsed house are  
21 outside the proposed DNT 4B/5A ROW.

**Figure 4. Retaining wall in the proposed DNT 4B/5A ROW located northeast of Historic Resource Location 1.**

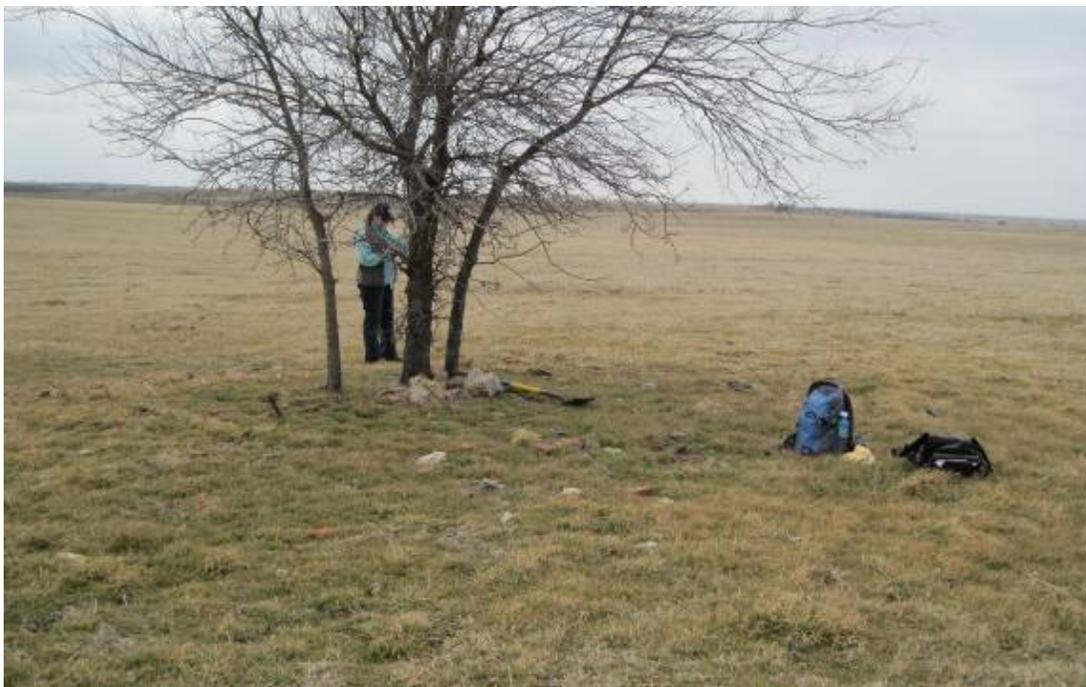
1  
2  
3 **Figure 6. Historic Site 41DN577 with “PALMER” bricks and limestone cobbles**  
4 **surrounding the hackberry trees, view is facing southwest.**  
5

30  
31 A concise history of the Palmer Pressed Brick Works was prepared for a historic resource  
32 survey of Ellis County (Hardy, Heck and Moore 1990). “PALMER” bricks were manufactured by  
33 the Palmer Pressed Brick Works, which began operation in 1902 then merged with the Standard  
34 Brick Company to form the Barron Brick Company which operated until 1973 (Texas Secretary  
35 of State n.d.). The bricks were marked “PALMER” to distinguish them from others (Steinbomer  
36 1980). Overall, very little of the cultural material is *in situ*, and much of the site appears to have  
37 been cleared of cultural resources; therefore, the integrity is poor. The presence of the  
38 “PALMER” bricks suggests that the site could date to the early 20<sup>th</sup> century.

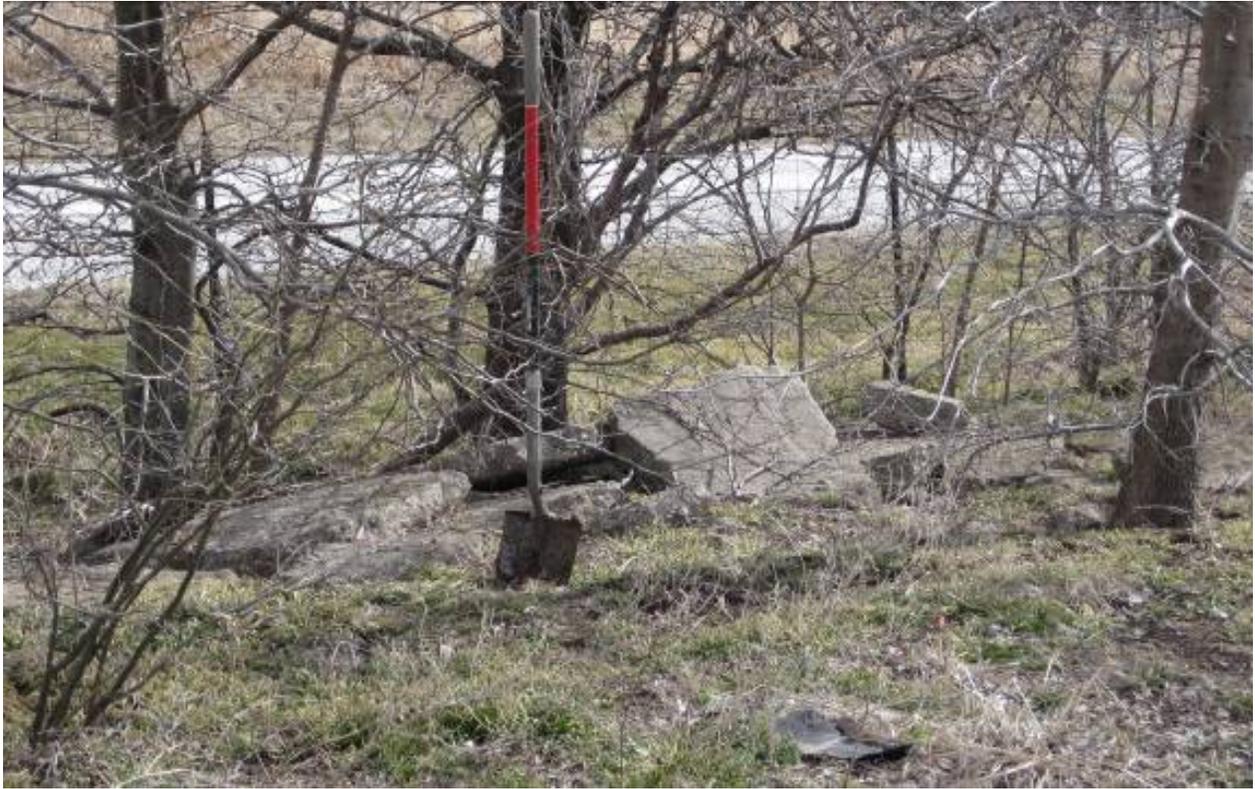
1  
2  
3 **Figure 9. Foundation debris on west side of County Line Road (CR 10), view is to the**  
4 **east.**  
5

15 On the 1961 Marilee, TX 7.5' USGS topographic map, seven structures were mapped near the  
16 proposed DNT 4B/5A ROW, four near CR 60 and three approximately 3,700 feet (1,127.8 m)  
17 south of CR 60. Upon survey of the plowed fields in this area, no evidence of the mapped  
18 structures or artifact scatters was present. On the west side of County Line Road (CR 10) and  
19 within its ROW, a foundation was recorded (**Figure 9**). Shovel tests (N129-N131) were placed  
20 to the north, west, and south of the foundation. All three of these shovel tests were negative for  
21 cultural material, and the subsoil was relatively shallow (20 cmbs to 25 cmbs; 9.8 inches to  
22 7.9 inches) in two of the shovel tests. The foundation was broken up and appeared to have  
23 been pushed or dumped in the location. Due to the lack of any additional cultural material or  
24 features, it was determined that the foundation was out of context and not recorded as a site.

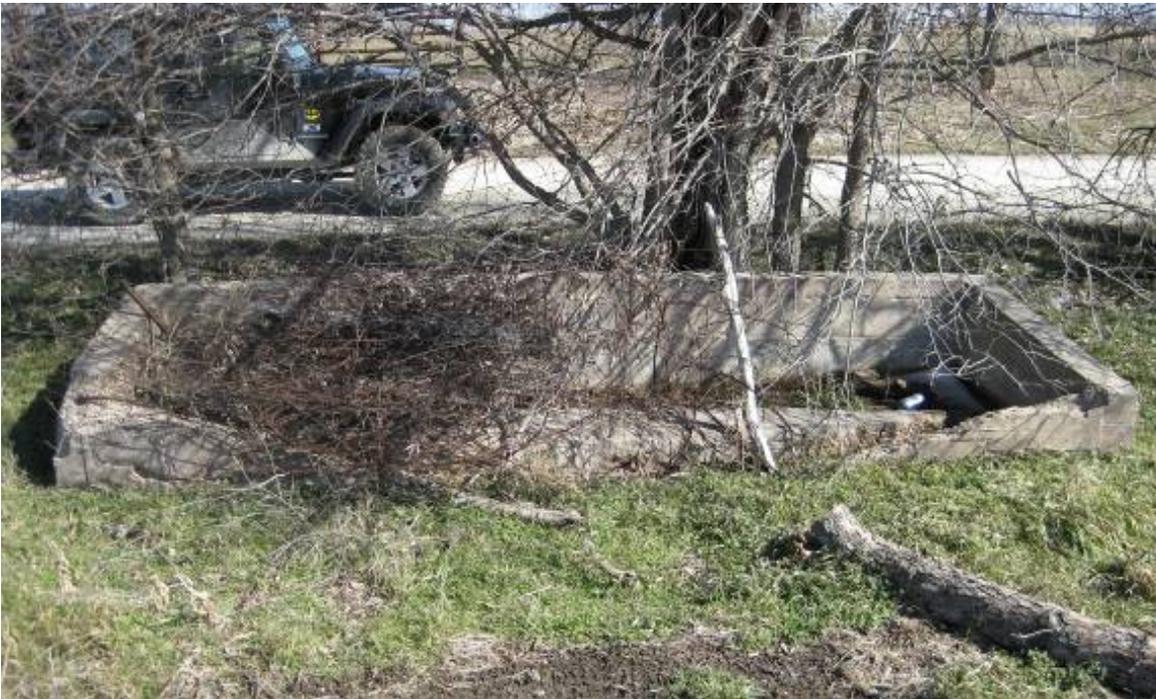
19 A small concrete trough (4 feet x 12 feet; 1.2 m x 3.7 m) was located on the east side of the  
20 proposed DNT 4B/5A ROW on the west side of County Line Road (CR 10) in the northeast  
21 corner of Denton County, where the Collin, Denton, and Grayson county lines converge  
22 (**Figures 10** and **11**, and **Appendix C, Exhibit 3**). The concrete was reinforced with rebar and  
23 filled with debris such as barbed wire, t-post, and chicken wire. Ground visibility was 80%. The  
24 trough is near a mapped structure shown on the 1961 Marilee, TX 7.5' USGS topographic map  
25 at approximately 660 feet (201.2 m) asl, yet no remains of the structure were present. The

10 **Figure 11. Concrete trough located on the west side of County Line Road (CR 10), view**  
11 **is to the east.**

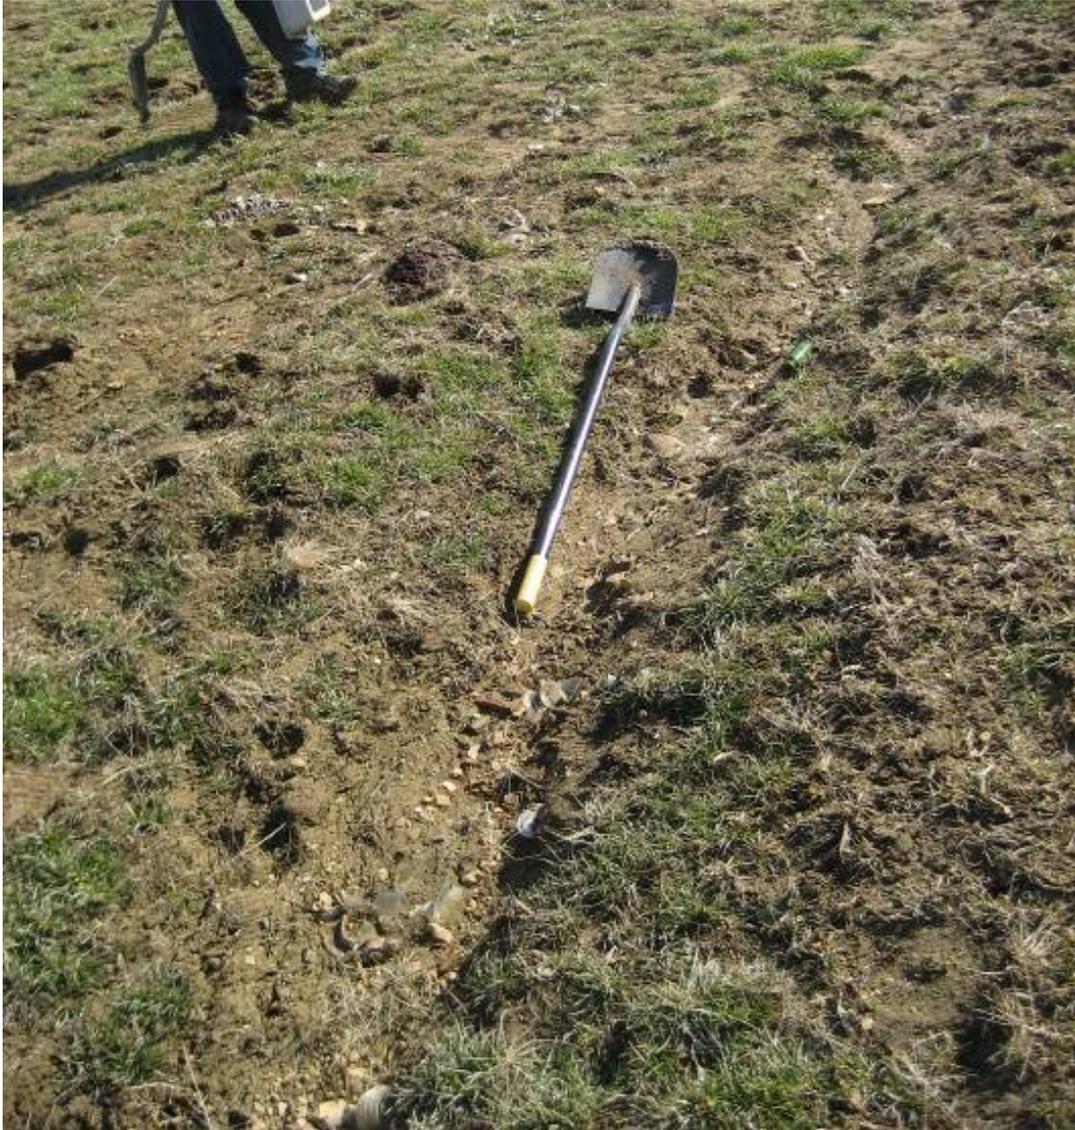
36 Continuing north, the proposed DNT 4B/5A proceeds upslope to follow and ridge line. Ground  
37 visibility was excellent, and a historic trash scatter, designated site 41GS221, was located in the  
38 proposed DNT 4B/5A ROW near a fence line at 680 feet (207.3 m) asl in a low lying area  
39 downslope from a well defined ridge to the west (**Figure 12, and Appendix C, Exhibit 3**).  
40 A large variety of glass shards and bottles (consisting of clear, green, milkglass, and blue  
41 opalescent varieties) was present, as well as metal fragments and a few commercially  
42 manufactured brick fragments. The bottles were screw top rather than hand blown. One bottle  
43 had a square base similar to a medicine bottle. Milkglass, as well as the other material present,  
44 are typical of household goods, and the site dates to the early to mid-20<sup>th</sup> century. Historic trash

1 scatters are typically located in gullies or at the edges of property lines, and this trash scatter is  
2 most likely associated with a residence to the west where the USGS topographic map shows  
3 mapped structures. The structure locations are well out of the proposed DNT 4B/5A ROW and  
4 therefore were not investigated. Trash scatters are worth recording for their research value, but  
5 due to the ephemeral nature of the cultural material, these types of sites are not eligible for  
6 listing on the NRHP and no further investigations are recommended.

**Figure 12. A portion of historic trash scatter at Site 41GS221.**

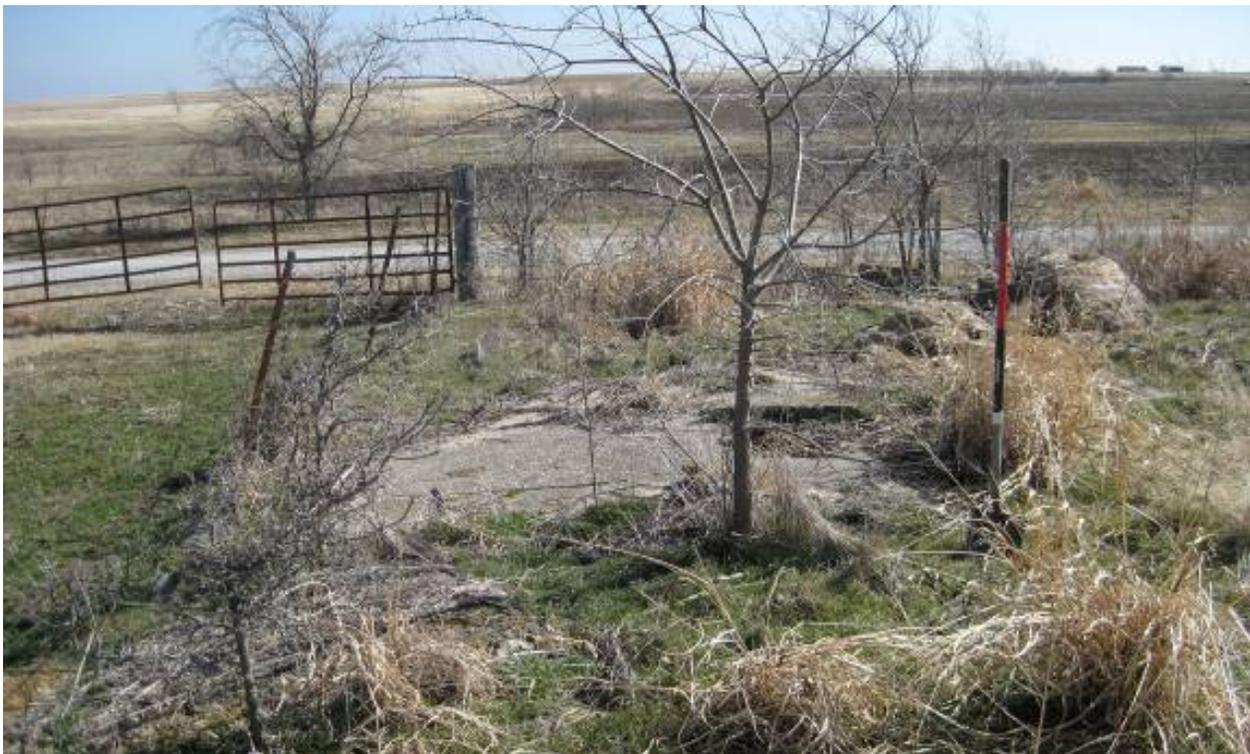
5 The final section of the proposed DNT 4B/5A parallels Scharff Road and crosses through  
6 relatively level pastures (**Appendix C, Exhibit 4**). Before crossing the two parallel intermittent  
7 channels, the proposed DNT 4B/5A crosses two mapped structures as shown on the 1961  
8 Marilee, TX 7.5' USGS topographic map, one at Stiff Chapel Road and the second which was  
9 west of Historic Resource Location 8 in the HRDDR (Terrell 2011:13). Heading north from Stiff  
10 Chapel Road, ground visibility was between 50% and 90% through plowed fields. Approximately  
11 700 feet (213.4 m) north of one of the mapped structures, there was a broken concrete  
12 foundation within the proposed DNT 4B/5A ROW at the corner of the fenced property line  
13 (**Figure 13**). Four shovel tests (C29-C32) were placed in each cardinal direction to determine if  
14 the foundation was associated with other artifacts such as an *in situ* foundation or if it was an

15 isolated feature. The shovel tests were negative for cultural resources and contained brown  
16 loamy clay in the top 50 cm (19.7 inches). This foundation appears too far north to be directly  
17 associated with Historic Resource Location 8 recorded in the HRDDR, and to far east of the  
18 former structures mapped on the 1936 Grayson County Highway Map. Due to the lack of any  
19 additional cultural material or features, it was determined that the foundation was out of context  
20 and not recorded as a site.

23 **Figure 13. Broken foundation on west side of Scharff Road.**
