**PRE-CONSTRUCTION NOTIFICATION  
NATIONWIDE PERMIT 14, LINEAR  
TRANSPORTATION CROSSINGS**

**FOR THREE SINGLE AND COMPLETE  
CROSSINGS OF WATERS OF THE U.S.**

**State Highway 121**

**From Farm-to-Market 1187 to  
U.S. Highway 67**

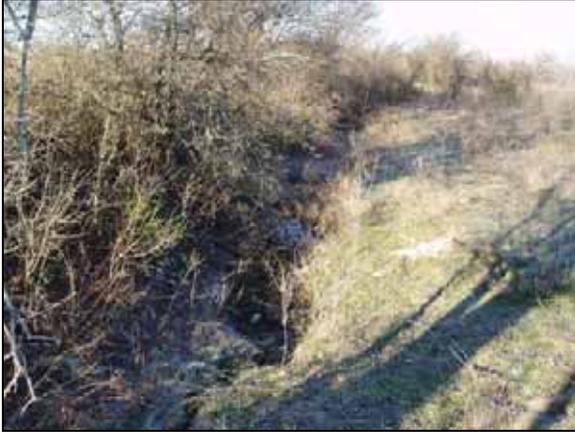
**Photo 1.** Facing west along Stream Channel 1 (S-1) south of FM917. S-1 is an ephemeral stream with a scrub overstory.

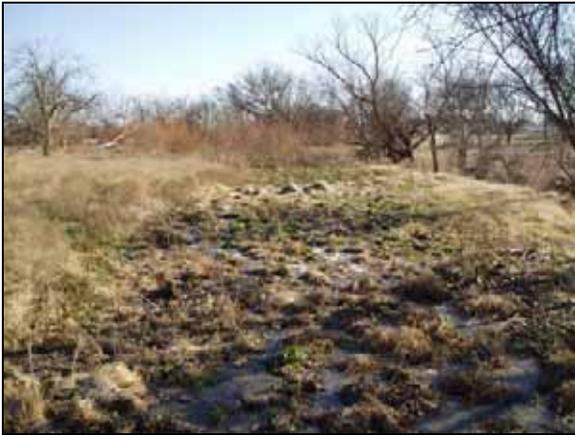
**Photo 2.** Facing northeast across W-1 which is located on the northern side of S-2. W-1 is approximately 0.25 acres.

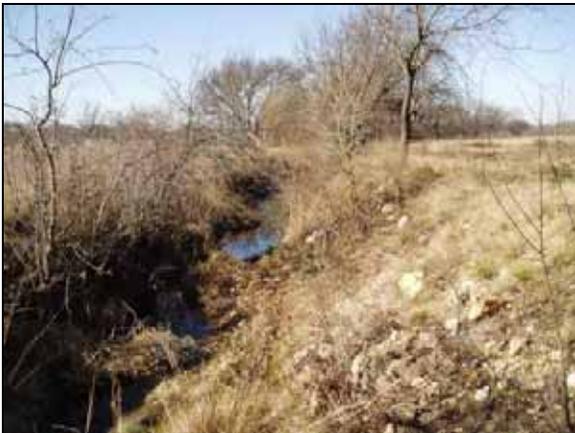
**Photo 3.** Facing southwest along S-2 from the eastern edge of the proposed ROW location. The stream has been channelized for past land uses.

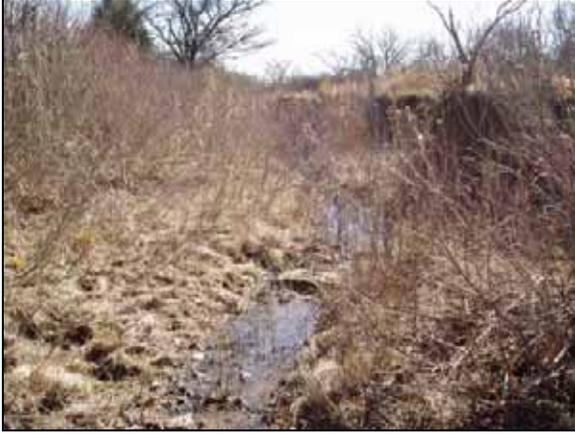
**Photo 4.** Facing southeast along S-3 from the western edge of the proposed ROW.

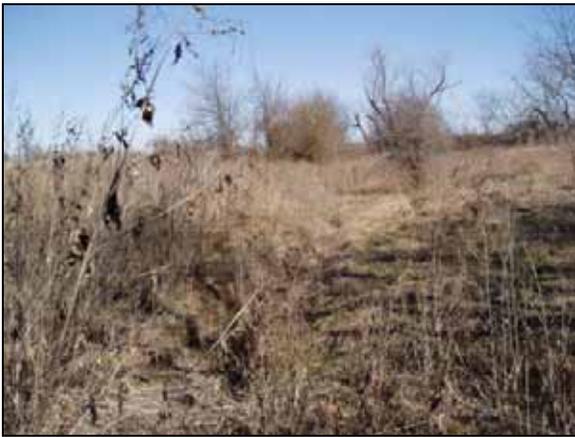
**Photo 5.** Facing northeast or upstream along S-6. The head of the stream is approximately 35 feet upstream of the photo location.

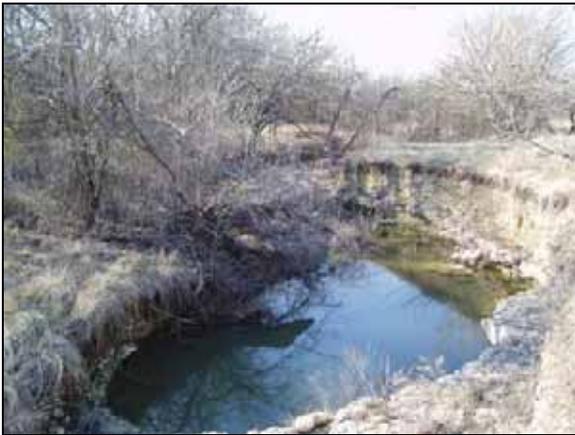
**Photo 6.** Facing northwest along S-6. The photo was taken looking downstream from the eastern edge of the proposed ROW.

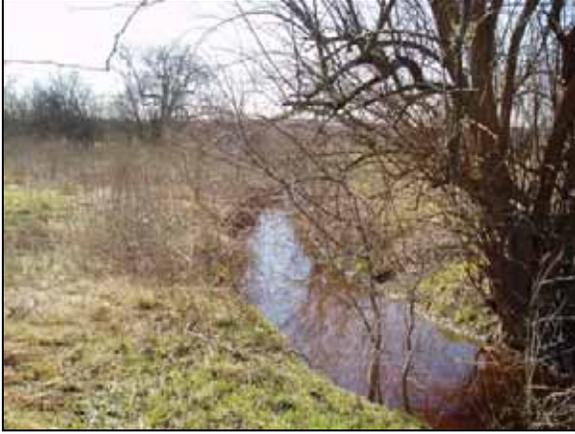
**Photo 7.** Facing west from the head of S-7. The stream begins at the centerline of the proposed highway and flows east out of the proposed ROW.

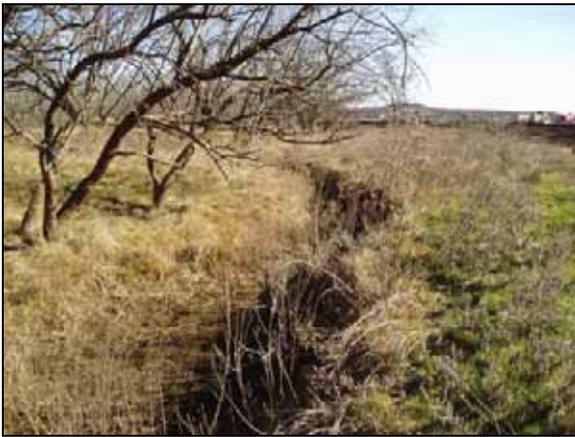
**Photo 8.** Facing north along S-8 from the convergence of S-7 and S-8. This ephemeral stream is approximately 116 lf.

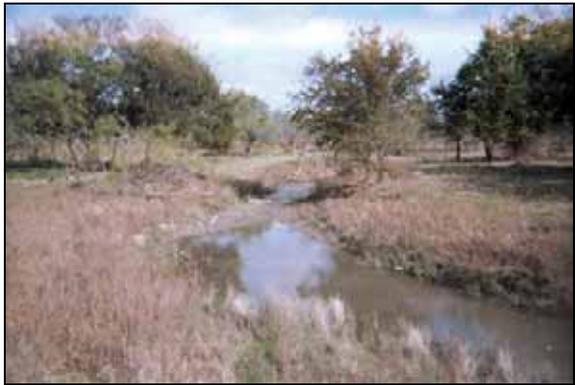
**Photo 9.** Facing south along S-10 (West Buffalo Creek).

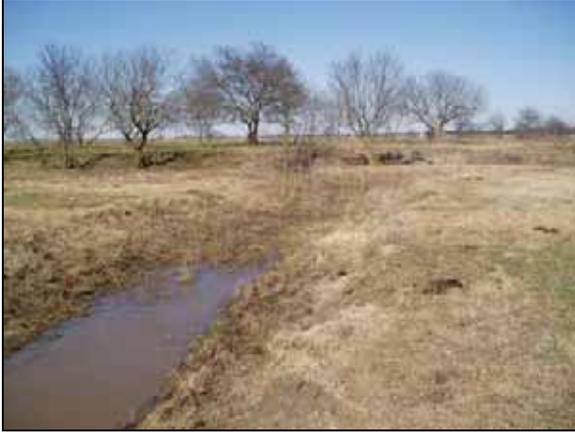
**Photo 10.** Facing northeast along S-11 back downstream towards the George Marti Reservoir northwest of the City of Cleburne.

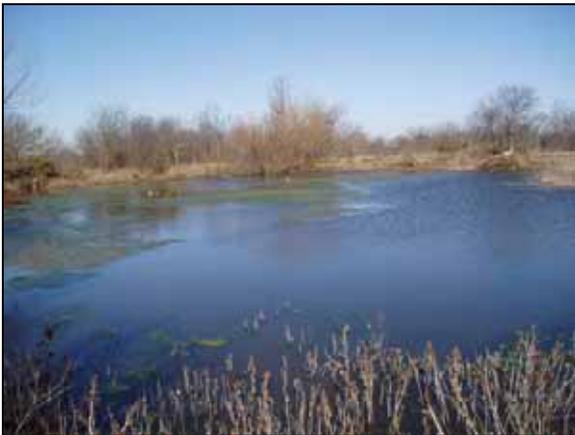
**Photo 11.** Facing west across the On-Channel Pond located along S-7.

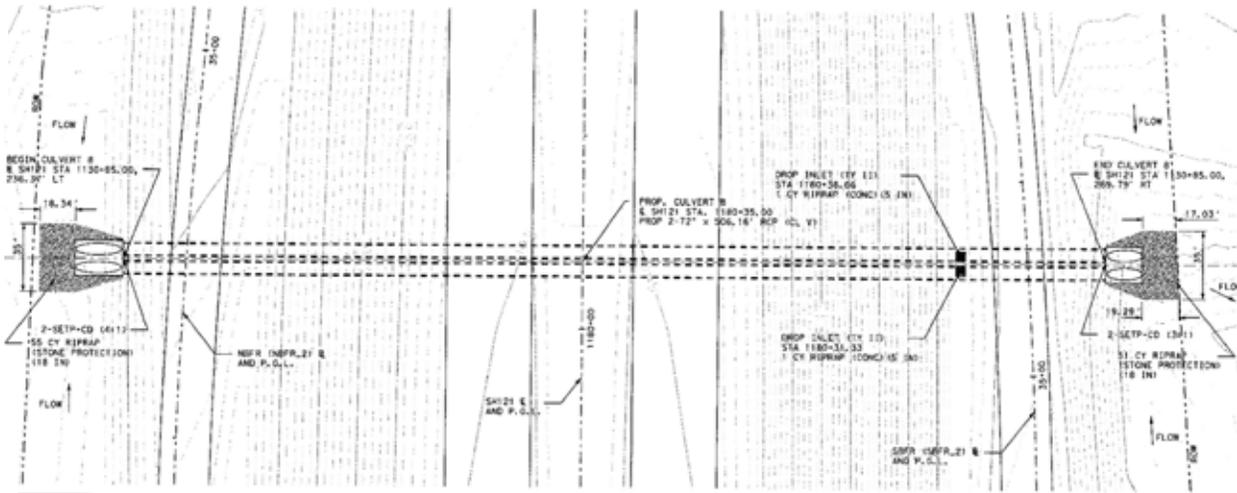
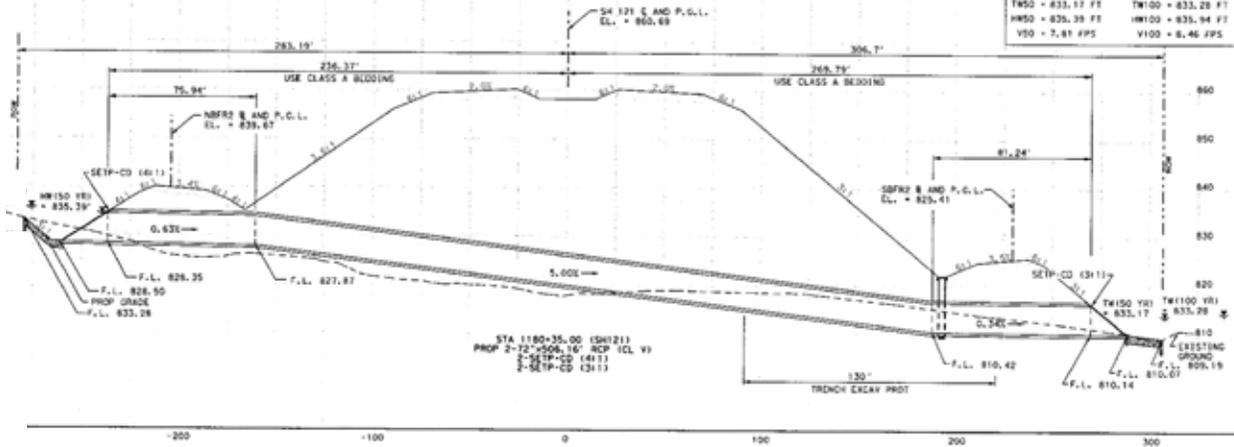
PROPOSED CULVERT LAYOUT  
AT STREAM S-1

HYDRAULIC DATA	
DA = 20.97 ACRES	
Q50 = 93.15 CFS	Q100 = 108.58 CFS
TW50 = 833.17 FT	TW100 = 833.28 FT
HW50 = 825.39 FT	HW100 = 835.94 FT
V50 = 7.81 FPS	V100 = 8.46 FPS

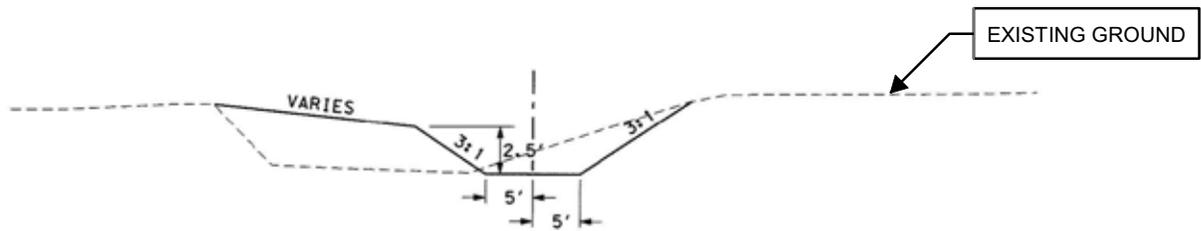
CROSS SECTION A-A

PROPOSED STREAM S-6  
CHANNEL RE-ALIGNMENT  
STATION 1310

Station 1312 + 05

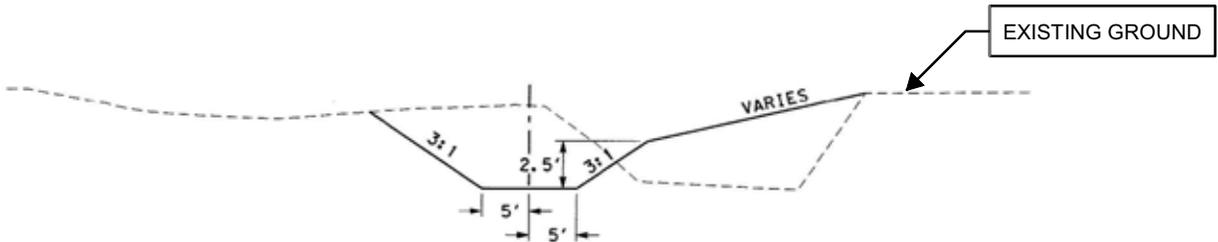
CROSS SECTION B-B

Station 1313 + 90

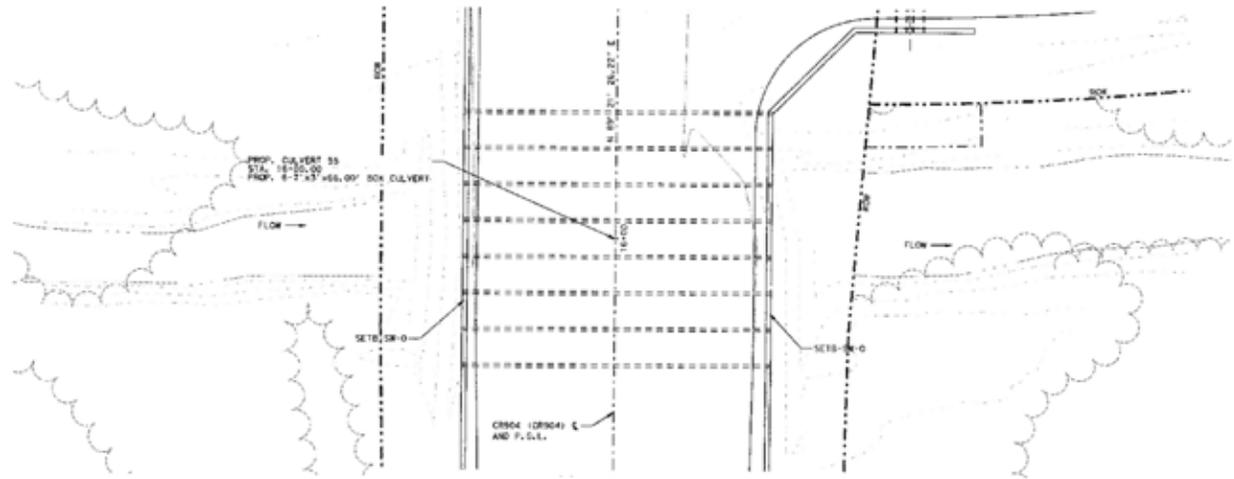
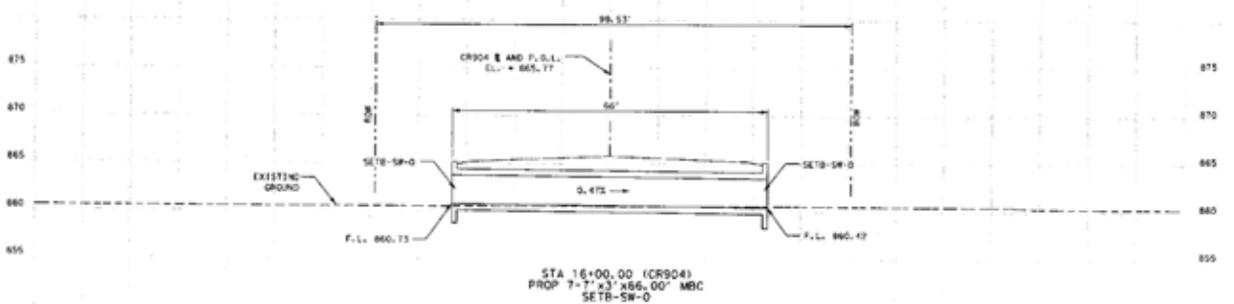
PROPOSED CULVERT LAYOUT  
AT STREAM S-10 AND COUNTY ROAD 904  
(SH 121 STATION 1592 + 75)

HYDRAULIC DATA	
DA = 645.24 ACRES	
Q50 = 3252.87 CFS	Q100 = 3309.49 CFS
TW50 = 889.32 FT	TW100 = 893.53 FT
HW50 = 902.69 FT	HW100 = 906.98 FT
V50 = 22.13 FPS	V100 = 24.54 FPS

One stream segment of West Buffalo Creek (S-10) will be impacted by the required widening of CR 904, a previously existing roadway. Six new culverts, measuring 7-feet by 3-feet and 66-feet in length will replace the existing 8-foot diameter by 43 feet in length. This crossing is located adjacent to SH 121 at Station 1592+75 (**Appendix C, Sheet 20**). This crossing of S-10 by CR 904 is not within the SH 121 ROW and is separate and distant from the SH 121 crossings of S-10; therefore, the impacts to S-10 by CR 904 and SH 121 are considered two single and complete crossings.
