ANNUAL INSPECTION REPORT SPECIAL PROJECTS SYSTEM

FISCAL YEAR 2015

Prepared by Atkins North America, Inc.
General Engineering Consultant

May 2015

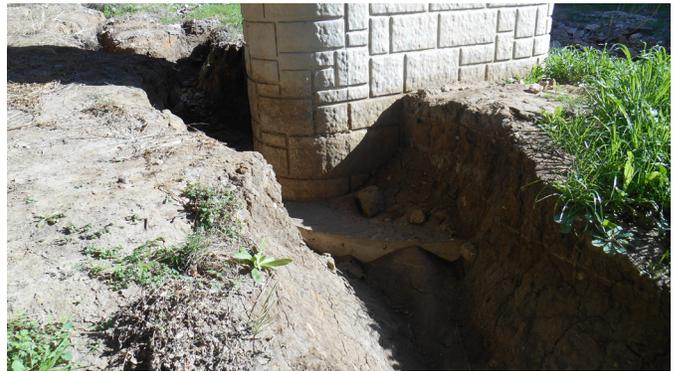
Figure 3: Erosion at Johnson Creek Bridge Column

Several areas of erosion were observed under the main lane and frontage road bridges. Erosion in these areas is occurring predominately in locations at Johnson Creek (Figure 3) and at the West Fork Trinity River.

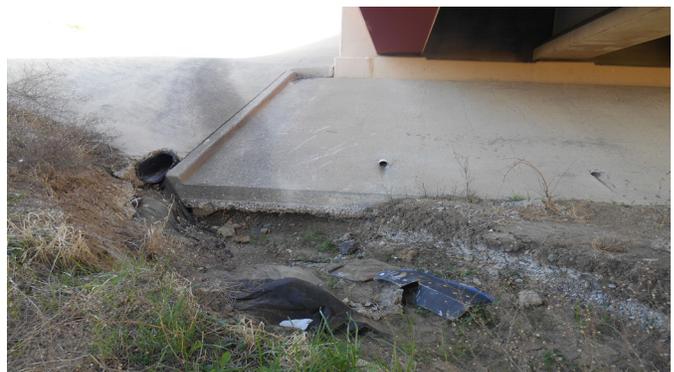
Figure 4: Current Erosion Status near Bridge Abutment at SH 183 Eastbound to PGBT Southbound Direct Connector

The majority of bridge elements are also in like-new condition with few issues observed. The only issue concerning bridges is erosion of the slope protection near abutments that will require further monitoring as illustrated in Figure 4. Based on observations made, none of the erosion near abutments is impacting the structural integrity of the bridges.

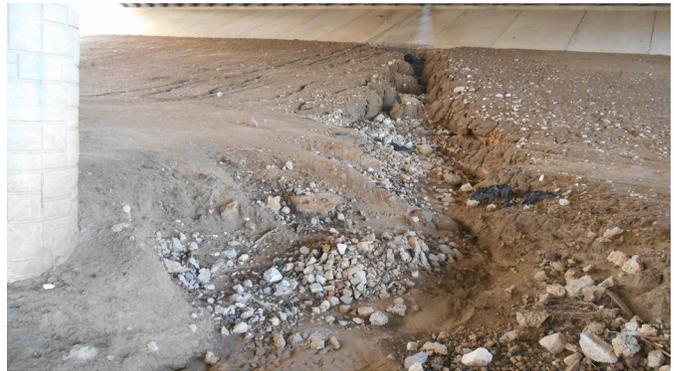
Figure 5: Drainage ruts at the ML abutment near Johnson Creek

Observation 1 – Erosion on the center line under the bridges at Johnson Creek

The first area of concern is on the north side of the Johnson Creek under the main lane bridge. The erosion is taking place at the toe of the sloped paving under the bridge as evidenced in Figure 5. The storm water runoff draining through the center between the northbound and southbound lanes of the bridge is causing a large rut as shown in Figure 6.

The Maintenance Department committed to repairing this area, and at the time of this report, the Department has let a construction contract for repair. The estimated date of construction completion is August 2015.

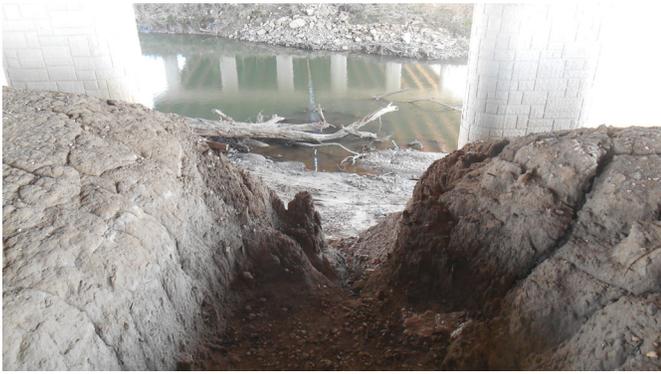
Figure 7: Erosion between bent columns at West Fork Trinity River

Observation 2 – Erosion under the main lane bridges at West Fork Trinity River

The south side of the West Fork Trinity riverbank under the main lanes is a steep embankment approximately 15 feet high. The storm water is draining off of the main lanes at the centerline and is running down toward the river. Over time, the runoff has cut large ruts in the embankment as shown in Figure 7. A small rock riprap strip has been eroded as well, as evidenced in Figure 8.

The Maintenance Department committed to repairing this area, and at the time of this report, the Department has let a construction contract for repair. The estimated date of construction completion is August 2015.
