ANNUAL INSPECTION REPORT SPECIAL PROJECTS SYSTEM

FISCAL YEAR 2014

Prepared by Atkins North America, Inc.
General Engineering Consultant

May 2014

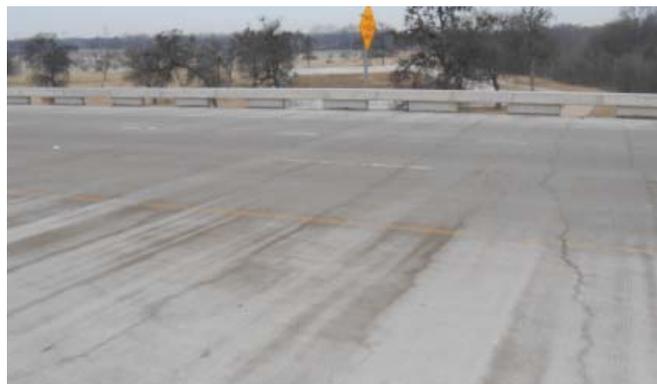
Figure 3: Faded Stripping Sta. 635+00 to 455+00

The main lane (ML) pavement markings between IH-30 and SH 183 are faded as shown in Figure 3. Also, the south bound Frontage Road (FR) markings from Egyptian Way to IH-20 have begun to fade. The phase 4 main lanes contain prefabricated tape markings and are in generally good condition. A project to restripe the mainlanes between SH 183 and IH-30 has been awarded to a contractor and is scheduled to be completed in July, 2014.

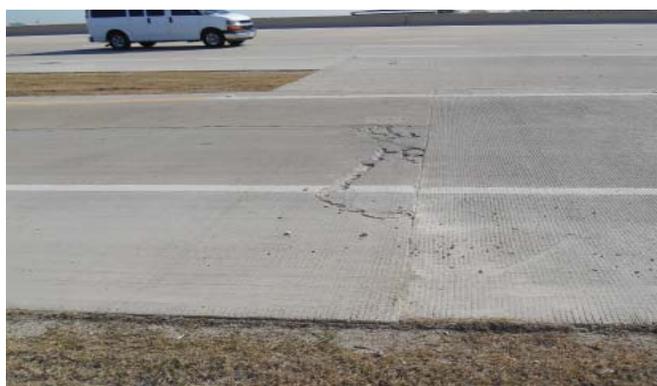
Figure 4: Pavement Cracking Entrance Ramp South of Trinity Mills Sta. 565+00

Consistent with the age of the roadway, a few isolated areas of pavement cracking were observed relative to the condition of the pavement as illustrated in Figure 4.

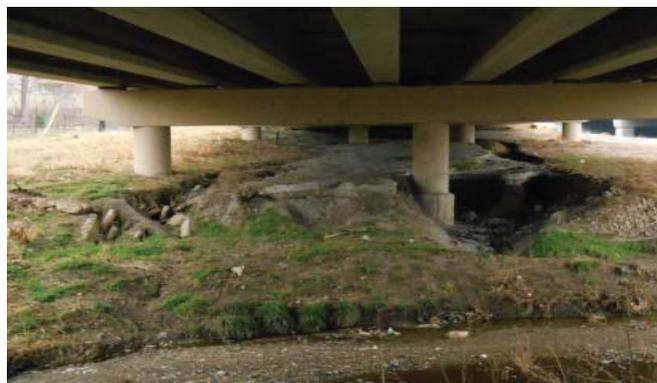
Figure 5: Erosion at Cottonwood Creek Sta. 245+00

Several areas of erosion were observed throughout the roadway, especially under the main lane and frontage road bridges. Erosion in these areas is occurring predominately in locations without significant vegetative establishment as shown in Figure 5. A project is scheduled to be complete in August, 2014 to repair and mitigate the erosion near Pioneer Parkway, Oakdale Road, and Rock Island Road.

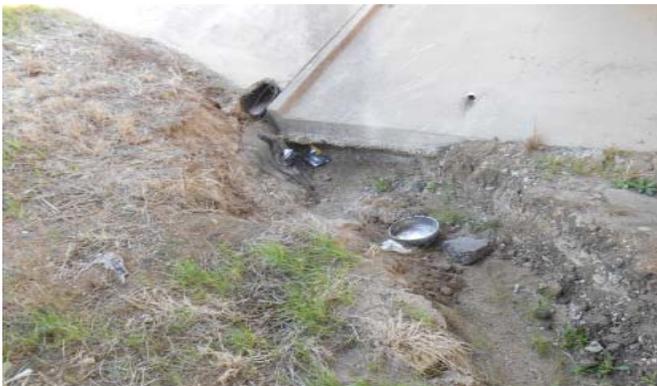
Figure 6: Erosion Near Bridge Abutment at SH 183 Eastbound to PGBT Southbound Direct Connector

The majority of bridge elements are also in like-new condition with few issues observed. The only issue concerning bridges is erosion near abutments that will require further monitoring as illustrated in Figure 6. Based on observations made, none of the erosion near abutments is impacting the structural integrity of the bridges.

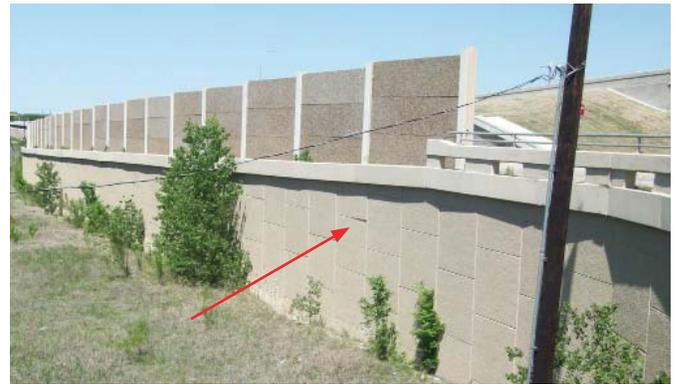
Figure 7: Mechanically Stabilized Earth Wall Panels 2013

One area of concern that appeared in last year's report is the retaining wall on the west side of the intersection of Egyptian Way and the south bound frontage road. A panel on the mechanically stabilized earth wall is out of alignment. The misalignment of this panel was noted in the 2013 inspection (Figure 7), and no notable movement has been observed in 2014 (Figure 8). The panel has shown no signs of movement and closer inspection of the existing coatings suggest that the panel was constructed this way.

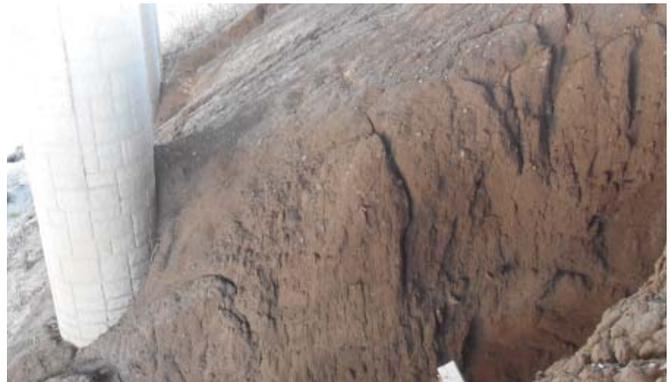
Figure 9: Observation 1 - Erosion at Trinity River

The south side of the Trinity riverbank under the main lanes is a steep embankment approximately 15 feet high. The storm water is draining off of the main lanes at the centerline and running down toward the river. Over time, the runoff has cut large ruts in the embankment as shown in Figure 9. The soil in this area was insufficiently stabilized by a small rock riprap strip on the top edge that has

The Maintenance Department committed to repairing this area, and at the time of this report, the Department is negotiating a design contract for a repair project.

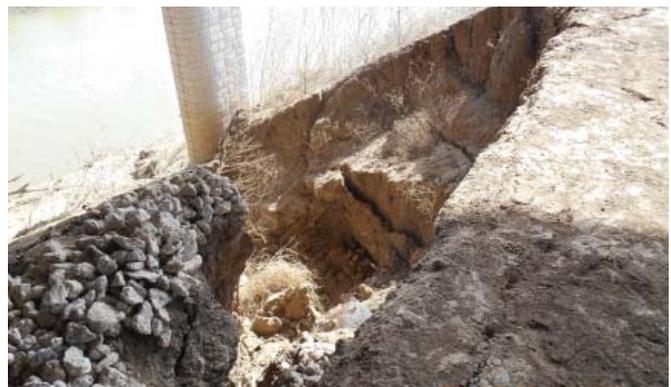
Figure 10: Observation 1 - Erosion at Trinity River

since been eroded as well, as evidenced in Figure 10. This runoff is carrying soil into the Trinity River.

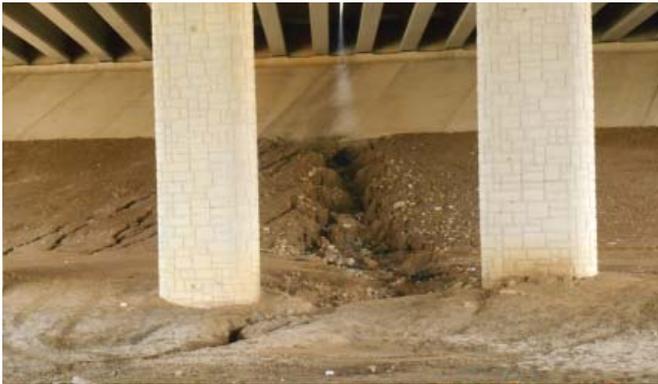
Figure 11: Observation 2 - Erosion at Johnson's Creek

between the northbound and southbound lanes of the bridge is causing a large rut that could undermine the bridge abutment as shown in Figure 12. The runoff is carrying the soil into Johnson's Creek.

The Maintenance Department committed to repairing this area, and at the time of this report, the Department is negotiating a design contract for a repair project.

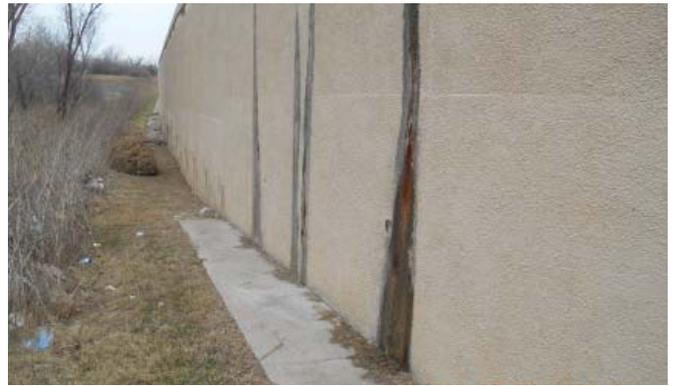
Figure 13: Observation 3 - Water Seeping Through Northbound Frontage Road Wall

Observation 3 – Water seeping through the retaining wall on the northbound frontage road north of Dalworth Street.

The third area of concern is the retaining wall on the east side of the northbound frontage road between Dalworth Street and NW 14th Street. Water is seeping through the wall leaving rust stains down the side as shown in Figure 15. The seepage is unusual because the roadway is elevated above the areas on either side, and the weep holes were dry. One possibility that will require further investigation is a storm water pipe that runs through the wall. If the pipe is broken, it might explain the rust that is seeping through and staining the wall. Further investigation is needed to determine the cause of the seepage.

The GEC inspection is only visual and further investigation is needed to determine the cause of the seepage in this area. In the meantime, it is recommended the Maintenance Department continue monitoring this observation quarterly until the cause can be determined and the issue fully addressed.
