**SYSTEM ANNUAL
INSPECTION REPORT**
Fiscal Year 2022

NORTH TEXAS TOLLWAY AUTHORITY

Subject: FY 2022 GEC System Annual Inspection

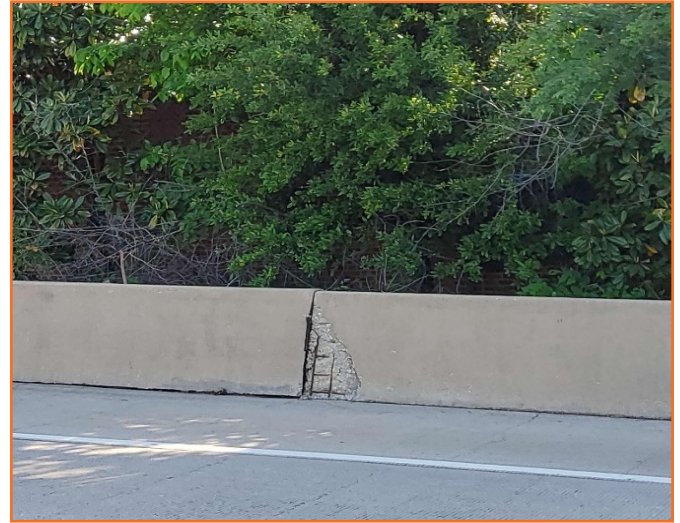
Minor barrier spalling was observed at various locations throughout the corridor as illustrated in Figure 2. There were multiple areas of erosion under bridges and landscape areas as illustrated in Figure 3. Also noted were areas of pavement cracking and spalling as well as joint deterioration noted in Figures 4 and 5.

Figure 2: DNT barrier wall spall NBML S. of Knight St.

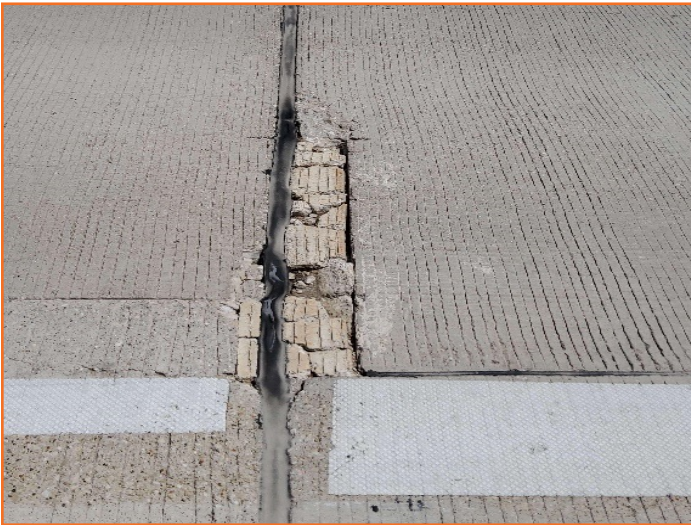
Figure 4: DNT pavement distress SBML N. of Windhaven Pkwy.

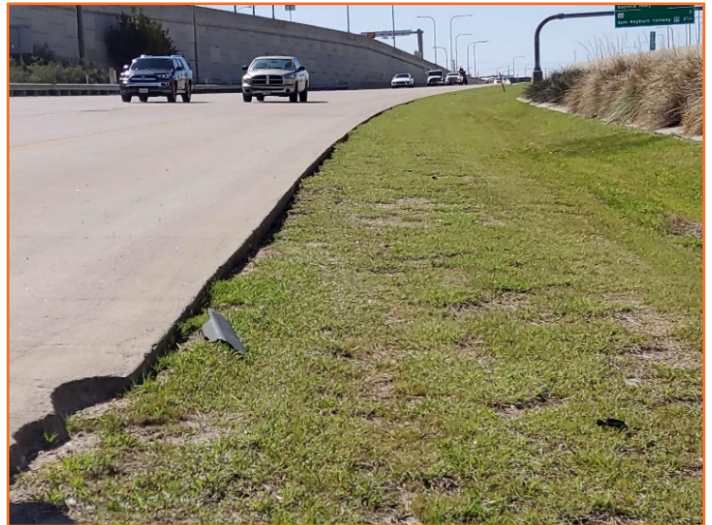
There are multiple isolated locations of pavement edge drop offs as illustrated in Figure 6. Pavement markings and striping need replacing in various locations as illustrated in Figure 7. Several clearance signs were faded as noted in Figure 8. These are being corrected as part of a sign replacement that is currently in construction.

Figure 6: DNT pavement edge drop-off NBML S. of Stonebrook Pkwy.

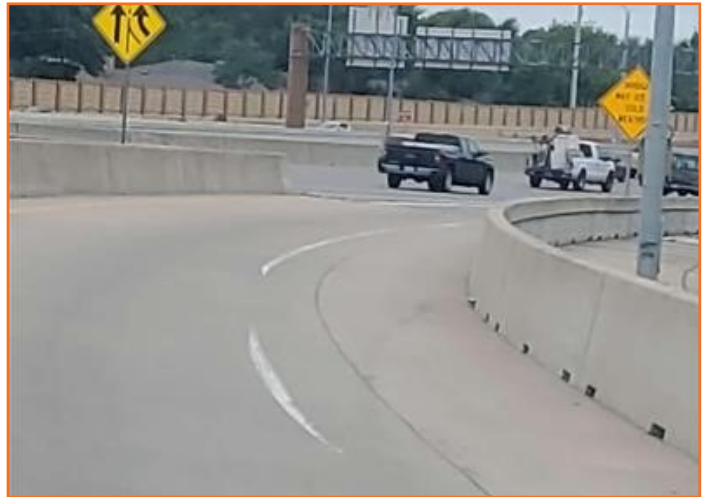
Figure 7: DNT faded pavement markings NBML N. of IH-635

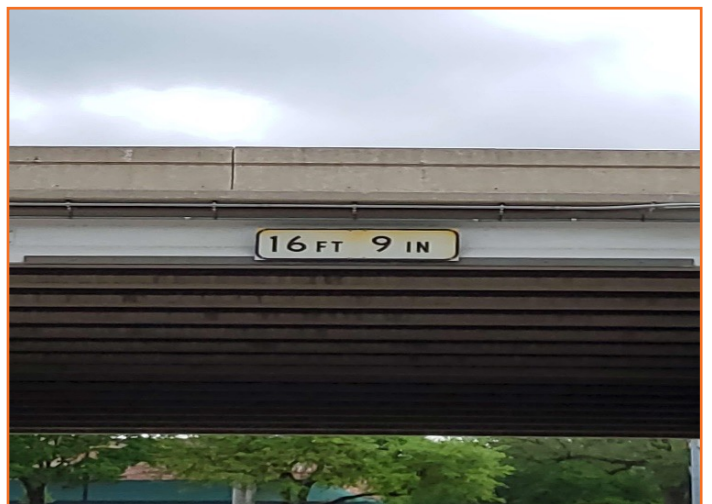
Figure 8: DNT clearance sign faded SB U-Turn at Trinity Mills Rd.

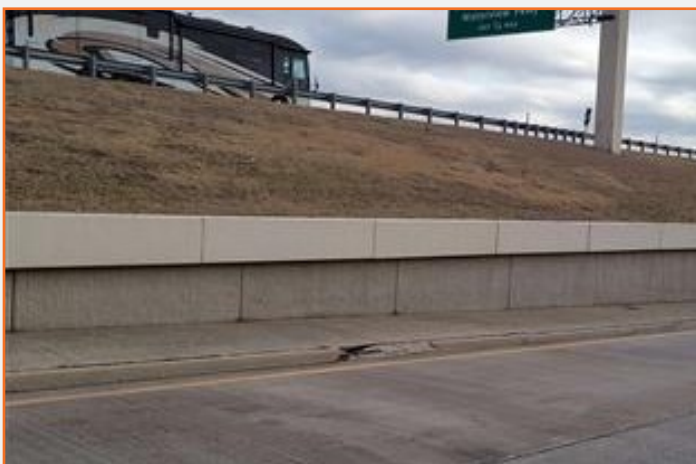
- There were multiple areas of damaged curb as illustrated in Figure 14. There were also areas of erosion on the roadside (Figure 15) and under bridges.
- Pavement edge drop-offs (Figure 16) and pavement cracking and spalling (Figure 17) were observed at various locations throughout the corridor.

Figure 14: PGBT curb damage NBRF at Conflans Rd.

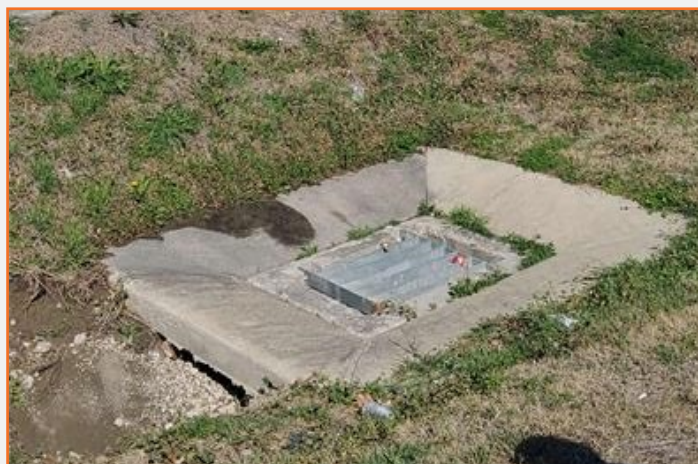
Figure 15: PGBT erosion under inlet NBRF North of W. Pioneer Pkwy.

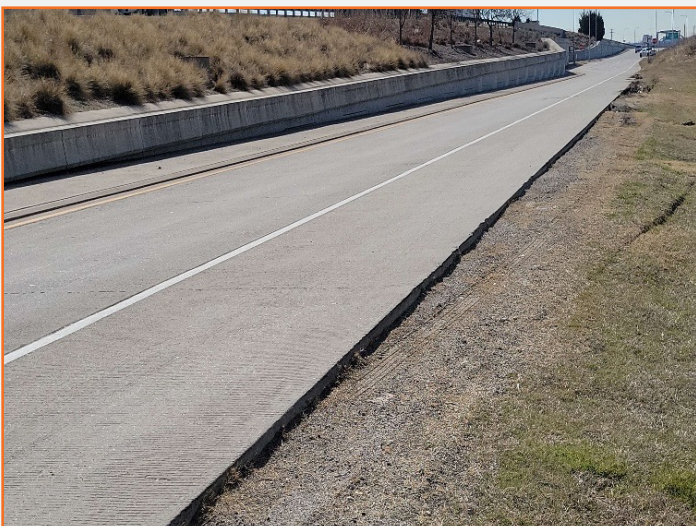
Figure 16: PGBT pavement edge drop-off SB exit ramp to Merritt Rd.

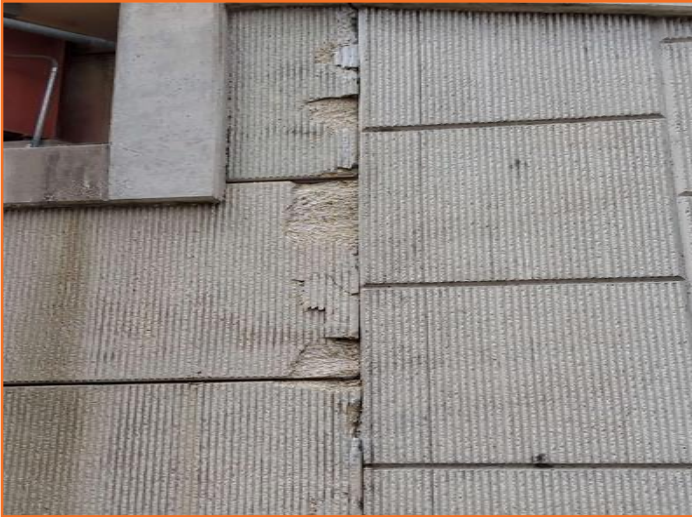
Wall observations include cracks and spalls on retaining wall panels as shown in Figure 18.

Figure 18: PGBT retaining wall panel spalling SB at N. MacArthur Blvd.

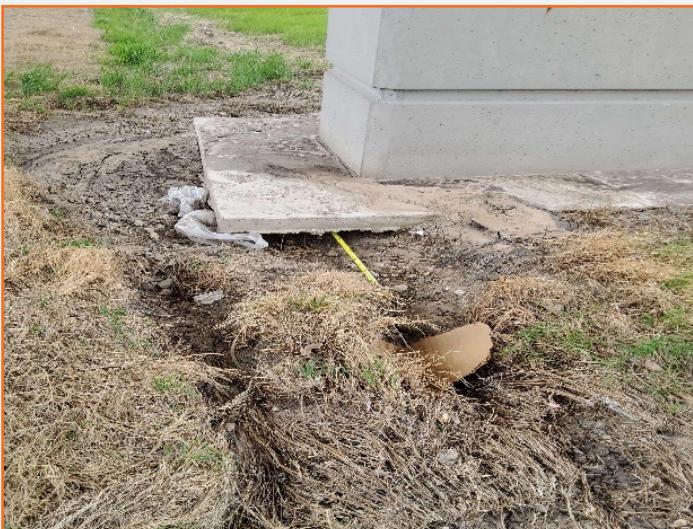
Figure 27: SRT erosion NB-US75-NB SRT DC

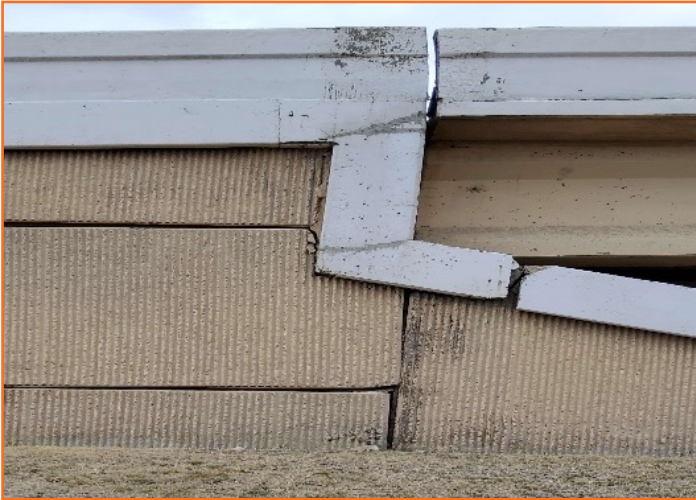
Wall observations noted some shifted and spalled wall panels as illustrated in Figure 29.

Figure 29: SRT misaligned wall panel at NB 121 Bus. DC

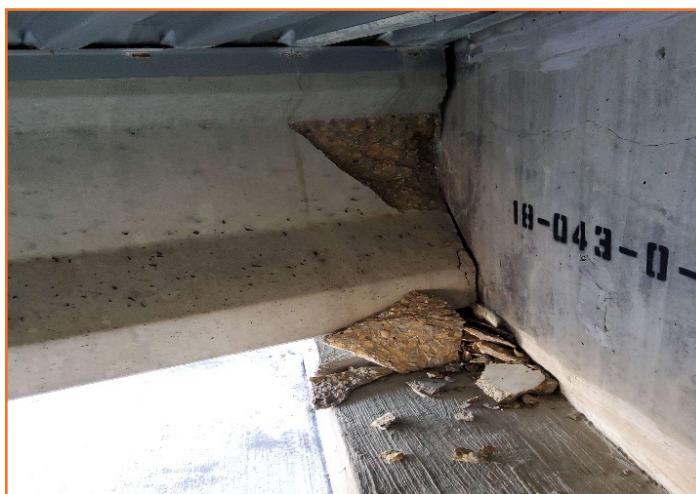
Bridges are in good condition with one recurring observation where the beams are pushing against the backwall causing minor spalling at the beam end and backwall as noted in Figure 30. This condition is being monitored by NTTA staff.

Figure 30: SRT beam end spall SB structure at Hardin Blvd.

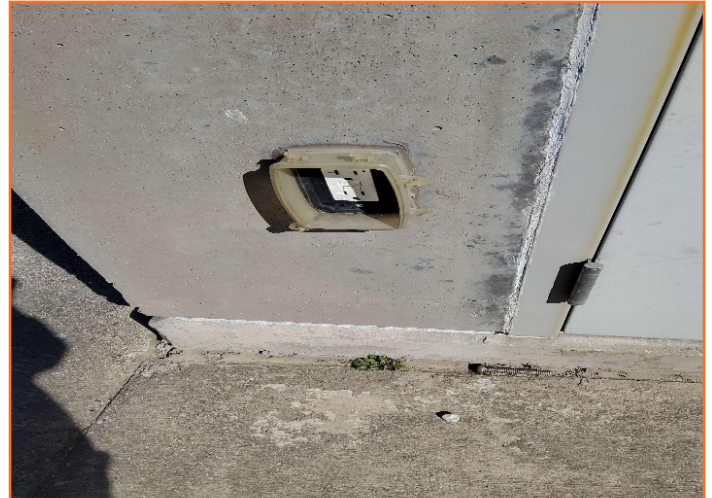
There were several observations noted on mainlane gantries including an electrical outlet box missing the protective cover at MLG 2 and sealant missing at building perimeter at MLG 3 (Figures 31 and 32). Insect infestation is a continuing issue at these facilities.

Figure 31: SRT MLG 2 – electrical box cover missing

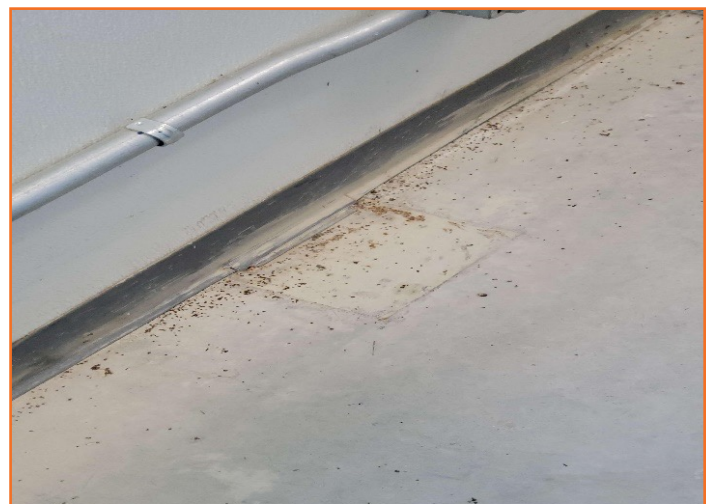
Figure 32: SRT MLG 3 – active insect infestation

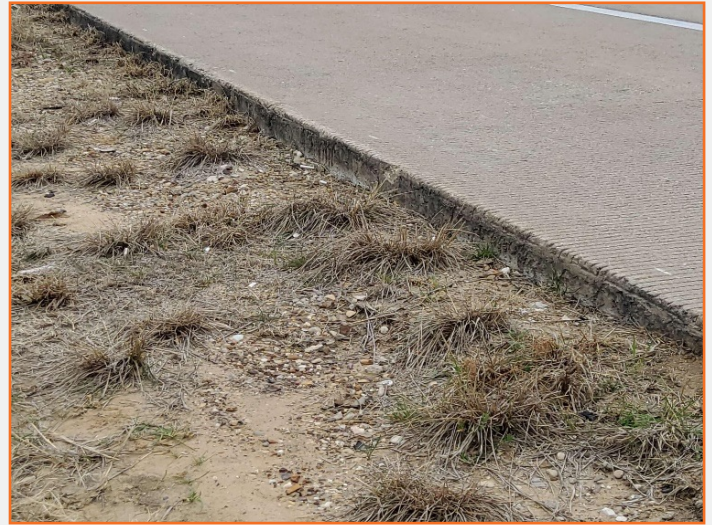
Figure 34: CTP pavement edge drop-off NB just South of FM 917

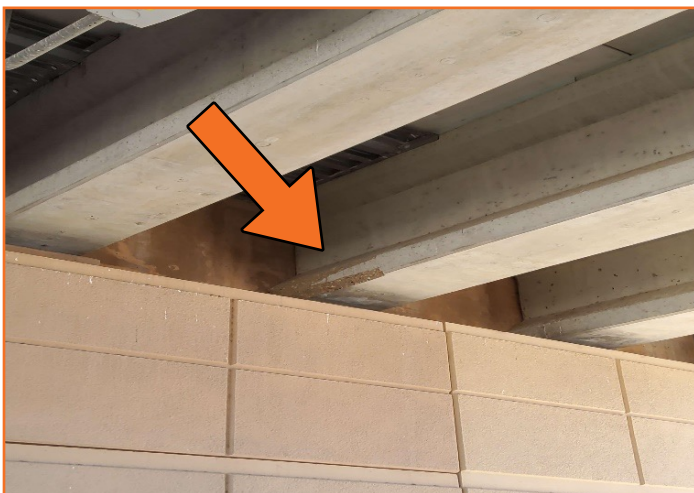
The majority of the bridge elements are in good condition with few issues observed. One observation noted this year was minor bearing pad movement and minor beam spalls as illustrated in Figure 37.

Figure 37: CTP bridge beam spall at Edwards Ranch Rd.

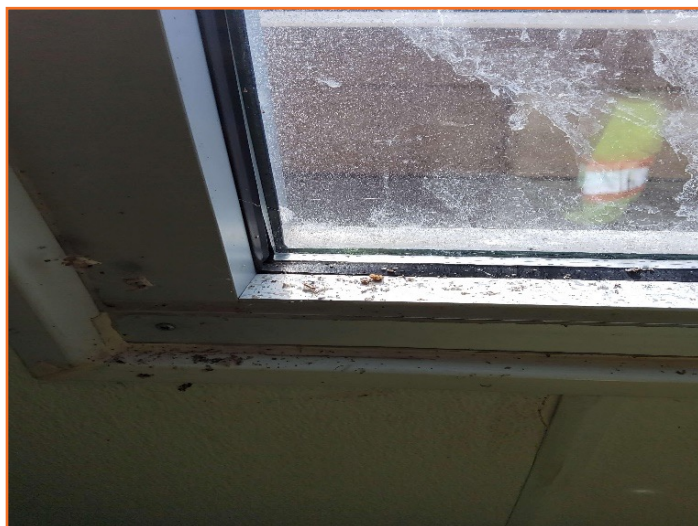
Figure 39: CTP MLG 2 – insect infestation

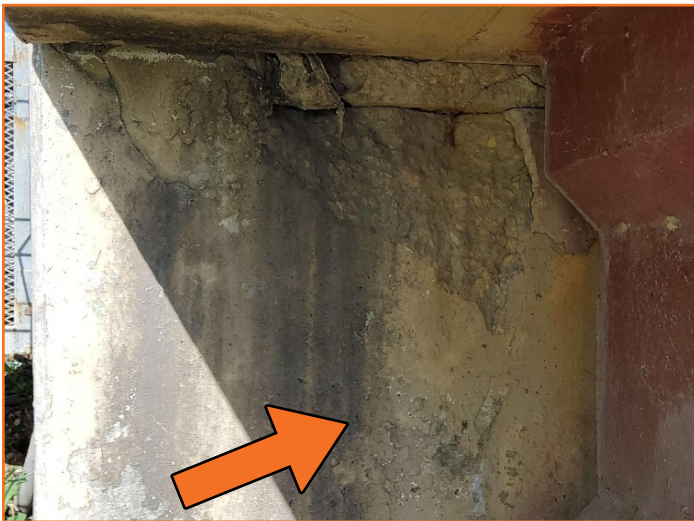
Figure 43: MCLB backwall spalling at West abutment

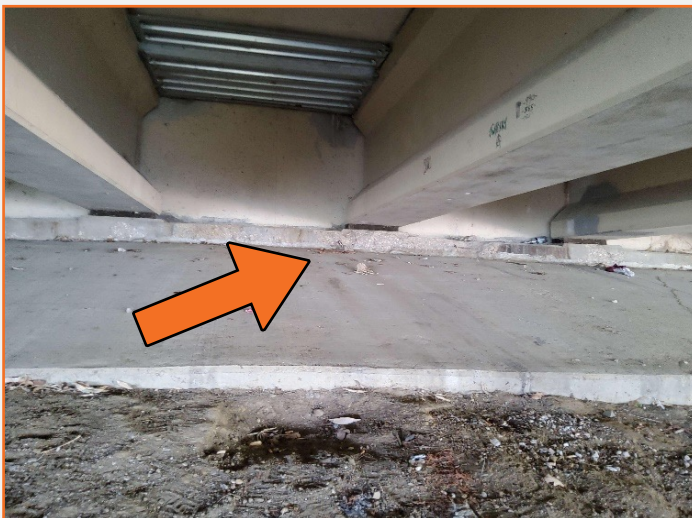
Figure 47: LLTB abutment spalling at East end of bridge

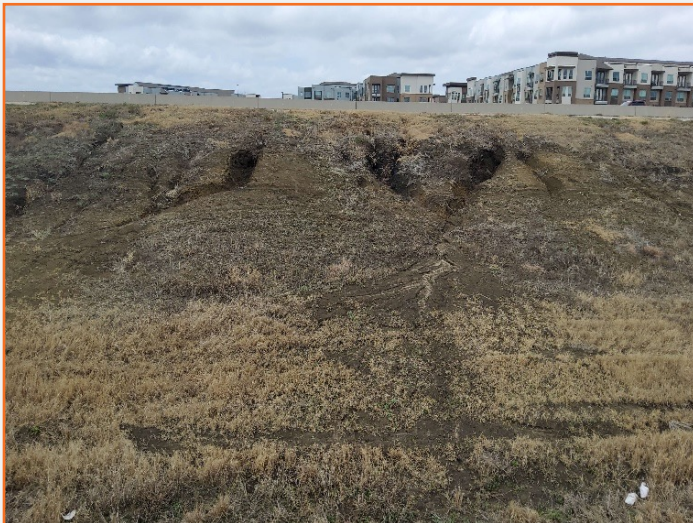
- Areas of erosion were noted at various locations as illustrated in Figure 51.
- There were several areas with pavement edge drop offs as shown in Figure 52. Areas of pavement spalls (Figure 53) were observed.

Figure 51: 360T embankment erosion NB North of Heritage Pkwy.

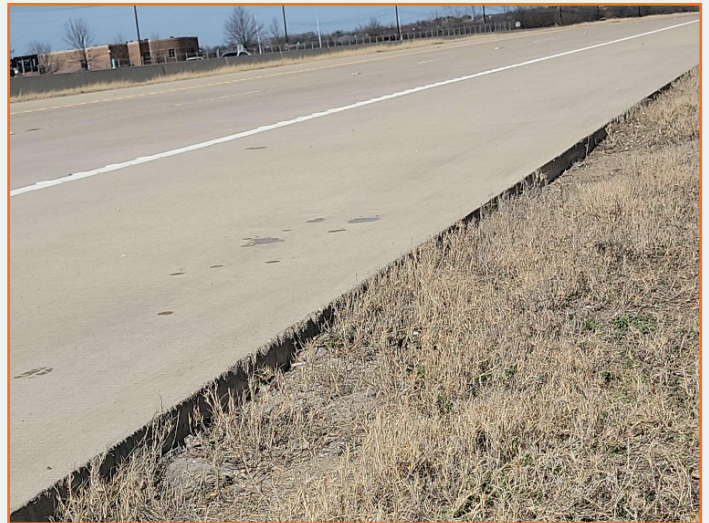
Figure 52: 360T pavement edge drop-off North of Ragland Rd.

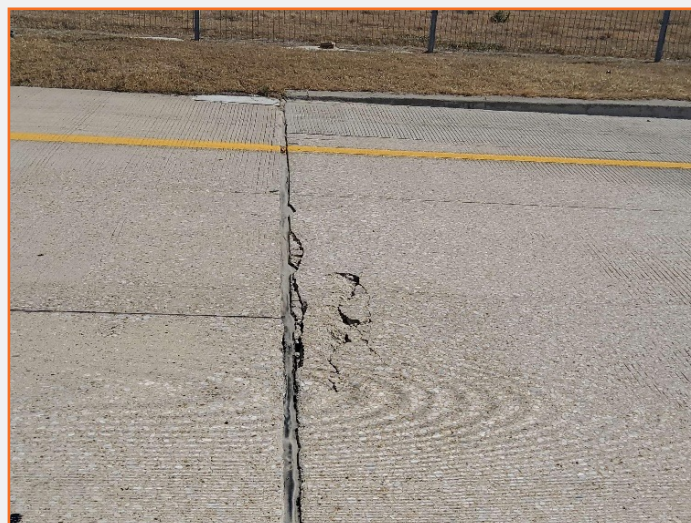
Figure 53: 360T pavement spall SB exit ramp to Webb Lynn Rd.

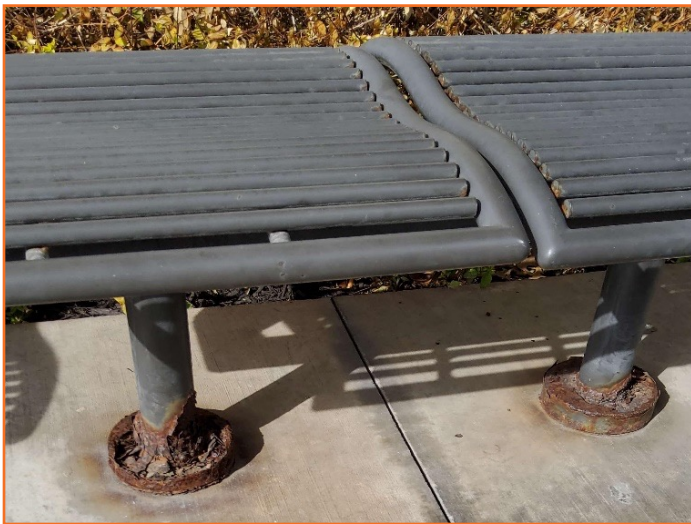
Observations at the Gleneagles Office Center at 5910 West Plano Parkway include bench bases are rusting (Figure 60), masonry cracking, sprinkler head missing, vinyl wall covering peeling, ceiling T bar loose and ceiling tiles dislodged.

It was noted that rusting and deterioration of ferrous metal coating was present at most NTTA facilities. At this time this is primarily a cosmetic issue, but continued deterioration will merit maintenance of those components.

Figure 60: Gleneagles 5910 – bench bases rusting

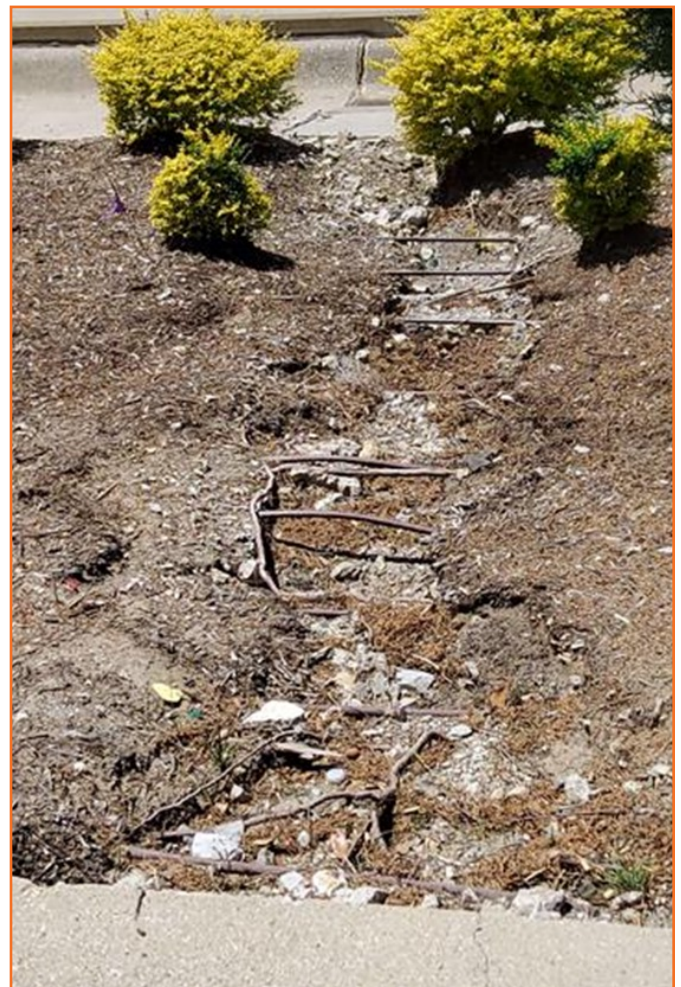
Minor barrier spalling was observed at various locations throughout the corridor as illustrated in Figure 2. There were multiple areas of erosion under bridges and landscape areas as illustrated in Figure 3. Also noted were areas of pavement cracking and spalling as well as joint deterioration noted in Figures 4 and 5.

Figure 3: DNT erosion SBML S. of Gaylord Pkwy.

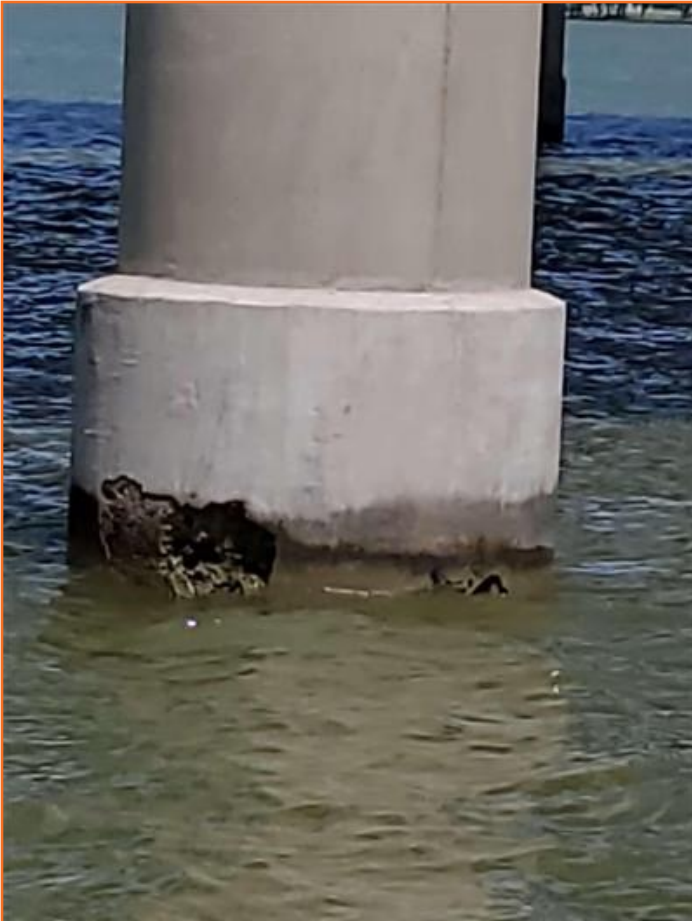
The substructure of the mainlane bridge over Lake Ray Hubbard is in good condition with only minor spalling in the sacrificial column protection (Figure 21). There were a few areas where the water collection system piping was disconnected and leaking (Figure 22).

Figure 21: PGBT at Lake Ray Hubbard column spall NB bent No. 48

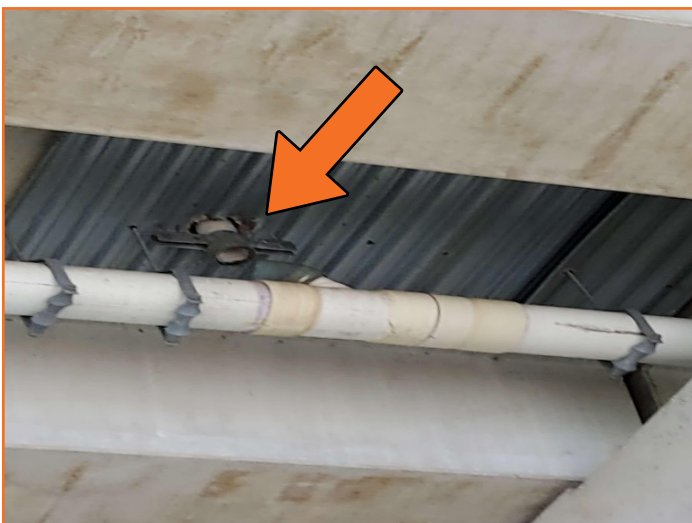
Figure 22: PGBT at Lake Ray Hubbard Deck drain pipe disconnected NB bent No. 21

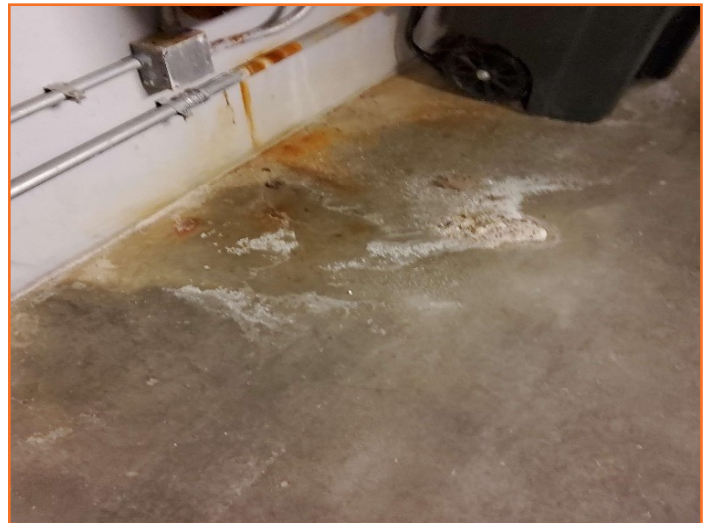
Observations identified throughout the facilities included stains on the ceiling indicating a roof or mechanical leak, missing lens on light fixtures, paint failing and rust developing on steel as noted on Figures 23 and 24. Recent HVAC replacement and roofing projects at MLPs 7, 8 and 10 have provided for high functionality of those facilities.

Figure 23: PGBT MLP 7 – rust staining on floor

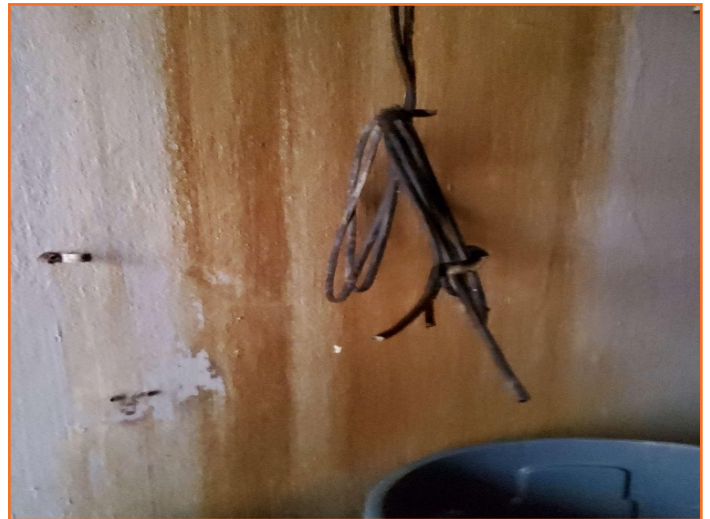
Figure 24: PGBT MLP 8 – rust developing on wall

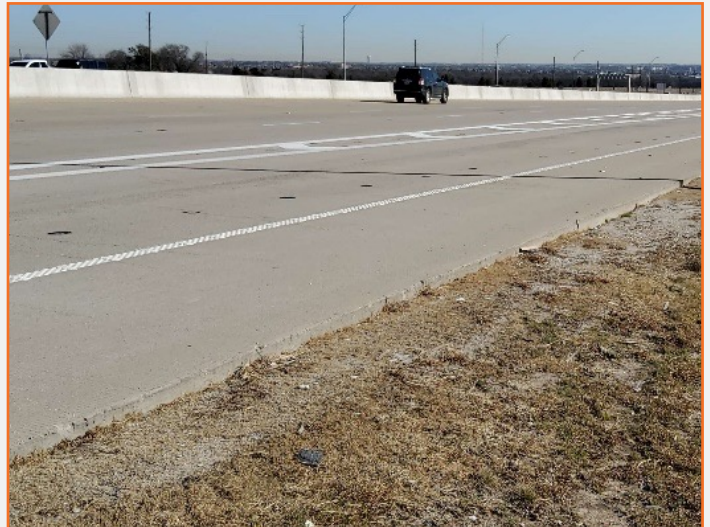
Figure 26: SRT pavement edge drop-off NB exit ramp to Independence Pkwy.

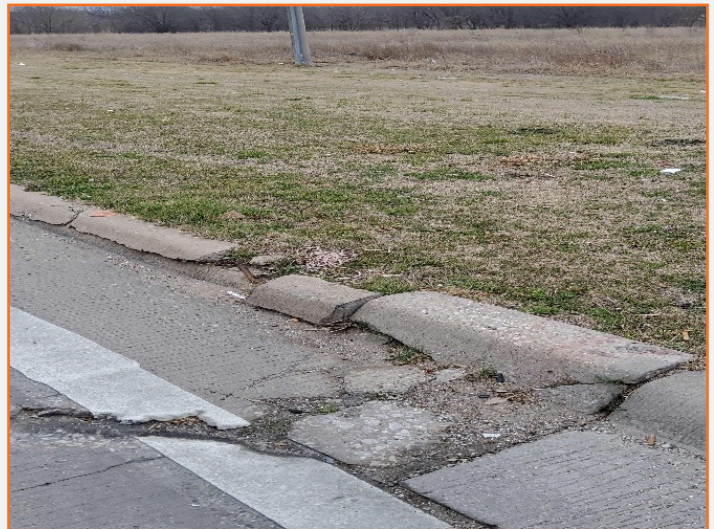
Figure 28: SRT curb damage NBR at Razor Blvd.

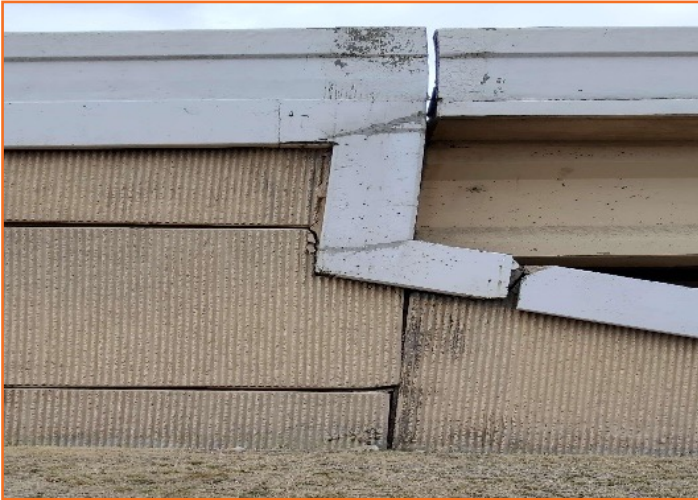
Wall observations noted some shifted and spalled wall panels as illustrated in Figure 29.

Figure 29: SRT misaligned wall panel at NB 121 Bus. DC

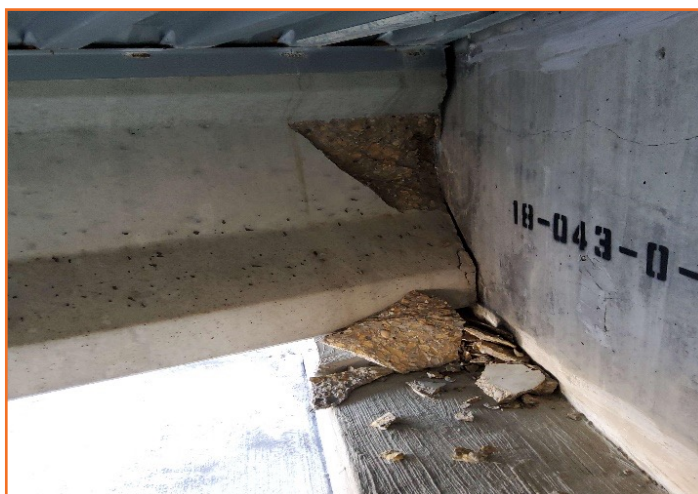
Bridges are in good condition with one recurring observation where the beams are pushing against the backwall causing minor spalling at the beam end and backwall as noted in Figure 30. This condition is being monitored by NTTA staff.

Figure 30: SRT beam end spall SB structure at Hardin Blvd.

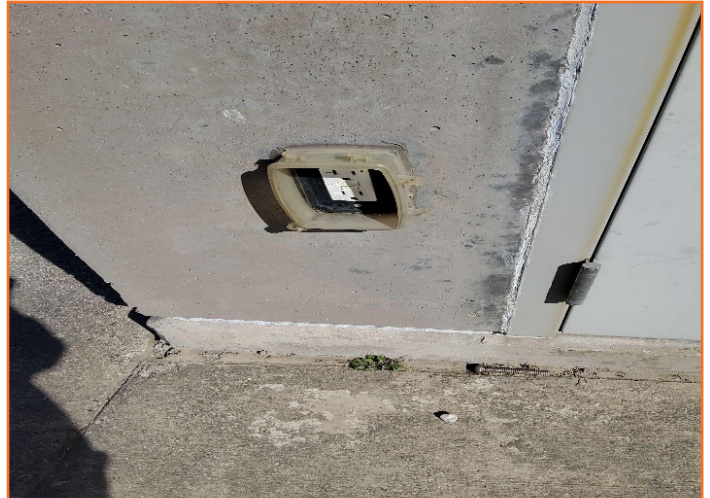
There were several observations noted on mainline gantries including an electrical outlet box missing the protective cover at MLG 2 and sealant missing at building perimeter at MLG 3 (Figures 31 and 32). Insect infestation is a continuing issue at these facilities.

Figure 31: SRT MLG 2 – electrical box cover missing

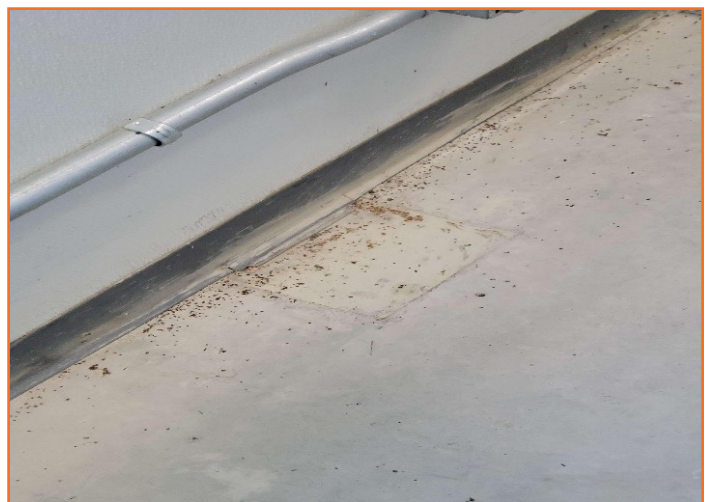
Figure 32: SRT MLG 3 – active insect infestation

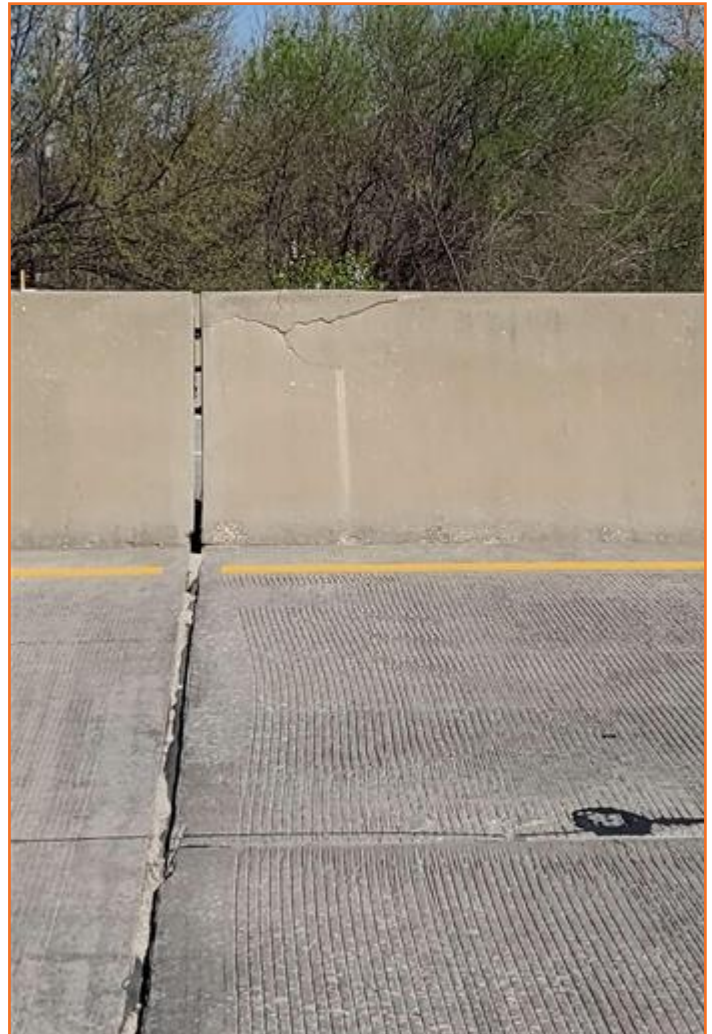
Observations on the roadway include minor cracking and spalling on the concrete rail in addition to pavement joint seal missing/damaged as shown in Figure 44.

Figure 44: LLTB pavement seal missing/damaged

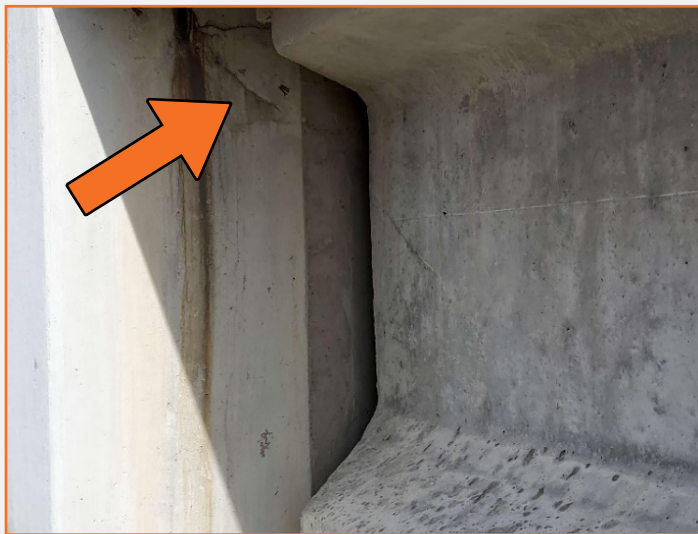
There were noted a few areas of backwall cracking as illustrated in Figure 54.

Figure 54: 360T backwall cracking at Bowman Branch bridge

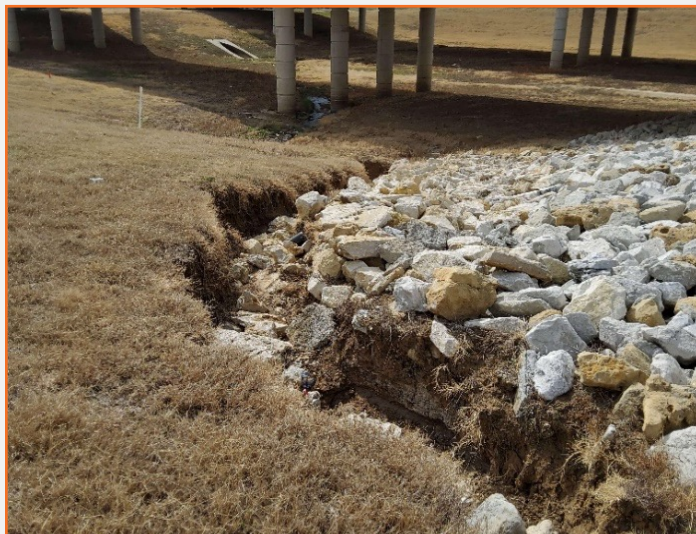
There was also noted minor erosion under a bridge as shown in Figure 55.

Figure 55: 360T erosion around riprap at Walnut Creek bridge
