NORTH TEXAS TOLLWAY AUTHORITY

# SYSTEM ANNUAL INSPECTION REPORT

## Fiscal Year 2026

Subject: FY 2026 GEC System Annual Inspection

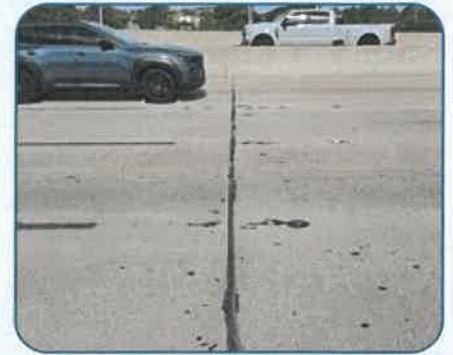
Our visual observations included several locations of reflective pavement cracking (Figure 2) and delamination that have migrated through the existing overlays on the mainlane pavement. Also noted were multiple locations where pavement joints, both longitudinal and transverse, are unsealed (Figure 3) due to damaged sealants or where the joint sealant material has met its expected lifecycle. Additionally, there were isolated instances of missing, damaged, and faded pavement markings (Figure 4) and erosion at landscape beds resulting in exposed irrigation lines (Figure 5). There were multiple locations south of IH 635 where curb inlet tops have been damaged and have exposed reinforcing steel (Figure 6). The inspection program also observed instances of concrete pavement spalling (Figure 7) corridor-wide which is consistent with the age, pavement types and traffic volumes on the roadway.

Figure 3: DNT NB Unsealed Pavement Joints South of W. Park Blvd.

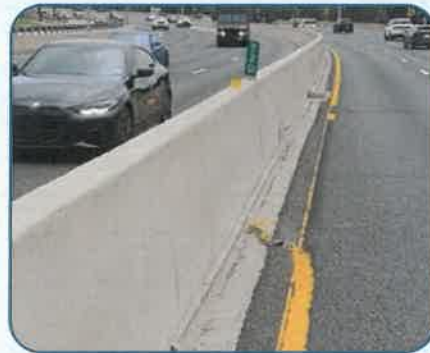
Figure 4: DNT SB Damaged or Faded Pavement Markings South of Sojourn Dr.

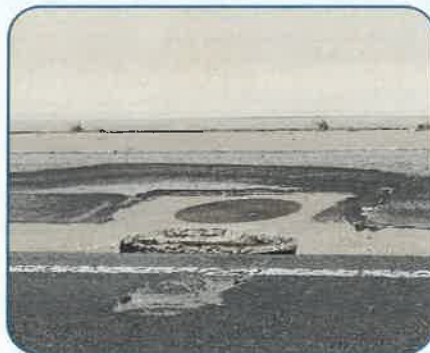
Figure 6: DNT NB Inlet Damage North of Lemmon Ave.

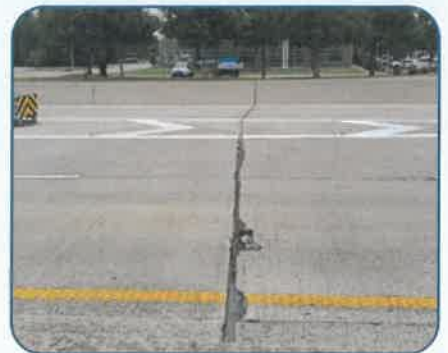
Figure 7: DNT NB Pavement Spalling North of Plano Pkwy.

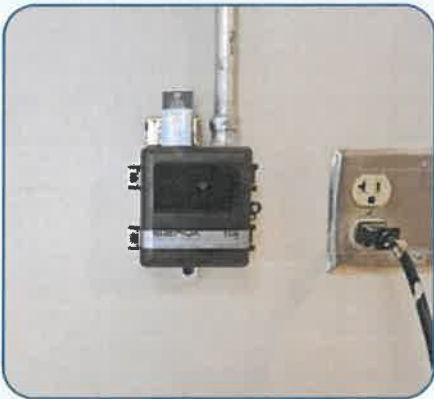
Notable observations included: water infiltration, insect/rodent infestation, and window frame corrosion at MLG1. At the MLG3 fiber hut, foundation spall was observed. At MLP3, damaged pipe insulation (at the yard), foundation spall, joint sealant failure, ceiling issues, and a CO<sub>2</sub> sensor issue (Figure 15) were observed again. At MLP4, a roof HVAC unit was missing a hail guard (Figure 16), while the gantry structure coating failures were again observed (Figure 17). At the Fiber Hut near MLP2, the gate lock remained inoperable and could not be closed for locking (Figure 18), with water infiltration and insect infestation issues observed. At the Meaders Lane Winter Weather Operations Facility, there was still widespread corrosion (Figure 19).

Figure 15: DNT MLP3 Non-Functioning CO Sensor.

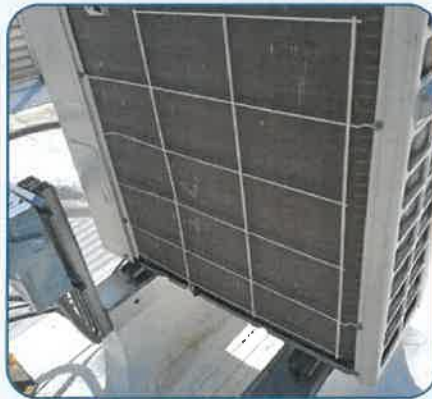
Figure 16: DNT MLP4 Roof HVAC Unit without Hail Guard.

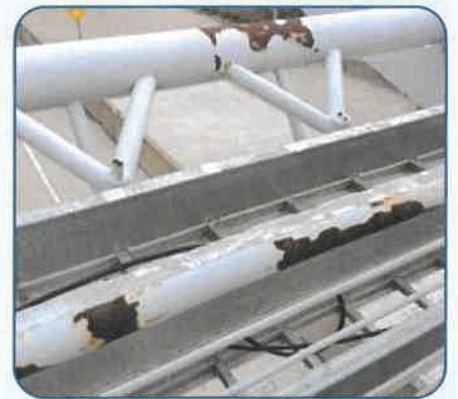
Figure 17: DNT MLP4 Gantry Coating Failure.

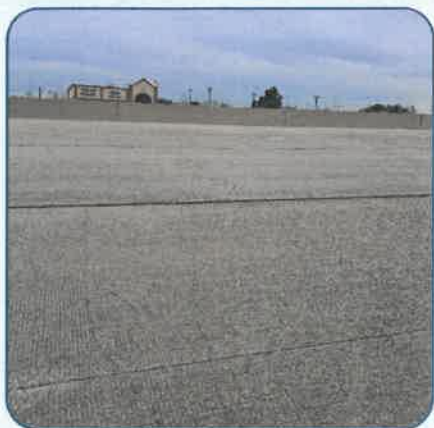
Our observations included isolated unsealed longitudinal joints (Figure 20) and asphalt shoulder cracking (Figure 21). There were multiple locations that exhibited deterioration of pavement markings (Figure 22) in addition to general erosion observations that include erosion of roadway turf slopes and undermining of the flume (Figure 23) and within landscape beds (Figure 24).

Figure 20: PGBT WB Unsealed Longitudinal Joint at IH-35E.

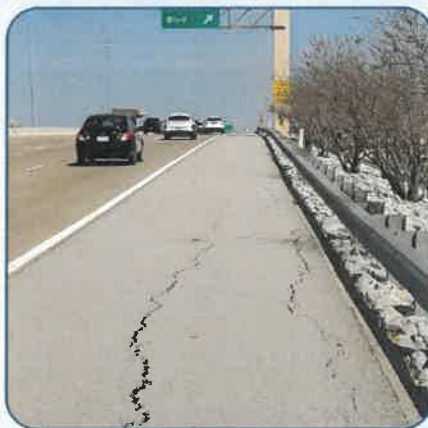
Figure 21: PGBT EB Asphalt Shoulder Cracking West of SH 114.

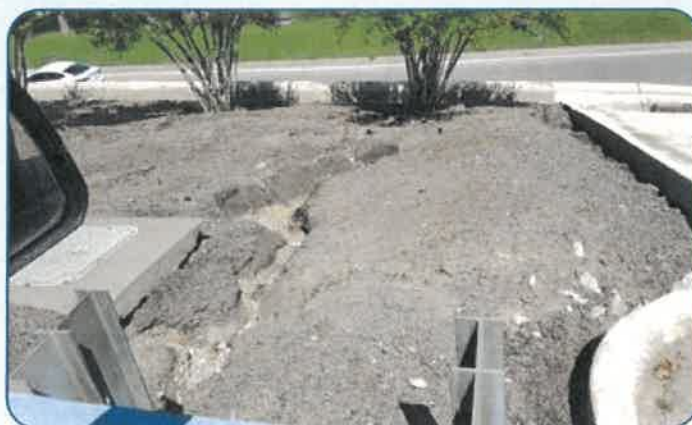
Figure 24: PGBT WB Landscape Bed Erosion at Coit Rd.

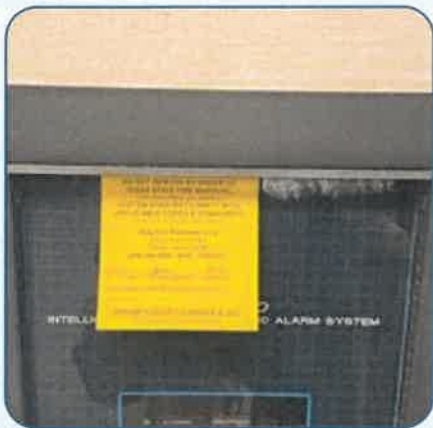
The MLP7 roof replacement and the MLP9 HVAC replacement projects were in progress at inspection time. Notable observations at PGBT facilities included: continued exterior and sealant deterioration, and continued tunnel water infiltration (creating door corrosion and water damage). In MLP7, the fire alarm control panel was yellow-tagged (Figure 30). Main lane and ramp gantry roofs exhibited continued deterioration (Figure 31), and lightning protection failures were observed again. At the Midway Road Eastbound On-Ramp gantry, more wall panels were separating from the structure (Figures 32 and 33). Also, the winter weather operations facilities had wall and fence damage issues (Figures 34 and 35).

Figure 30: MLP7 Yellowed-Tagged Fire Alarm Control Panel.

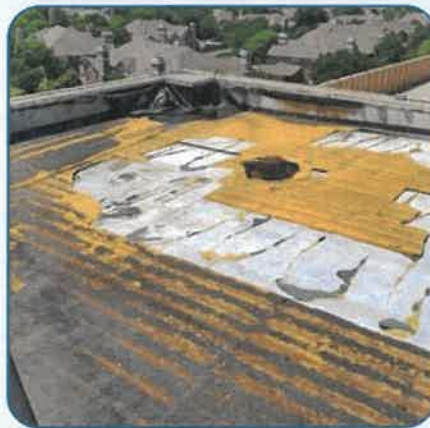
Figure 31: PGBT Eastbound Renner Road On-Ramp Deteriorated Roof.

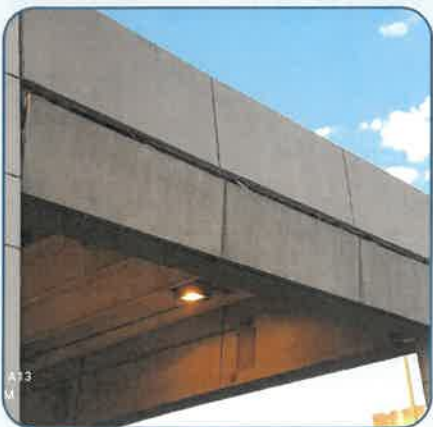
Figure 33: PGBT Midway On-Ramp Gantry Separated Wall Panel 2.

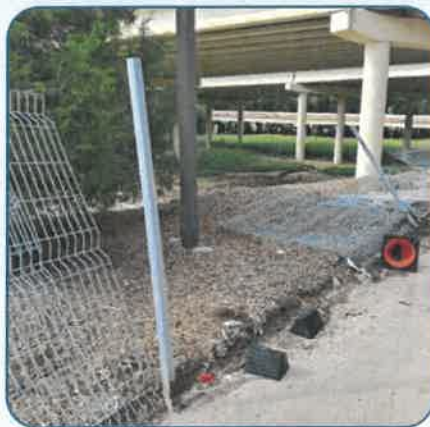
Figure 34: PGBT Brand Road Winter Weather Operations Facility Damaged Fence.

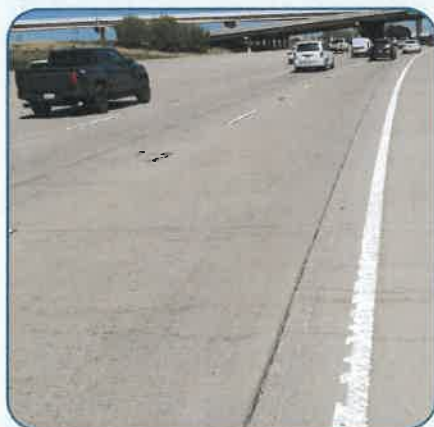
Our observations included multiple locations of unsealed longitudinal pavement joints (Figures 36, 37). There were isolated instances of missing, damaged, and faded pavement markings (Figure 38). Erosion issues included erosion at landscape beds resulting in exposed irrigation lines (Figure 39) and in some instances undermined landscape concrete edging (Figure 40).

*Figure 36: SRT EB Unsealed Longitudinal Pavement Joint West of Old Denton Rd.*

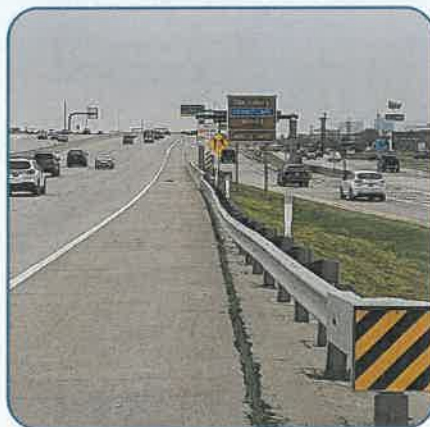
*Figure 37: SRT EB Unsealed Longitudinal Shoulder Pavement Joint East of N. Josey Ln.*

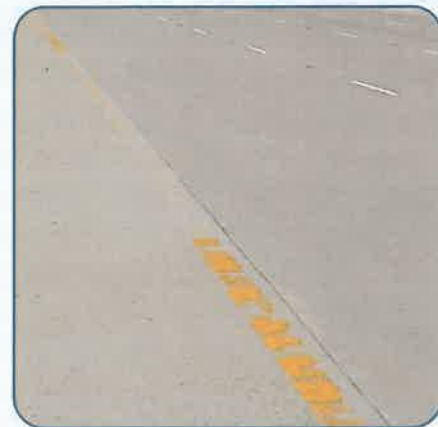
*Figure 38: SRT WB Damaged or Faded Pavement Markings West of Coit Rd.*

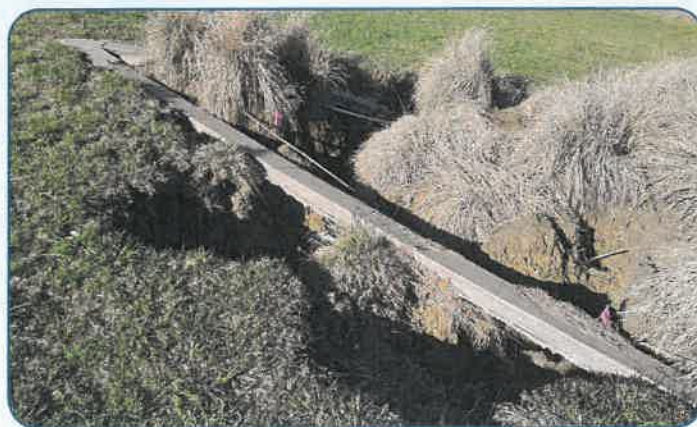
*Figure 40: SRT WB Landscape Bed Concrete Edging Undermining West of W. Hebron Pkwy.*

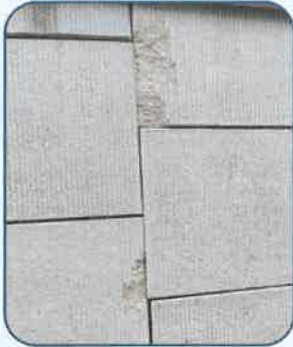
*Figure 41: SRT WB MSE Wall Panel Racking and Spalling at Ohio Dr.*

Our observations included instances of wall panels that were racked or exhibited concrete cracking and/or spalling (Figure 41) or coping that cracked and spalled (Figure 42). These observations alone cannot confirm nor negate current wall movement. NTTA, the MMC and the GEC conduct regular coordination meetings where NTTA has confirmed that further evaluation of these walls is being conducted.

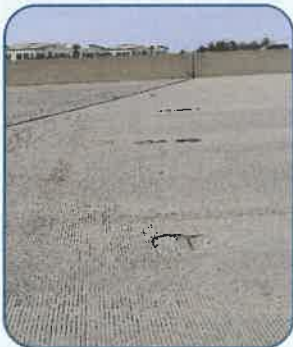
*Figure 43: SRT EB Bridge Deck Spalling at Coit Rd.*

Our observations along the SRT corridor included bridge decks with multiple types of distresses including concrete spalling with exposed rebar (Figure 43), and unsealed deck and approach slab joints (Figure 44). Superstructure observations also included cracking and spalling of the concrete beams with exposed rebar (Figures 45, 46). The overall good condition of the structures reflects the effectiveness of ongoing maintenance activities in preserving their structural integrity and long-term performance.

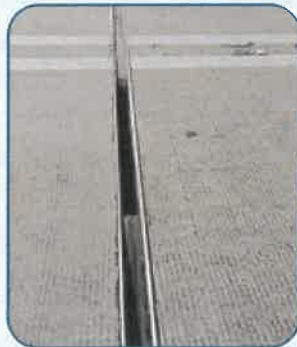
*Figure 44: SRT WB Unsealed Bridge Deck Joints at Lake Vista Dr.*

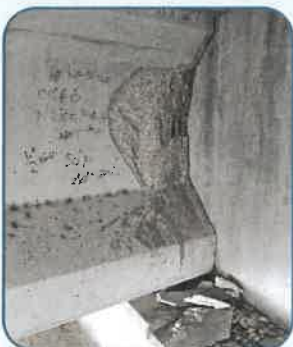
*Figure 45: SRT WB Bridge Beam Spalling at Standridge Dr.*

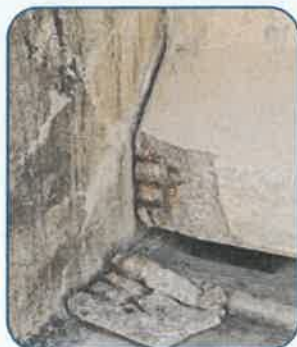
*Figure 46: SRT EB Bridge Beam Spalling with Exposed Reinforcement East of N. MacArthur Blvd.*

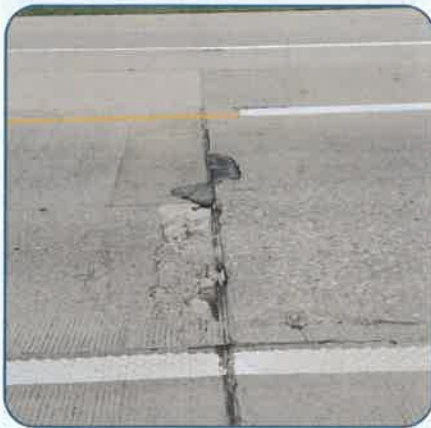
Our observations included concrete pavement punchouts (Figure 49) and cracking, spalling, and joint deterioration (Figure 50). There are also areas where unsealed joints contribute to the undermining of the MBGF concrete mow strips (Figure 51). Additionally, other common erosion issues include turf erosion on embankment slopes (Figure 52), roadside ditch erosion (Figure 53) and landscape bed erosion exposing tree roots and irrigation lines (Figure 54).

Figure 49: CTP NB Pavement Punchout North of McPherson Blvd.

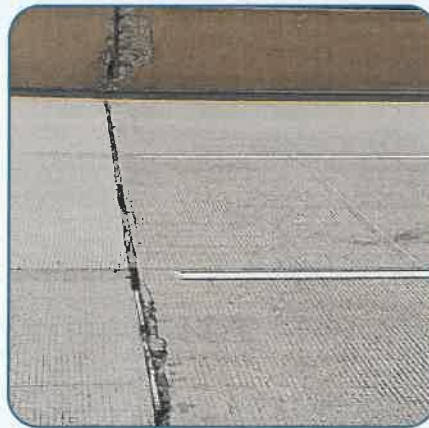
Figure 50: CTP SB Pavement Joint Deterioration and Barrier Spall South of Arborlawn Dr.

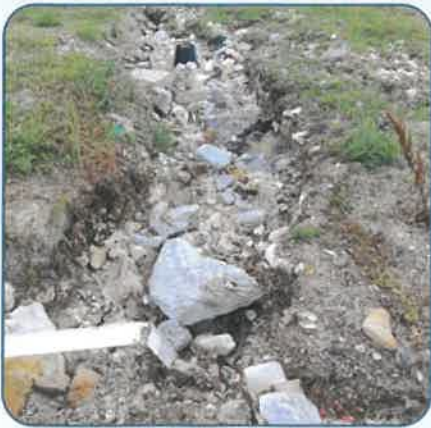
Figure 52: CTP NB Turf Erosion South of Dutch Branch Rd.

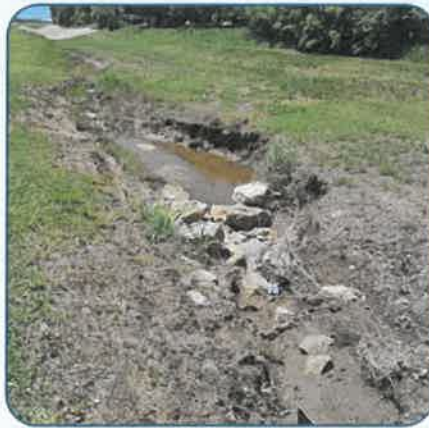
Figure 53: CTP SB Minor Ditch Erosion South of W FM 917.

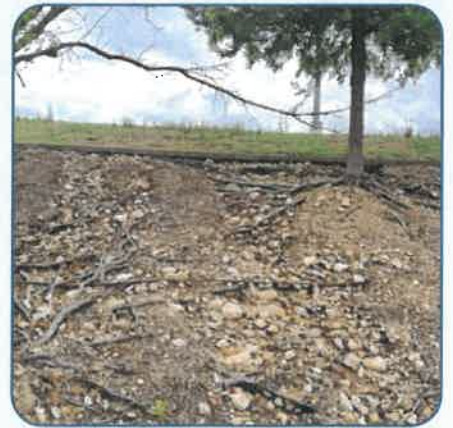
Figure 54: CTP SB Landscape Bed Erosion South of Overton Ridge Blvd.

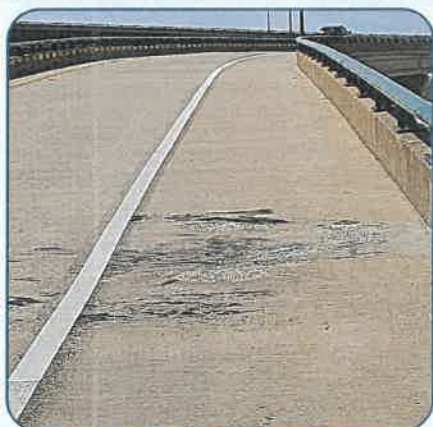
Our observations along the CTP corridor included locations of concrete cracking and spalling of the bridge deck (Figure 57). Other observations included unsealed deck and bridge approach slab joints (Figure 58) and debris in the joints (Figure 59). General erosion observations included erosion under the bridge (Figure 60) and a few locations of bridge backwall cracking and spalling (Figure 61).

Figure 57: CTP SB Bridge Deck Spalling at CTP to IH 20 WB DC.

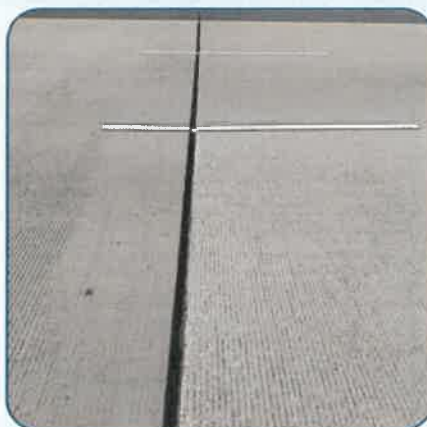
Figure 58: CTP NB Unsealed Bridge Joint at S. Hulen St.

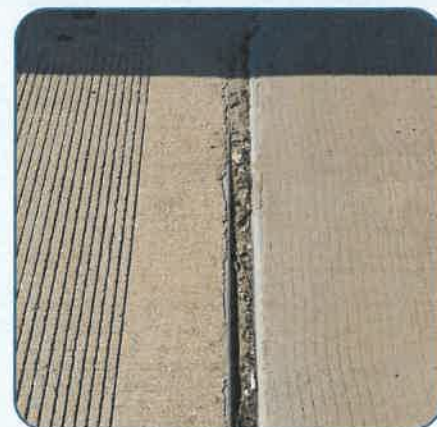
Figure 59: CTP SB Debris Filled Relief Bridge Joint at W Risinger Rd.

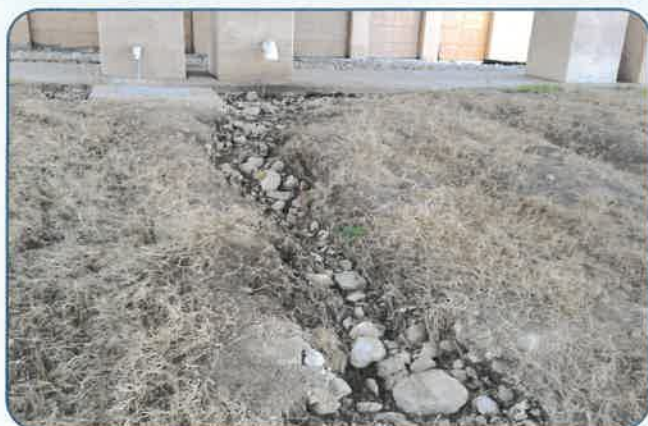
Figure 60: CTP SB Bridge Column Drainage System Erosion at IH-20.

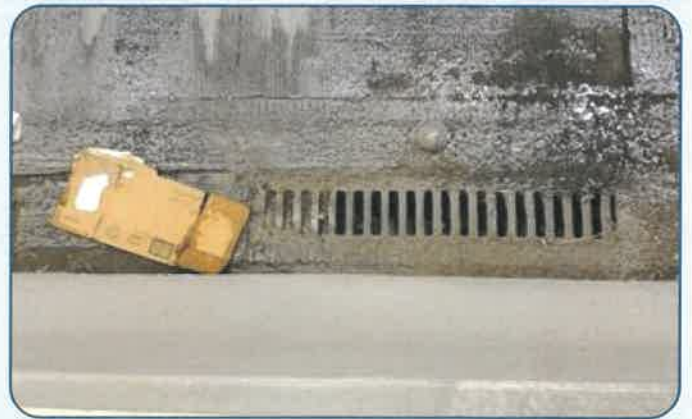
Our observations included an unsealed joint at a concrete flume adjacent to a retaining wall (Figure 85) and an isolated occurrence of a grate inlet obstructed by dirt and debris within the tunnel (Figure 86). Additional observations along the east side of the tunnel included localized erosion on the turf slope (Figure 87) and fence damage (Figure 88).

Figure 86: AATT Obstructed Grate Inlet within Tunnel.

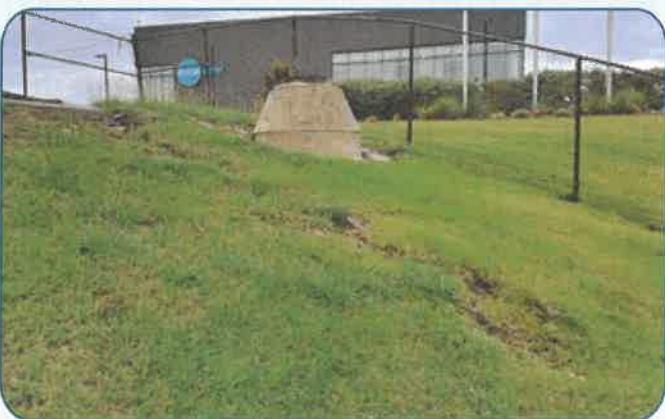
Figure 87: AATT Turf Erosion at East End.

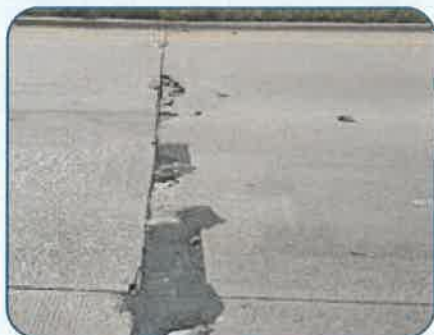
Figure 94: 360T NB Spalled Pavement Joint North of Doryn Dr.

Our observations included spalled concrete joints (Figure 94), unsealed longitudinal joints (Figure 95), cracked pavement (Figure 96), and damaged concrete barriers (Figure 97) and curbs with exposed reinforcement (Figure 98). Additional observations included isolated areas of missing, damaged, and faded pavement graphics (Figure 99). Common erosion-related observations included turf erosion along roadway slopes (Figure 100).

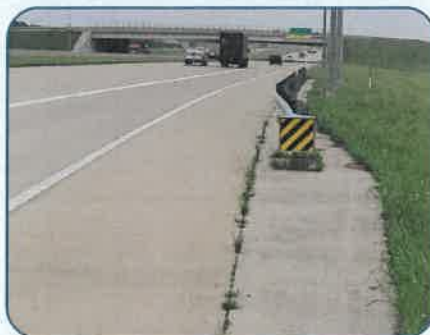
Figure 95: 360T NB Unsealed Longitudinal Joint South of Ragland Rd.

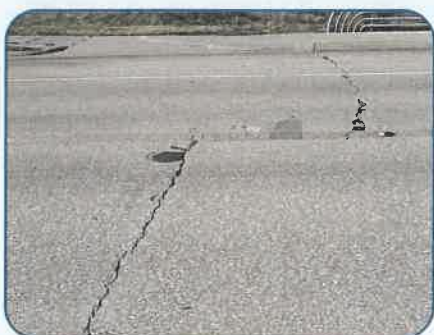
Figure 96: 360T SB Pavement Cracking South of Lone Star Rd.

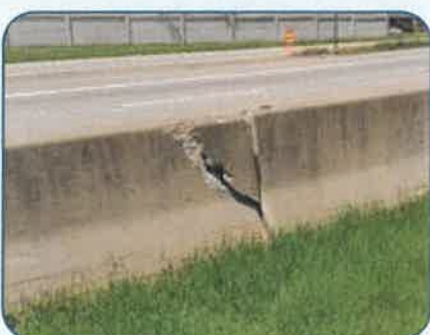
Figure 97: 360T SB Damaged Concrete Barrier South of SE Green Oaks Blvd.

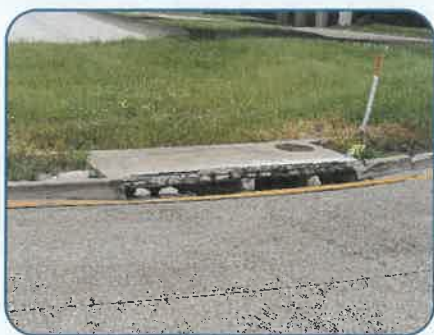
Figure 98: 360T SB Curb Inlet Damage with Exposed Reinforcement at SE Green Oaks Blvd.

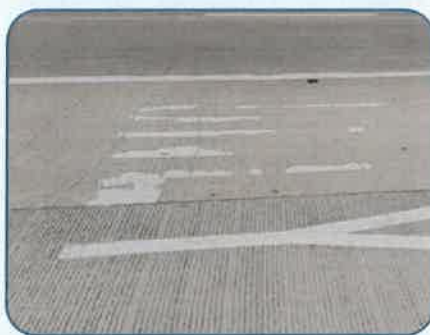
Figure 99: 360T Damaged or Faded Pavement Markings at US 287.

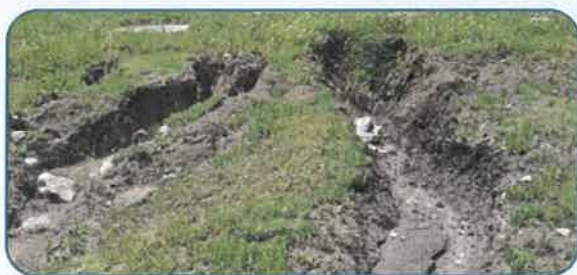
Figure 100: 360T NB Turf Erosion North of Heritage Pkwy.

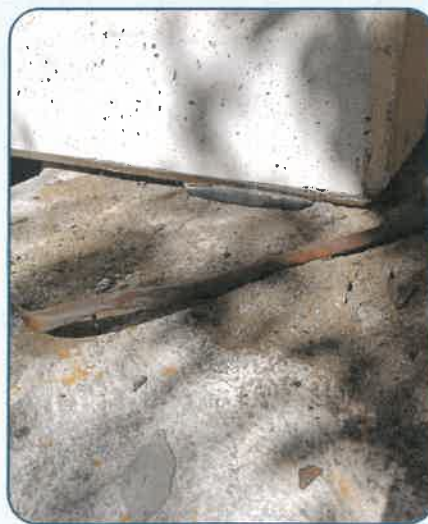
The GEC's inspection identified recurring observations of dirt and debris accumulation within bridge approach joints (Figure 101), deformed bearing pads (Figure 102), and debris and sediment accumulation within bridge-class box culverts (Figure 103). If left unaddressed, these conditions can reduce drainage efficiency, impede hydraulic performance, and contribute to the long-term deterioration of bridge components.

Figure 102: 360T Bridge Deformed Bearing Pad SB Frontage Road Over Fish Creek.

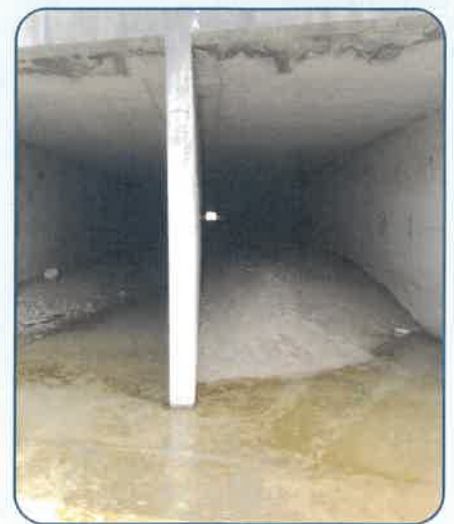
Figure 103: 360T Bridge Class Culvert with Sediment Buildup North of Webb Lynn Rd.

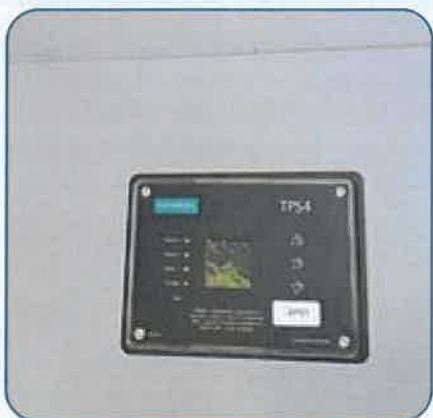
Notable observations at the Plano Operations Center included: a panelboard surge suppressor in alarm (Figure 108), roof damage (Figure 109), Bulk Storage Building roof drain separations/damage (Figure 110), pipe penetration boots damaged/improperly installed (Figure 111), gutter damage (Figure 112), joint sealant failures, and rust/paint failures at the outbuildings/fuel island (Figure 113).

Figure 108: POC Switchboard SESB Alarmed Surge Suppressor.

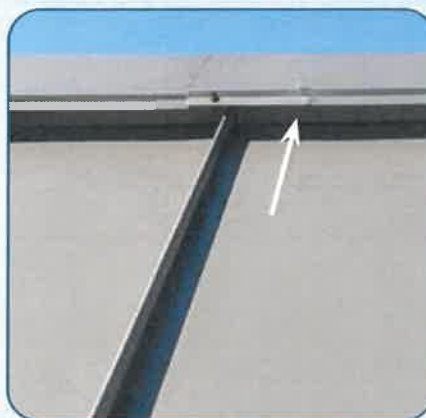
Figure 109: POC Damaged Roof.

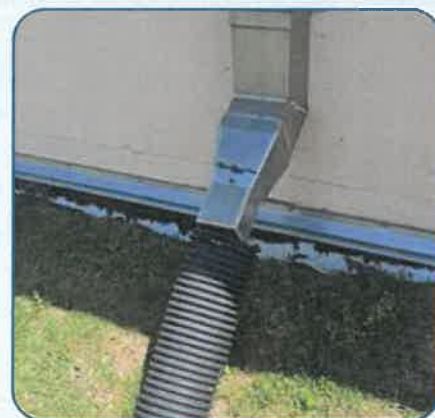
Figure 110: POC Storage Building Separated Roof Drain.

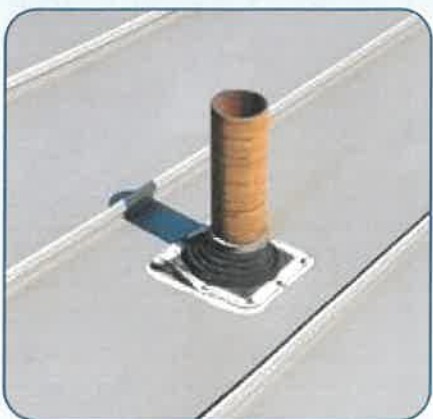
Figure 111: POC Roof Damaged Pipe Penetration.

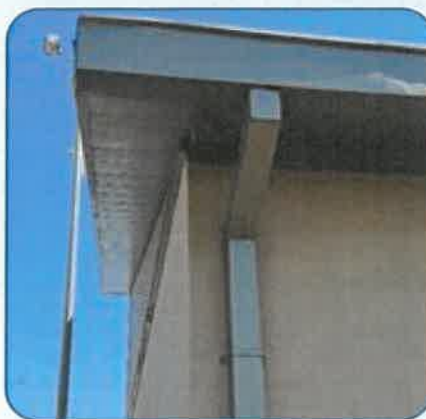
Figure 112: POC Damaged Gutter.

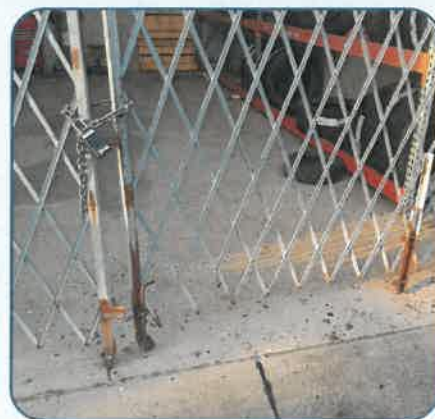
Figure 113: POC Storage Building Corroded Gate.
