SYSTEM ANNUAL INSPECTION REPORT

Fiscal Year 2024

Subject: FY 2024 GEC System Annual Inspection

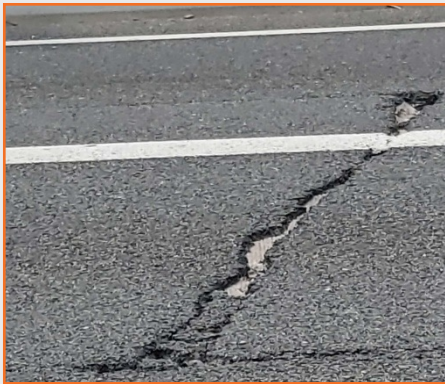
There were multiple locations of reflective pavement cracking and joint deterioration along the south bound mainlanes between IH-635 and Lomo Alto Dr. (Figure 2). Also noted were concrete barrier cracking and spalling (Figure 3). There were areas of erosion in turf areas (Figure 4) and landscape beds north of PGBT (Figure 5). There were isolated locations of damaged or missing pavement markings (Figure 6). Several locations south of IH-635 had damaged inlet tops (Figure 7).

Figure 2: DNT pavement cracking and spalling SBML north of IH-635.

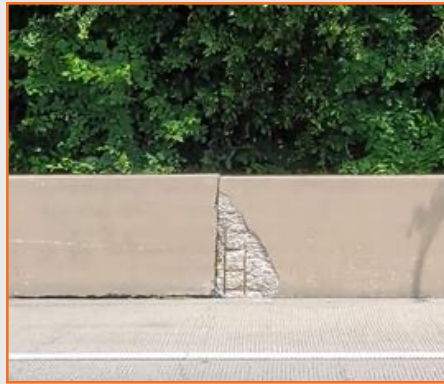
Figure 3: DNT concrete rail damage NBML south of Maple Ave.

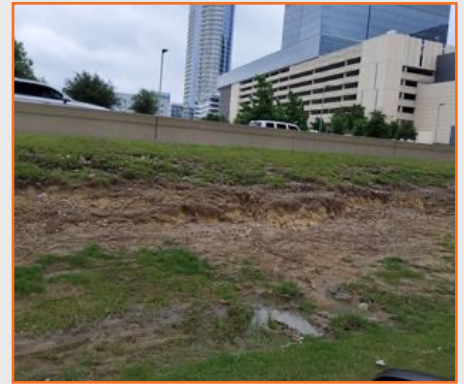
Figure 4: DNT turf erosion SBML south of SRT.

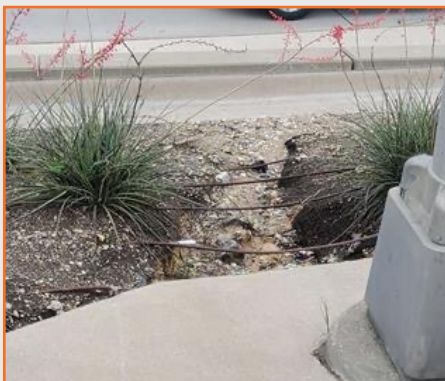
Figure 5: DNT erosion NBML south of Eldorado Pkwy.

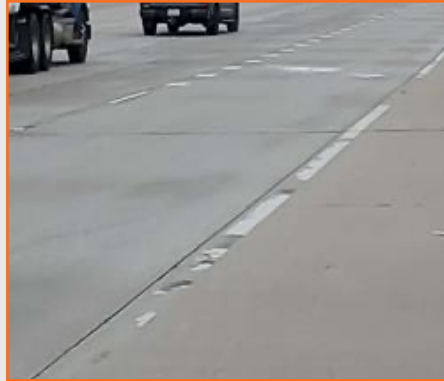
Figure 6: DNT pavement markings faded or missing NBML north of Arapaho Rd.

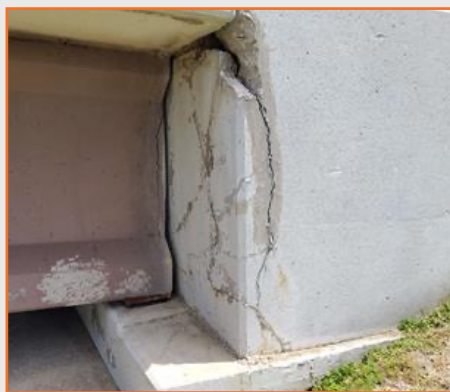
Common observations along the DNT corridor included deterioration of various bridge decks which occurred primarily within the southern-most segment (Figure 9). Cracking and spalling at abutments were observed at multiple locations throughout the corridor (Figure 10). Also noted were locations of concrete beam spalling, some with exposed reinforcement (Figure 11).

Figure 10: DNT abutment backwall cracking at IH-635.

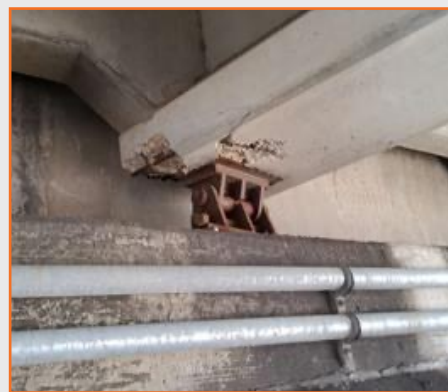
Figure 11: DNT concrete beam end damage with exposed reinforcement at Forest Ln.

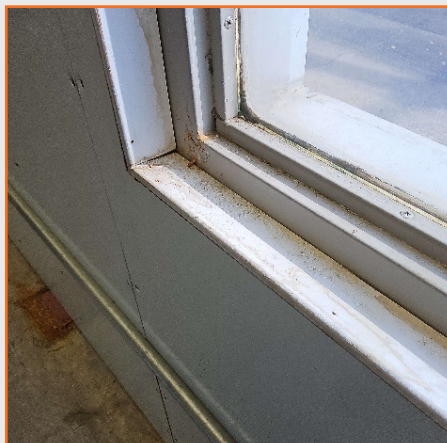
At MLG1, water infiltration (Figure 12) and insect/rodent infestation were noted. At the MLG3 new IT building, spalling at the foundation was observed. At the MLP3 Operations Building, damaged pipe insulation at the yard, foundation spall, joint sealant failure (Figure 13), and ceiling issues were observed. At MLP4, there is a new roof, but the railing wasn't fully reattached (Figure 14), and while the water-damaged gypsum board had been removed, the new gypsum board was not yet installed (Figure 15). The gantry structure coatings failure was again observed, and a basement wall opening wasn't sealed (Figure 16). At the Fiber Hut near MLP2, the gate lock could not be closed for locking (Figure 17), with water infiltration, insect infestation, and GFCI receptacles issues also observed. GEC has been informed that there is a project to renovate the MLP4 building, and that the DNT widening project will remove the tunnels there.

Figure 12: DNT MLG1 water infiltration.

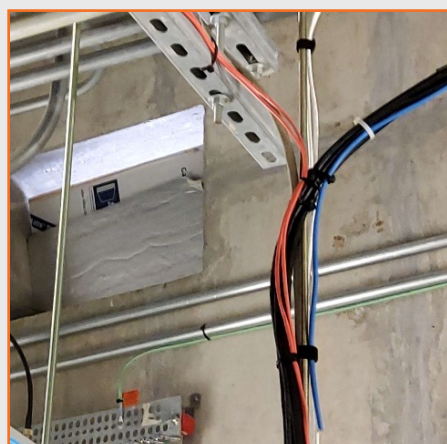
Figure 16: DNT MLP4 basement wall opening.

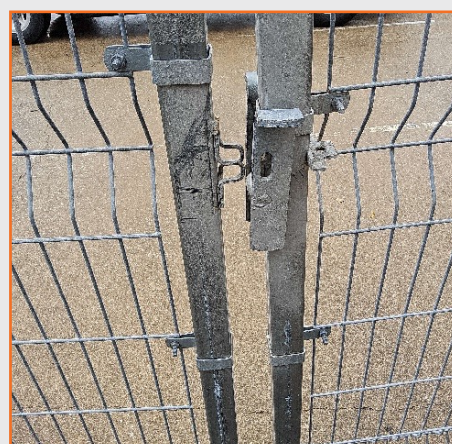
Figure 17: DNT MLP2 Fiber Hut inoperable gate lock.

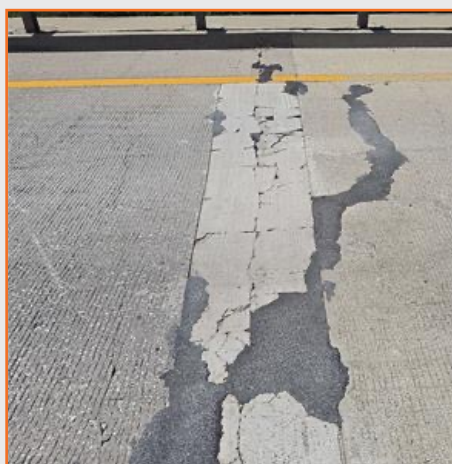
Several locations of ditch and embankment erosion (Figure 18) were observed. Also noted were locations of concrete pavement distresses (Figure 19). Asphalt pavement shoulder deterioration was identified at numerous locations (Figure 20). There was a location that was exhibiting concrete pavement and MBGF separation at Merritt Rd. (Figure 21). There were several locations of concrete barrier cracking and spalling (Figure 22). Multiple locations of damage or faded pavement markings (Figure 23) were identified.

Figure 19: PGBT pavement distress NBML entrance ramp north of Dalworth St.

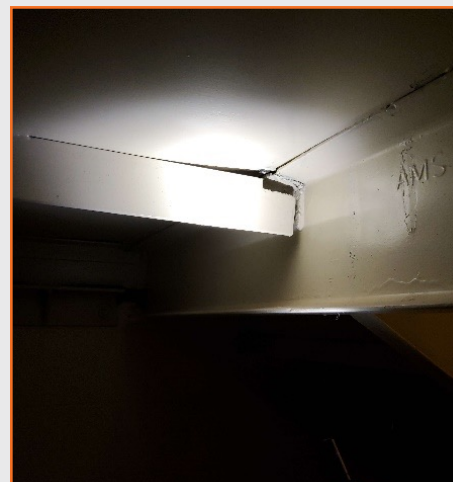
Figure 31: PGBT MLP9 stair frame separation/settling.

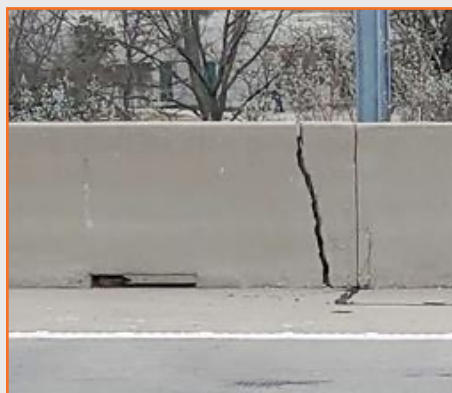
Multiple locations are experiencing concrete pavement deterioration (Figure 35). Also noted were instances of concrete barrier cracking and spalling (Figure 36). There are several locations with erosion within and adjacent to landscape beds (Figures 37 and 38) and in turf areas (Figure 39). Faded or damaged pavement markings (Figure 40) were observed at various locations along the corridor. Also noted are the multiple locations along the frontage road and cross streets of inlet top and curb damage (Figure 41).

Figure 36: SRT concrete rail cracking NBML south of Medical Center Dr.

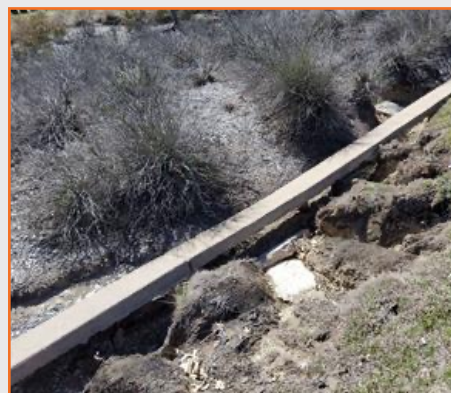
Figure 37: SRT turf and landscape bed erosion NBML at near Custer Rd.

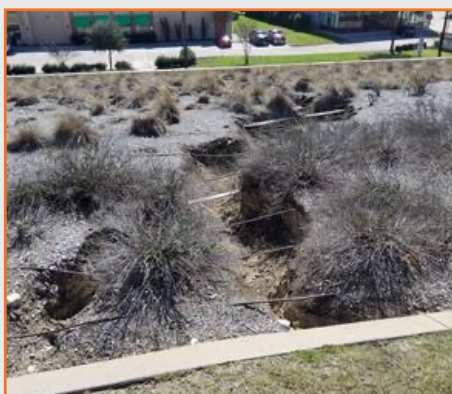
Figure 38: SRT landscape bed erosion NBML at Custer Rd.

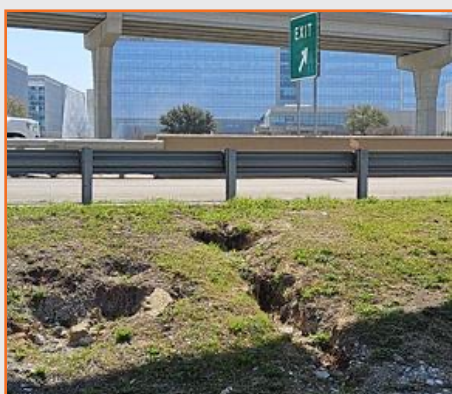
Figure 39: SRT erosion SBML at Lebanon Ln.

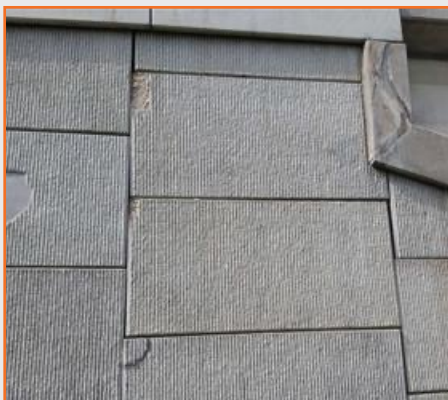
General visual observations included instances of panels that were racked or exhibited some level of spalling or cracking at various locations (Figure 42). These observations alone can not confirm nor negate current wall movement. NTTA, the MMC and the GEC hold regular coordination meetings, and NTTA has confirmed that further evaluation of these walls is being conducted. Water seepage was observed along the northbound frontage road at Custer (Figure 43). There were a few instances of retaining wall coping cracking and spalling (Figure 44).

Figure 42: SRT retaining wall spalling NBML at W. Spring Creek Pkwy.

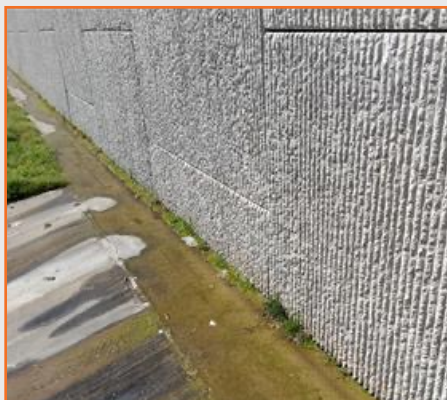
Figure 43: SRT retaining wall with considerable water seepage NBML at Custer Rd.

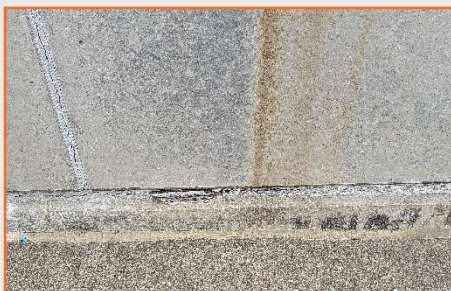
Sealant failure and insect infiltration were observed at the main lane gantry buildings (Figures 48 and 49). The SRT at DNT winter operations facility restroom has a plumbing (water pipe) leak (Figure 50).

Figure 48: SRT MLG1 failed joint sealant.

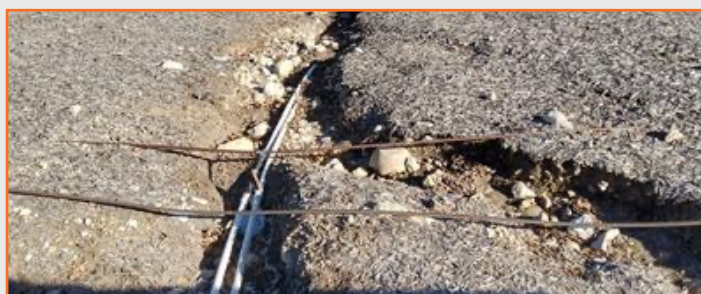
Erosion was noted in ditch lines (Figure 51), landscape beds exposing irrigation lines (Figure 52) and included the undermining of drainage flumes (Figure 53). Observations also included multiple locations with concrete pavement joint deterioration (Figure 54).

Figure 52: CTP landscape erosion NBML at IH 20.

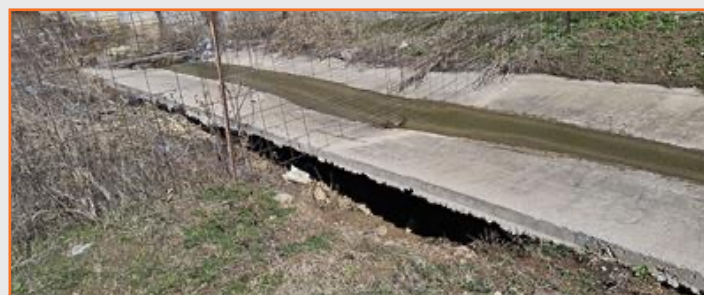
Figure 53: CTP drainage flume undermining SBML north of FM 1187.

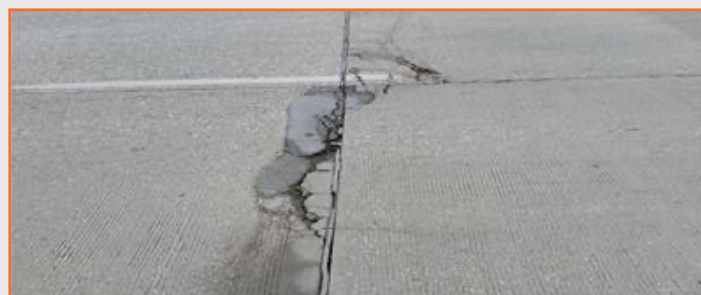
Figure 54: CTP concrete pavement distress at on-ramp from McPherson Blvd.

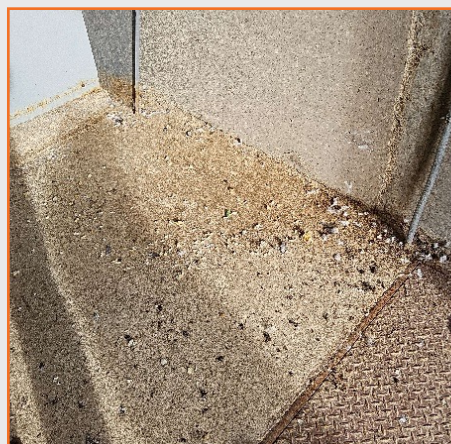
Corrosion was observed on electrical conduit/enclosures (most severe at one box — Figure 72), a separated drain pipe (Figure 73), and insect infestation was noted (Figure 74).

Figure 74: LLTB insect infestation.

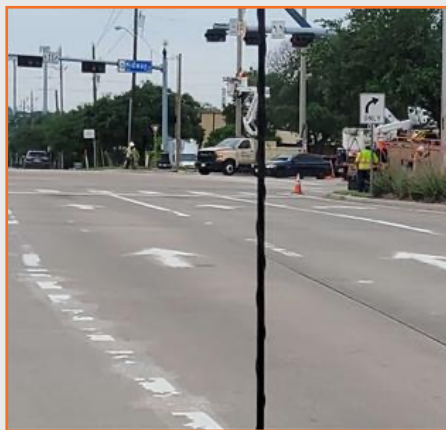
Observations on the roadway include faded or missing pavement markings (Figure 75), concrete pavement distresses (Figure 76), unsealed concrete flume (Figure 77) and damaged access control fencing (Figure 78).

Figure 75: AATT pavement marking deterioration.

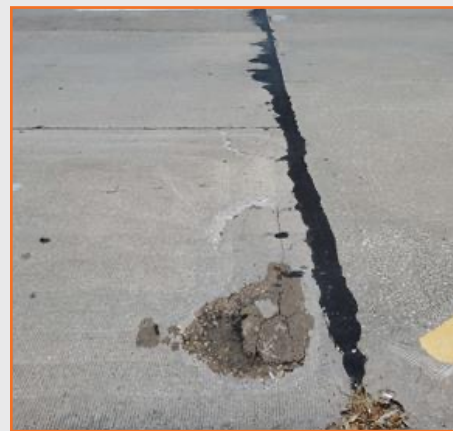
Figure 76: AATT concrete pavement distress.

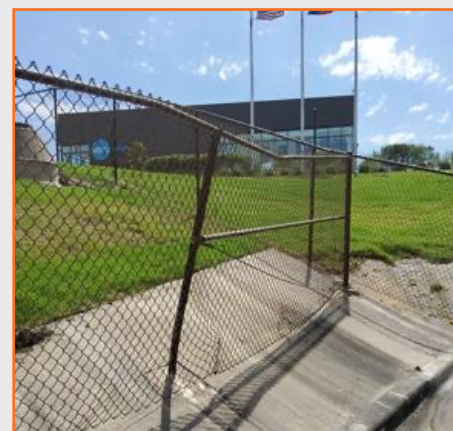
Figure 78: AATT access control fence damage.

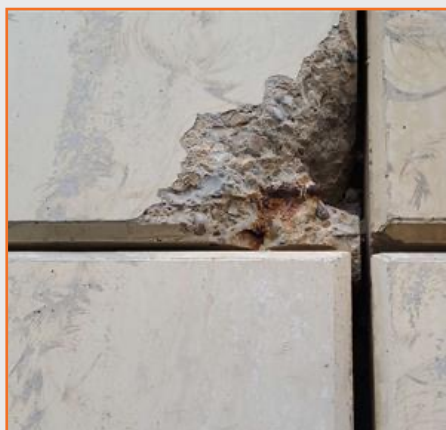
Wall observations include cracked and spalled wall panels (Figures 79 and 80)

Figure 79: AATT retaining wall panel spall on east approach to tunnel.

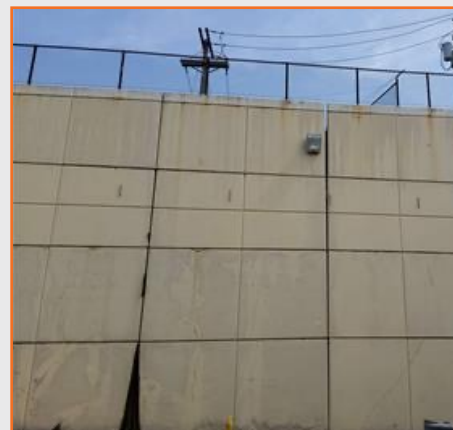
Figure 80: AATT retaining wall panel cracks, spalls and damaged/missing joint seal on west approach to tunnel.

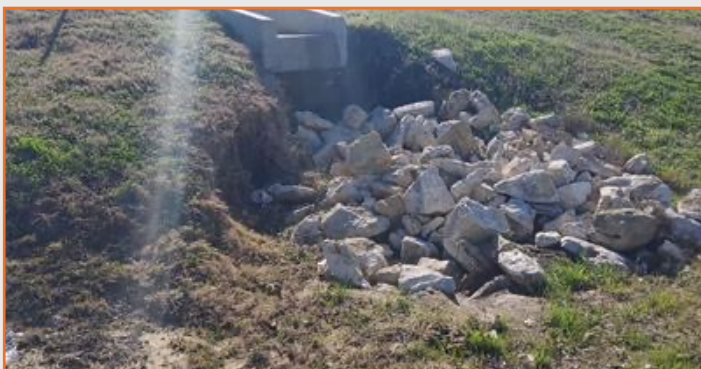
Observations on the roadway include locations concrete pavement deterioration (Figures 85 and 86) and asphalt overlay delamination (Figure 87). Also noted were locations of ditch line and outfall erosion (Figures 88 and 89). There were locations of damaged concrete curb inlets (Figure 90).

Figure 89: 360T drainage culvert outfall erosion at N. Holland Rd.

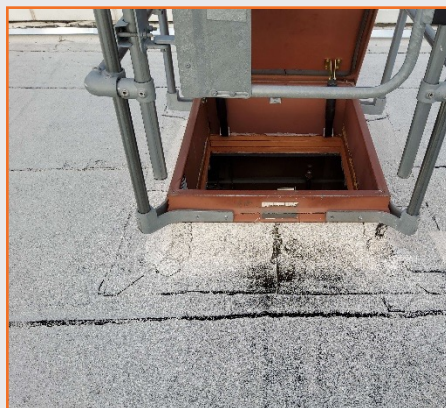
Observations at the Gleneagles 5900 West Plano Parkway Office Center included: a loose handrail at the east roof access ladder (Figure 105), roof top unit (RTU) damaged/bent condensate drain pipes (Figure 106), and continued spalling at a handrail base (Figure 107). Other observations included: RTU non-functioning GFCI receptacles, exterior metal coatings rust, exterior general wear/tear, ceiling issues, minor roof deterioration, and general interior wear/tear. NTTA has reported that there is a project to restore the building exterior finishes.

Figure 105: Gleneagles 5900 Plano Parkway loose roof access handrail.

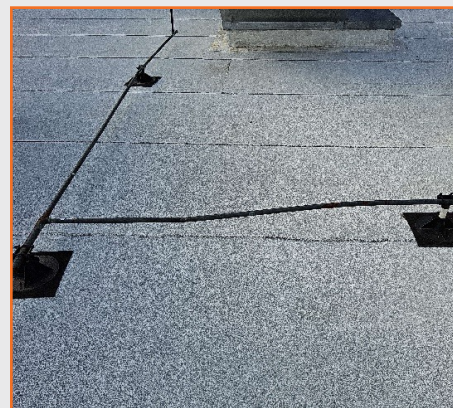
Figure 106: Gleneagles 5900 Plano Parkway damaged RTU condensate drain pipe.

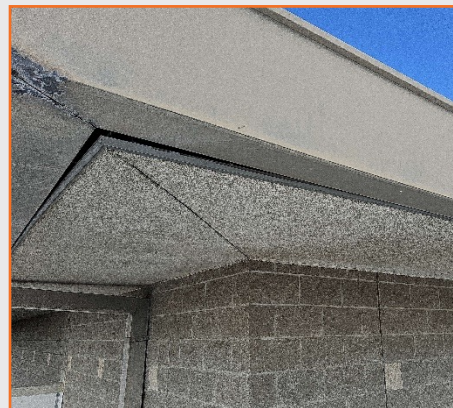
The Gleneagles 5910 West Plano Parkway Office Center reroofing project was completed by inspection time. This project eliminated most of previous years' roof observation issues, though improper installations at a few locations were observed. Other observations included: a sag/separation in the soffit (Figure 108), ceiling issues, minor plumbing items and exterior general wear/tear. GEC knows there is a project to restore the building exterior finishes, and a project to upgrade the data center (which will address ceiling observation issues in the data center).

Figure 108: Gleneagles 5910 Plano Parkway sagging/separated soffit.
