SYSTEM ANNUAL INSPECTION REPORT

Fiscal Year 2025

Subject: FY 2025 GEC System Annual Inspection

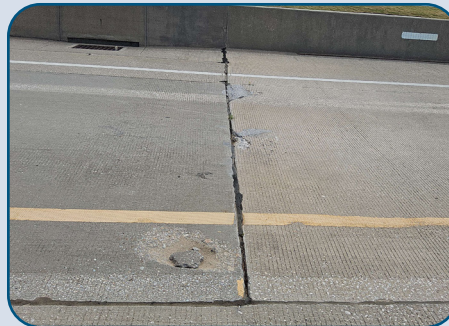
Our observations included several locations of concrete spall and joint deterioration on mainlane and ramp pavement (Figure 2). Also noted were multiple locations where reflective pavement cracking and delamination has migrated through the asphalt overlay (Figure 3). Common erosion issues included turf erosion at backslopes (Figure 4) and erosion at landscape beds resulting in exposed irrigation lines (Figure 5). There were multiple locations south of IH 635 where curb inlet tops have been damaged and have exposed reinforcement (Figure 6). Additionally, there were isolated instances of deteriorated pavement markings (Figure 7).

Figure 2: DNT NB Concrete Pavement Spalling North of Eldorado Pkwy.

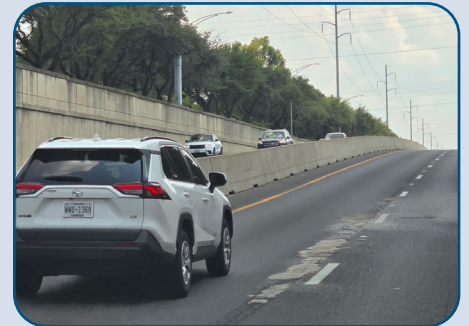
Figure 3: DNT SB Pavement Reflective Cracking and Spalling South of IH 635.

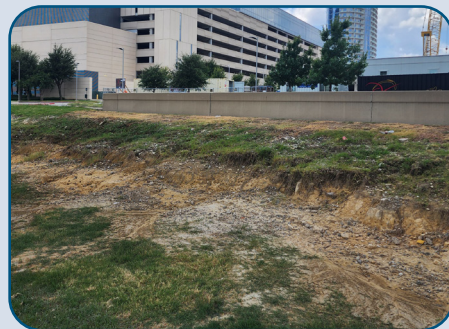
Figure 4: DNT NB Turf Erosion South of SRT.

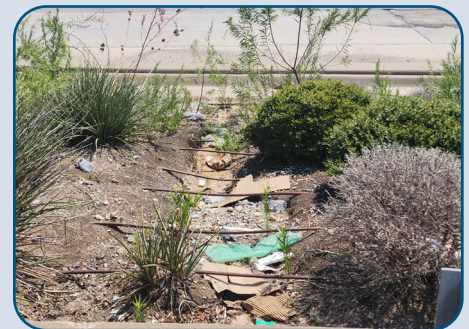
Figure 5: DNT NB Landscape Bed Erosion North of Main St.

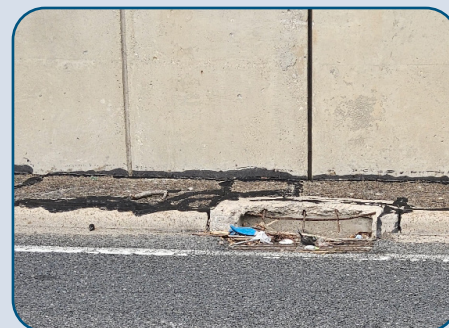
Figure 6: DNT NB Inlet Damage Near Oak Lawn Ave.

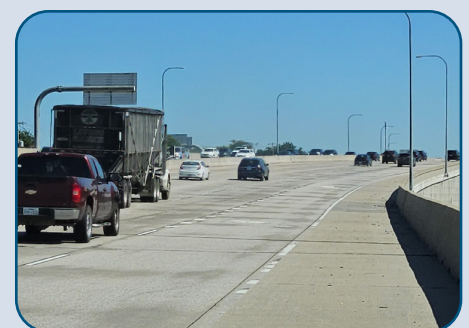
Figure 7: DNT NB Faded Pavement Markings North of PGBT.

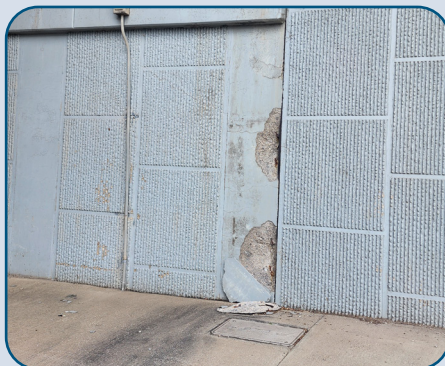
General visual retaining wall observations included instances where walls had racked panels (Figure 8), exhibited concrete cracking and/or spalling (Figure 9), and showed wall staining (Figure 10). These observations alone can not confirm nor negate current wall movement. NTTA, the MMC and the GEC conduct regular coordination meetings where NTTA has confirmed that further evaluation of these walls is being conducted.

Figure 9: DNT MSE Wall Spalling at Headquarters Dr.

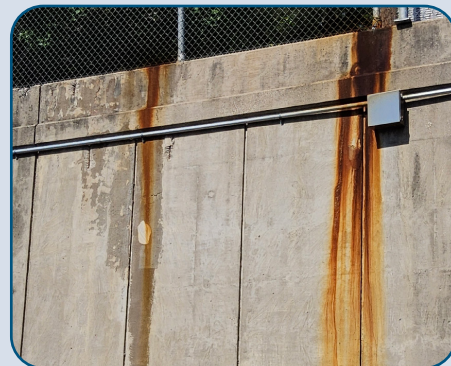
Figure 10: DNT SB Wall Staining at University Blvd.

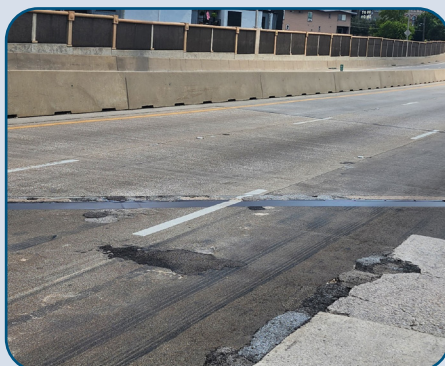
Common observations along the DNT corridor include bridge decks which are exhibiting multiple types of deficiencies including concrete spalling, deterioration of joints, and cracking (Figure 11). Substructure deficiencies include spalling, cracking in the caps with exposed reinforcement in isolated areas (Figures 12,13,14).

Figure 11: DNT Deck Deterioration at Wycliff Ave.

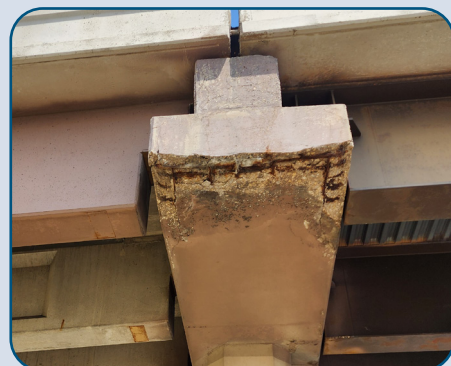
Figure 12: DNT Bent Cap Spalling at IH 635.

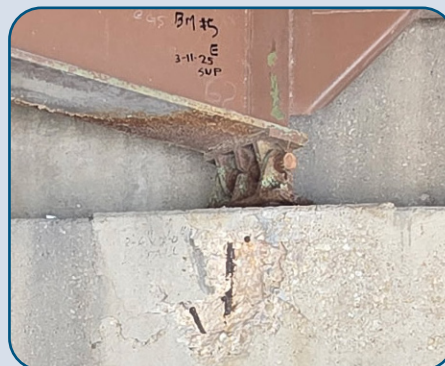
Figure 13: DNT Abutment Spalling at Lomo Alto Dr.

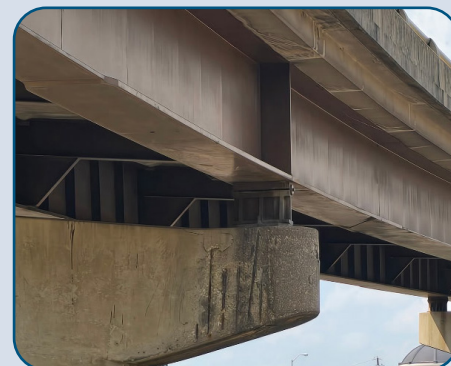
Figure 14: DNT Bent Cap Spalling North of IH 35E.

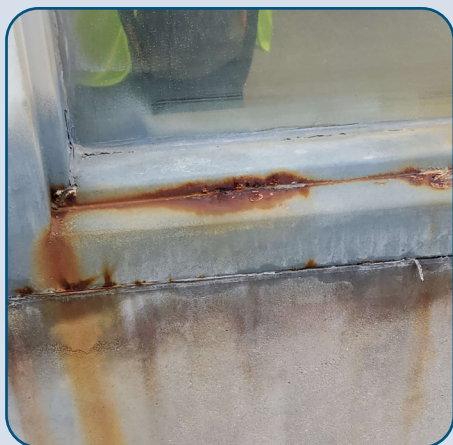
At MLG1, water infiltration, insect/rodent infestation, and window frame corrosion (Figure 15) were noted. At the MLG3 IT building, spalling at the foundation was observed. At the MLP3 Operations Building, damaged pipe insulation (at the yard), foundation spall, joint sealant failure, and ceiling issues were again observed; in addition, a CO2 sensor issue was noted. At MLP4, there is a new roof, but the railing still isn't fully reattached (Figure 16). In addition, the gantry structure coatings failure were again observed, and a basement ventilation opening still wasn't sealed (external ventilation not needed, as the space is now conditioned) (Figure 17). At the Fiber Hut near MLP2, the gate lock still could not be closed for locking (Figure 18), with water infiltration, insect infestation, and GFCI receptacles issues also observed. At the Meaders Lane and DNT Winter Weather Operation Facilities, there was widespread corrosion (Figure 19), while at the US-380 Winter Weather Operation Facility, there was ponding on the roof (Figure 20).

Figure 15: DNT MLG1 Window Frame Corrosion.

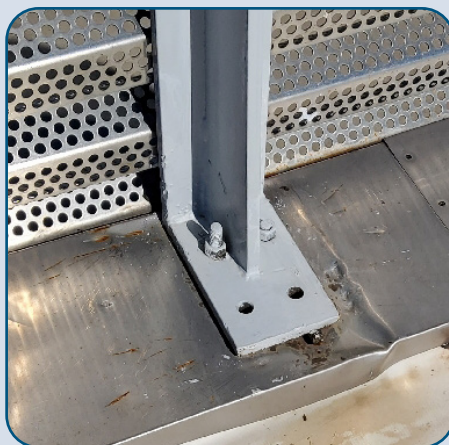
Figure 16: MLP4 Roof Railing Post Partially Reattached.

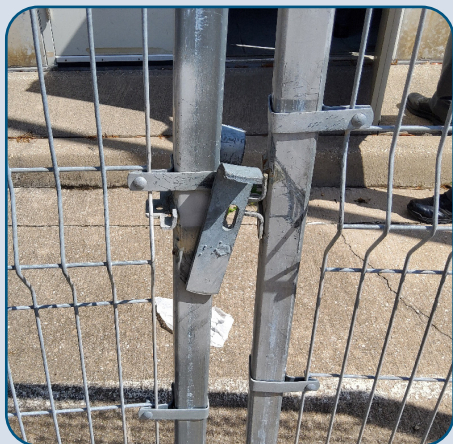
Figure 18: DNT Fiber Hut 1 Uncloseable Gate Lock.

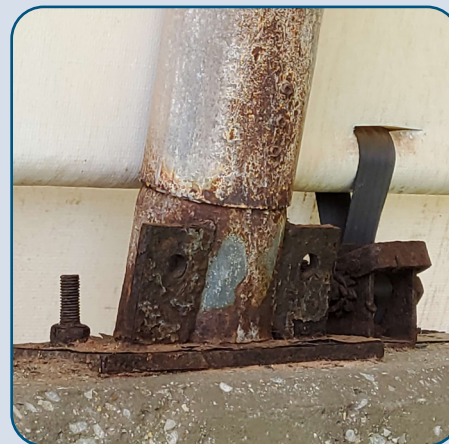
Figure 19: DNT Meaders Lane Winter Weather Operation Facility Corroded Roof Member.

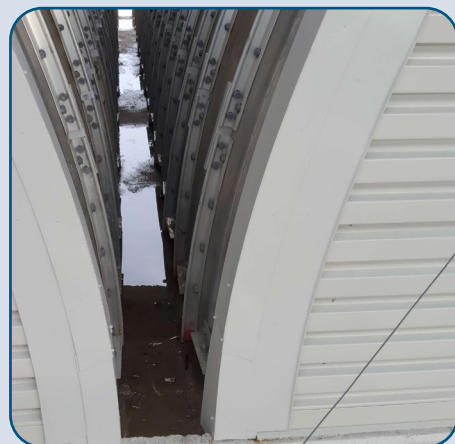
Figure 20: DNT US-380 Winter Weather Operation Facility Roof with Ponding.

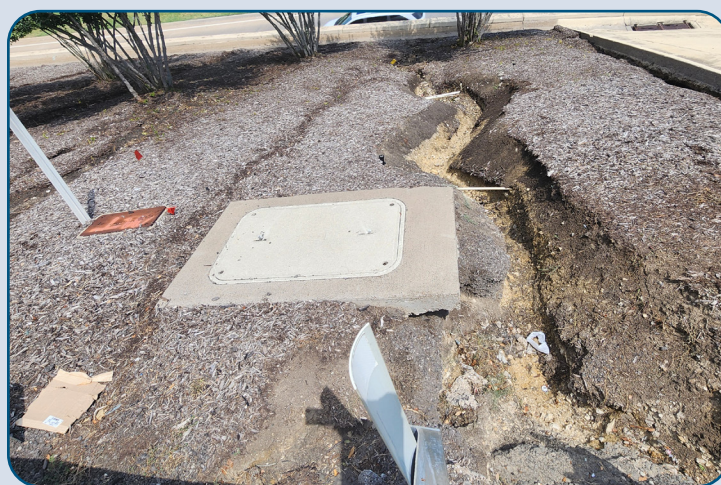
Common roadway deficiencies included cracking and spalling at joints and deterioration of previous pavement repairs (Figures 21,22). There were several locations that included concrete spalling, cracking, and damage to concrete barriers (Figure 23). General erosion observations included erosion of roadway slopes, areas under bridges, and erosion/rutting of landscape beds exposing irrigation lines (Figures 24,25).

Figure 25: PGBT WB Landscape Bed Erosion at Coit Rd.

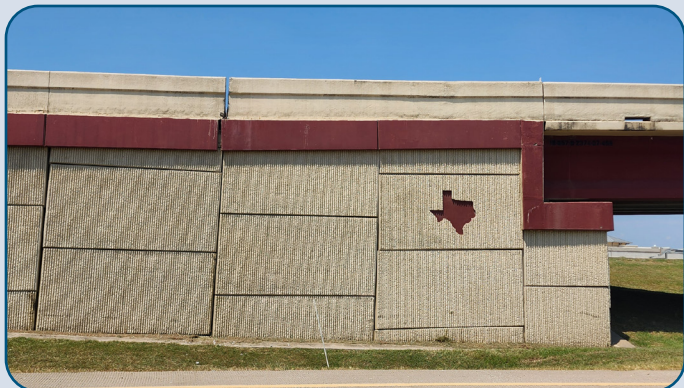
General visual observations included instances of panels that were racked at some locations (Figure 26) and a sound wall alignment issue (Figure 27). These observations alone can not confirm nor negate current wall movement. NTTA, the MMC and the GEC conduct regular coordination meetings where NTTA has confirmed that further evaluation of these walls is being conducted.

Figure 26: PGBT MSE Wall Racked Panels at IH 635.

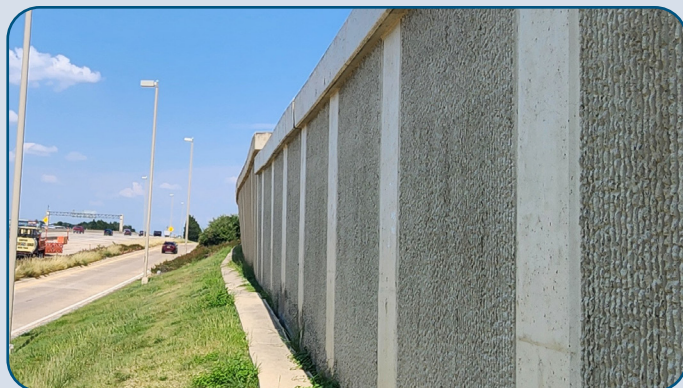
Figure 27: PGBT Soundwall Movement West of Frankford Rd.

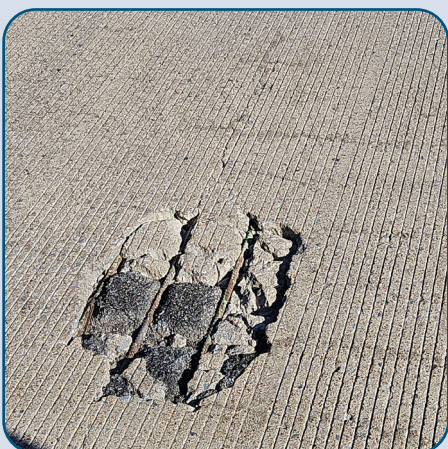
Common observations along the PGBT corridor included bridge deck locations with concrete spalls with some exhibiting exposed reinforcement (Figure 28). Substructure deficiencies include spalling and cracking of the backwalls (Figure 29) and exposed column footings from channel scour and erosion (Figure 30).

Figure 28: PGBT Deck Deterioration on Bridge Over Lake Ray Hubbard.

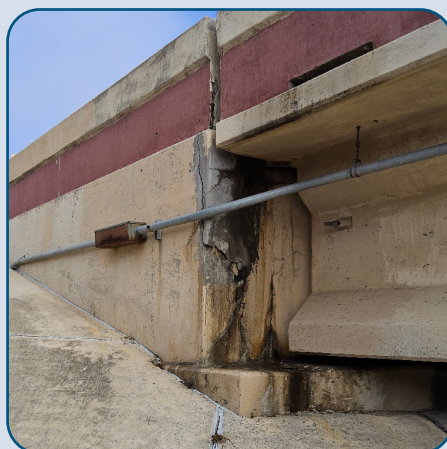
Figure 29: PGBT Backwall Cracking and Spalling West of Hillcrest Rd.

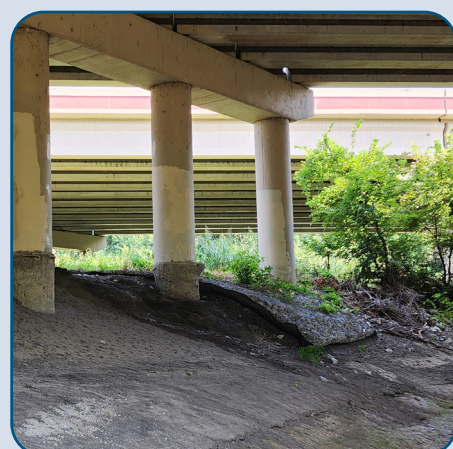
Figure 30: PGBT Channel Erosion at White Rock Creek.

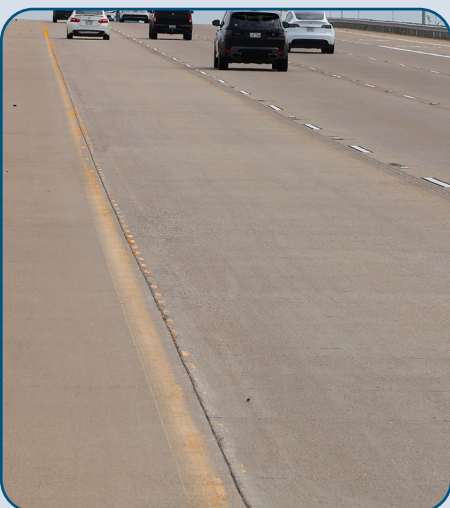
Figure 42: SRT EBML Faded Pavement Markings West of Stacy Rd.

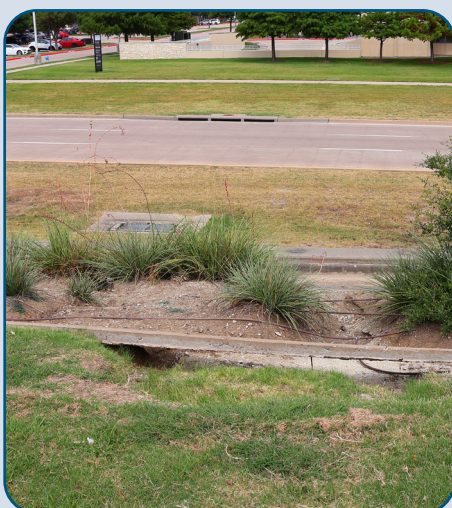
Our observations included several locations of concrete spalls at joints (Figure 39), and joint deterioration and spalls at previous repairs (Figure 40). There were several locations where the longitudinal joint between the pavement and the concrete mow strip for the Metal Beam Guard Fence (MBGF) is unsealed which has led to undermining of the mow strip due to erosion (Figure 41). Additionally, there were several instances of missing, damaged, or faded pavement markings (Figure 42). General erosion issues included erosion at landscape beds resulting in exposed irrigation lines and in some instances undermined landscaping mow strips (Figure 43) and turf erosion (Figure 44).

Figure 43: SRT SB Landscape Bed Erosion and Concrete Boarder Undermining West of S. Lake Forest Dr.

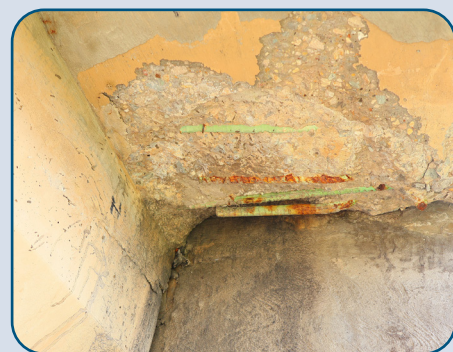
Common observations along the SRT corridor included bridge decks with multiple types of deficiencies including concrete spalling with exposed reinforcement, spalling under the deck (Figures 47,48). Observations also included cracking and spalling of the concrete barrier at the approach slab allowing water to erode the concrete flume (Figure 49). Superstructure observations included spalling of concrete beams with exposed reinforcement due to impact with the backwall (Figure 50).

Figure 48: SRT NB Under Deck Spalling West of Spring Creek Pkwy.

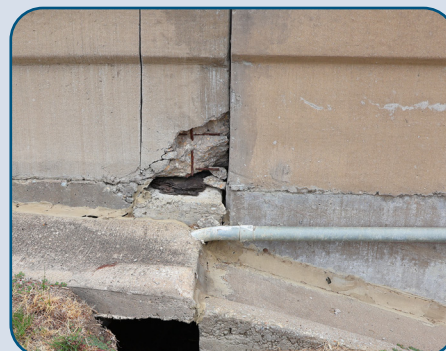
Figure 49: SRT NB Cracked Approach Rail Allowing Water to Erode the Backside at Standridge Dr.

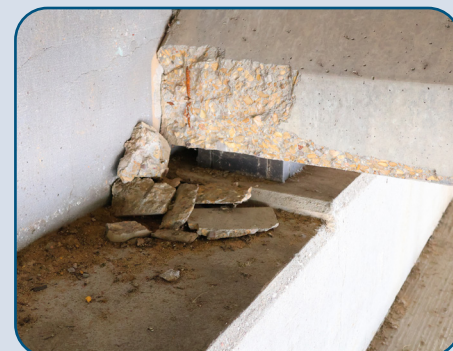
Figure 50: SRT SB Beam Hitting Backwall at West Rowlett Creek.

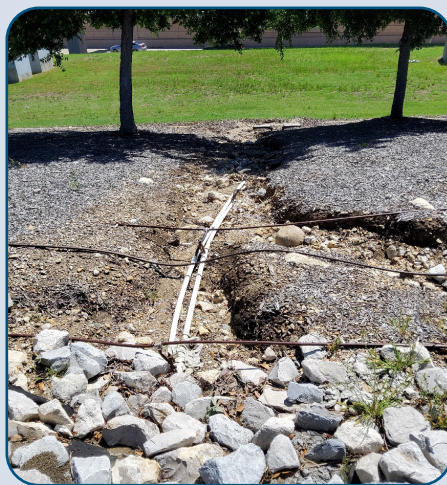
Common roadway deficiencies included concrete cracking and spalling of concrete pavement joints (Figure 54) and minor concrete spalling (Figure 55). There are several locations exhibiting separation between the concrete shoulder and the concrete mow strip for the MBGF (Figure 56). There are also areas where erosion is undermining the concrete mow strip for the MBGF (Figure 57). Other common erosion issues included erosion and rutting at landscape beds resulting in exposed irrigation lines and turf erosion and rutting at backslopes (Figures 58,59).

Figure 58: CTP NB Landscape Bed Erosion with Exposed Irrigation South of IH 20.

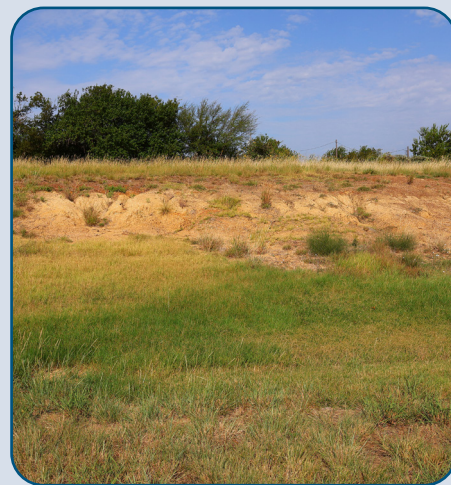
Figure 59: CTP SB Turf Erosion South of CR 913.

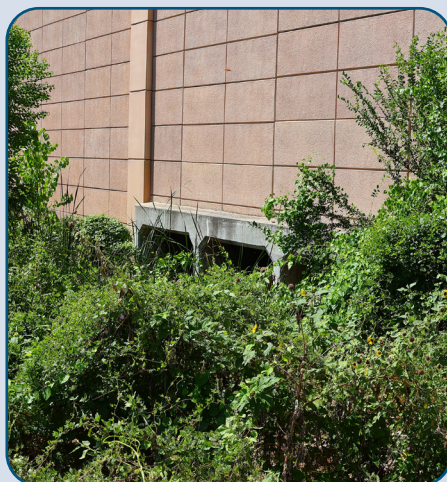
Common bridge observations along the Chisholm Trail Parkway corridor included locations with damaged concrete mow strip at the MBGF between the concrete shoulder and the concrete flume (Figure 62). Other observations included overgrown vegetation and small trees within the channel and adjacent to a bridge class culvert (Figure 63) and erosion to an unlined channel under a bridge (Figure 64).

Figure 63: CTP NB Obstructions at Bridge Class Culvert Headwall North of Dutch Branch Rd.

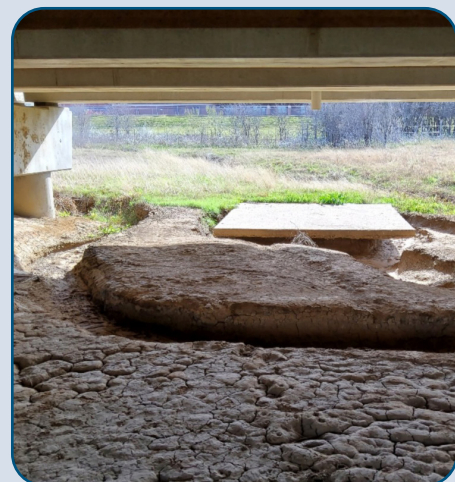
Figure 64: CTP NB Channel Erosion South of CR 913.

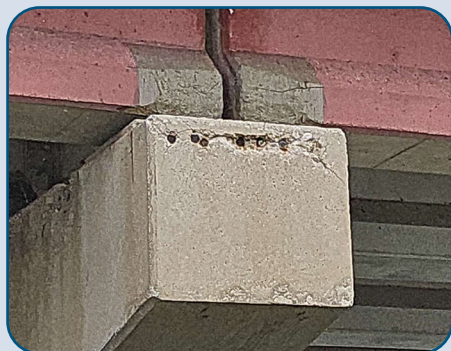
Common observations along the MCLB corridor included concrete spalling on the bridge deck (Figure 71), concrete spalling on the column collars (Figure 72), concrete spalling with exposed reinforcement on the bent caps (Figures 73, 74), and concrete spalling with exposed reinforcement on backwalls (Figure 75).

Figure 73: MCLB Bent Cap Spalling with Exposed Reinforcement.

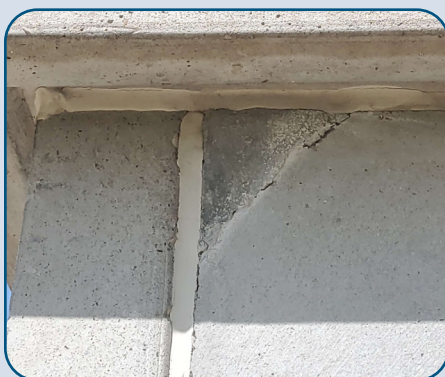
MCLB facilities are in generally good condition. The Fiber Hut had exterior wear/cracking (Figure 76), exterior joint failures (Figure 77), and water infiltration.

Figure 76: MCLB Fiber Hut Exterior Wear.

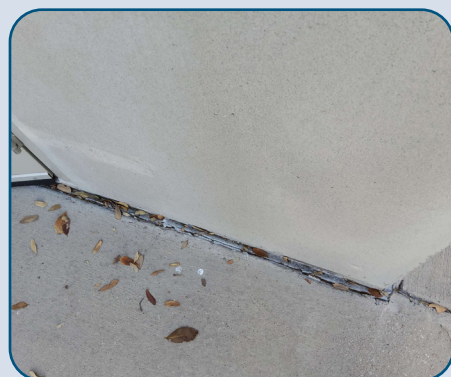
Figure 77: MCLB Fiber Hut Joint Failure.

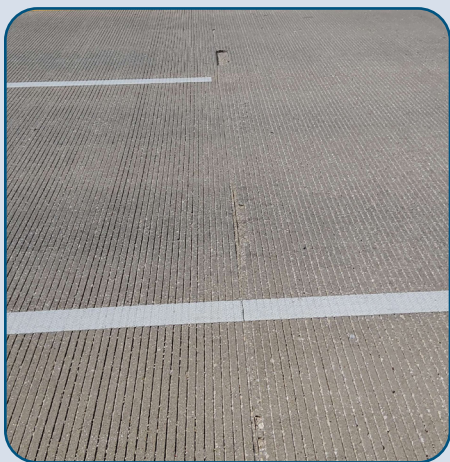
Common observations along the LLTB corridor included minor concrete spalling at joints (Figure 80). There were several locations that included concrete spalling, cracking, and damage to concrete rail (Figure 81) and bent caps exhibited staining from a corroded junction boxes (Figure 82).

Figure 80: LLTB Deck Spalling.

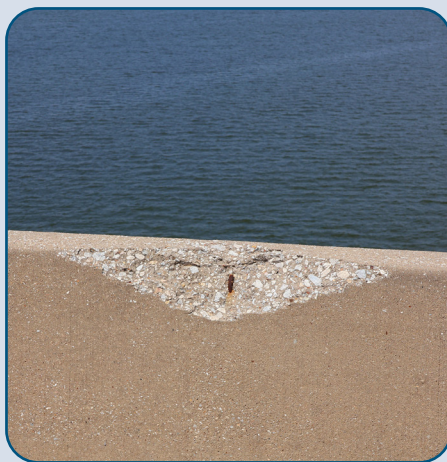
Figure 81: LLTB Concrete Rail Spalling.

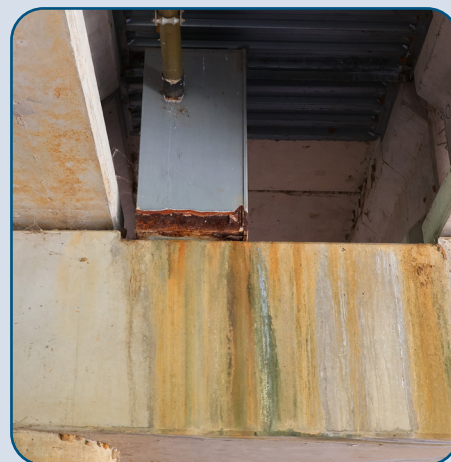
Figure 82: LLTB Corroded Junction Box/Bent Cap Staining.

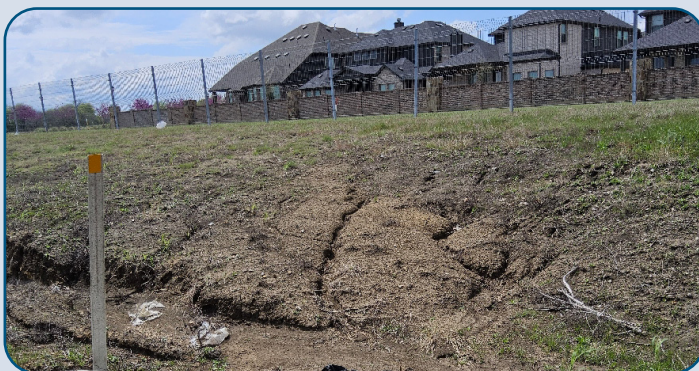
Common roadway deficiencies included cracking and spalling at joints (Figure 95). Other observations included damaged curb inlet tops with exposed reinforcement (Figure 96). Common erosion issues included outfall drainage structures being undermined (Figure 97) and eroded backslopes contributing to silted end treatments (Figure 98). There were several locations that included concrete spalls, cracking, and damage to concrete barriers (Figure 99).

Figure 98: 360T SB Slope Erosion and Sediment Buildup North of Sawmill Way.

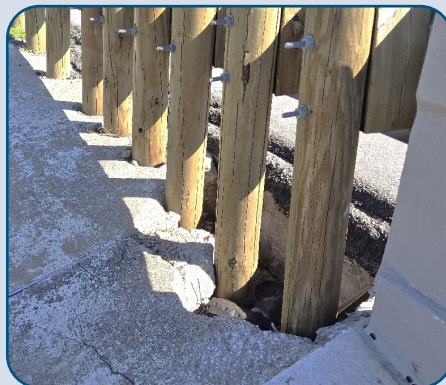
Common observations along the 360T corridor included damage concrete riprap mow strip for the MBGF at the bridge approach (Figure 102), silted in and obstructed headwalls of bridge class culverts (Figure 103), and concrete cracking and/or spalling with exposed reinforcement at the backwalls (Figures 104, 105).

Figure 102: 360T SB MBGF Mow Strip Undermining at SE Green Oaks Blvd.

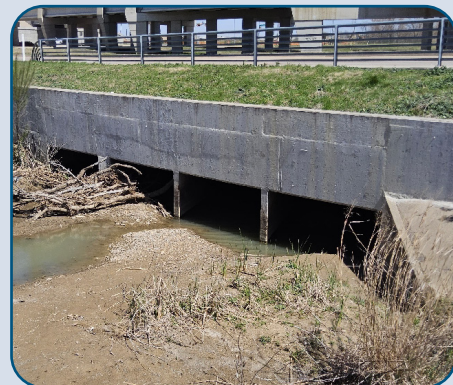
Figure 103: 360T SB Bridge Class Culvert with Sediment Buildup and Obstructions South of Lone Star Rd.

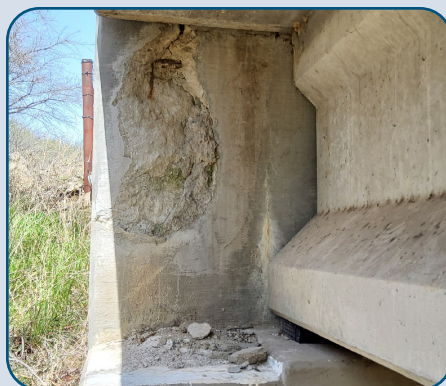
Figure 104: 360T SB Backwall Cracking and Spalling North of N. Holland Rd.

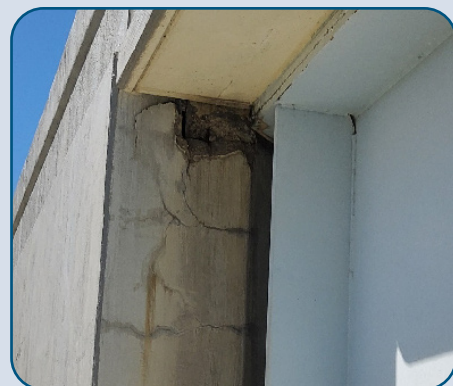
Figure 105: 360T NB Backwall Cracking and Spalling at NE Green Oaks Blvd.

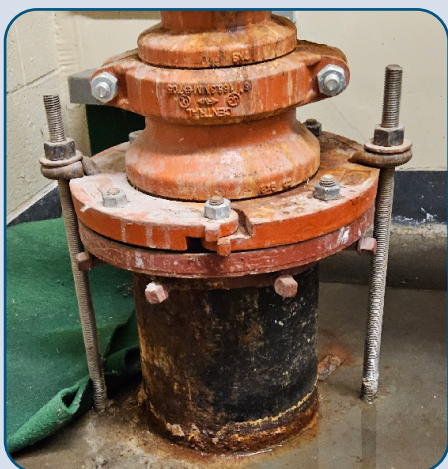
Observations at the Plano Operations Center again included: fire riser pipe corrosion (Figure 110), roof fasteners loose (Figure 111), Bulk Storage Building roof drain separations/damage (Figure 112), pipe penetration boots damaged/improperly installed (Figure 113), gutters damaged (Figure 114), joint sealant failures, and minor rust/paint failure at the outbuildings (Figure 115). GEC knows there are planned projects to upgrade the Truck Wash Building and the Bulk Storage Building.

Figure 110: POC Fire Riser Corrosion.

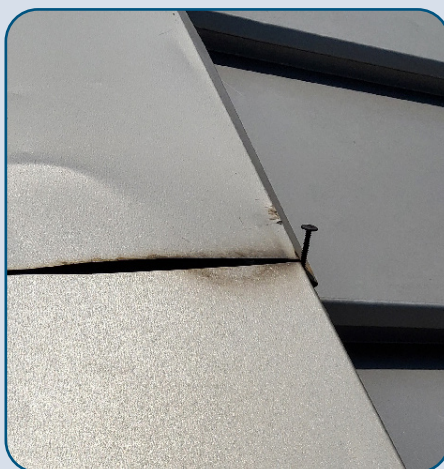
Figure 111: POC Roof Fasteners Loose.

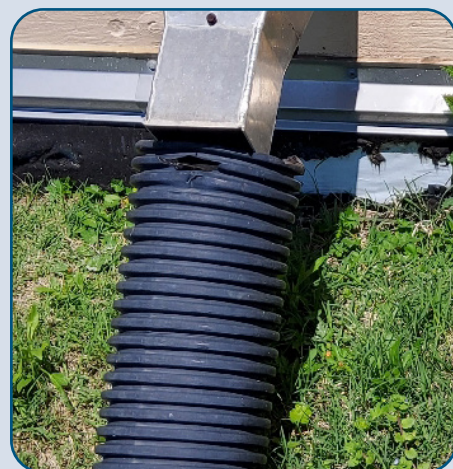
Figure 112: POC Bulk Storage Building Roof Drain Degradation.

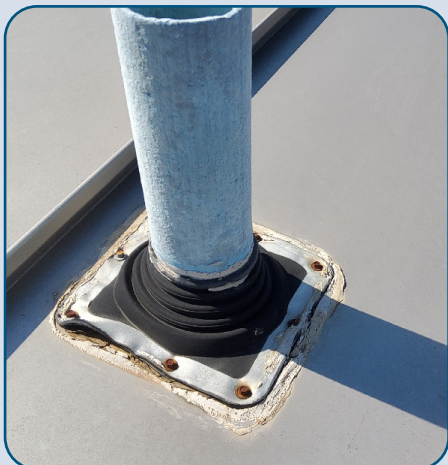
Figure 113: POC Damaged Roof Penetration.

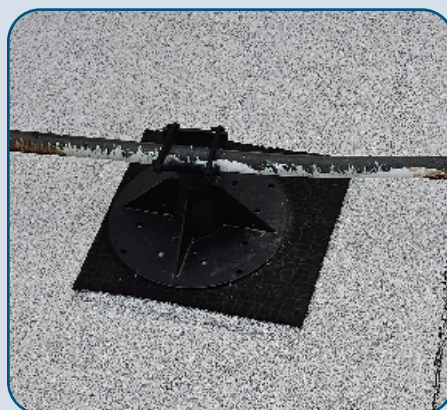
Observations at the Gleneagles 5900 West Plano Parkway Office Center again included: damaged/bent RTU condensate drain pipes (Figure 117), non-functioning exhaust fans, non-functioning RTU GFCI receptacles, ceiling issues, roof deterioration (Figure 118), and general interior wear/tear.

Figure 117: Gleneagles 5900 Bent HVAC Drain Pipe.

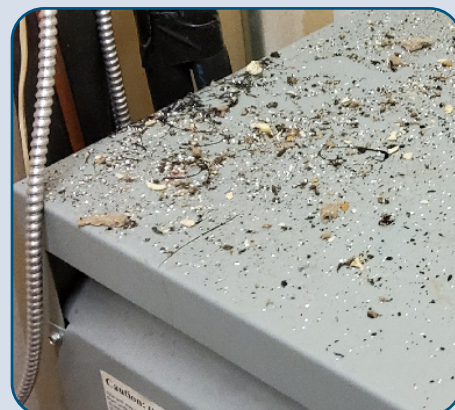
The Gleneagles 5910 West Plano Parkway Office Center observations included: a red-tagged Fire Alarm Control Panel (Figure 119), ceiling issues, minor plumbing items and insect infestation (Figure 120). GEC knows the data center project will address ceiling observation issues in the data center.

Figure 120: Gleneagles 5910 Insect Infestation.
