NORTH TEXAS TOLLWAY AUTHORITY

# SYSTEM ANNUAL INSPECTION REPORT

## Fiscal Year 2026

Subject: FY 2026 GEC System Annual Inspection

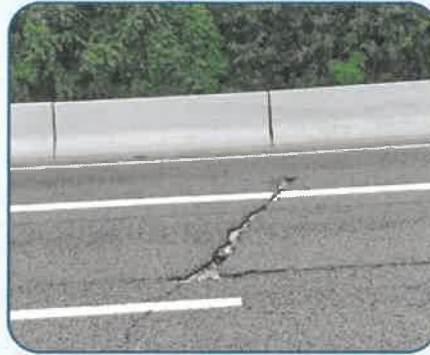
Our visual observations included several locations of reflective pavement cracking (Figure 2) and delamination that have migrated through the existing overlays on the mainlane pavement. Also noted were multiple locations where pavement joints, both longitudinal and transverse, are unsealed (Figure 3) due to damaged sealants or where the joint sealant material has met its expected lifecycle. Additionally, there were isolated instances of missing, damaged, and faded pavement markings (Figure 4) and erosion at landscape beds resulting in exposed irrigation lines (Figure 5). There were multiple locations south of IH 635 where curb inlet tops have been damaged and have exposed reinforcing steel (Figure 6). The inspection program also observed instances of concrete pavement spalling (Figure 7) corridor-wide which is consistent with the age, pavement types and traffic volumes on the roadway.

Figure 2: DNT SB Reflective Pavement Cracking South of Galleria Dr.

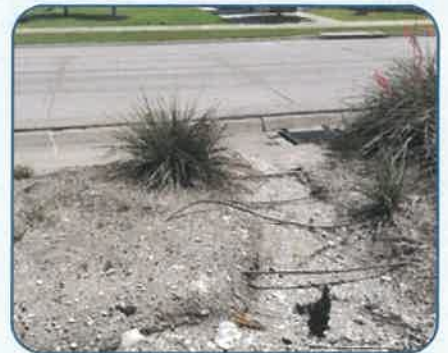
Figure 5: DNT NB Landscape Bed Erosion North of Cotton Gin Rd.

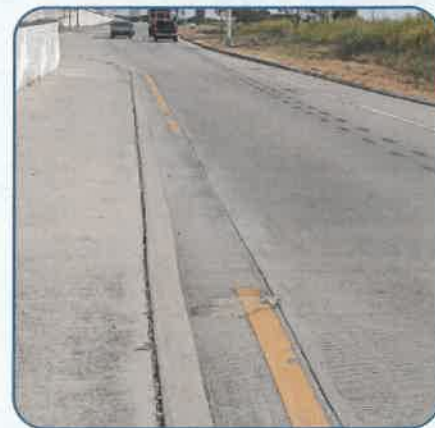
Our observations included isolated unsealed longitudinal joints (Figure 20) and asphalt shoulder cracking (Figure 21). There were multiple locations that exhibited deterioration of pavement markings (Figure 22) in addition to general erosion observations that include erosion of roadway turf slopes and undermining of the flume (Figure 23) and within landscape beds (Figure 24).

Figure 22: PGBT SB Damaged or Faded Pavement Markings North of Merritt Rd.

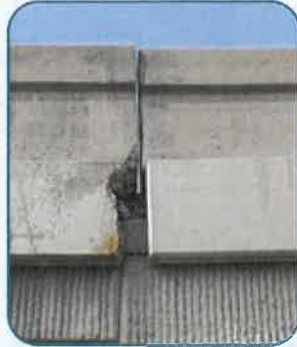
*Figure 42: SRT EB MSE Coping Spalling West of Spring Creek Pkwy.*

Our observations included instances of wall panels that were racked or exhibited concrete cracking and/or spalling (Figure 41) or coping that cracked and spalled (Figure 42). These observations alone cannot confirm nor negate current wall movement. NTTA, the MMC and the GEC conduct regular coordination meetings where NTTA has confirmed that further evaluation of these walls is being conducted.

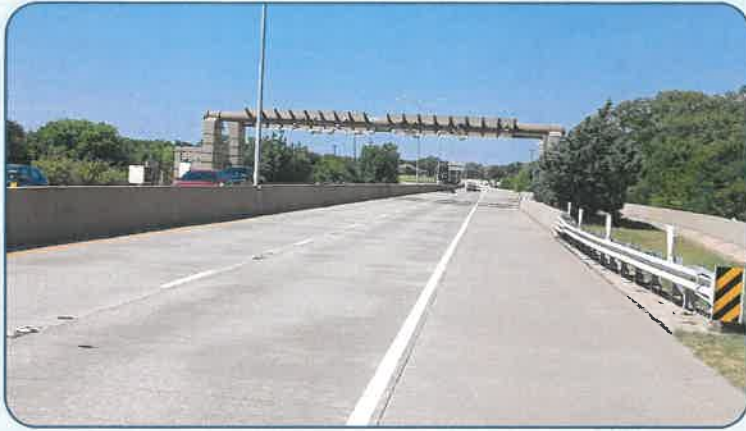
Figure 74: LLTB Roadway Approach.

The LLTB roadway assets are subject to normal deterioration associated with environmental exposure and aging. Because the roadway within the LLTB corridor consists of several short, non-contiguous pavement sections and is supported by an active routine maintenance program, very few maintenance observations were identified during this year's assessment. Planned mainlane restriping, together with continued routine maintenance activities, will further enhance roadway safety and visibility, address minor maintenance needs, and preserve the long-term safety, functionality, and serviceability of the facility. (Figure 74)
