ANNUAL INSPECTION REPORT SPECIAL PROJECTS SYSTEM

FISCAL YEAR 2013

Prepared by Atkins North America, Inc.
General Engineering Consultant

May 2013

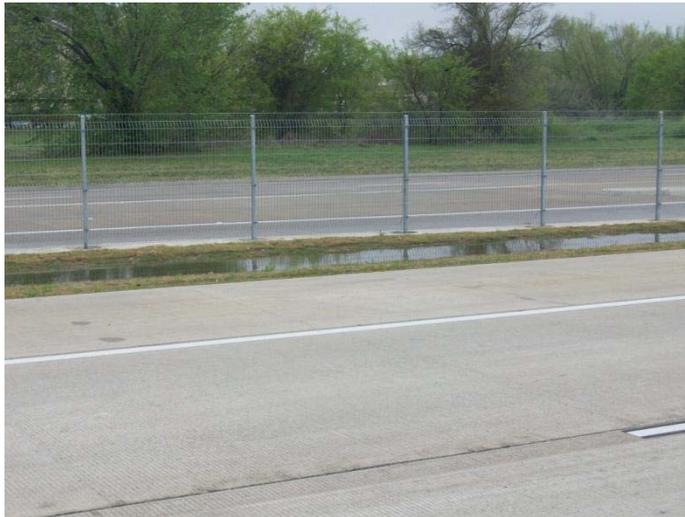
4

Standing water – Median between NBML and NBFR – North of Dickey Road – Sta 313+00

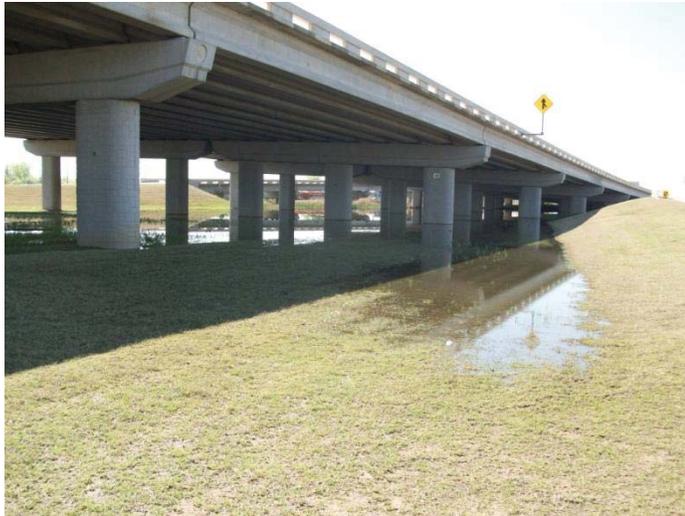
6

Standing water – Lower Tarrant/Trinity/Oakdale Bridge – Bent 48 – Sta 547+00

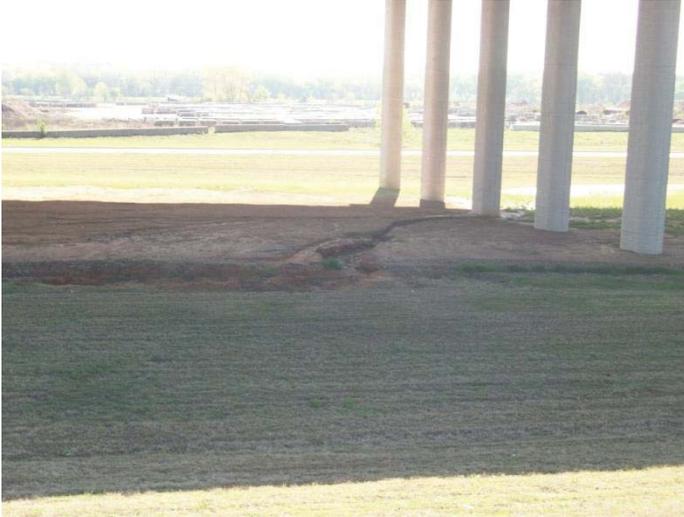
20

Erosion – Rock Island/TRE/Conflans Bridge – Bent 18 – Sta 629+00

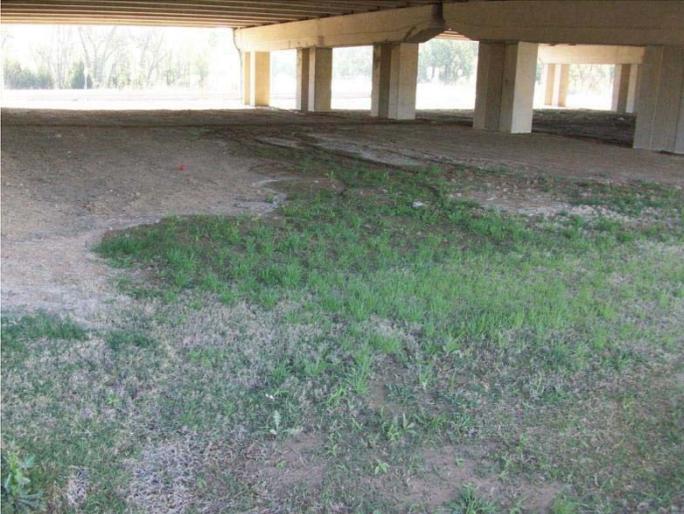
22

Erosion – Rock Island/TRE/Conflans Bridge – Bent 51 – Sta 667+00

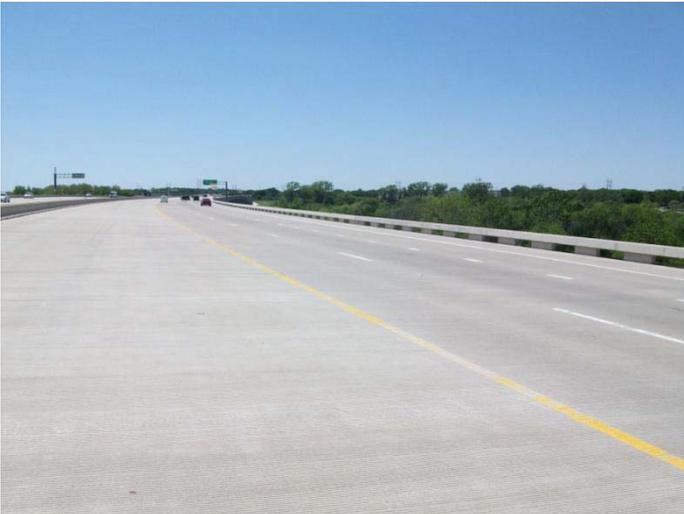
24

Faded pavement markings – SBML – North Carrier Parkway to SH 183– Sta 463+00 to 709+00
